***Performance Evaluation of New Orleans and Southeast  
Louisiana Hurricane Protection System***

***Floodwall and Levee Performance  
Analysis***

***Interagency Performance Evaluation  
Task Force (IPET)***

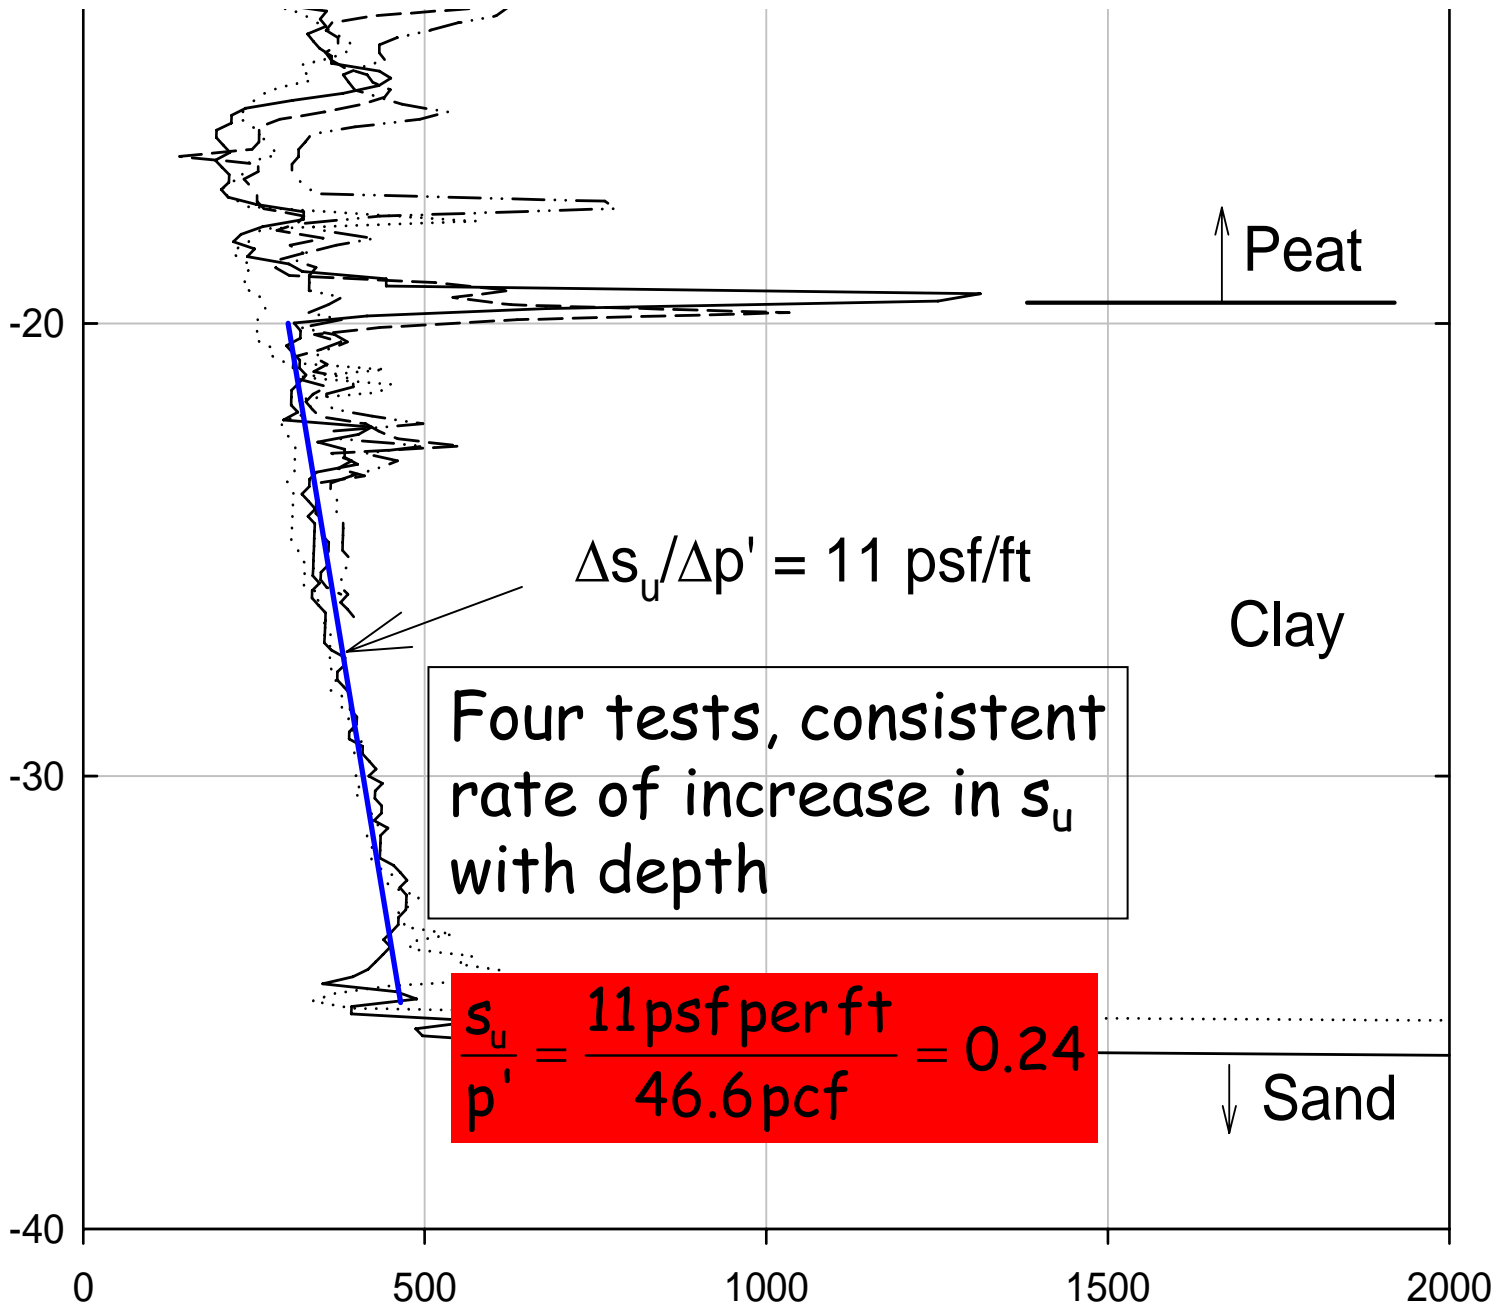
$$\Delta s_u / \Delta p' = 11 \text{ psf/ft}$$

Four tests, consistent rate of increase in  $s_u$  with depth

$$\frac{s_u}{p'} = \frac{11 \text{ psf per ft}}{46.6 \text{ pcf}} = 0.24$$

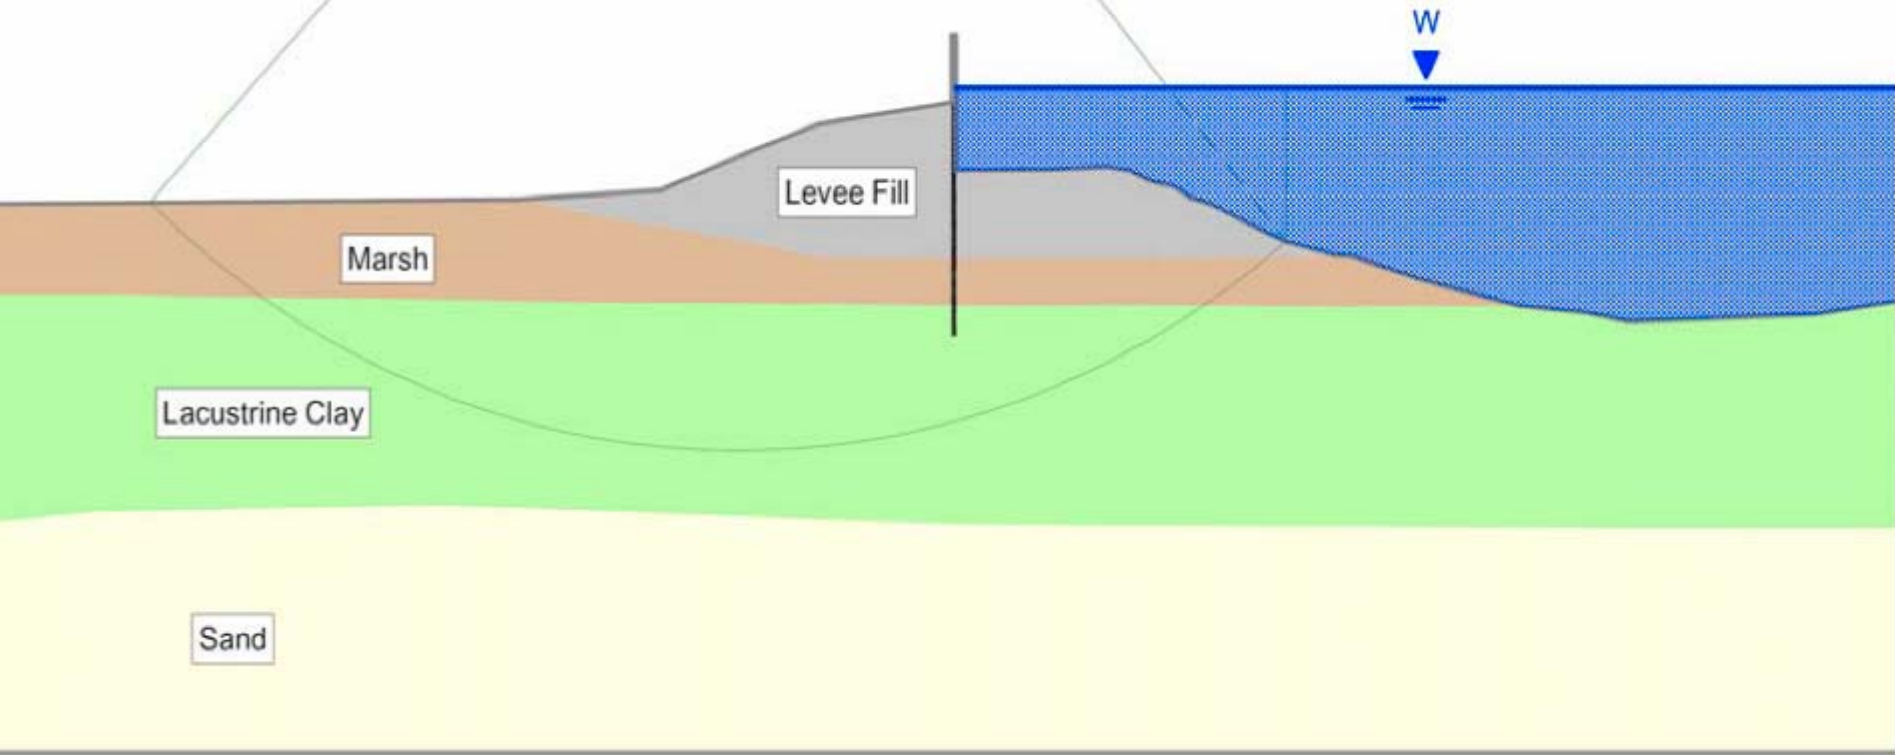
F = 1.57

17th Street Canal  
Case 6  
Section 10+00  
Water elev. = +8.5 ft NGVD  
No tension crack

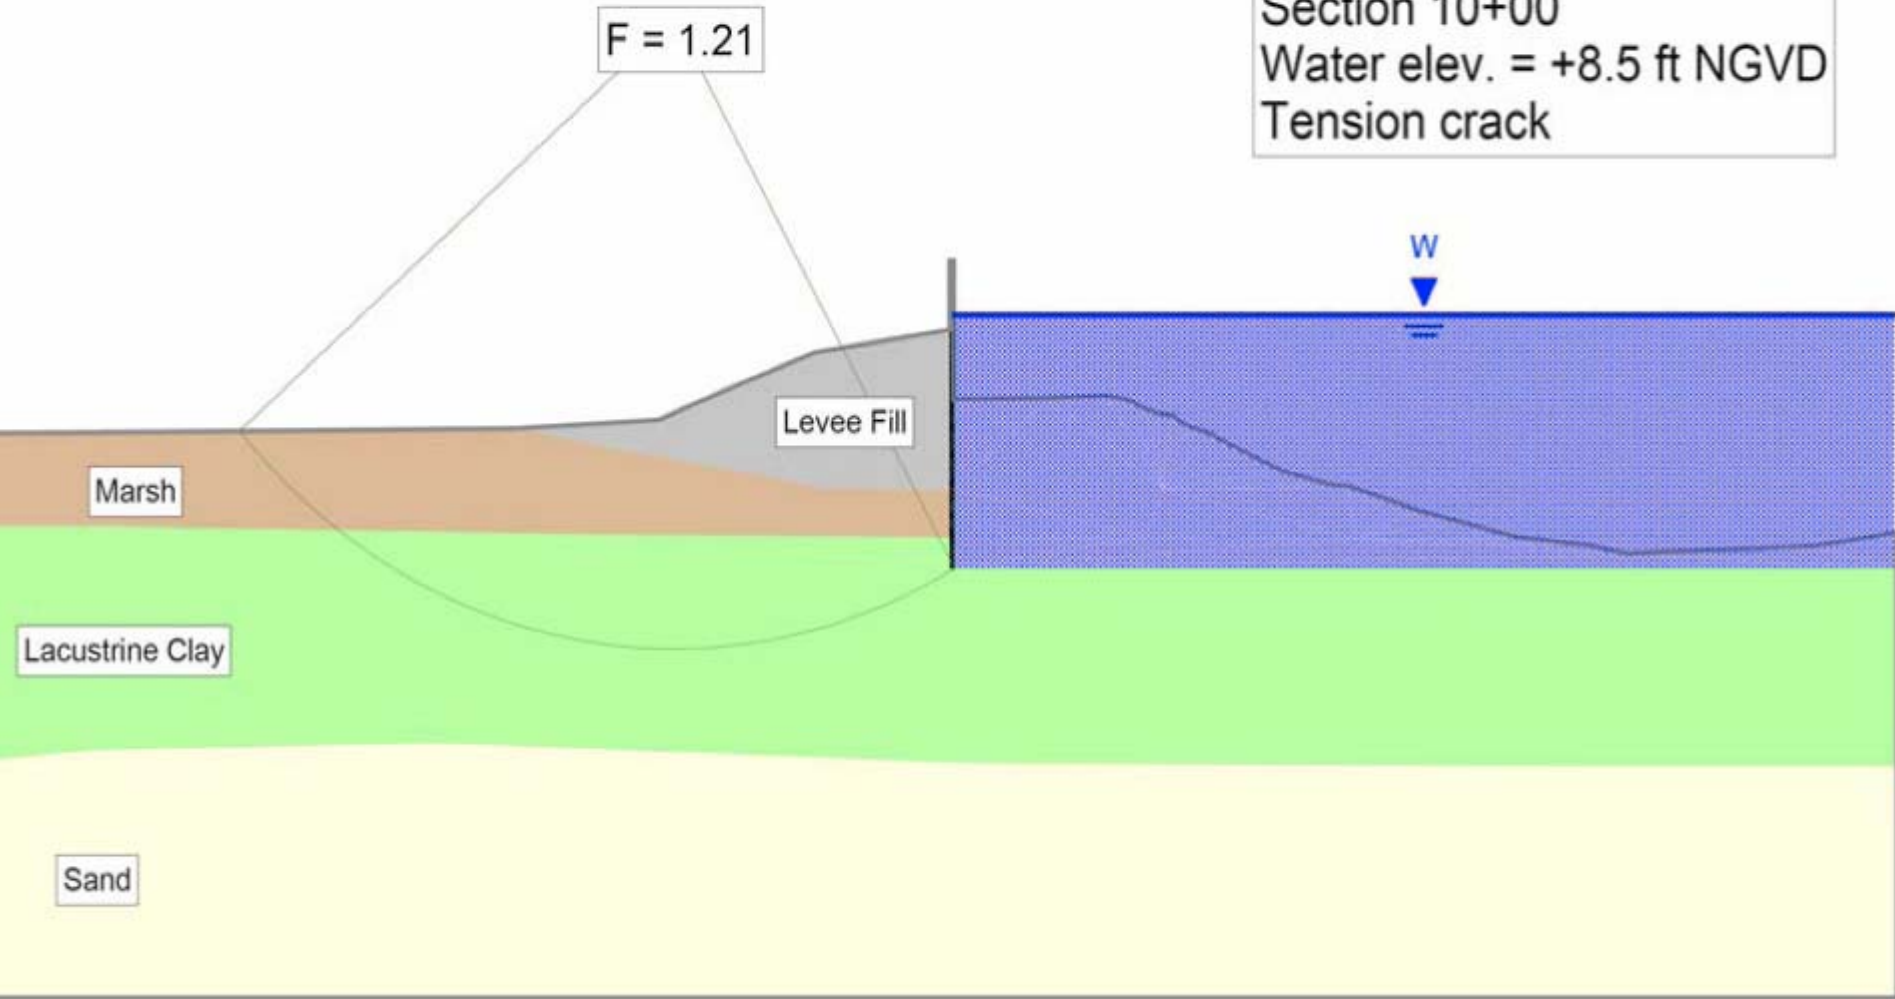
17th Street Canal  
Case 7  
Section 10+00  
Water elev. = +8.5 ft NGVD  
Tension crack

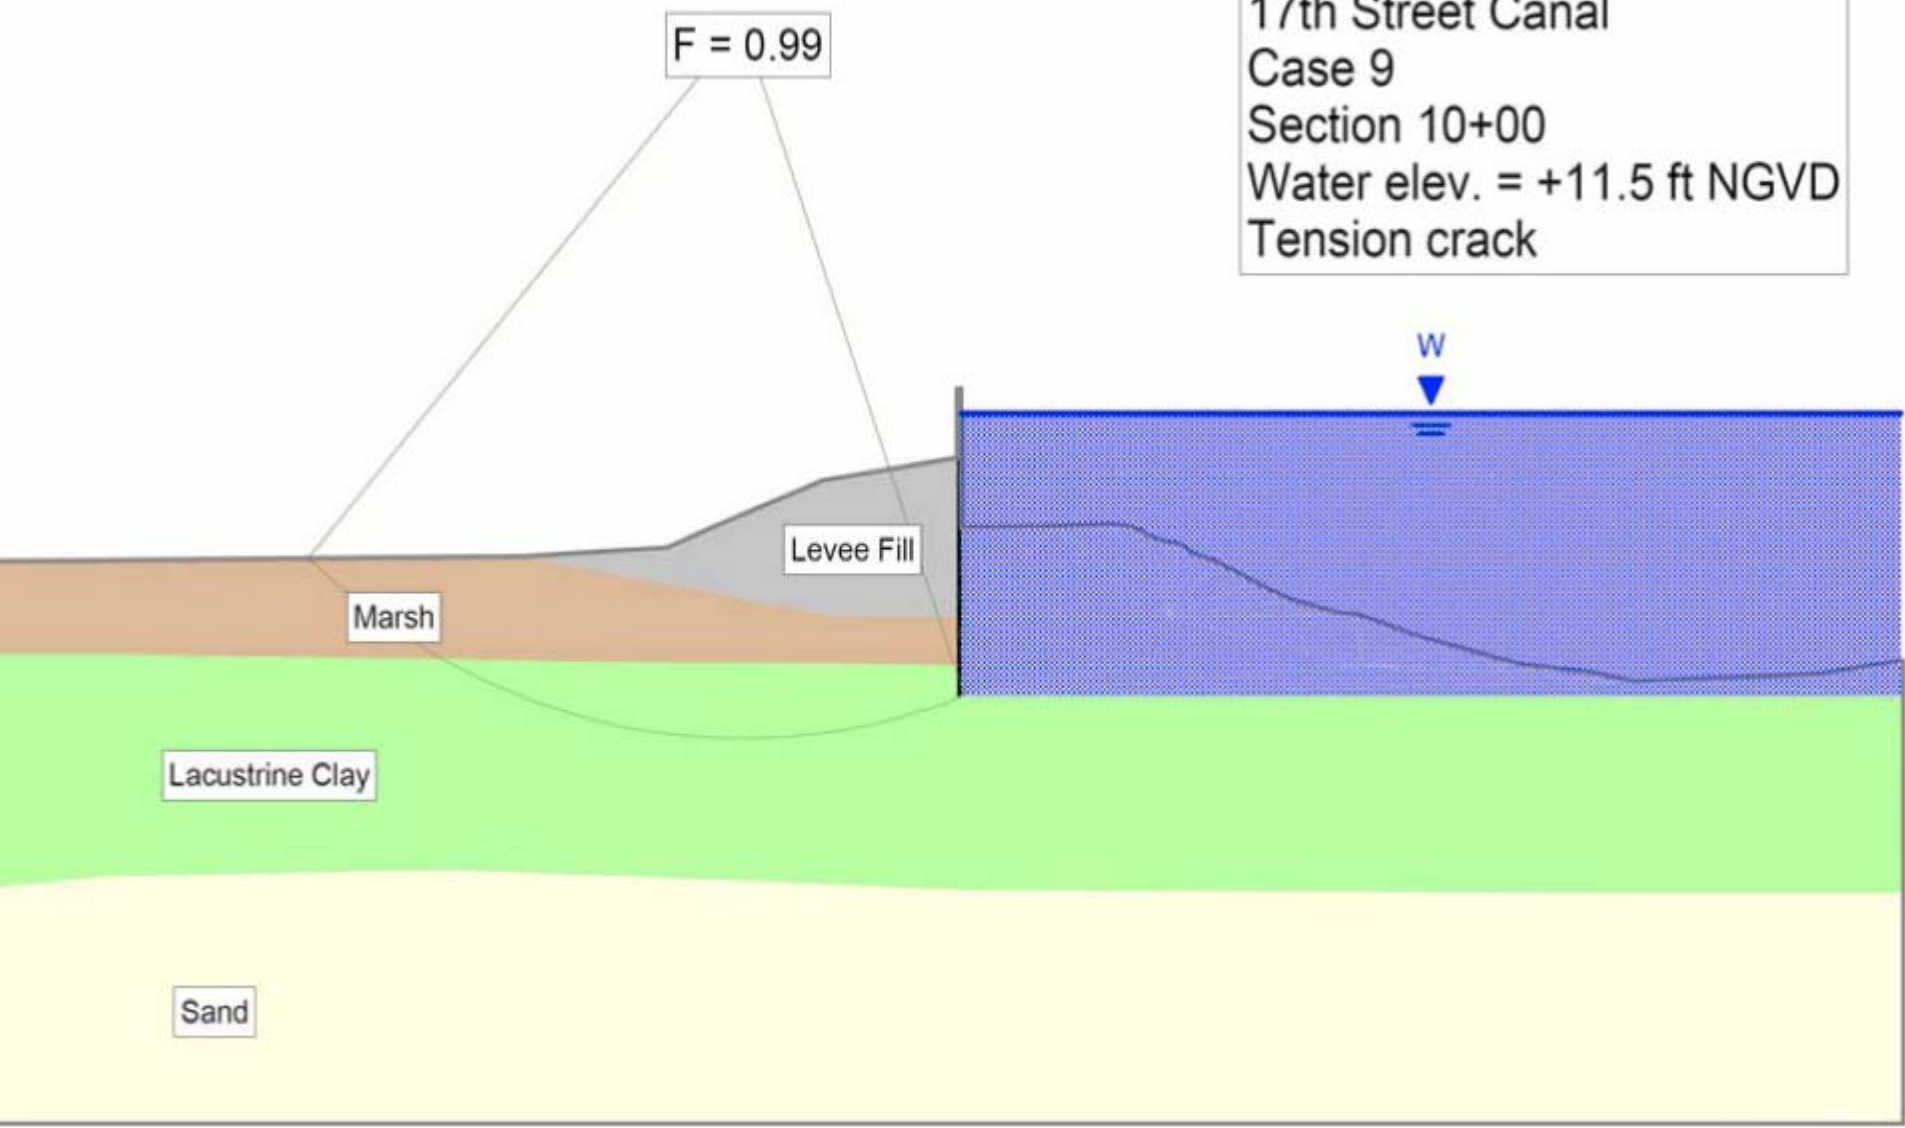
17th Street Canal  
Case 9  
Section 10+00  
Water elev. = +11.5 ft NGVD  
Tension crack

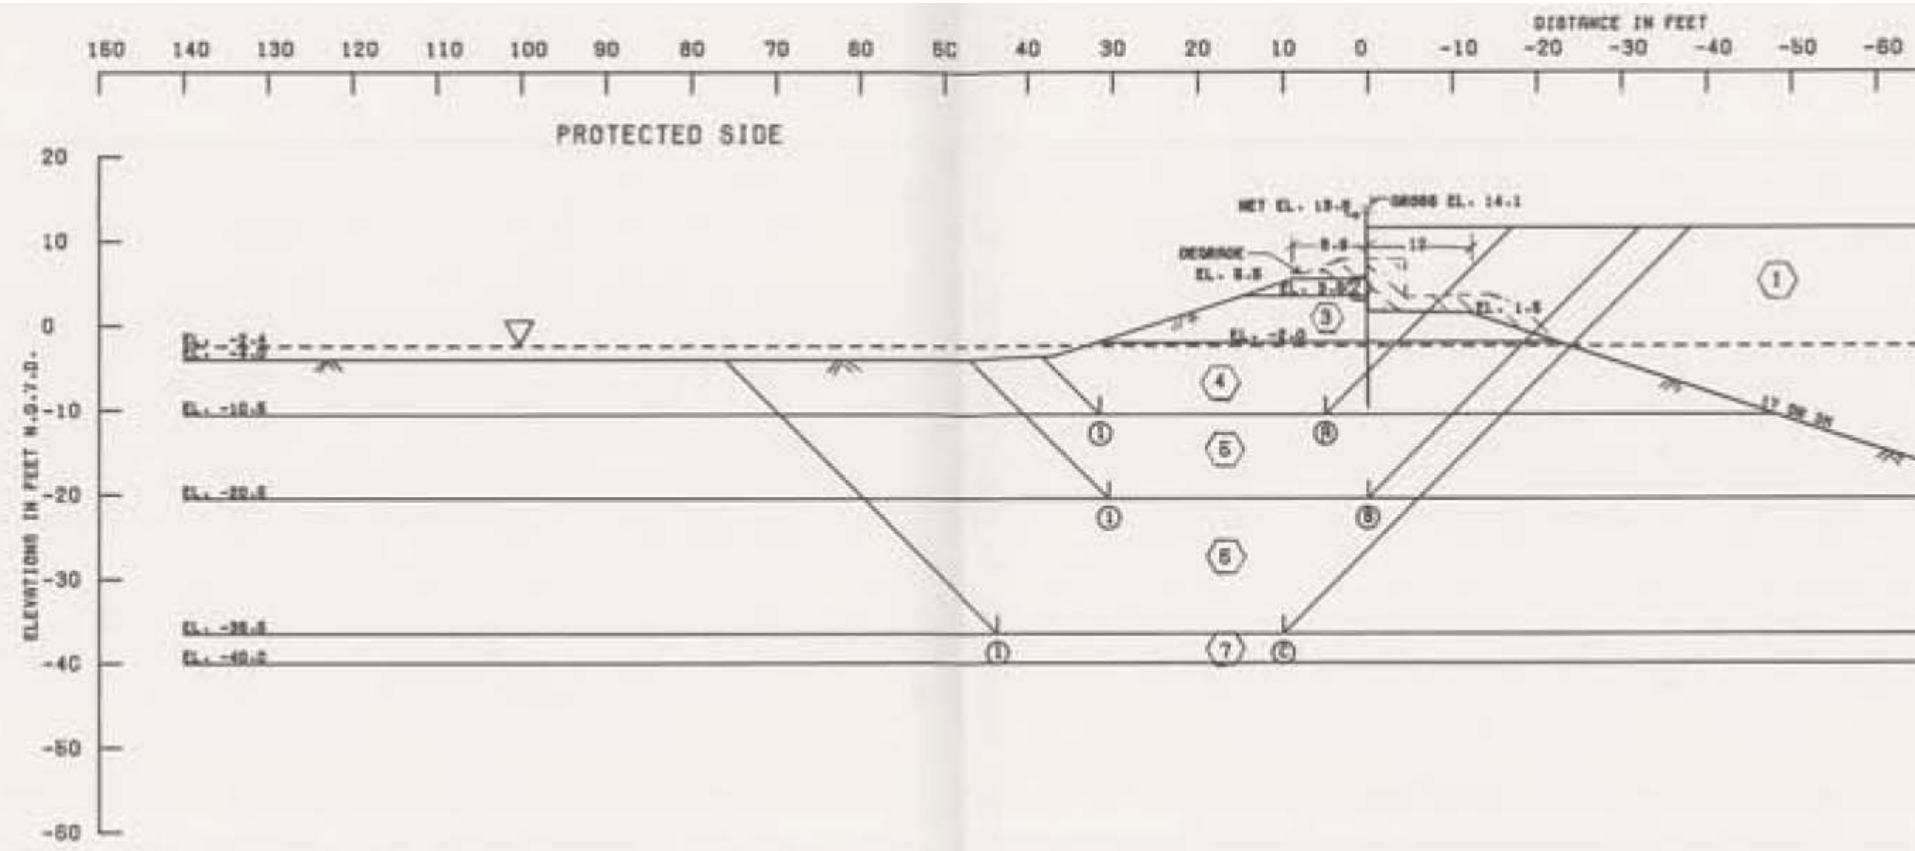
# Design Cross Section for Breach a Area

W. L. = 11.5 NGVD

No crack

Method of planes  $F = 1.30$

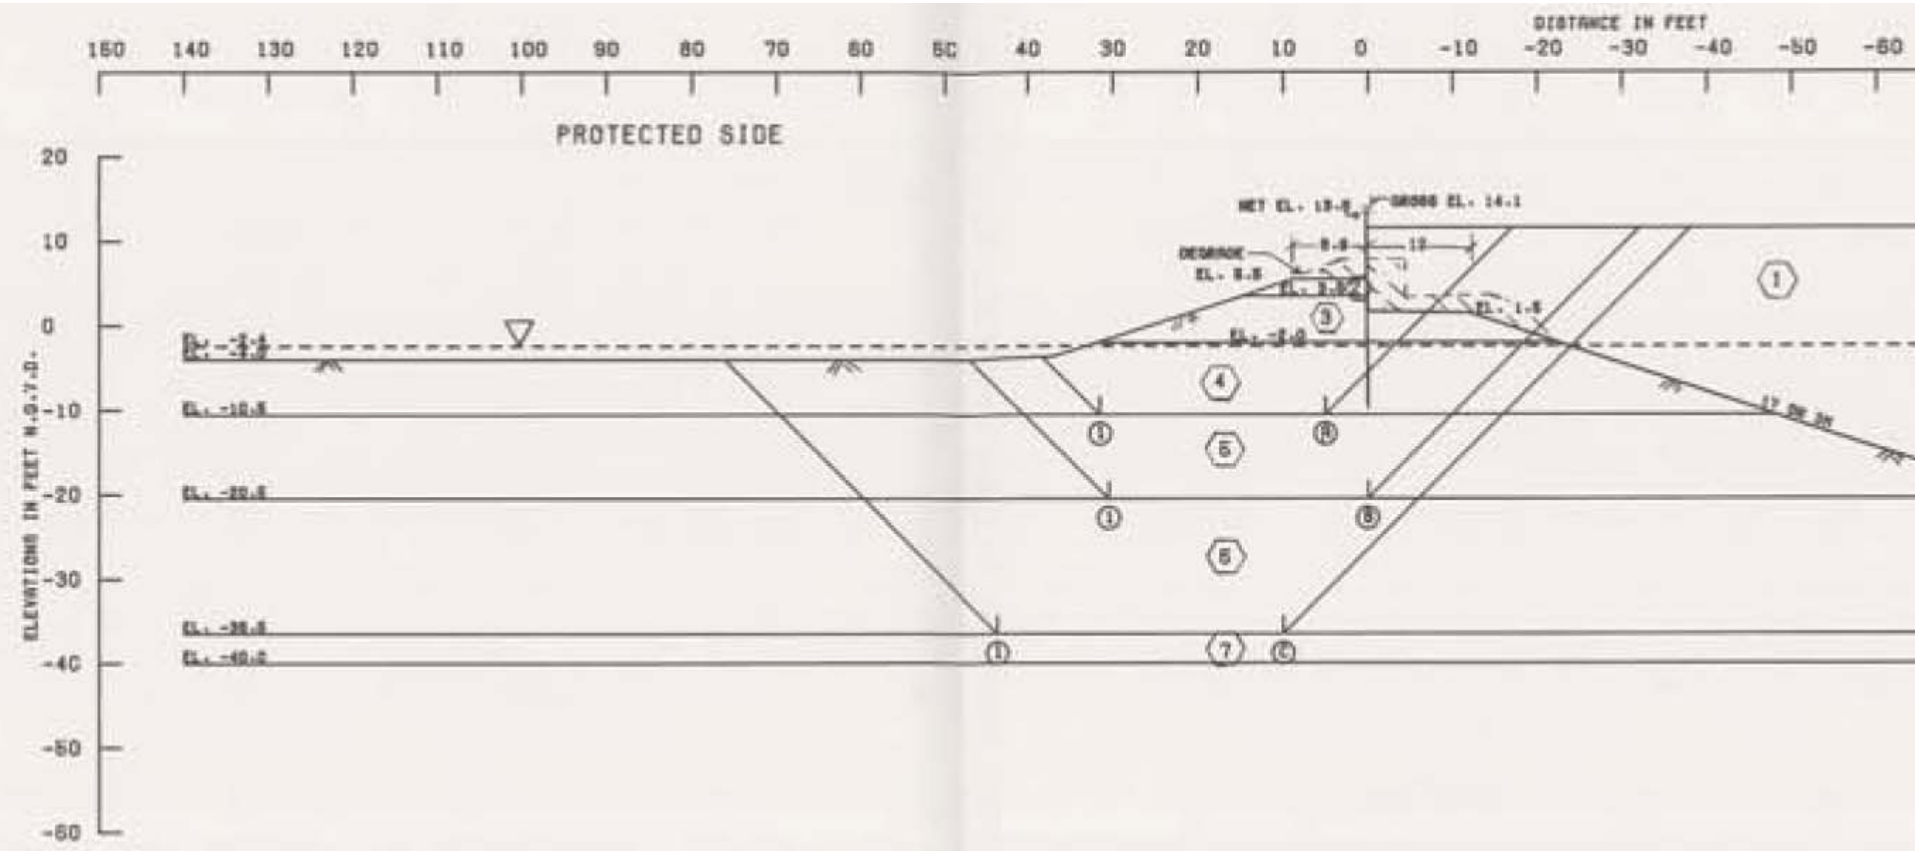
# Design Cross Section for Breach a Area

W. L. = 11.5 NGVD

No crack

Spencer's method  $F = 1.45$

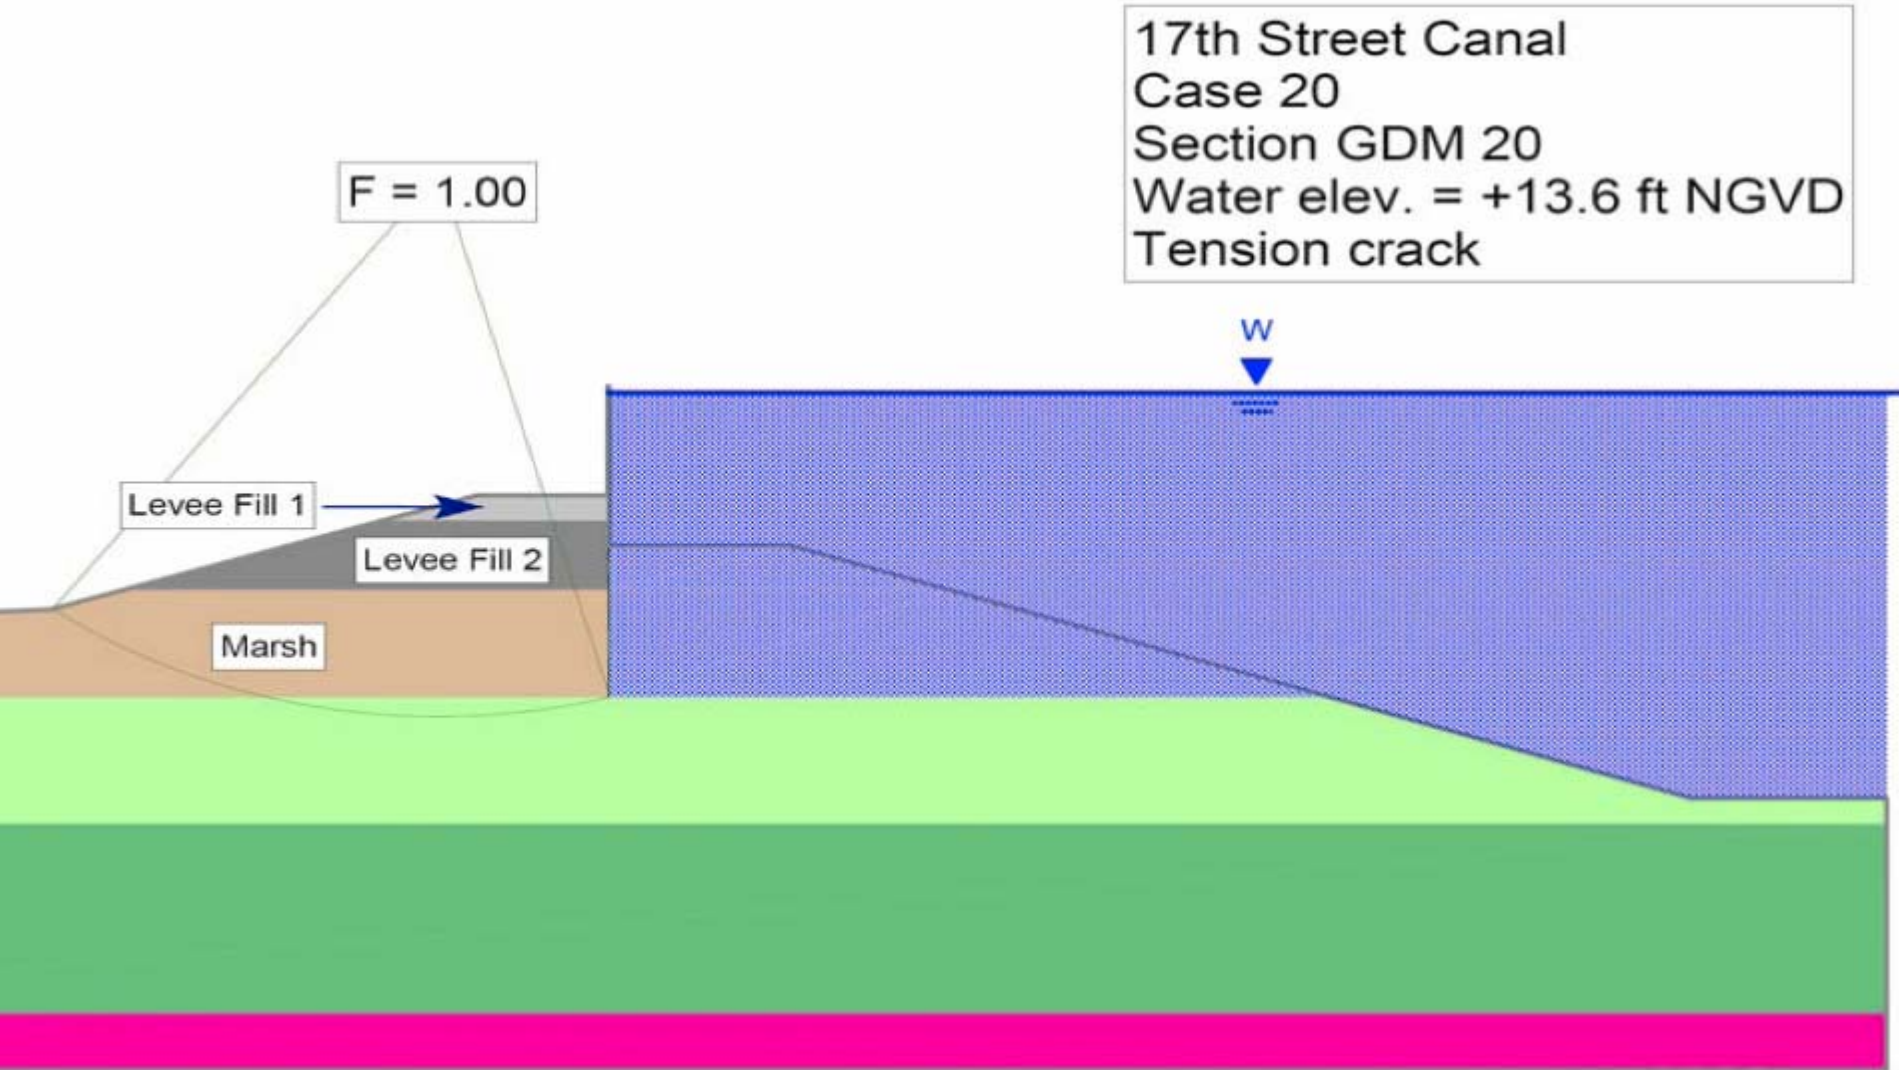
# Design cross section and strength

W. L. = 13.6 NGVD, with crack for  
 $F = 1.00$  using Spencer's method

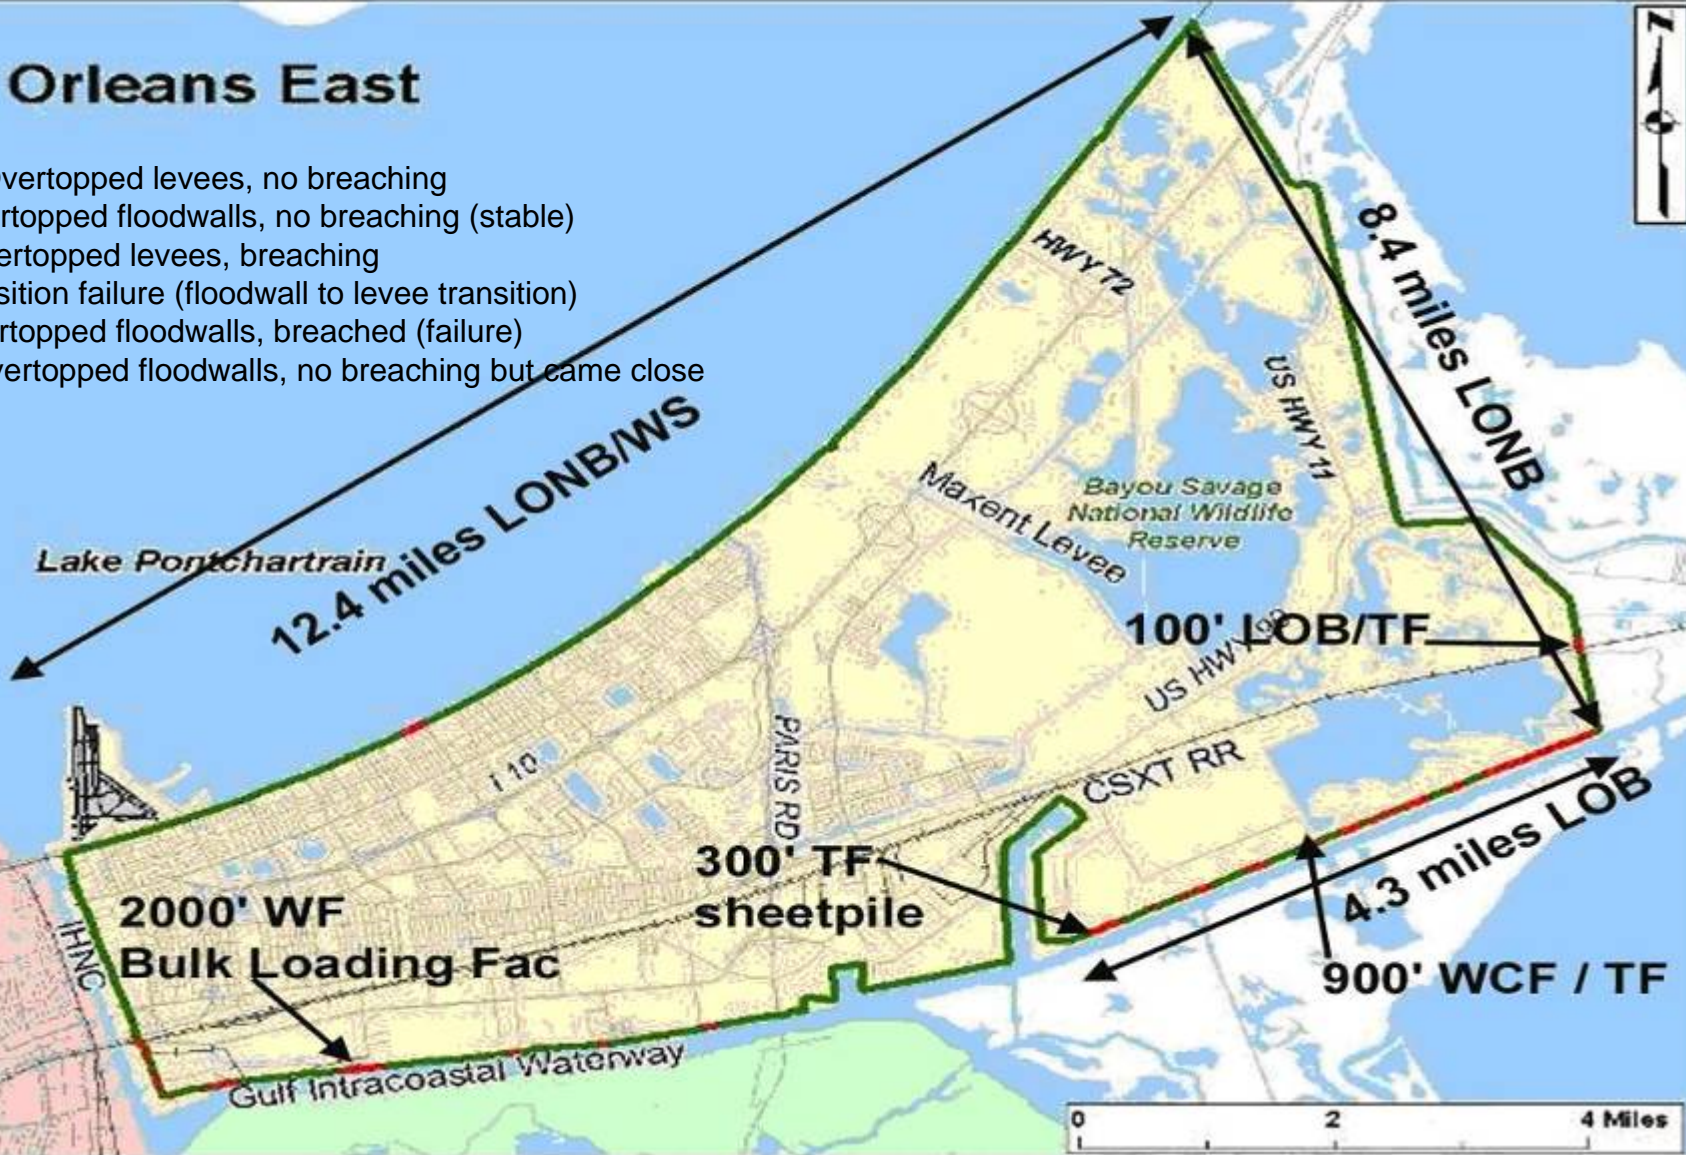
# New Orleans East Basin

- LONB = Overtopped levees, no breaching
- WS = Overtopped floodwalls, no breaching (stable)
- LOB = Overtopped levees, breaching
- TF = Transition failure (floodwall to levee transition)
- WF = Overtopped floodwalls, breached (failure)
- WCF = Overtopped floodwalls, no breaching but came close
