# Appendix 1

## Hydrograph and High Water Mark Analysis

### Introduction

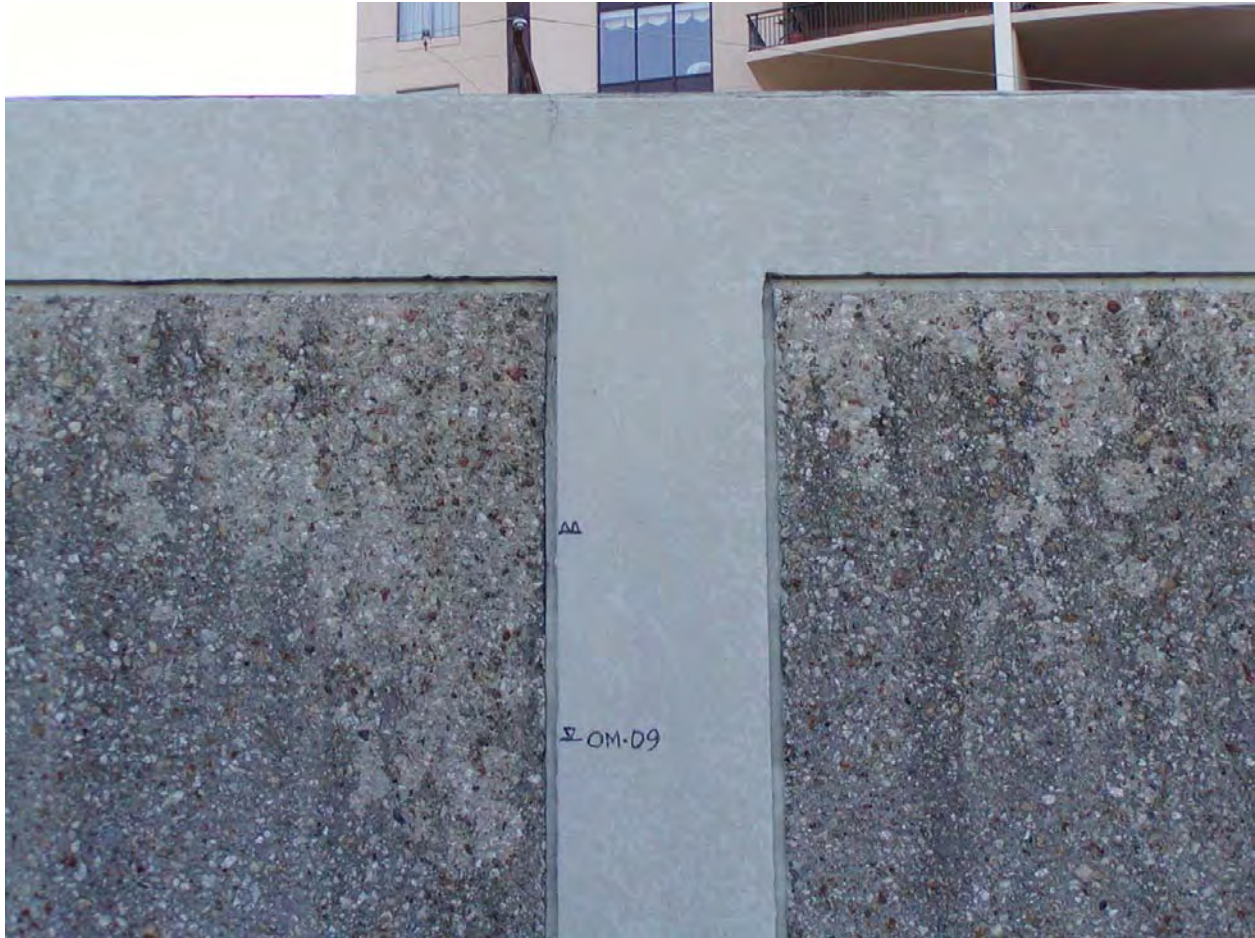
- h. Monday 8/29/05, 11:00, elevation 9.2 ft: The boat owner stated that he observed the water on the floodwall was falling at 1100 hrs. He pointed to a location on the floodwall that was 2'3" below the top of floodwall (floodwall at 12.5 ft NAVD88, 2004.65) that was the location of the peak of the 2 ft waves being caused by the West wind. A survey point was placed at 3'3" below the top of wall and asked if this level would represent an average water level. He agreed that it was. Survey point OM-09, Figure 1-30, was the average level. This point has a high degree of uncertainty.

Figure 1-30. Time 11:00 on 8/29/05, elevation 12.5 ft (top of floodwall), 10.2 ft (peak of 2 ft waves), 9.2 ft (average water level at OM-09)

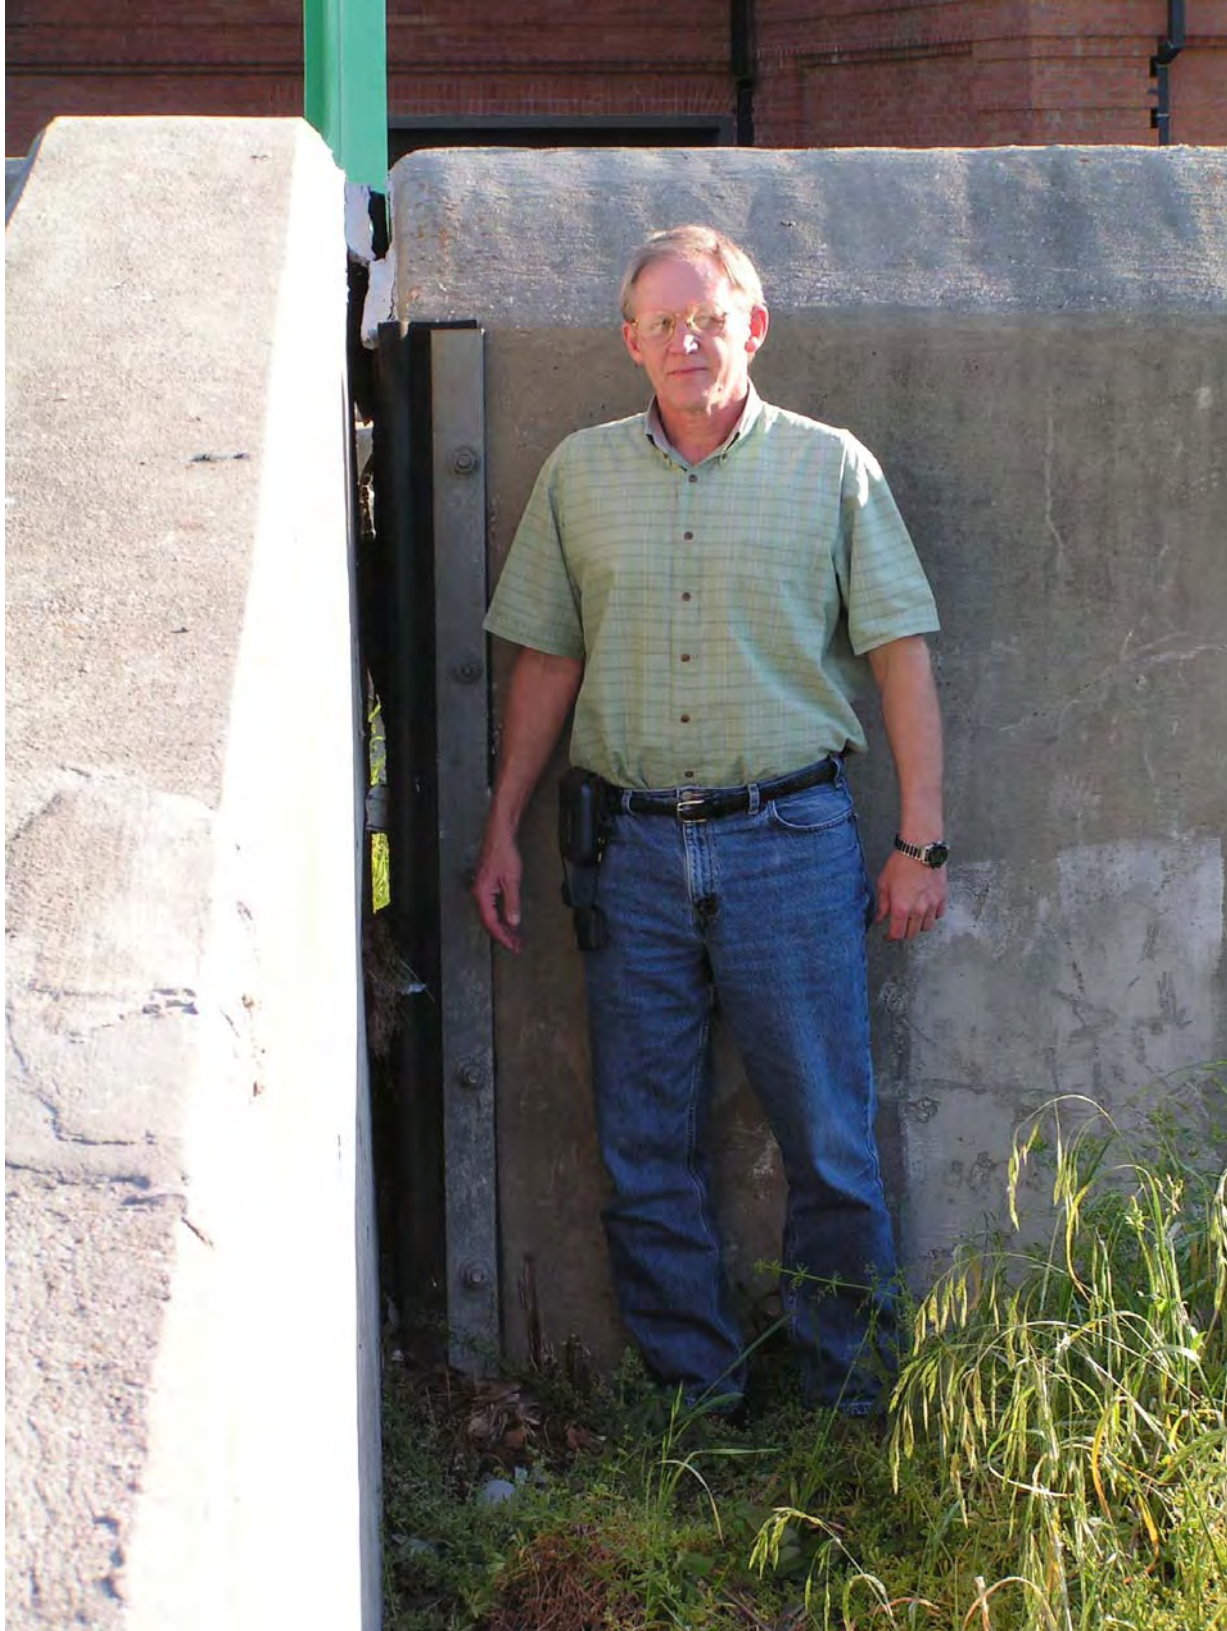
Figure 1-86. LA 1251 at crack in wall. Picture taken 4/06/06. Debris in crack was 2.2 ft below top of wall on 9/29/05.

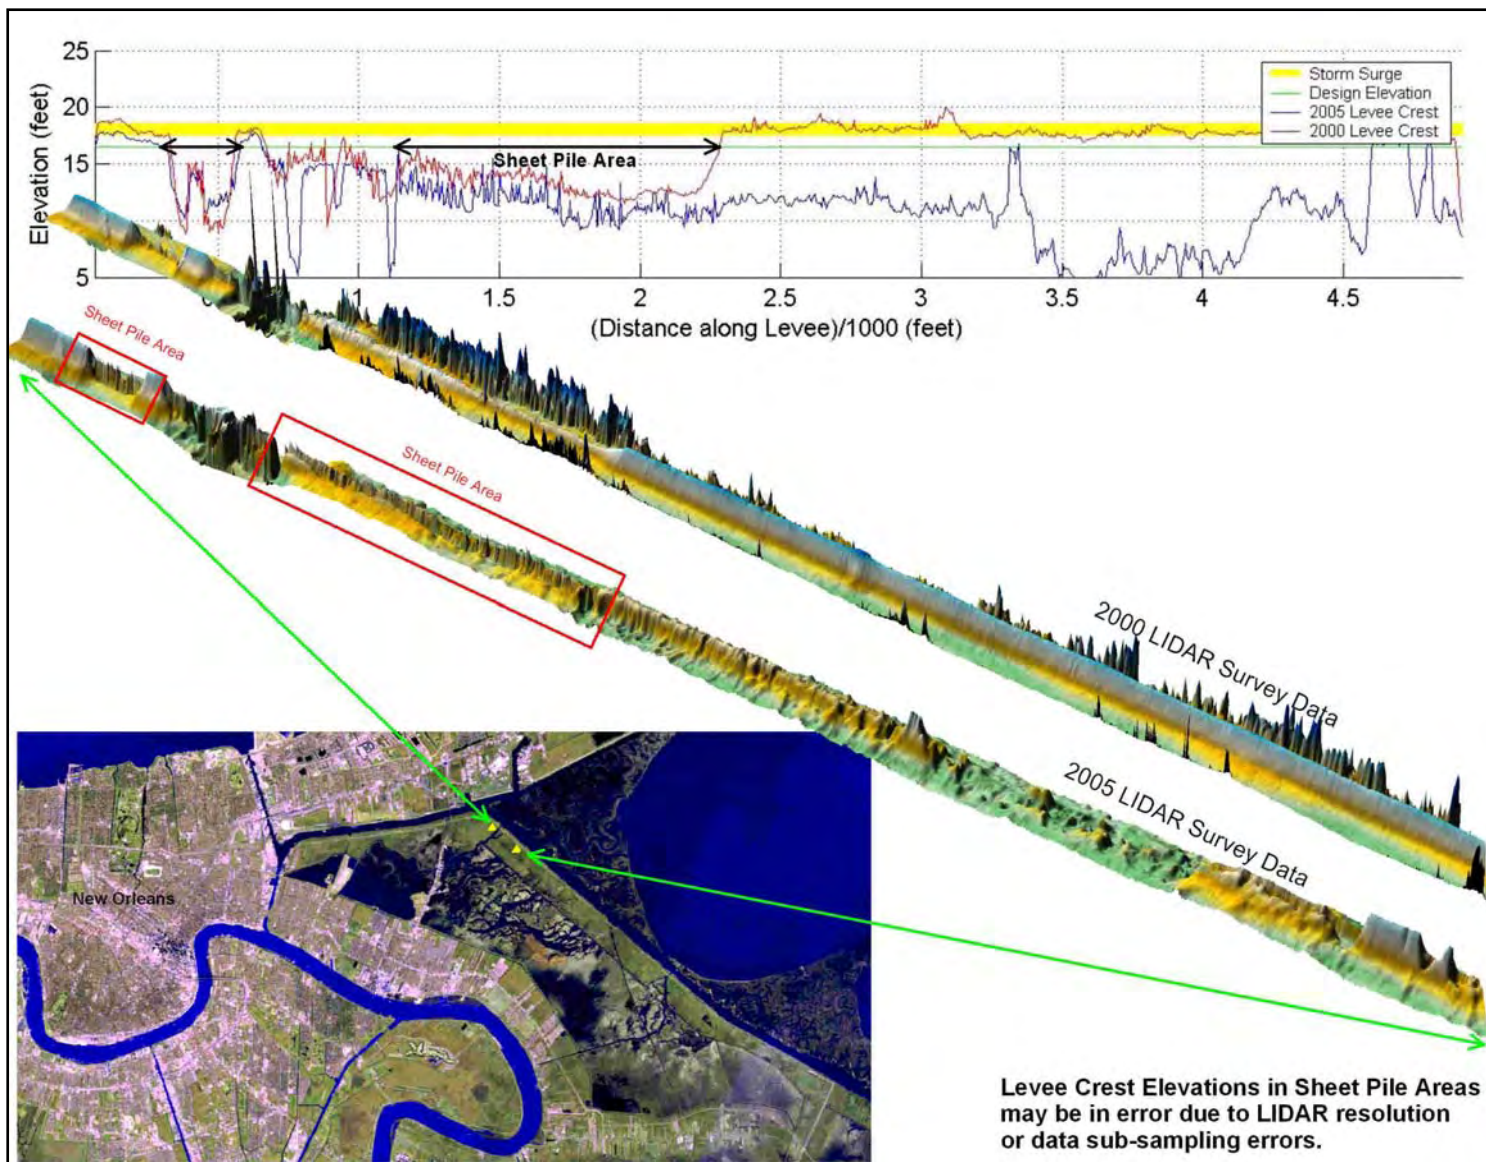
Figure 16-1. MRGO levee damage determined from LIDAR surveys; Station 0 to 4,500 ft

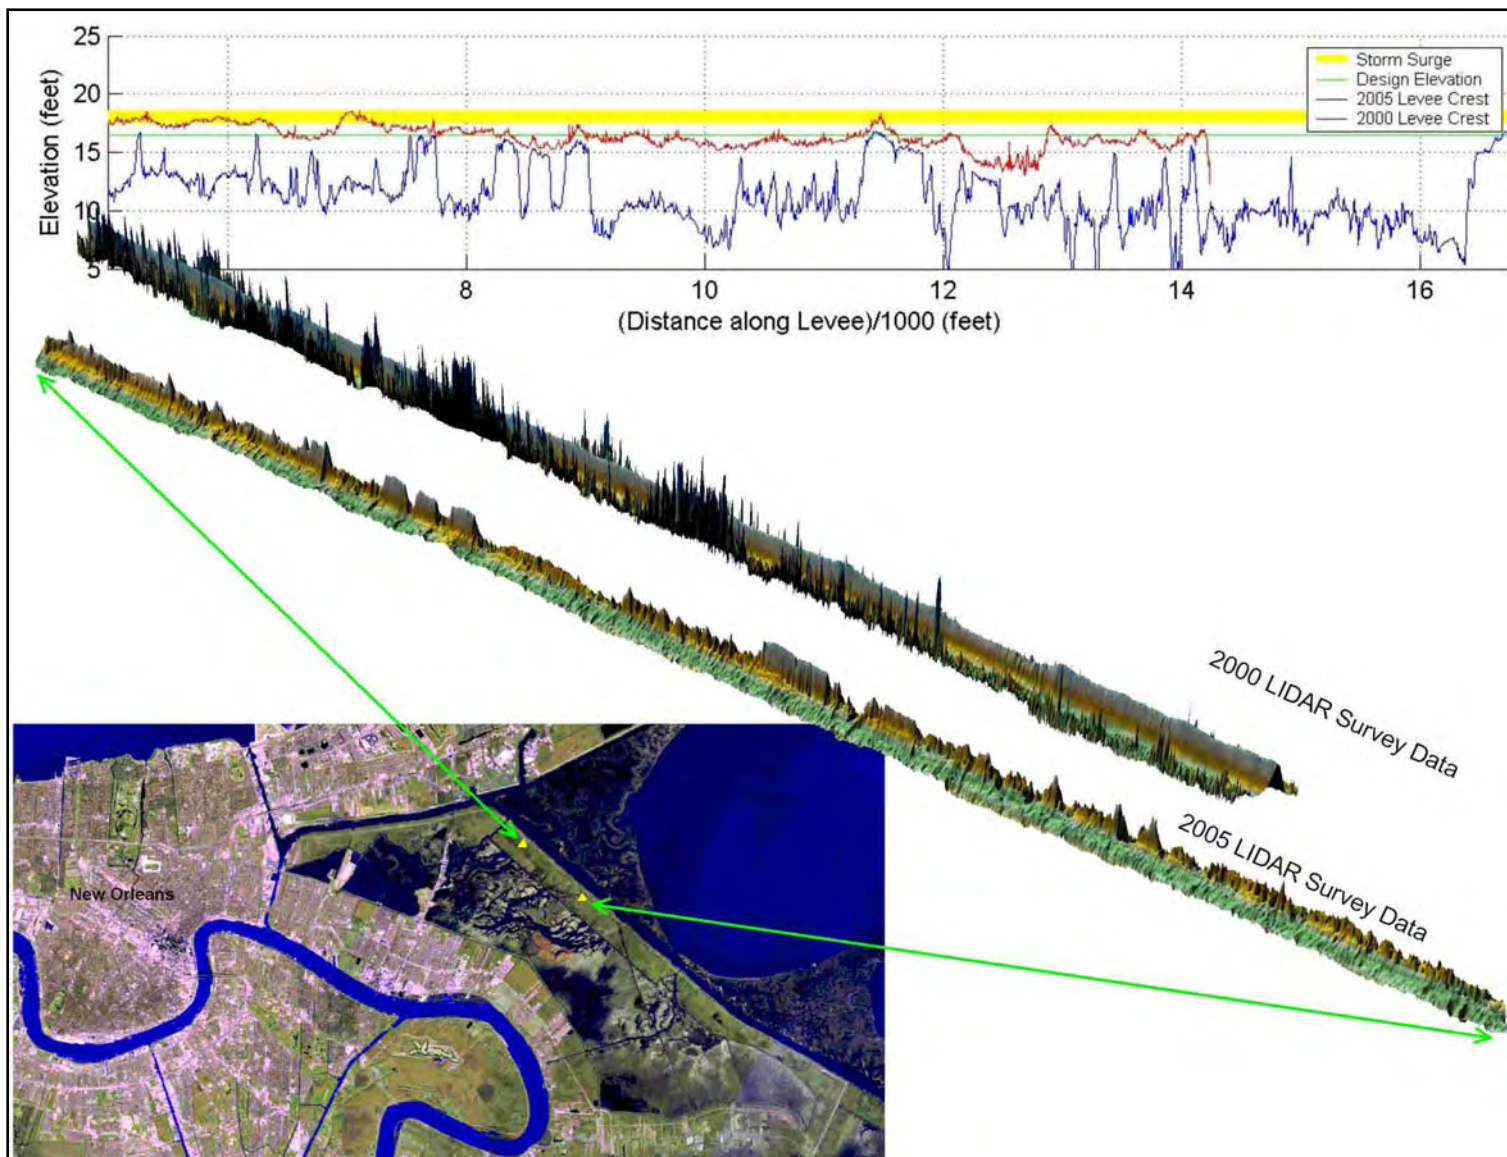
Figure 16-2. MRGO levee damage determined from LIDAR surveys; Station 6,000 to 16,000 ft

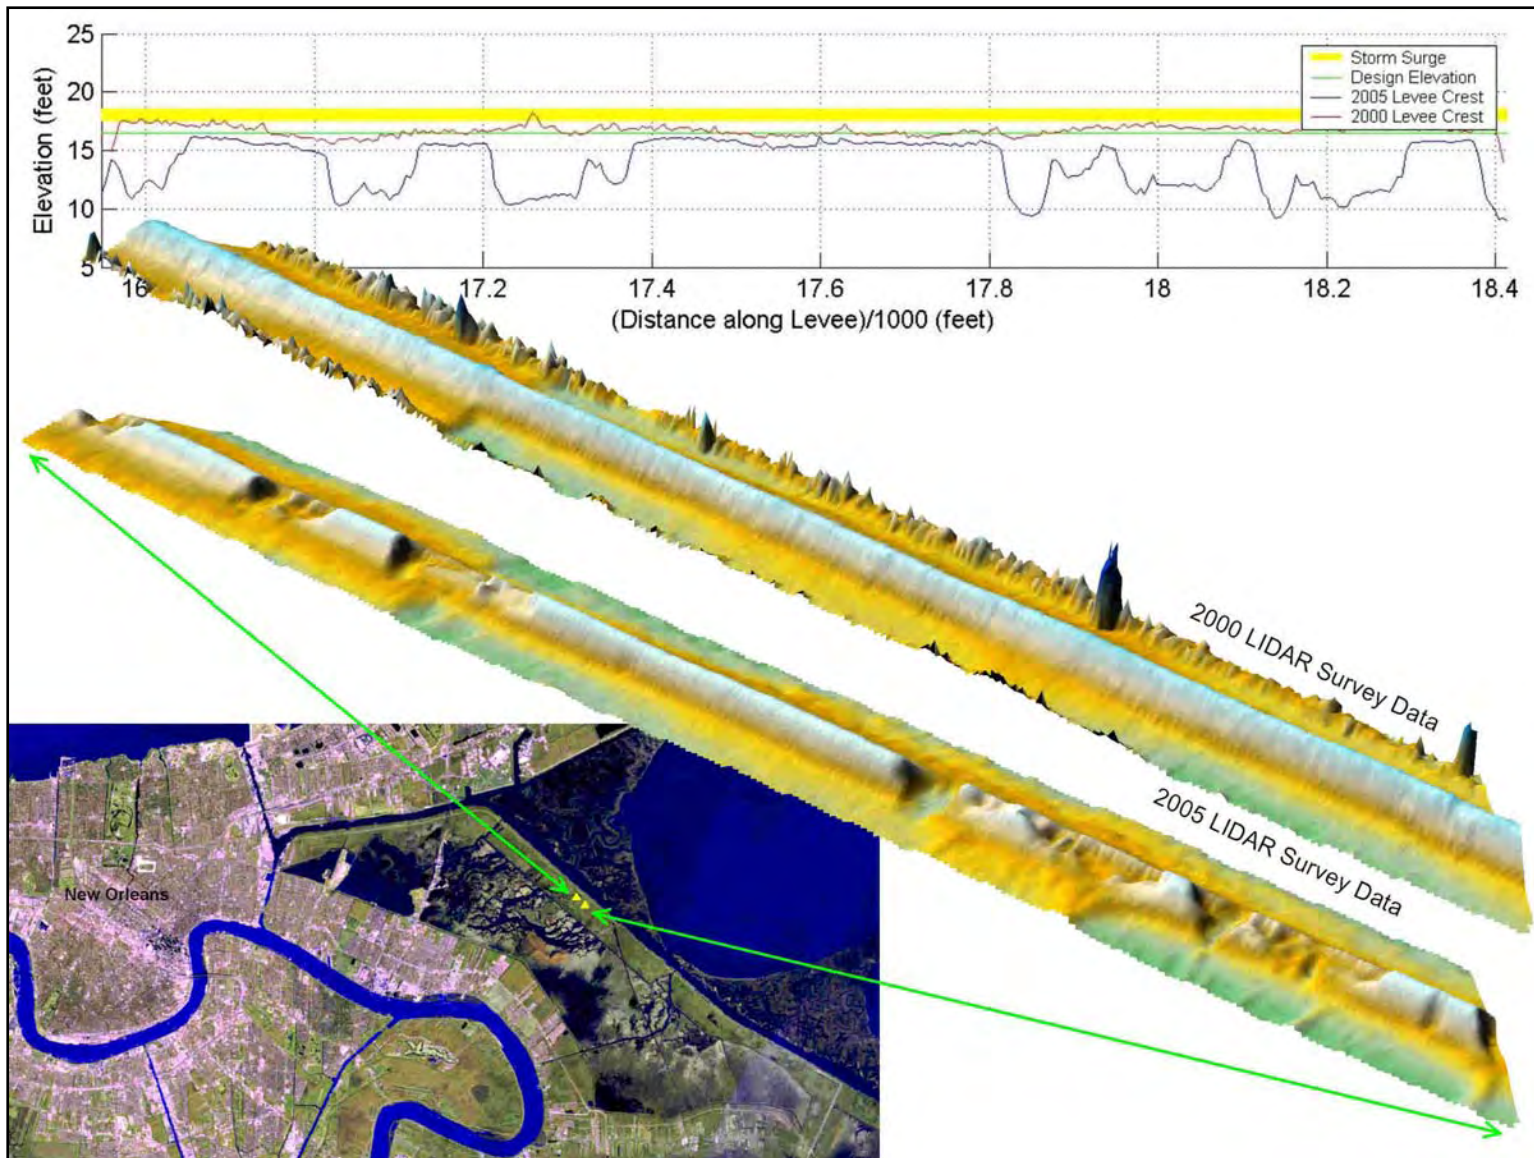
Figure 16-3. MRGO levee damage determined from LIDAR surveys; Station 16,800 to 18,400 ft

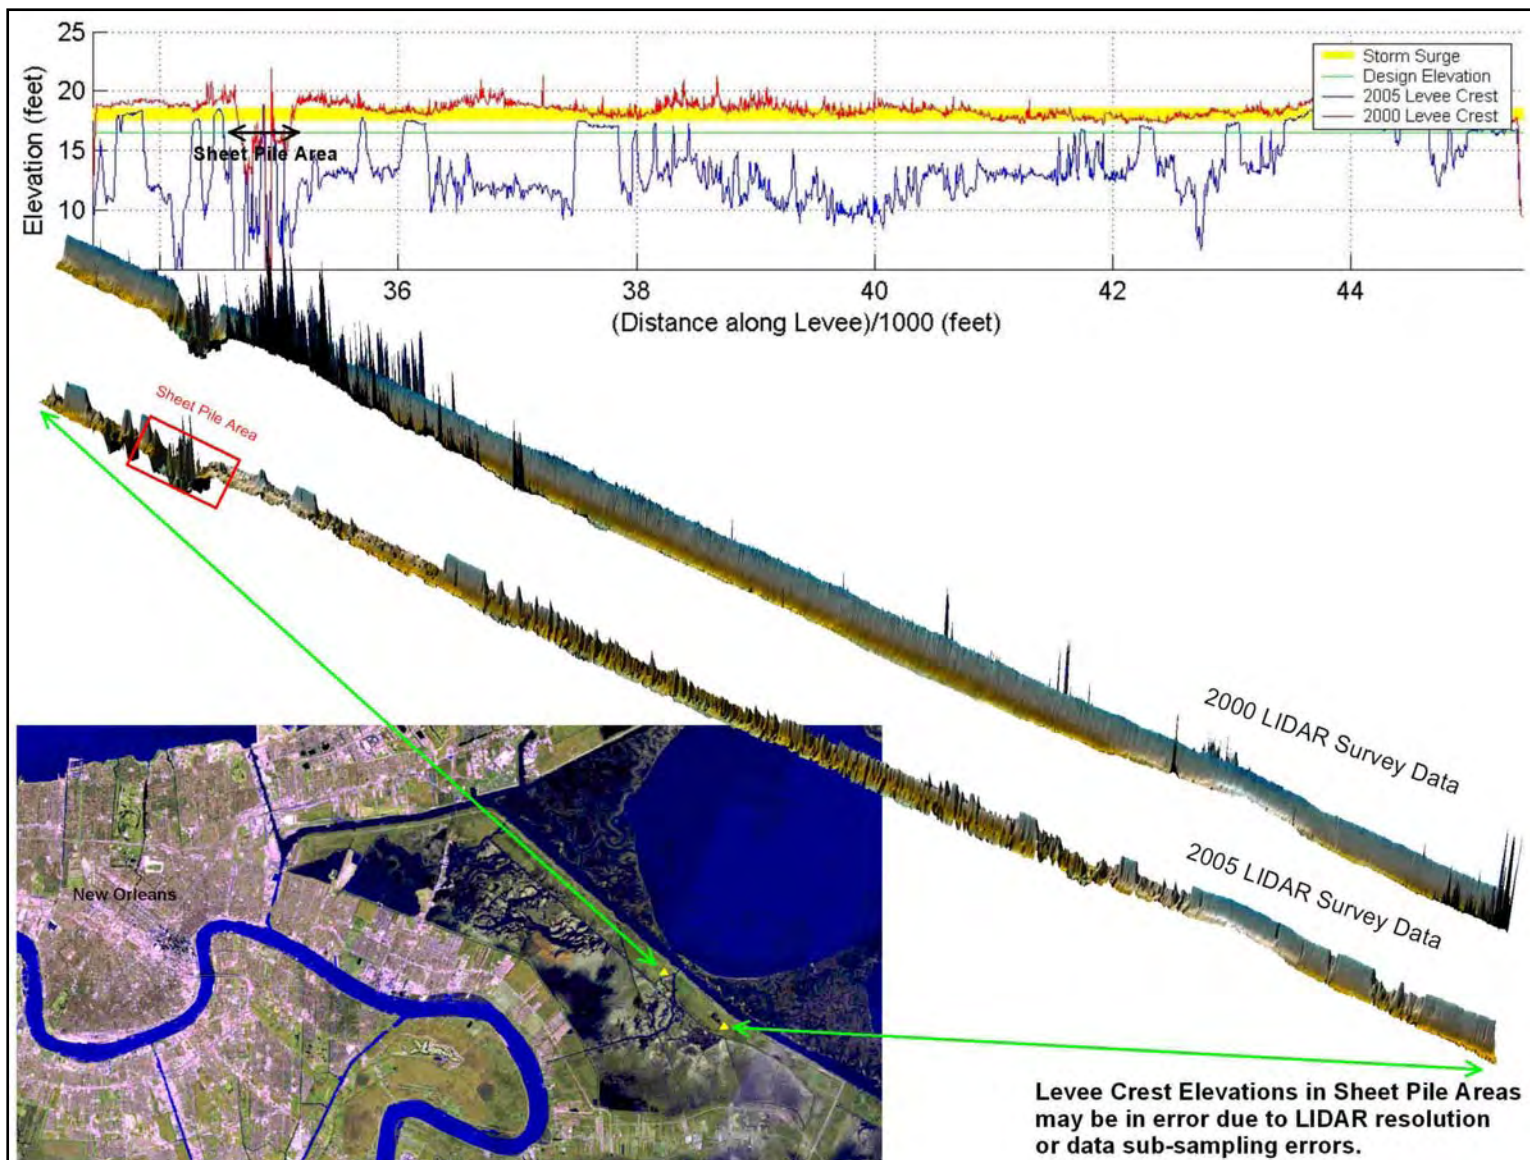
Figure 16-6. MRGO levee damage determined from LIDAR surveys; Station 34,000 to 44,000 ft

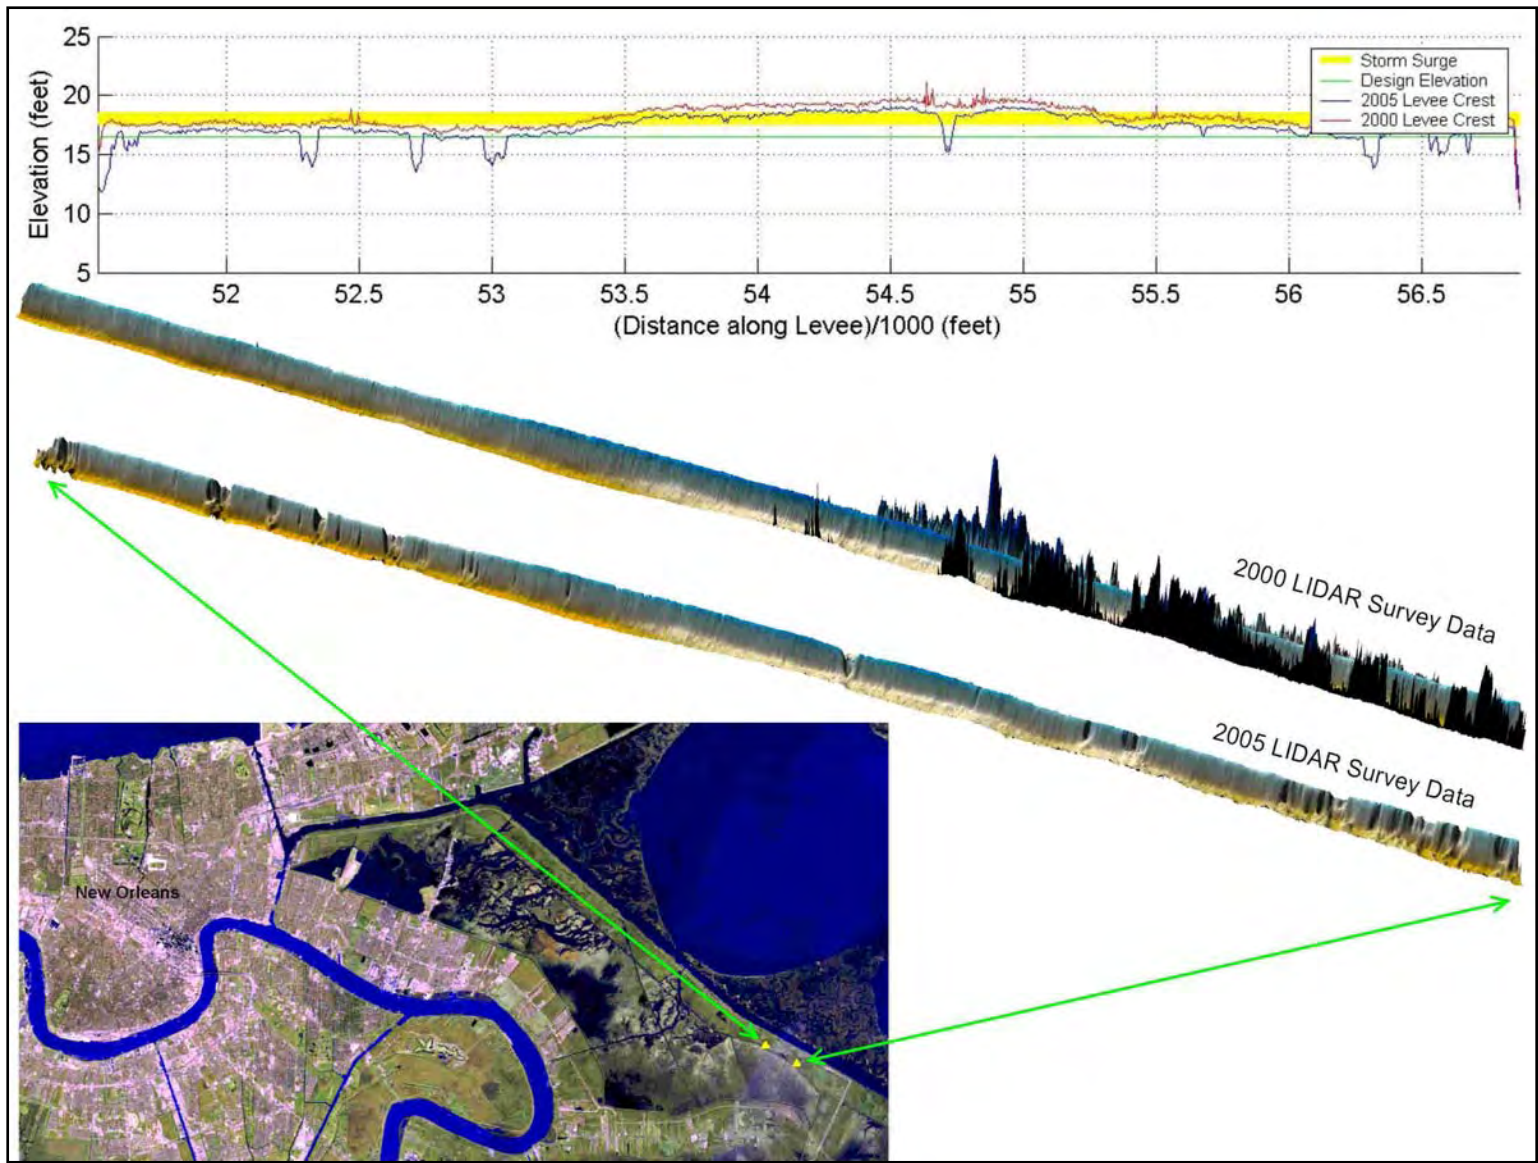
Figure 16-8. MRGO levee damage determined from LIDAR surveys; Station 52,000 to 56,500 ft
