Performance Evaluation of the New Orleans and Southeast Louisiana Hurricane Protection System

Draft Final Report of the Interagency Performance Evaluation Task Force

Volume V – The Performance — Levees and Floodwalls

1 June 2006

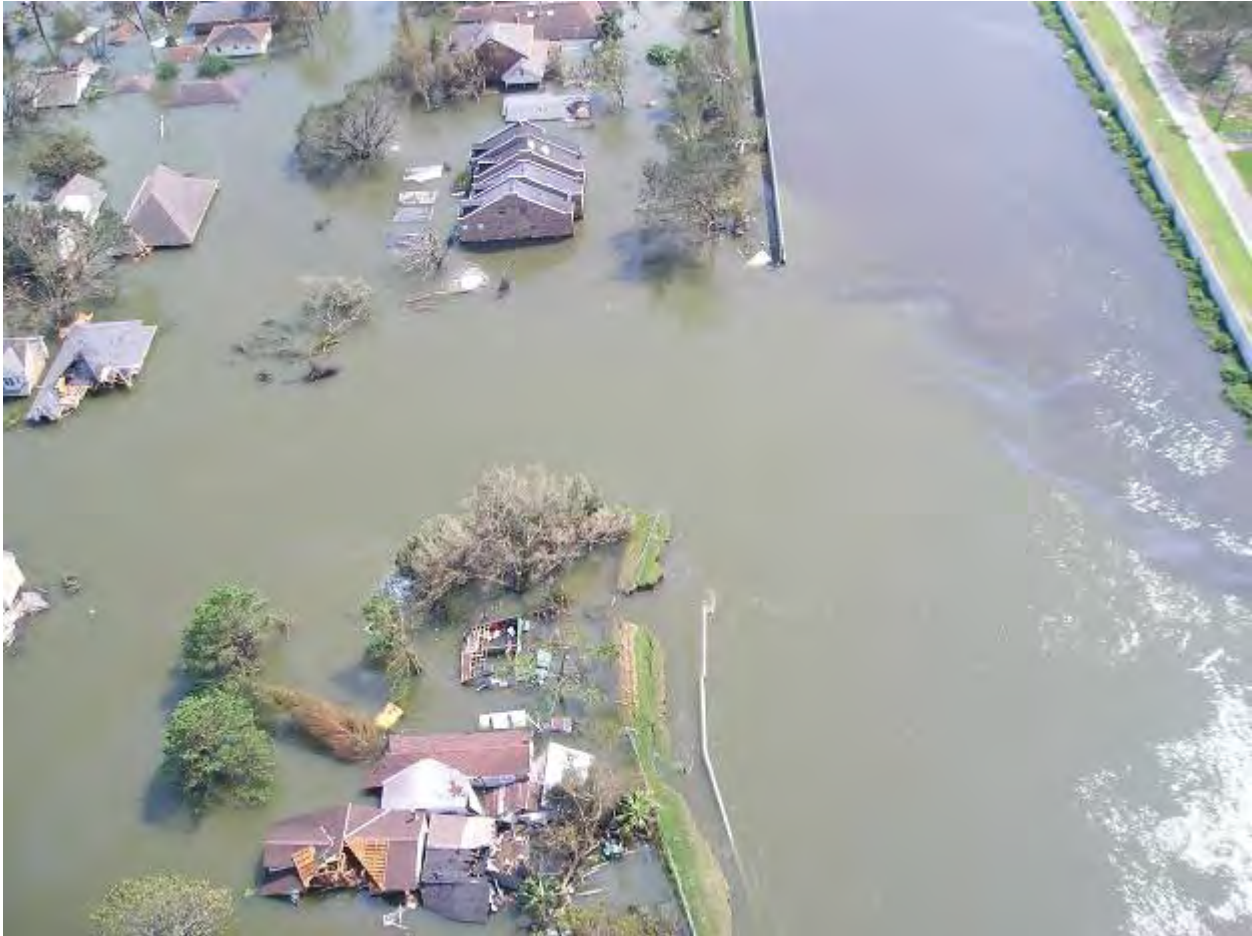
Figure 4. Aerial Photograph of the 17th Street Canal Breach Showing I-Wall and Embankment Translation

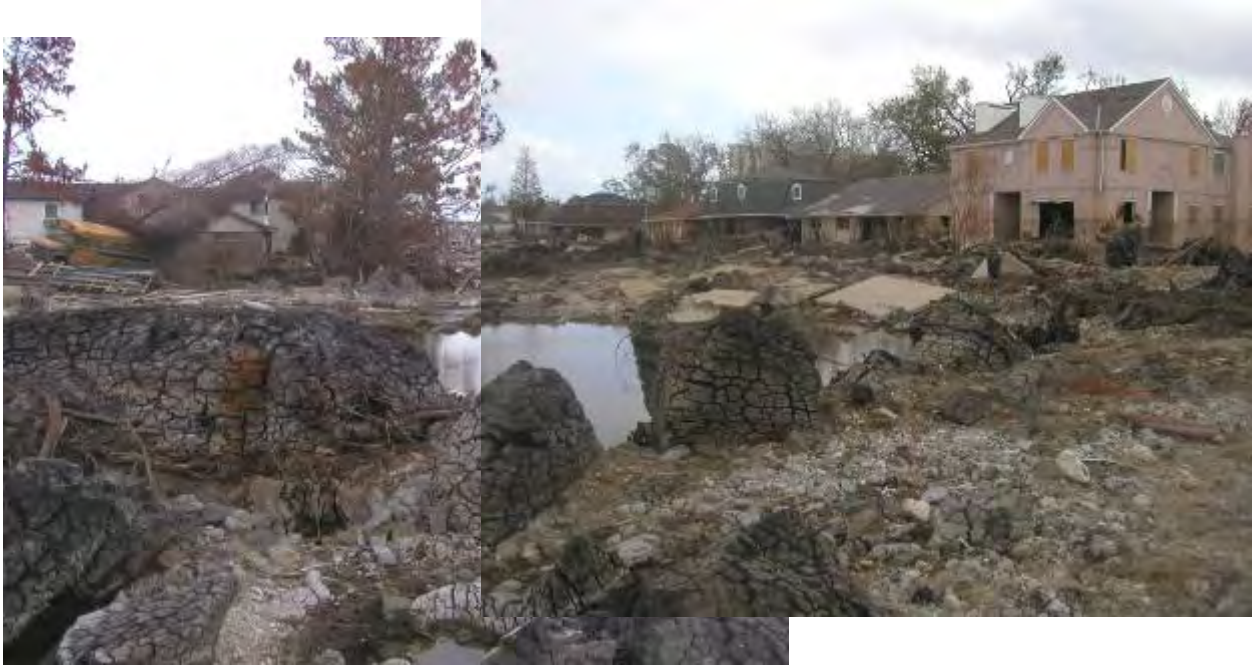
After the emergency closure was complete and the water levels were drawn down, large blocks of the marsh were found strewn in neighborhoods surrounding the breach, as shown in Figure 8. A close examination of the marsh blocks reveals that an approximately one-ft-thick clay layer is attached to the bottom of the marsh block, Figure 9. In order to inspect the failure plane or zone, a backhoe trench was excavated to expose a vertical surface through the slide block. A photograph of the side of this trench is shown in the upper left corner of Figure 10, and a closer view is shown in Figure 11. The photograph in Figure 11 shows a portion of the clay layer, which was initially located beneath the marsh layer, was displaced upward and over a portion of the marsh layer by the lateral displacement that occurred during the failure. The shearing mechanism that resulted in this condition is shown in Figure 12. This shows that the failure plane of the slide block was within the clay under the levee, and that the failure plane came upward through the marsh layer further landward.

Figure 8. Marsh Blocks From the Levee Embankment at the 17th Street Canal Breach

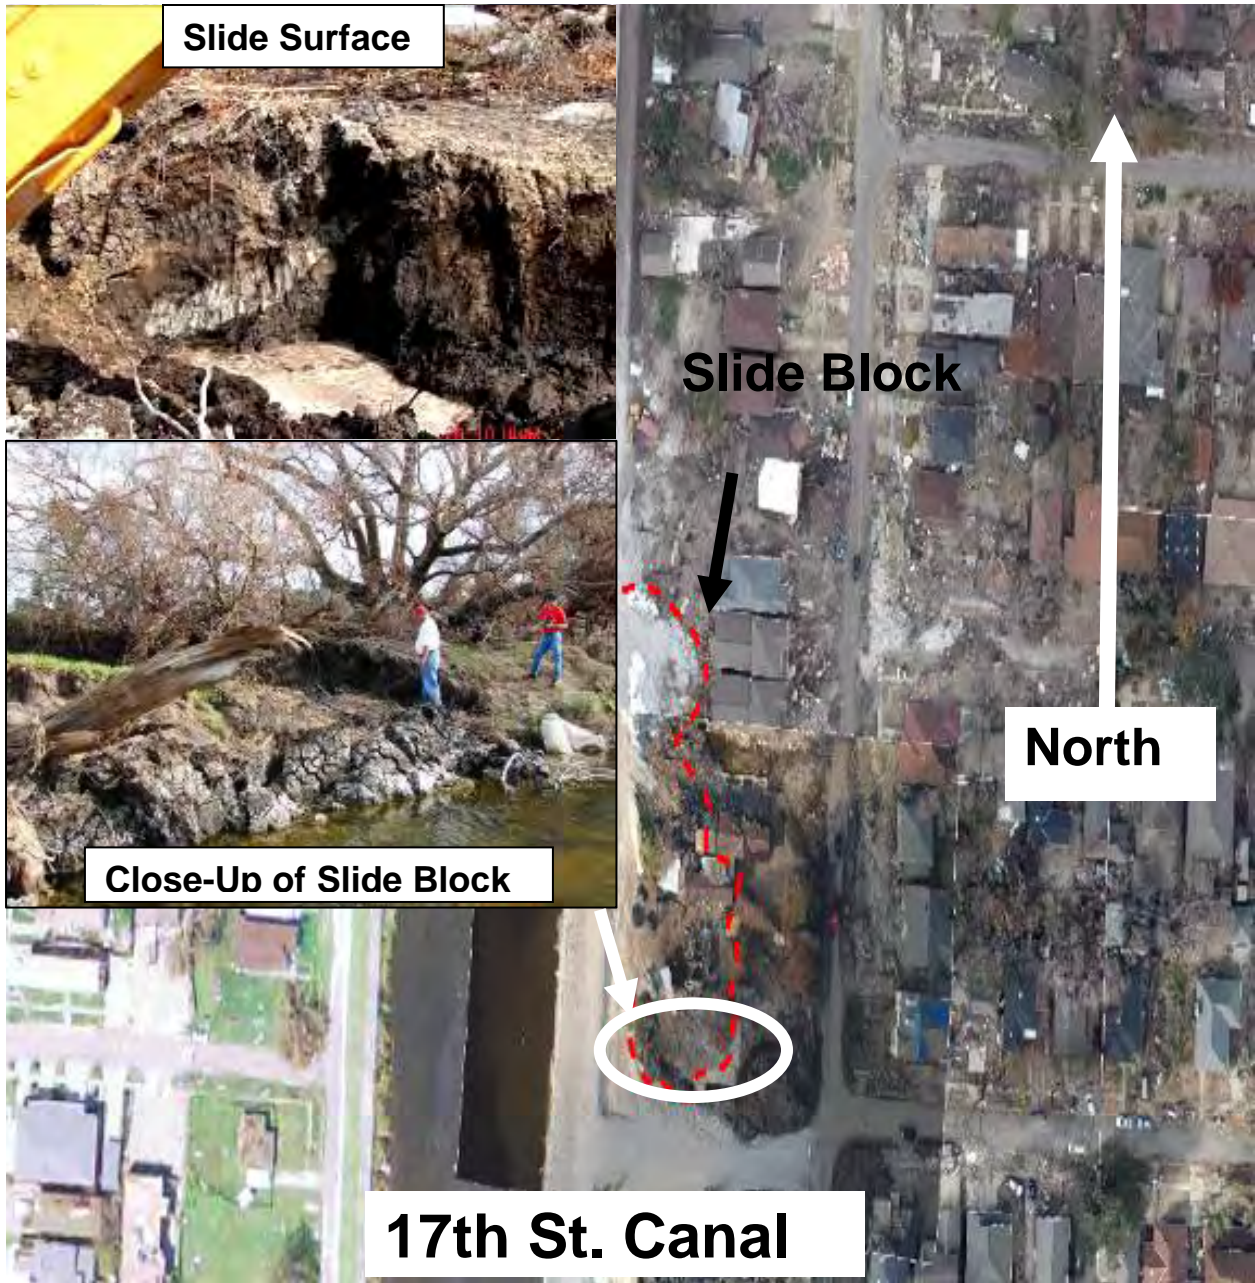
Figure 10. Photographs Taken at the 17th Street Canal Breach After the Failure

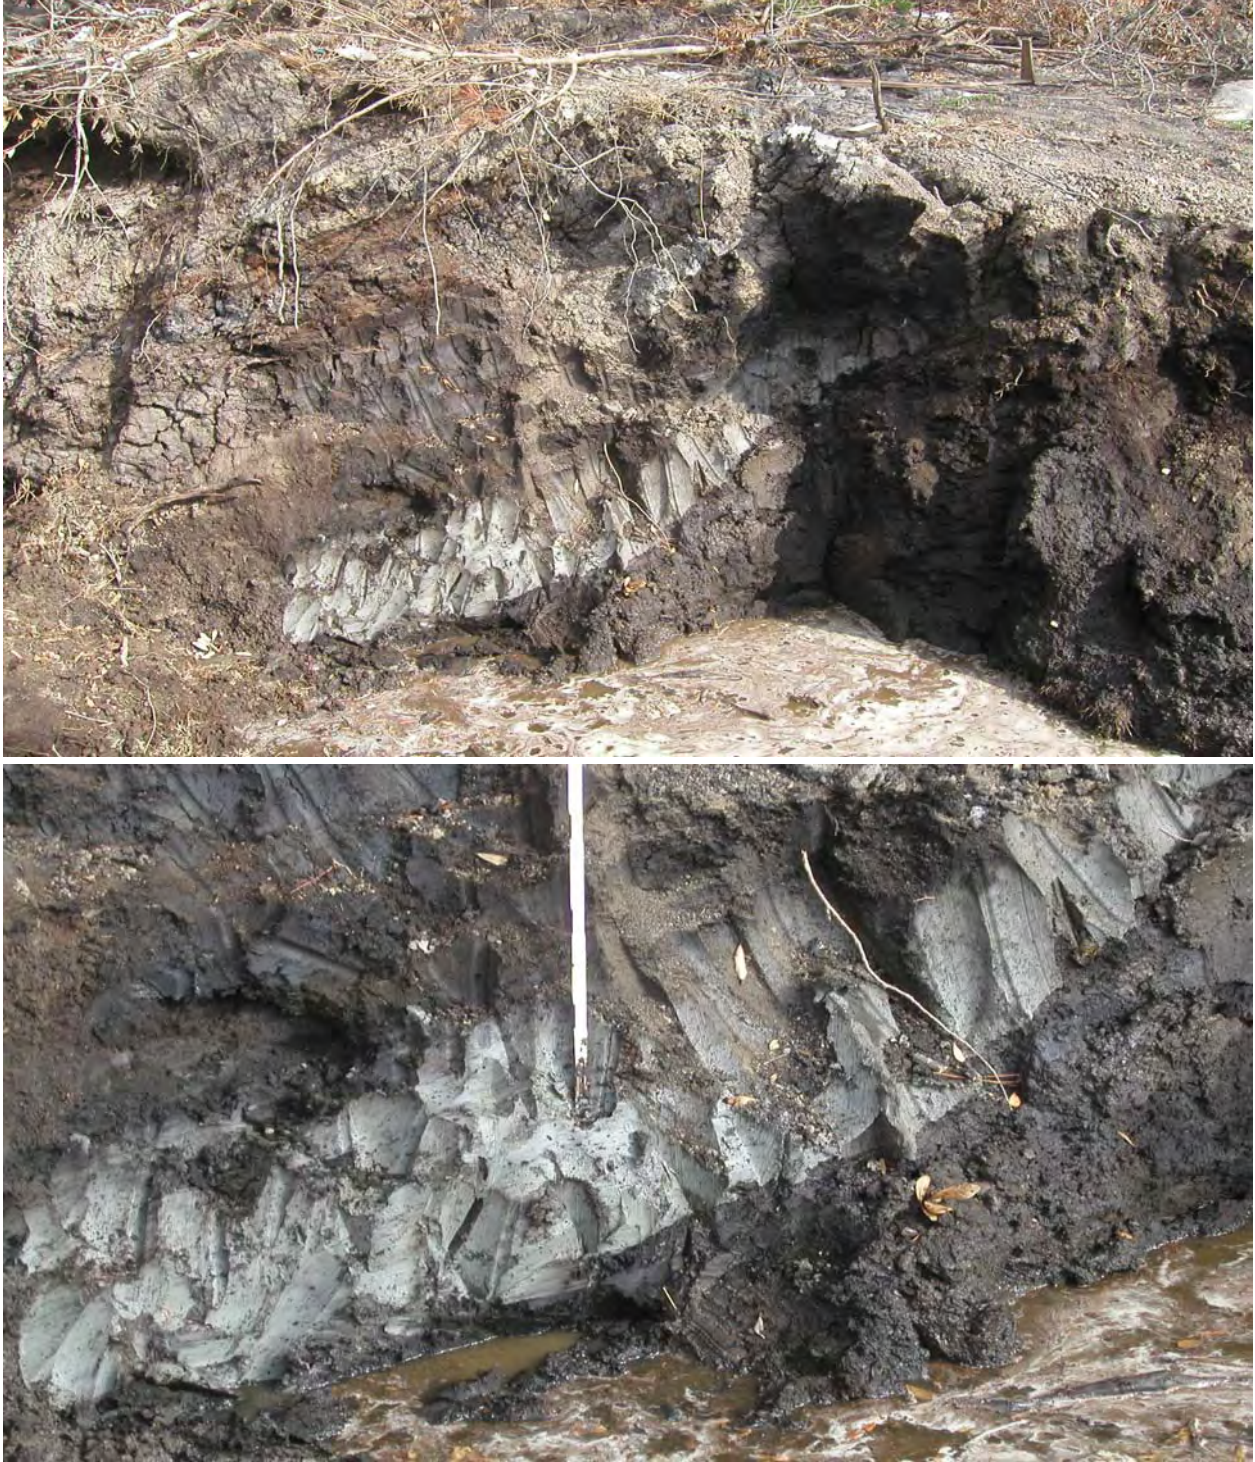
Figure 11. Exposed Failure Plane at the 17th Street Canal Breach, Showing Clay That Was Initially Below the Marsh Layer Was Displaced Above Some of the Marsh Material During the Failure. The marsh material above and below the clay is the same layer, confirmed by age dating. The clay was moved into this position during the failure, as shown in Figure 12

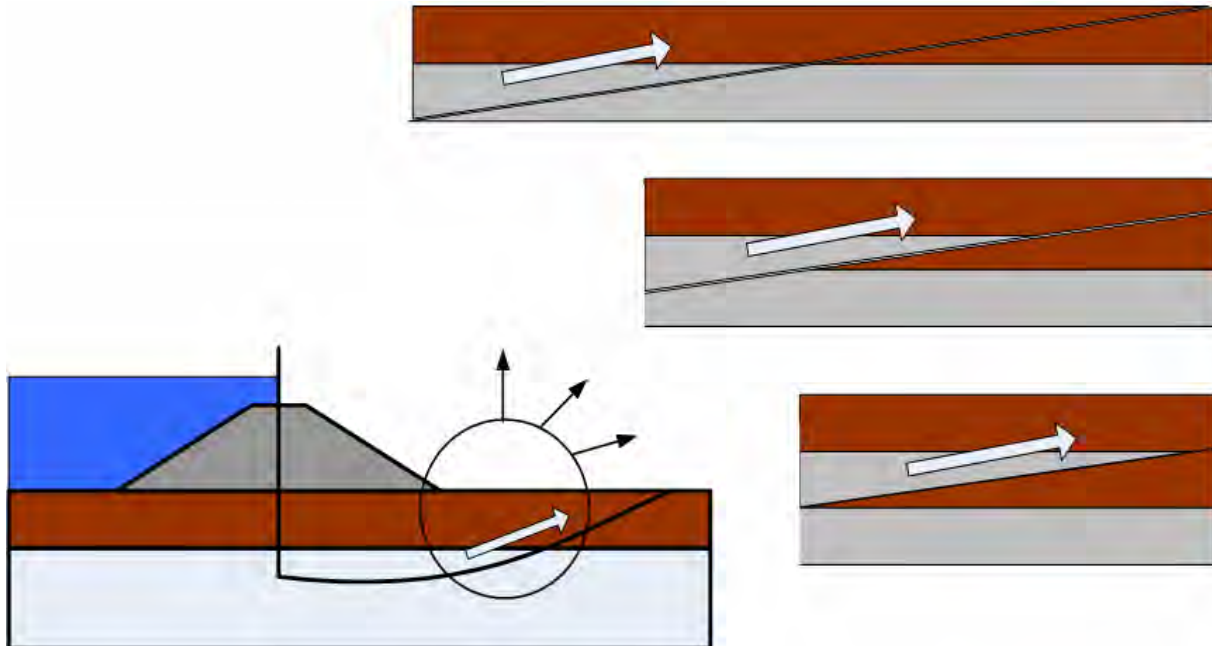
Figure 12. A Portion of the Clay Layer, Initially Located Beneath the Marsh Layer, Was Displaced Upward and Over a Portion of the Marsh Layer as it was Displaced Laterally by the Failure. A photograph of the displaced clay, with marsh material above it and below it, can be seen in Figure 11

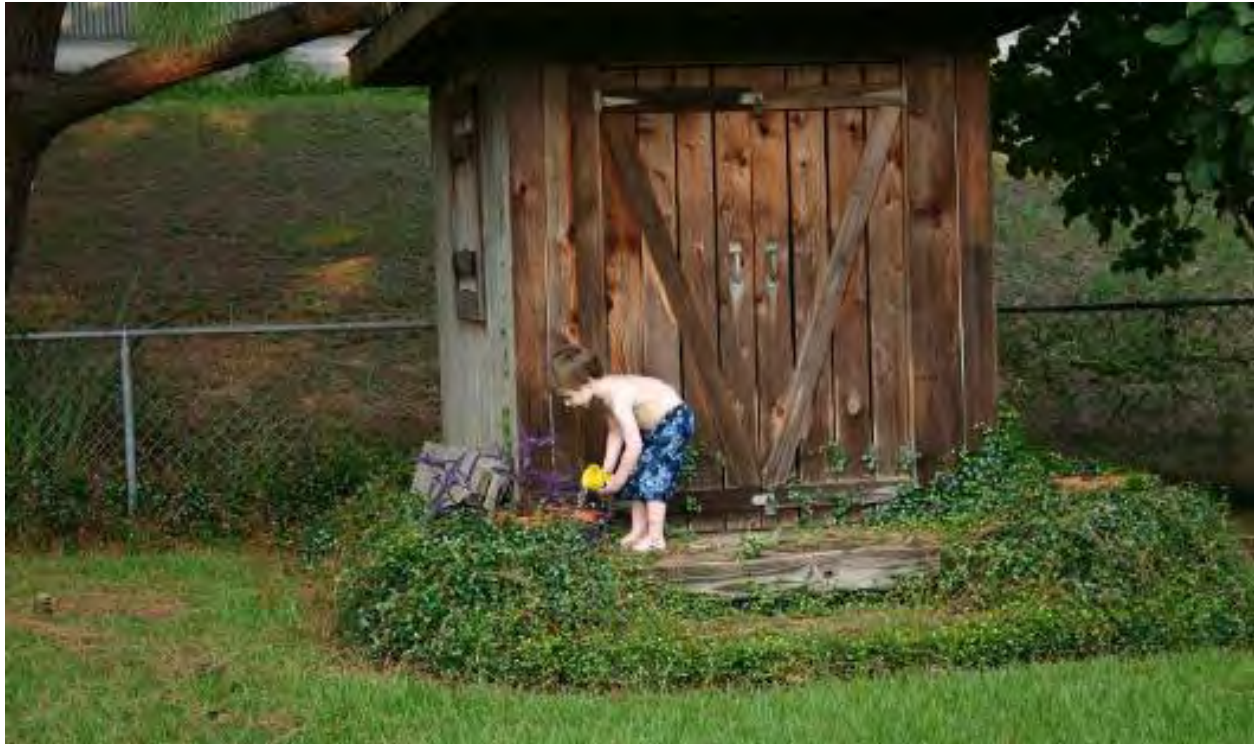
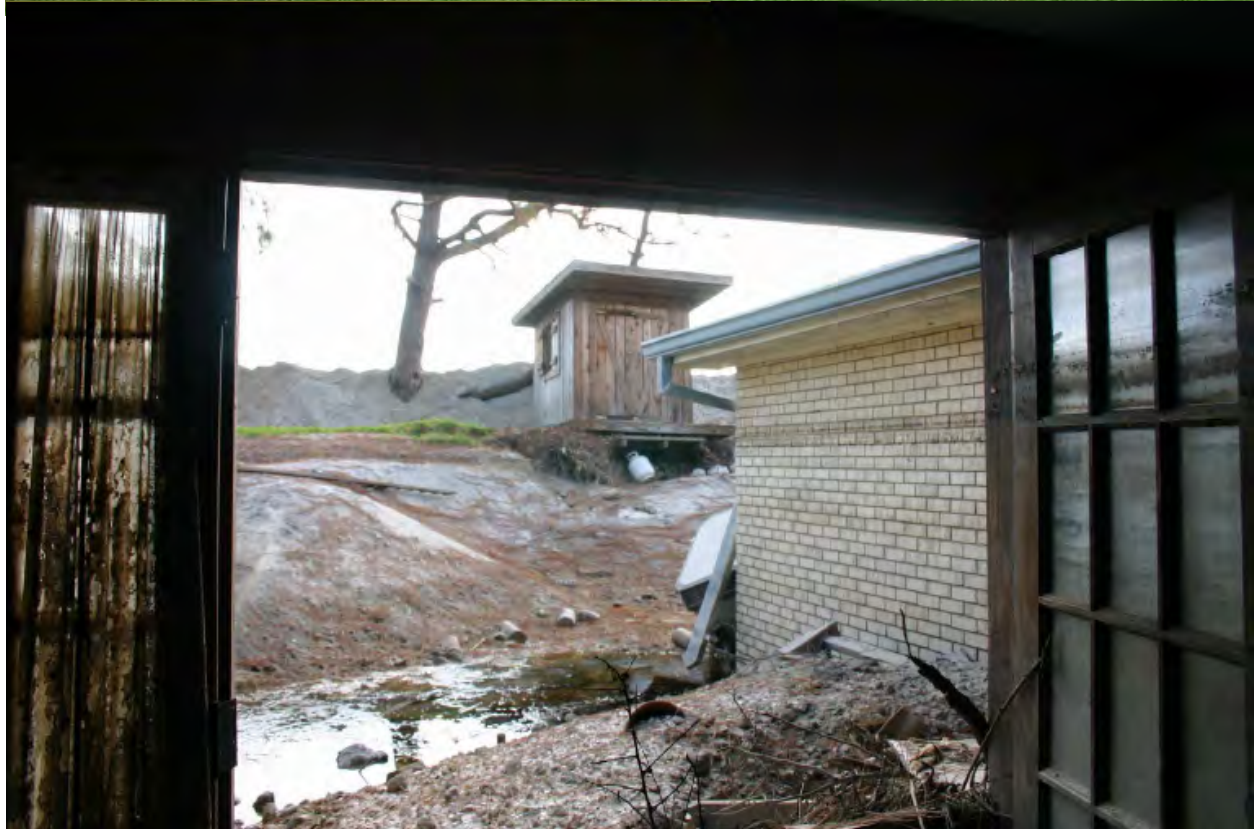
Figure 30. Playhouse at the London Avenue Canal North Breach Before the Failure (top photo) and After (bottom photo)

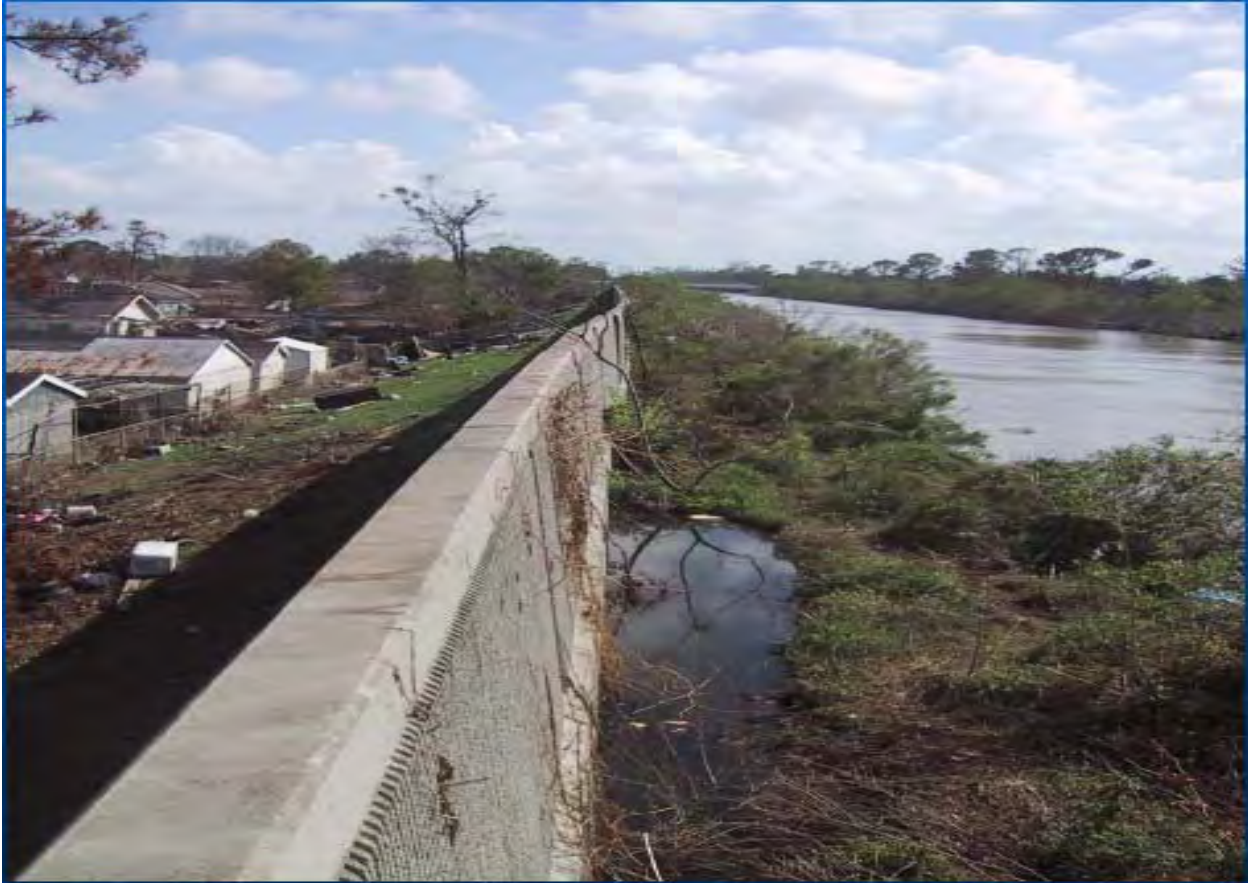
Figure 31. Tilted I-Wall Opposite the North Breach on the London Avenue Canal

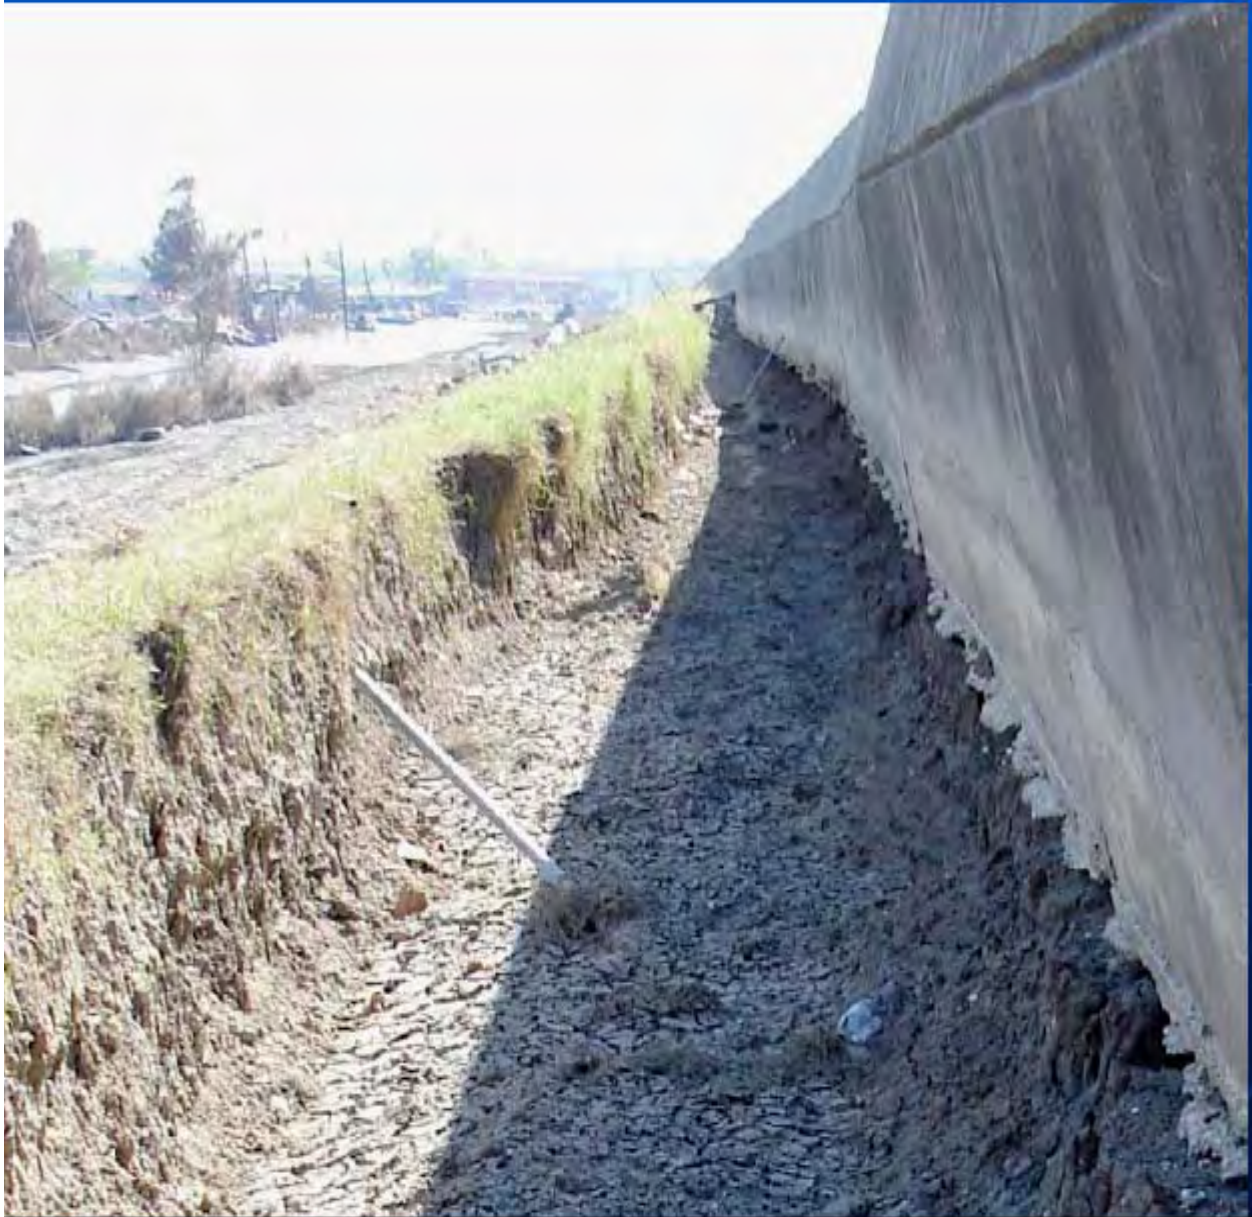
Figure 45. Scour and Erosion on the Protected Side of the IHNC Adjacent to the 9th Ward in the Vicinity of the South Breach

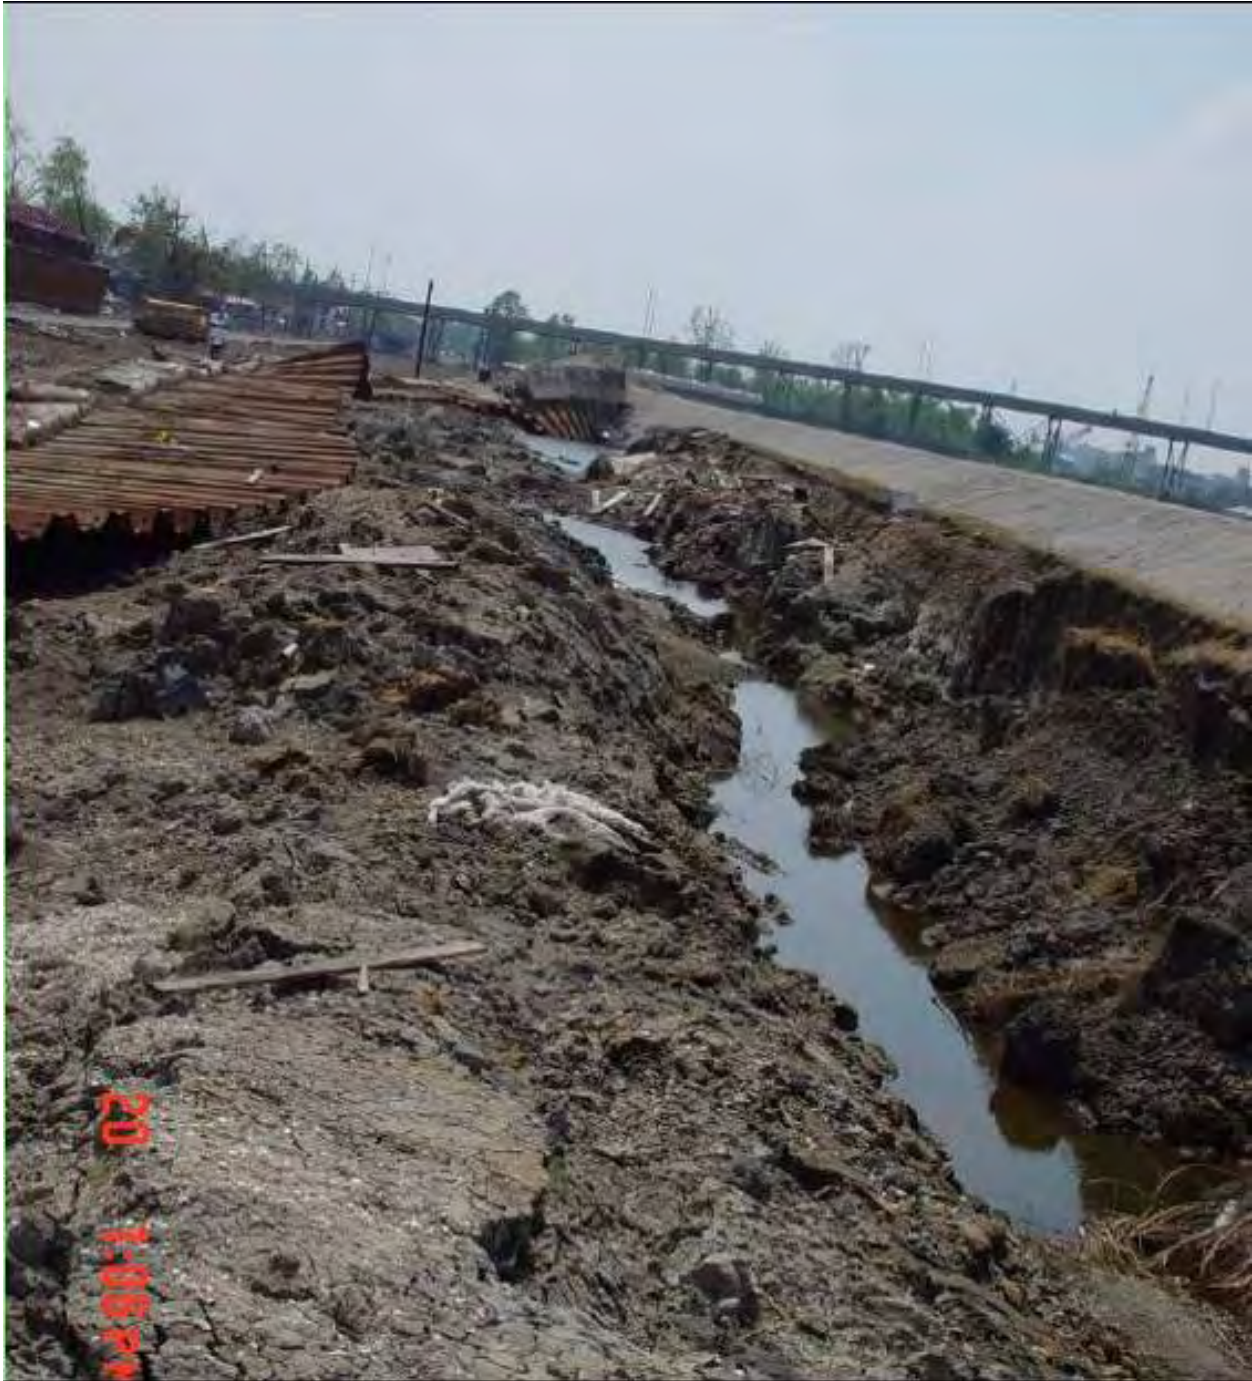
Figure 46. Scour and Erosion Leading to the Failure of the I-Wall on the IHNC Adjacent the South Breach (9th Ward)

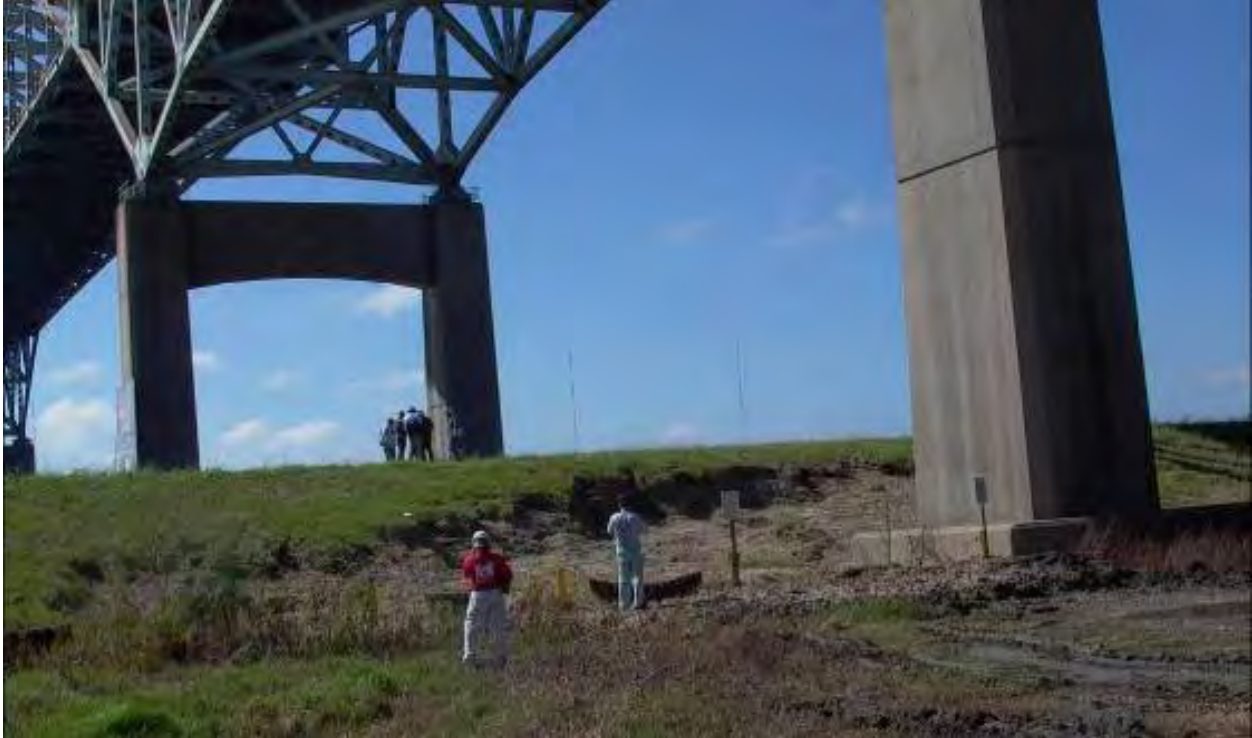
Figure 61. Overtopped Levee Under the Paris Road Bridge Adjacent to the Entergy Power Plant in the New Orleans East, After the Storm

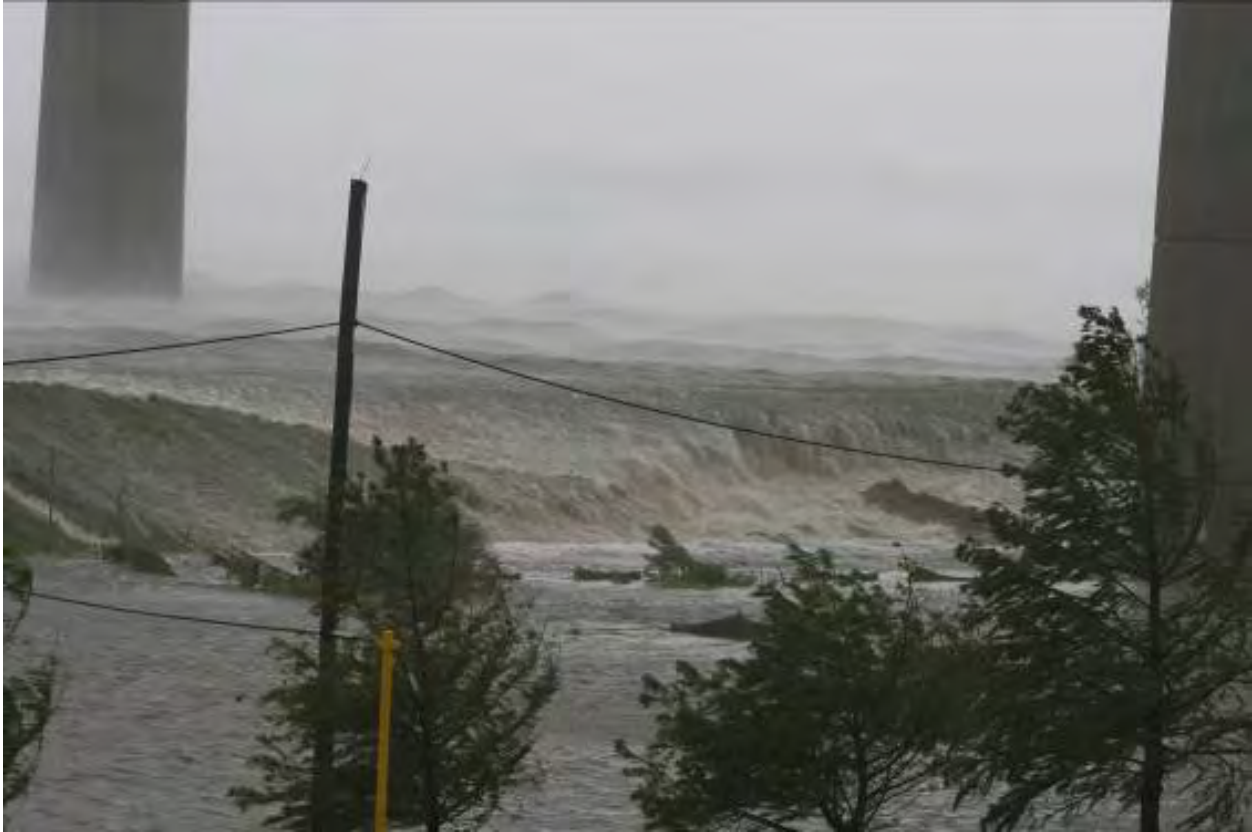
Figure 62. Overtopping of the Levee Under the Paris Road Bridge Adjacent to the Entergy Power Plant in the New Orleans East During Hurricane Katrina
