# Volume V - The Performance:

## Analysis of the London Avenue Canal I-wall Breaches

### **Analysis of the London Avenue Canal I-wall Breaches**

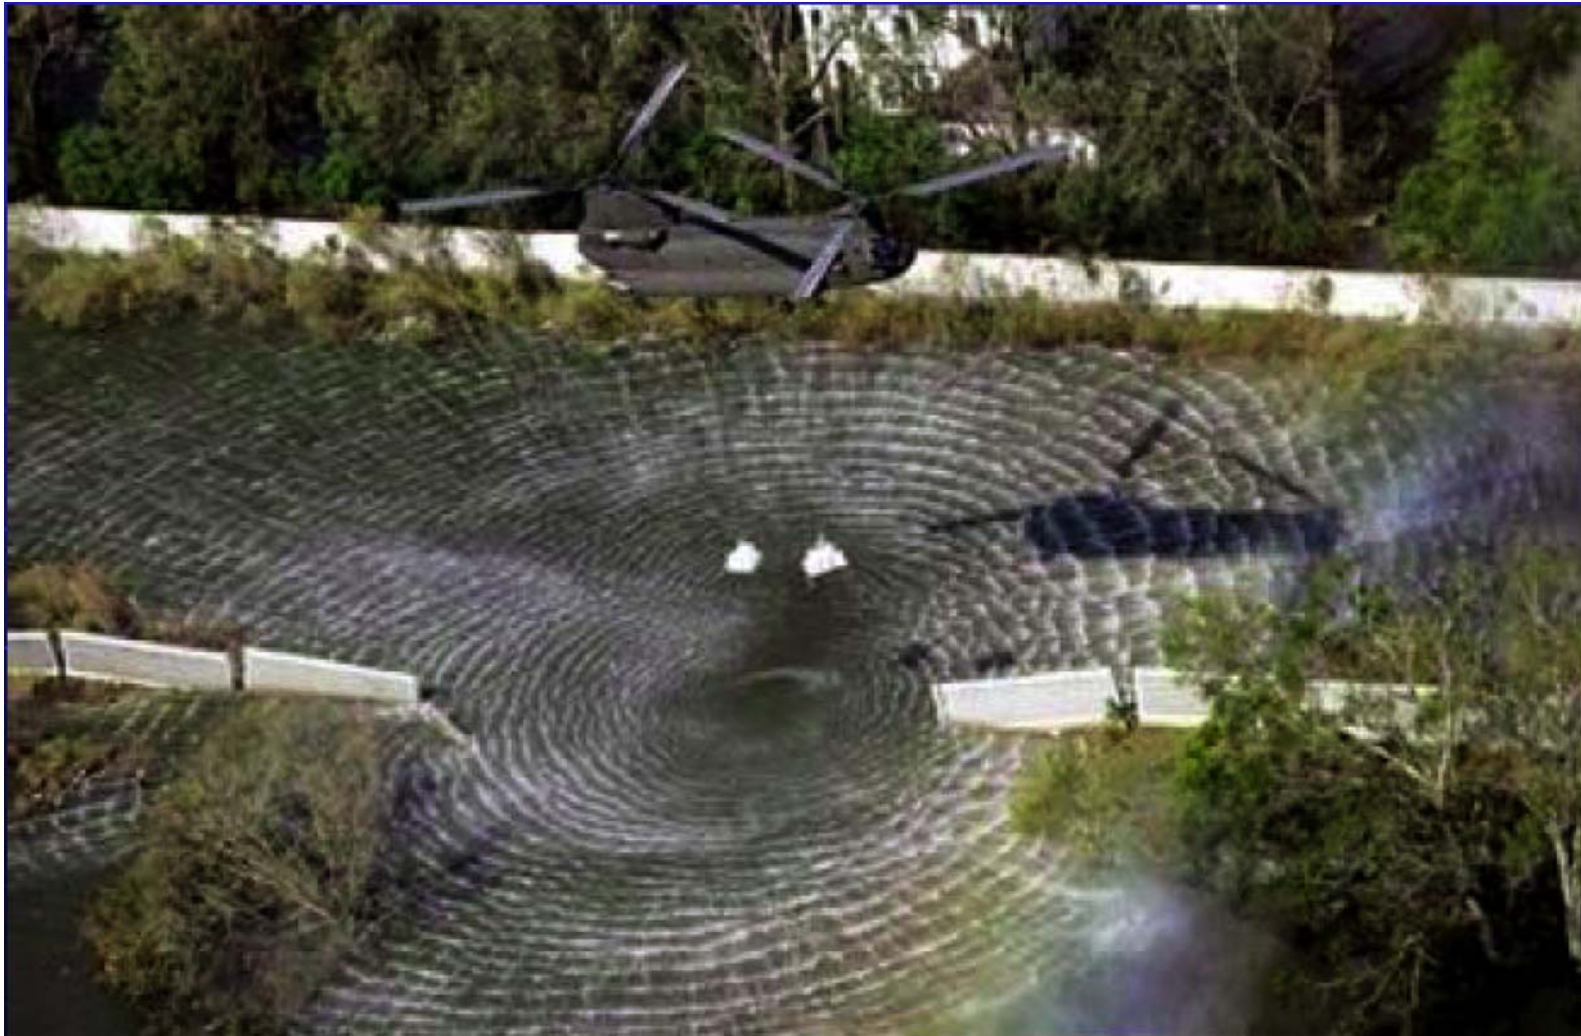
The south breach, shown in Figure 1, occurred about 6:00 AM to 7:00 AM on August 29<sup>th</sup>, when the water level in the canal was 7.1 ft to 8.2 ft NAVD88. The breach was narrower than the breach at 17<sup>th</sup> Street and the London Avenue north breach. A deep scour hole formed due to the inrush of water, and a large amount of eroded sand was deposited in the neighborhood inland of the breach. It appears that the breach was quite narrow when it formed, and subsequently widened to about 60 ft as wall panels adjacent to the initial breach were undermined by scour, and tilted into the scour hole.

Figure 1 – The south breach at the London Avenue canal occurred at 6:00 AM to 7:00 AM on August 29, 2005. The breach, on the east side of the canal, was approximately 60 feet wide.

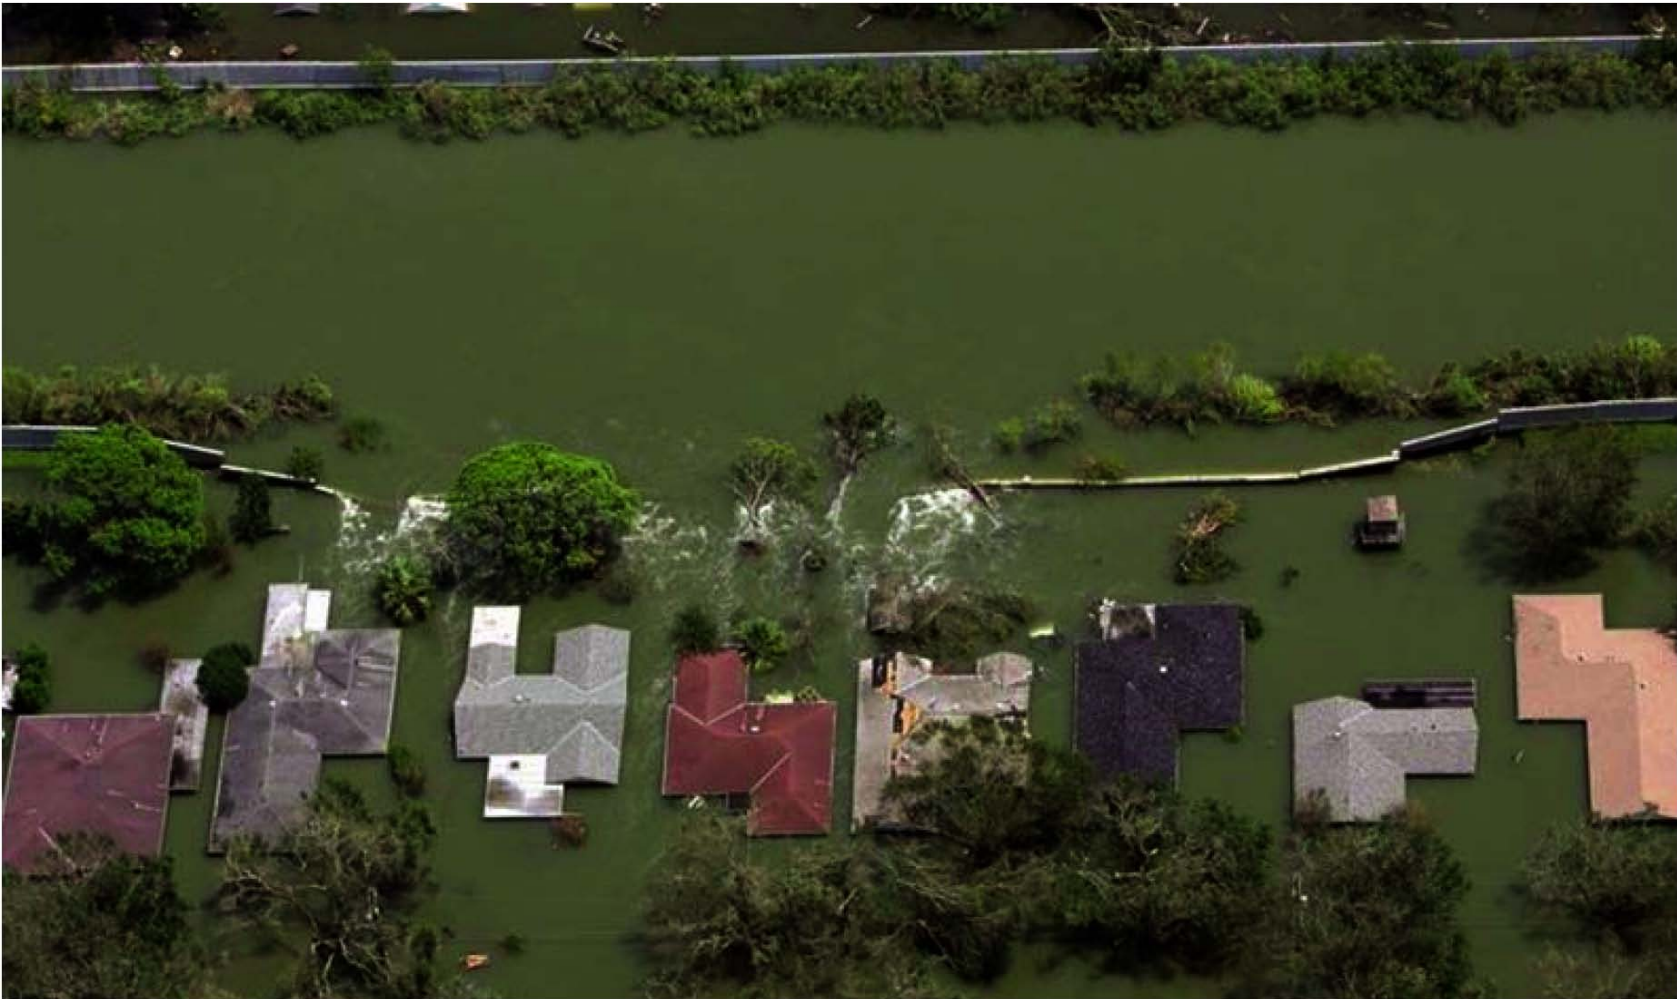
The north breach, shown in Figure 2, occurred about 7:00 AM to 8:00 AM on August 29<sup>th</sup>, about an hour after the south breach, when the canal water level was 8.2 ft to 9.5 ft NAVD88. The breach was about 410 ft wide, approximately the same width as the breach at 17<sup>th</sup> Street. A playhouse on the property adjacent to the breach was heaved upward when the breach occurred, indicating upward movement of the ground inboard of the levee toe. The I-wall opposite the north breach (on the east side of the canal) moved and tilted significantly at about the same time as the breach occurred on the west side, but the east I-wall did not breach. A line of sinkholes was observed at the inland side of the distressed east I-wall, and a sand boil at the inboard embankment toe indicate that erosive seepage and piping had occurred beneath the levee.

Figure 2 – The north breach at the London Avenue canal occurred at 7:00 AM to 8:00 AM on August 29, 2005. The breach, on the west side of the canal, is approximately 410 feet wide.

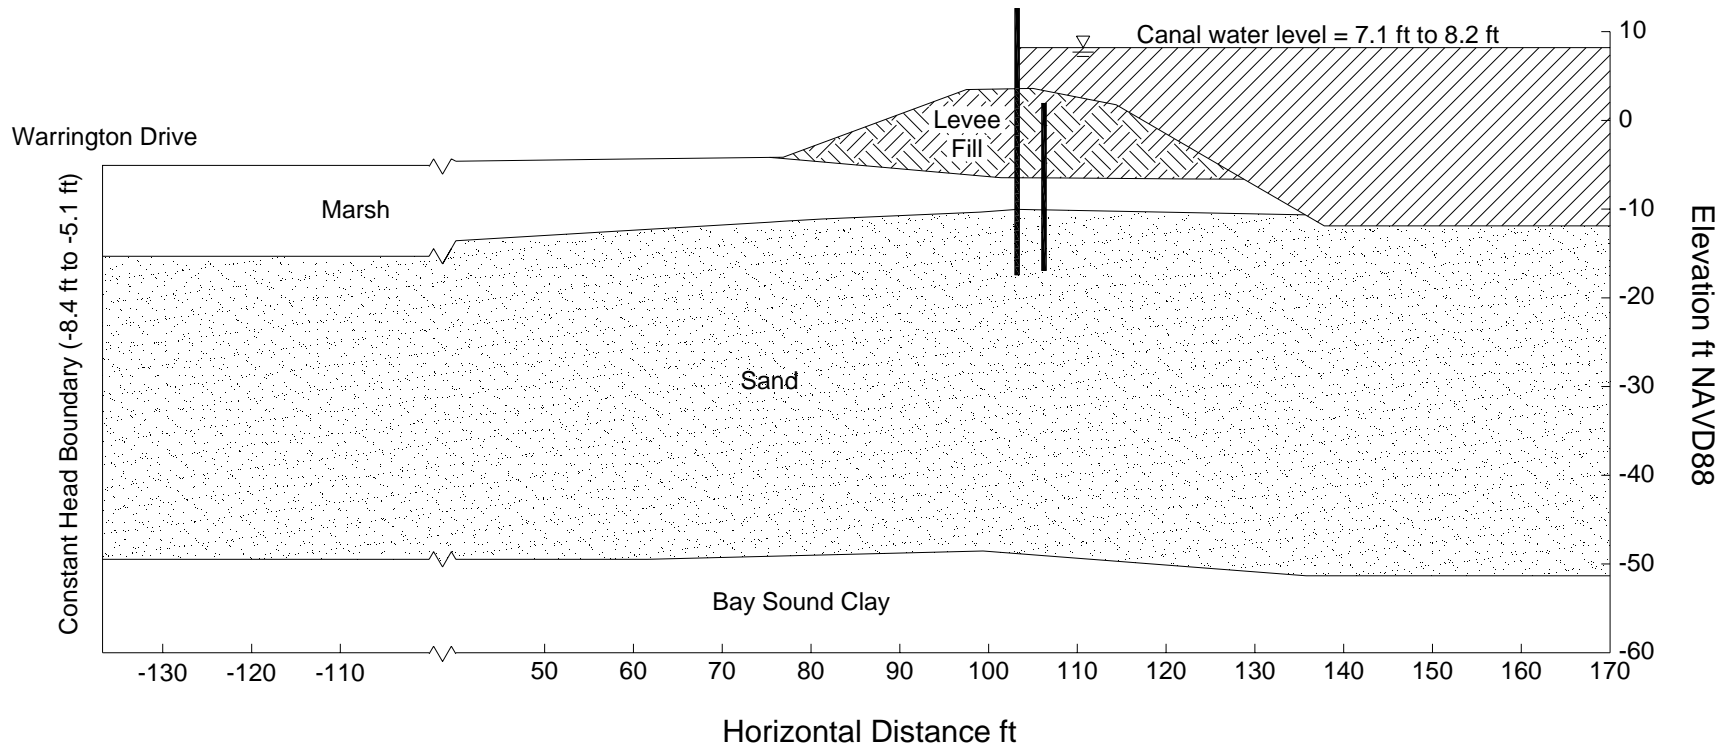
The hydraulic boundary conditions used in these analyses are shown in Figure 3. The canal water level was either 7.1 ft or 8.2 ft NAVD88, a range consistent with the estimated canal water levels at the time of failure. A constant-head boundary condition was imposed at the location of the drain beneath Warrington Drive. This head value was either -8.4 ft (the normal ground water level with pumps operating), or -5.1 ft NAVD88 (a higher level equal to the ground surface elevation, which might have occurred with pumps not operating). Reports indicate that the pumps stopped operating when the wall failed, severing the power line. In all, four different seepage cases were analyzed, as shown in Table 1.

Figure 3 - Schematic cross section at London South breach, with seepage boundary conditions.

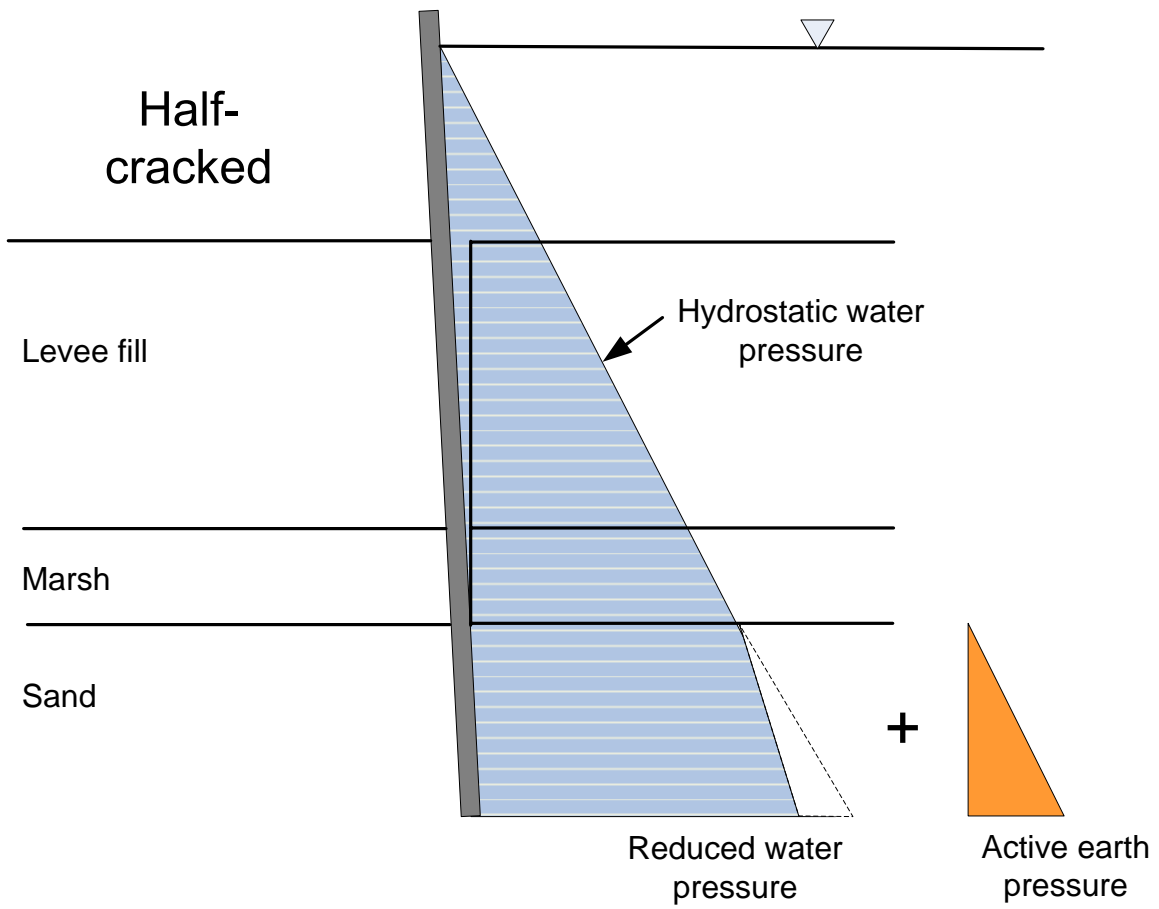
sand would be loaded by water pressures that are somewhat lower than hydrostatic pressures, plus active earth pressures, as shown in Figure 5. The lower-than-hydrostatic water pressures were determined from the finite element seepage analyses. All of the seepage and stability analyses were performed based on this half-cracked condition.

Figure 5 - Schematic of crack used in London Avenue Canal stability analyses.

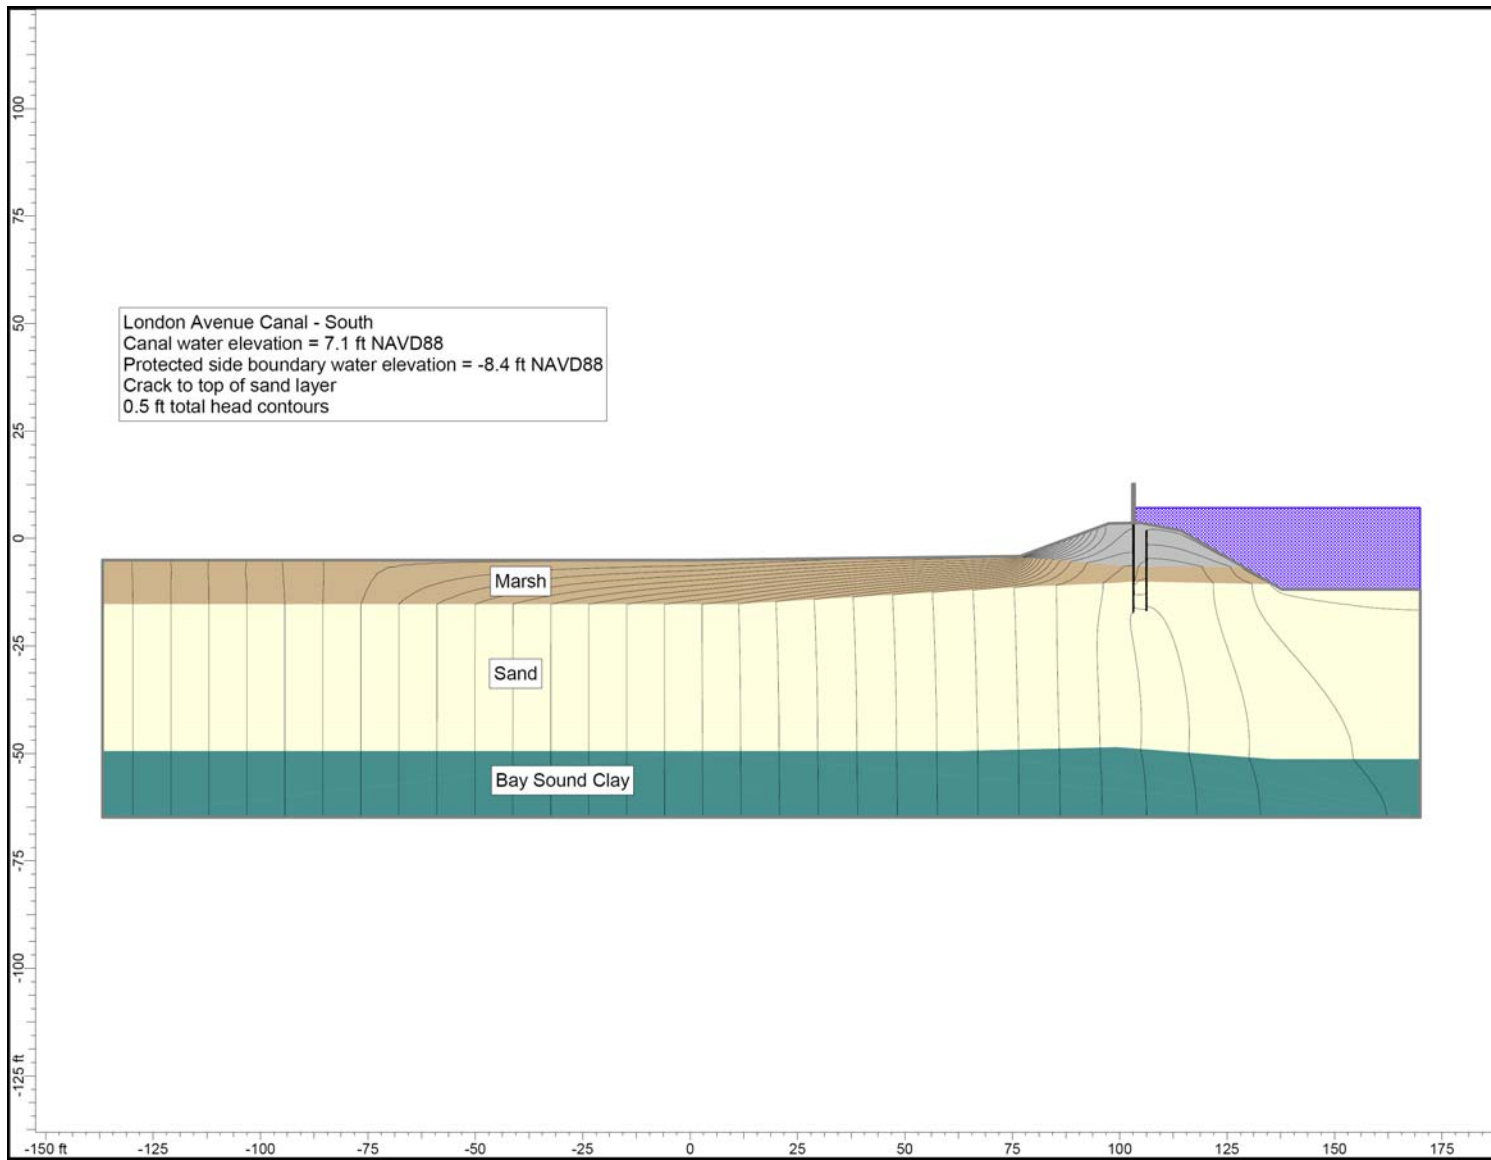
Six-node triangular elements were used for the seepage analyses. The finite element mesh is shown in Figure 6. Computed total head contours for Case 1 are shown in Figure 7. It can be seen that the flow through the sand is predominantly horizontal, and that the total head on the landward side of the levee is above the ground surface, which is at elevation  $-5.1$  ft. The head contours for the other three cases shown in Table 1 had similar shapes, although the values varied somewhat depending on the canal water level and the Warrington Drive water level.

Figure 7 - Total head contours calculated for seepage analysis of London south breach (Case 1).

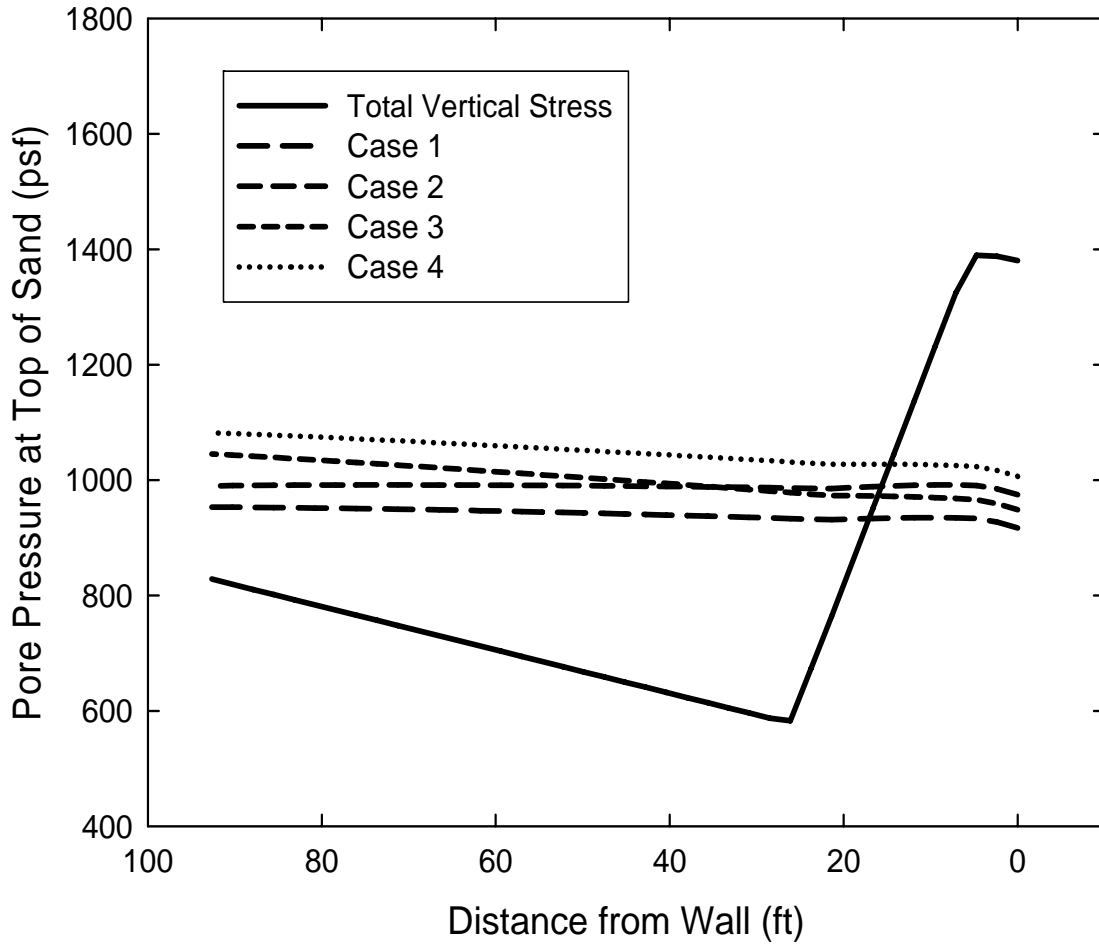
Computed pore pressures, or uplift pressures, at the base of the marsh layer are shown in Figure 8 for the four cases analyzed, together with the total overburden pressure at the base of the marsh layer. It can be seen that in all four cases the computed pore pressures exceed the total overburden pressure at the base of the marsh layer. This result indicates that the marsh layer would be heaved off the underlying sand by the high uplift water pressures. A likely result of this heave would be rupture of the marsh layer at one or more weak points, and upward flow of water through the rupture in the marsh material. This flow would relieve the high water pressure locally, and create a new hydraulic boundary condition at the point of rupture.

Figure 8 – Calculated uplift pressures and total overburden pressure for London south breach.

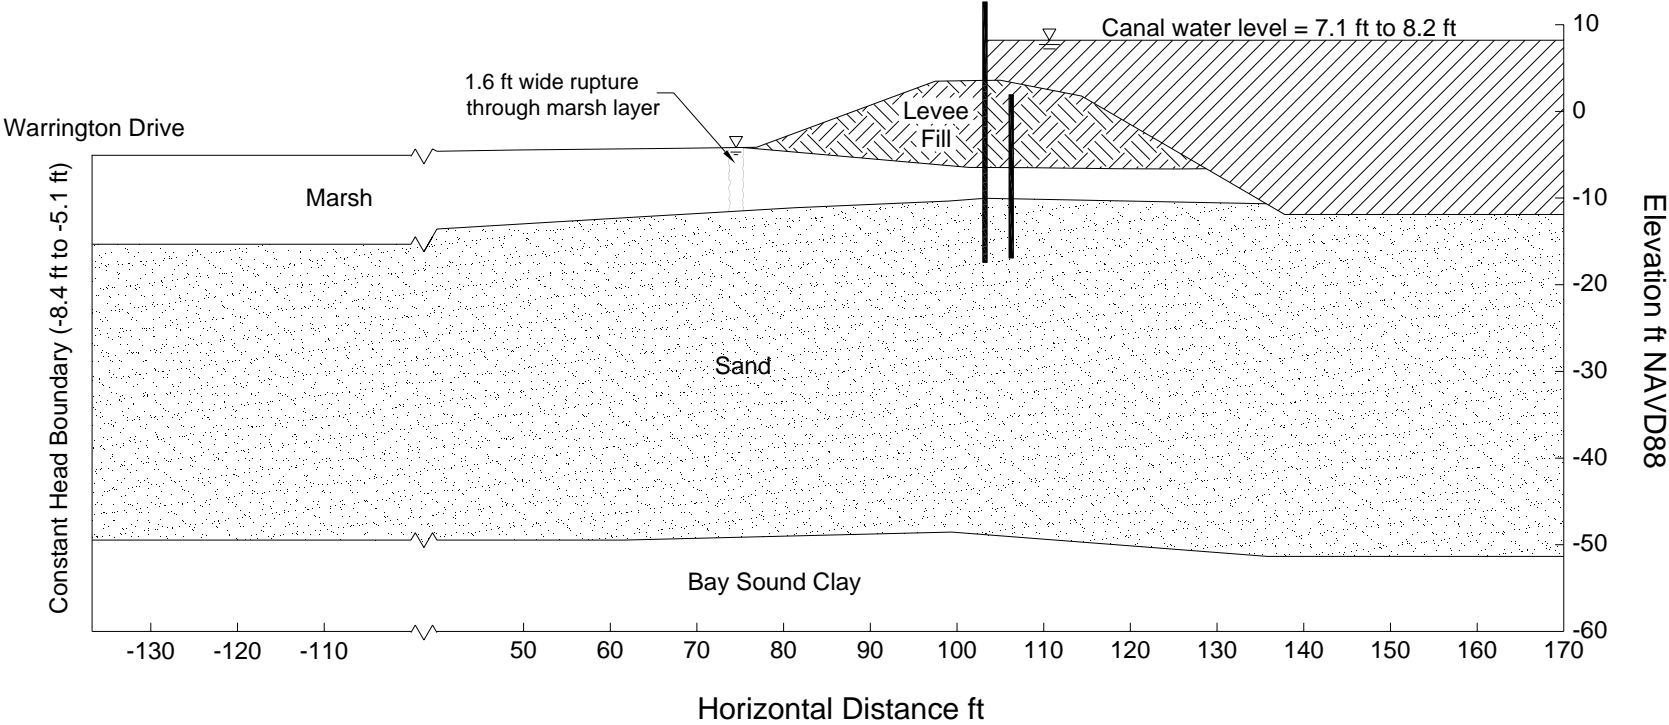
Additional seepage analyses were performed to determine if the hydraulic gradients within the sand after rupture of the marsh layer would be large enough to cause erosion of the sand and begin a piping failure. The seepage boundary conditions used in these analyses are shown in Figure 9, where a rupture extends upward through the marsh layer, from the top of the sand to the ground surface. The hydraulic gradients computed in these analyses were found to depend on the assumed width of the rupture in the marsh layer. While it seems clear that the marsh layer would rupture when the uplift pressures exceeded the overburden pressures, the width of the rupture would depend on factors that cannot be evaluated, and it is thus necessary to assign a width to the rupture zone based on judgment. Even so, we believe that the analytical results that follow reflect the essential aspects of the situation. The results support the view that the London south breach developed as a result of erosion and piping.

Figure 9 - Schematic cross section at London south breach, showing rupture through marsh layer.

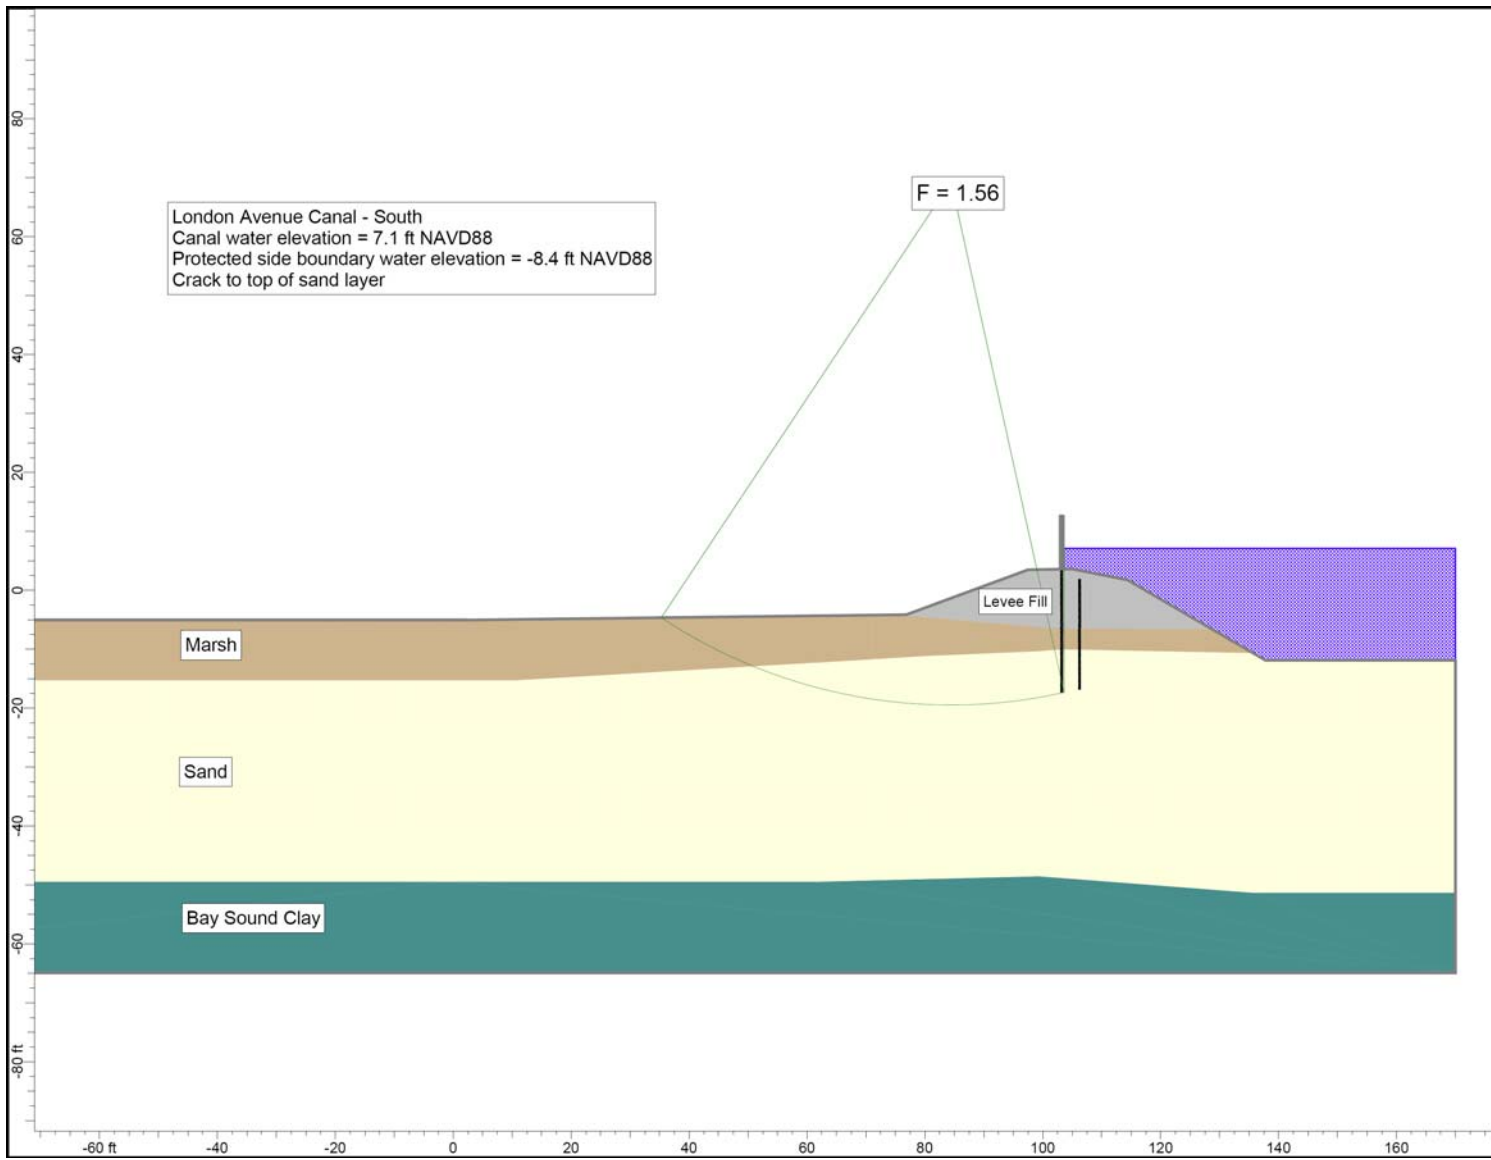
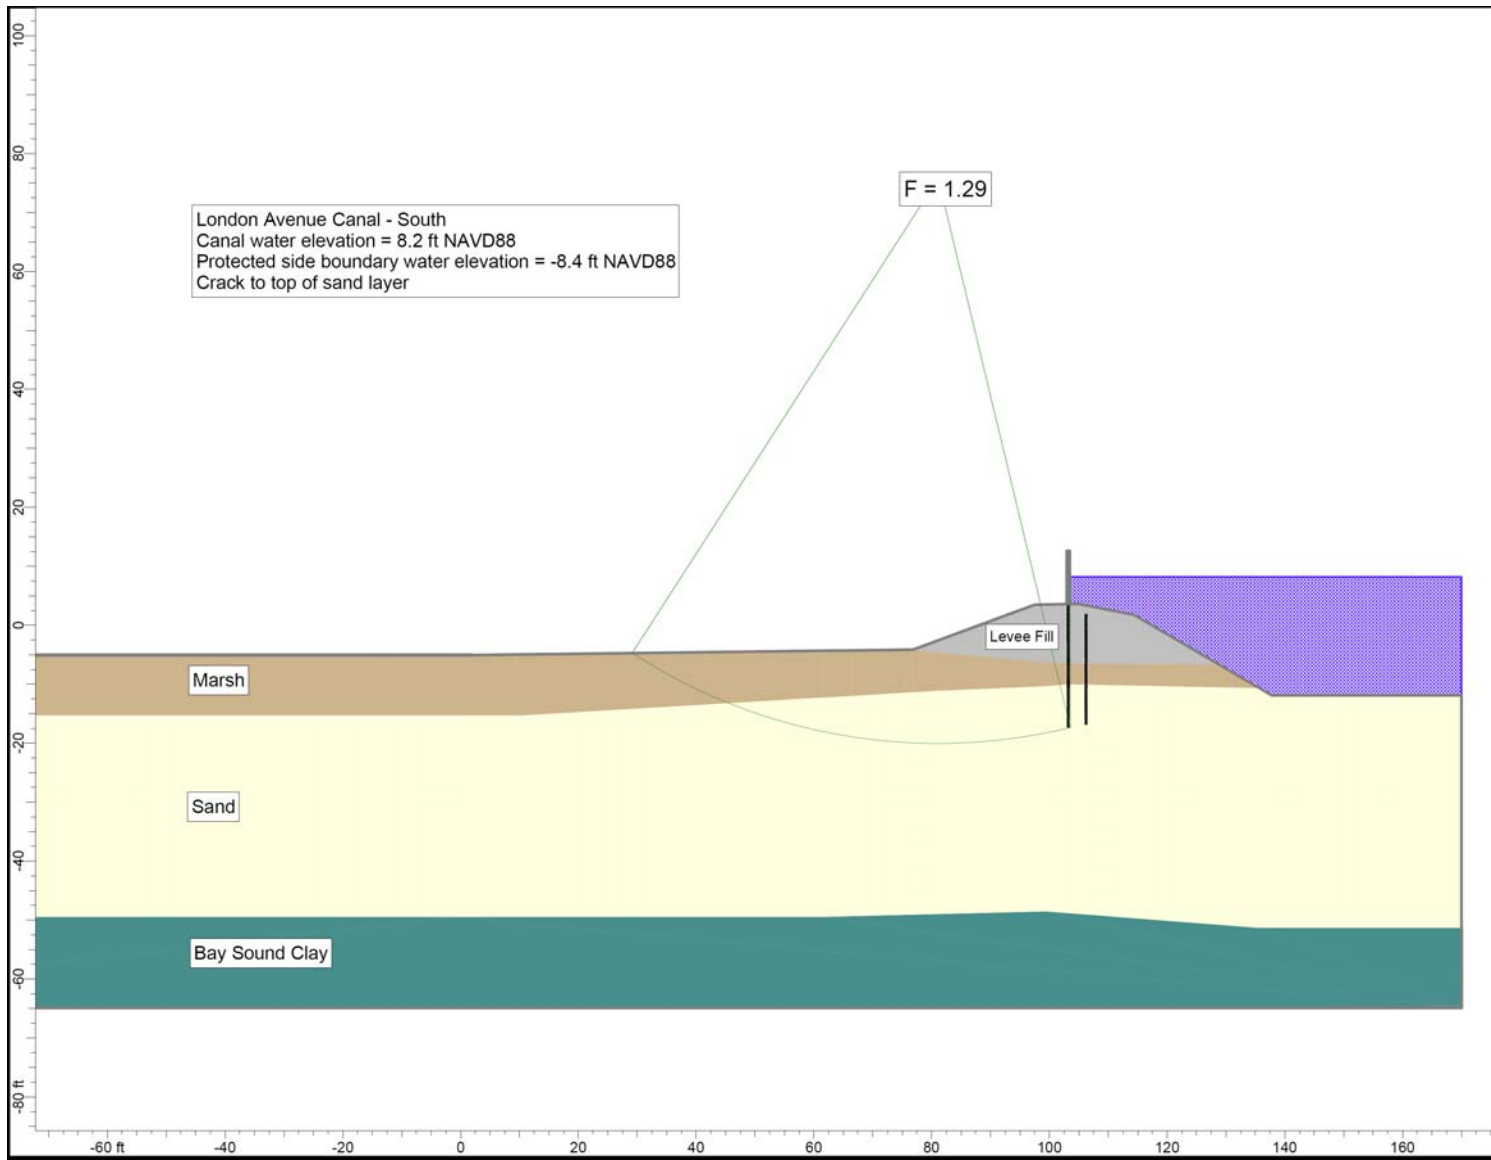
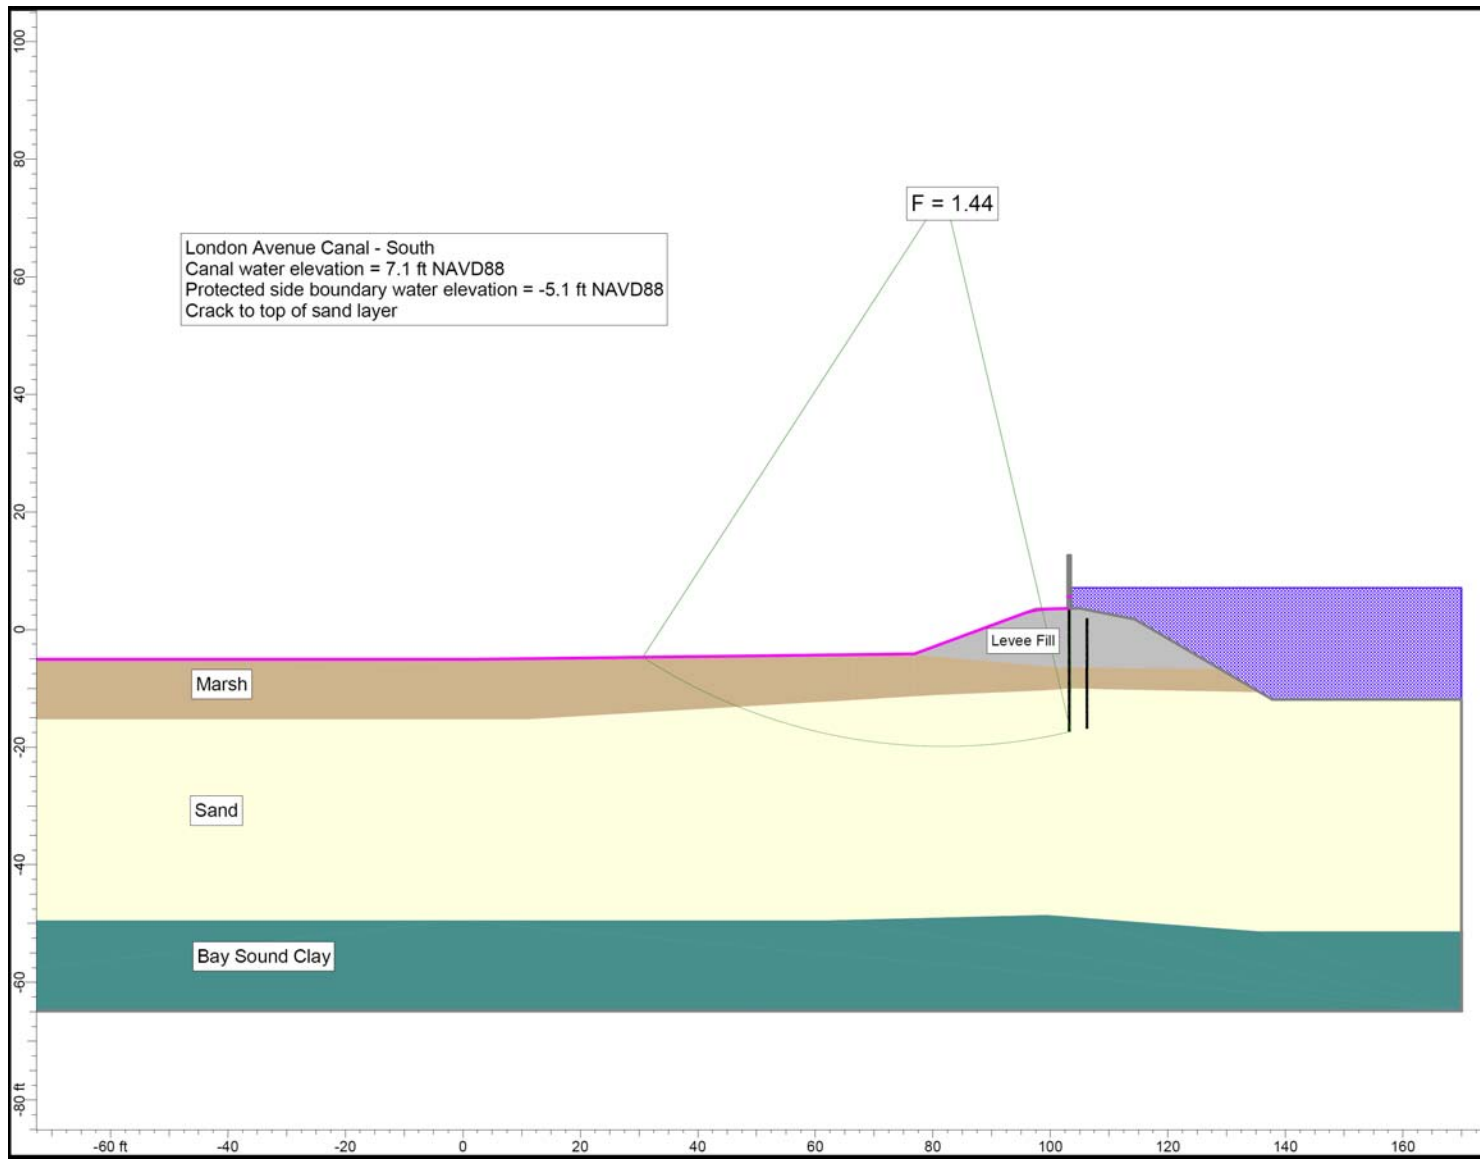
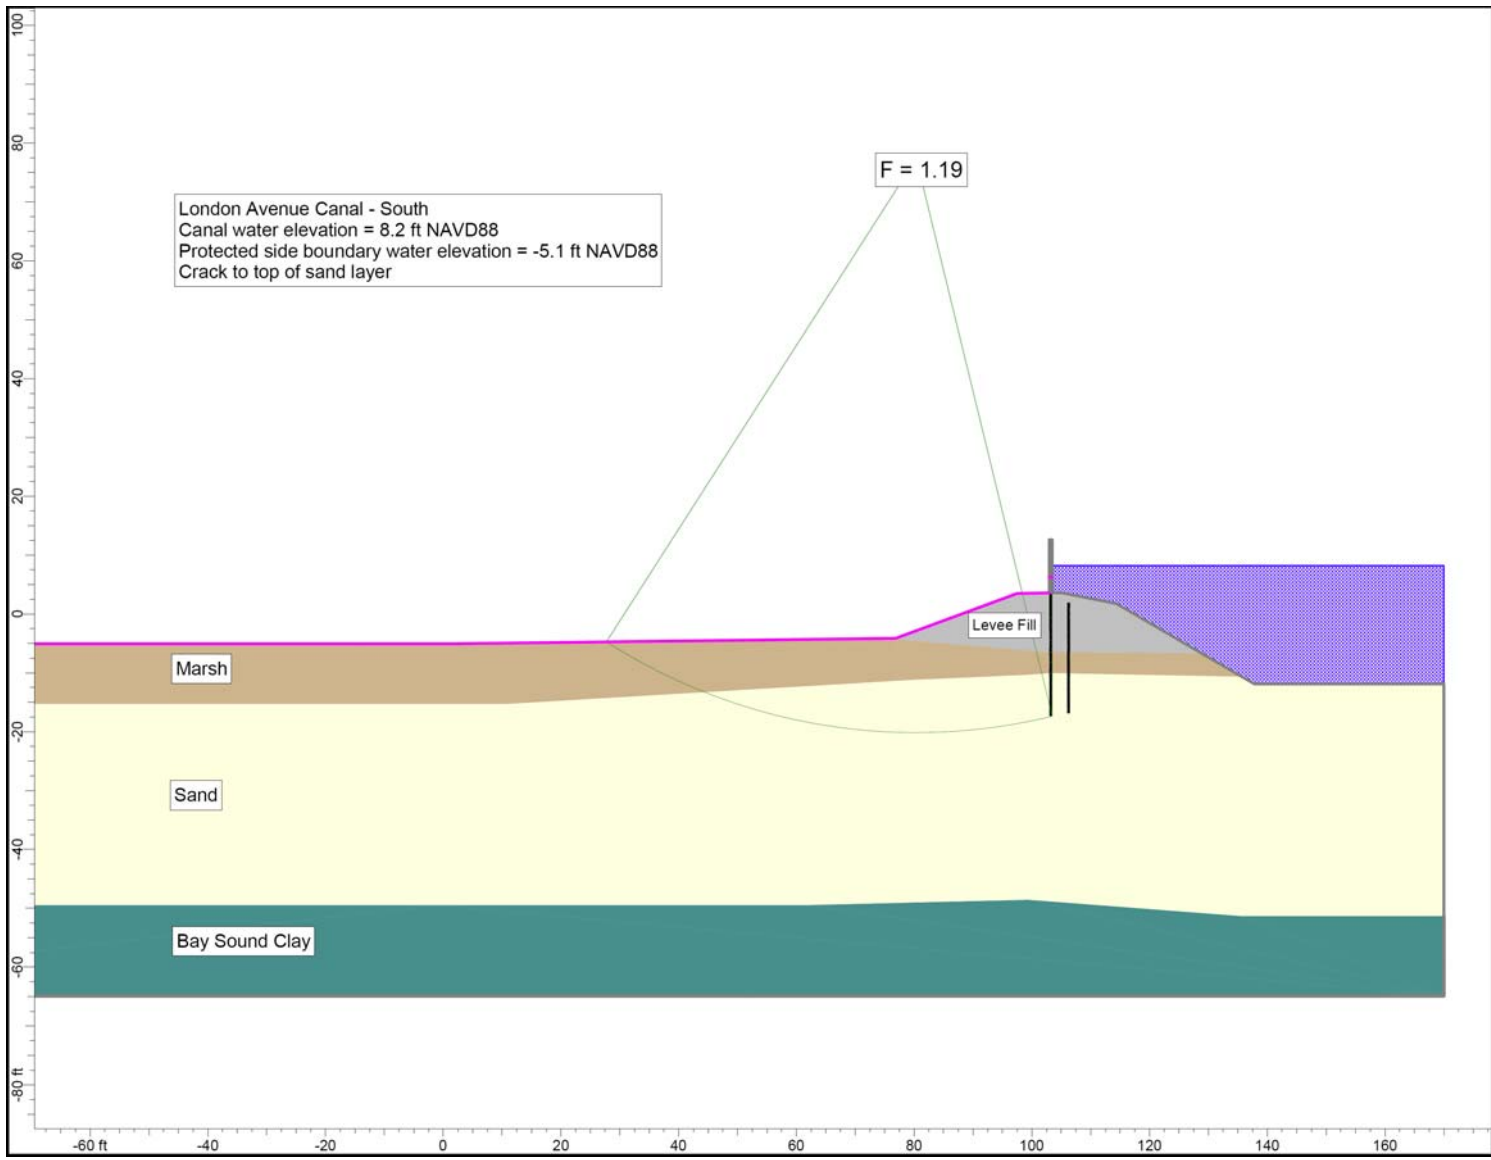
The stability analyses were performed for the cross section shown in Figures 11, 12, 13, and 14. This is the same cross section as used in the seepage analyses, and the same canal water levels and landside water levels were used.

The factors of safety calculated in these analyses are shown in Figures 11 through 14, and in Table 4. For the canal water levels estimated at the time of the breach (7.1 ft to 8.2 ft) the calculated factors of safety range from a low value of  $F = 1.19$  to a high value of  $F = 1.56$ . Thus, with this interpretation of the available data, and consistent assumptions for the seepage and stability analyses, a mechanism of failure involving erosion and piping is plausible at the south breach, but a slope stability failure mechanism is not.

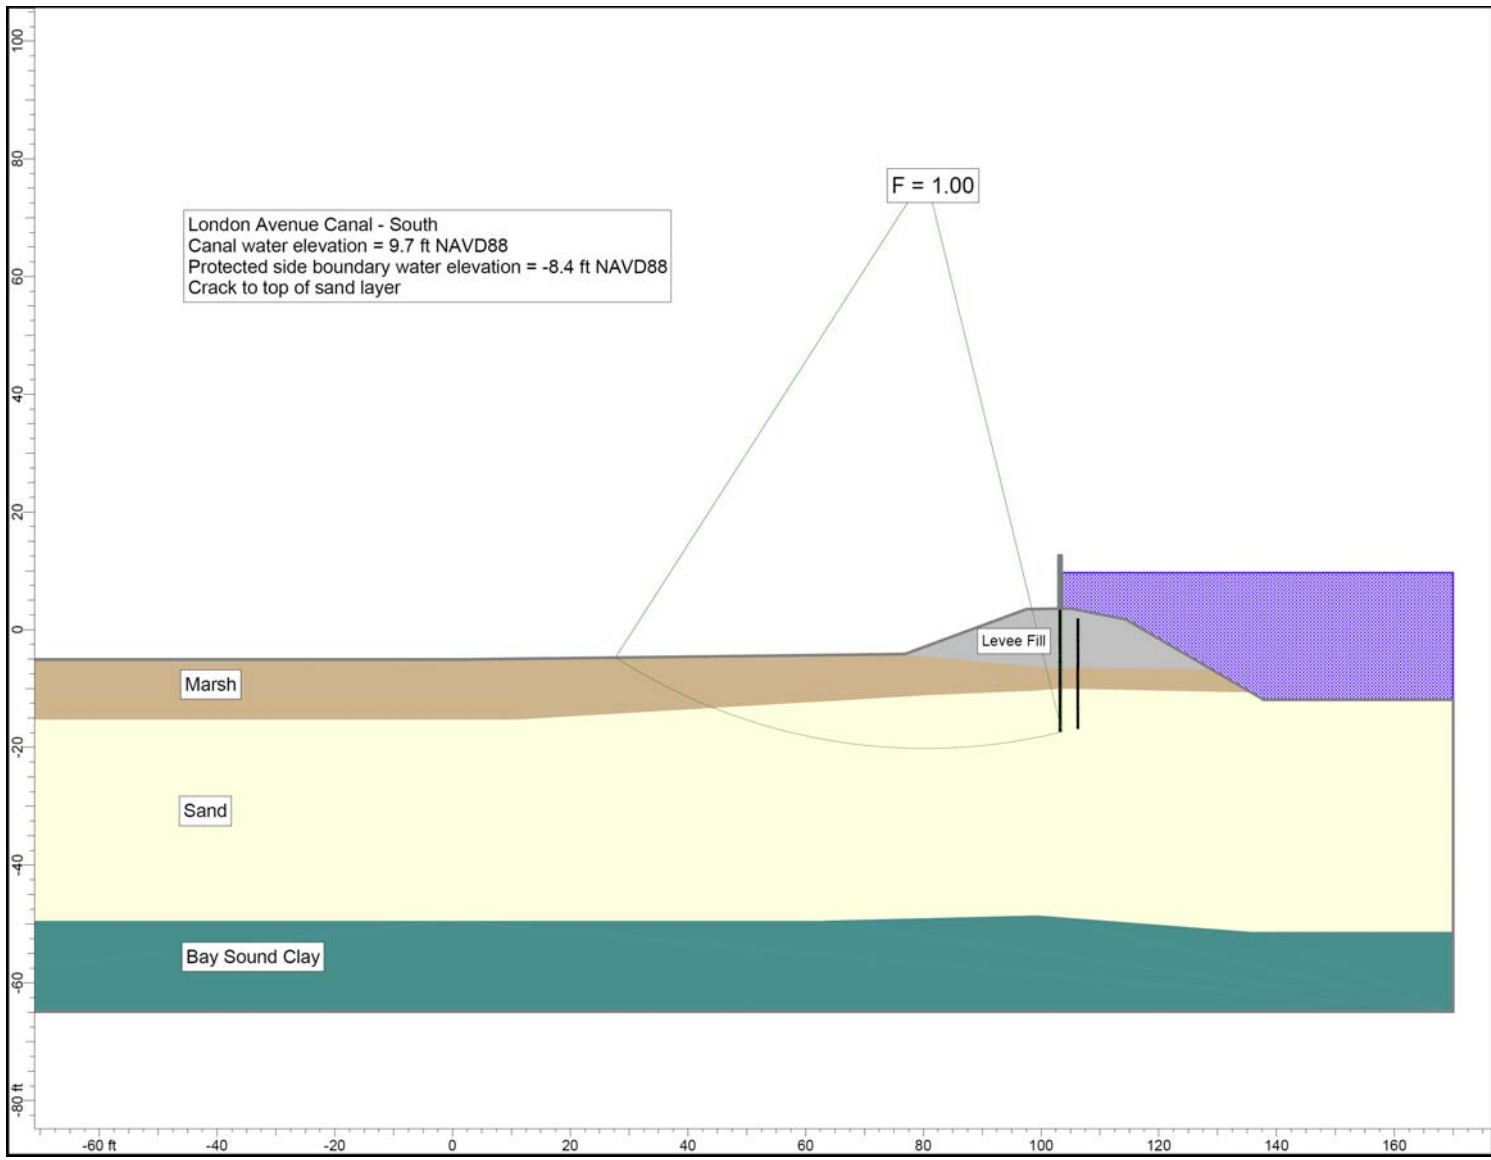
An analysis was performed, with the landside water level at -8.4 ft, to determine the canal water level corresponding to a calculated factor of safety equal to 1.00. As shown in Figure 15, a canal water level equal to 9.7 ft would be required for a factor of safety equal to 1.00. This is 1.5 ft higher than the highest estimated water level at the time the breach occurred, indicating that instability without removal of material by erosion and piping is unlikely at the south breach.

Figure 15 - London south breach Case 5 stability analysis.

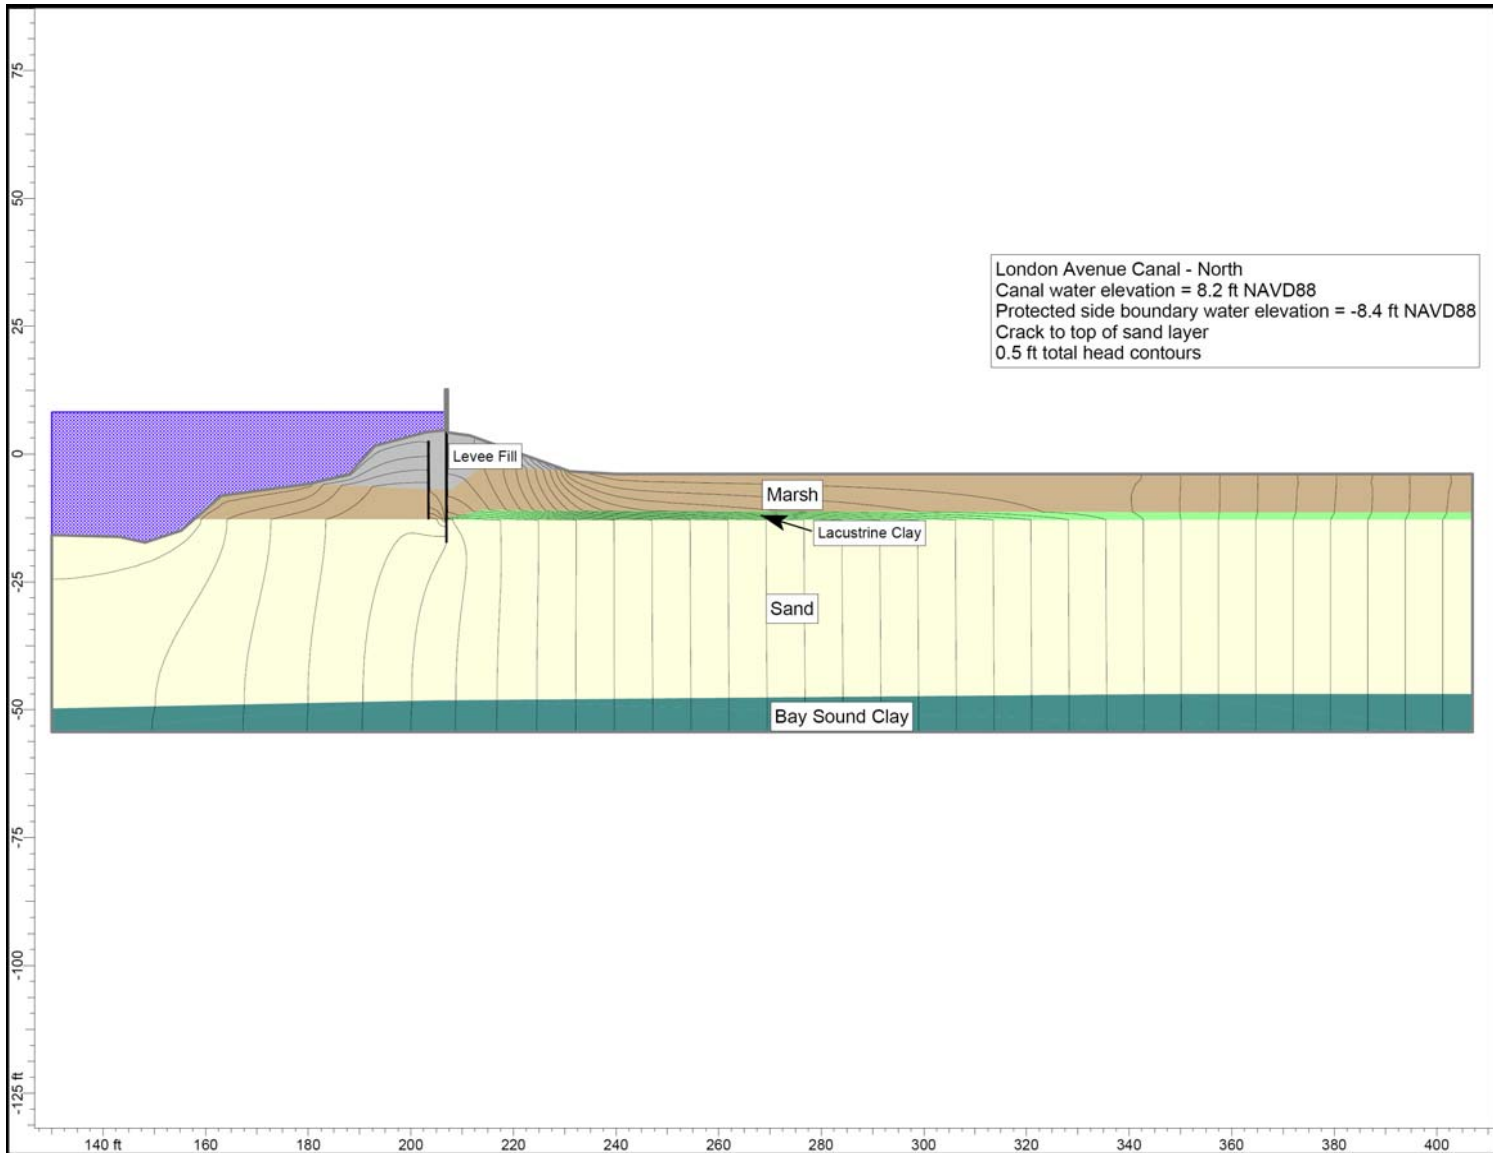
Computed total head contours for Case 1 are shown in Figure 18. As for the south breach, the flow through the sand is predominantly horizontal, and the total head on the landward side of the levee is above the ground surface, which is at elevation - 3.9 ft. The head contours for the other three cases that were analyzed had similar shapes, although the values varied somewhat depending on the canal water level and the Pratt Drive water level.

Figure 18 - Total head contours calculated for seepage analysis of London north breach (Case 1).
