# Volume V - The Performance:

## Analysis of the London Avenue Canal I-wall Breaches

### **Analysis of the London Avenue Canal I-wall Breaches**

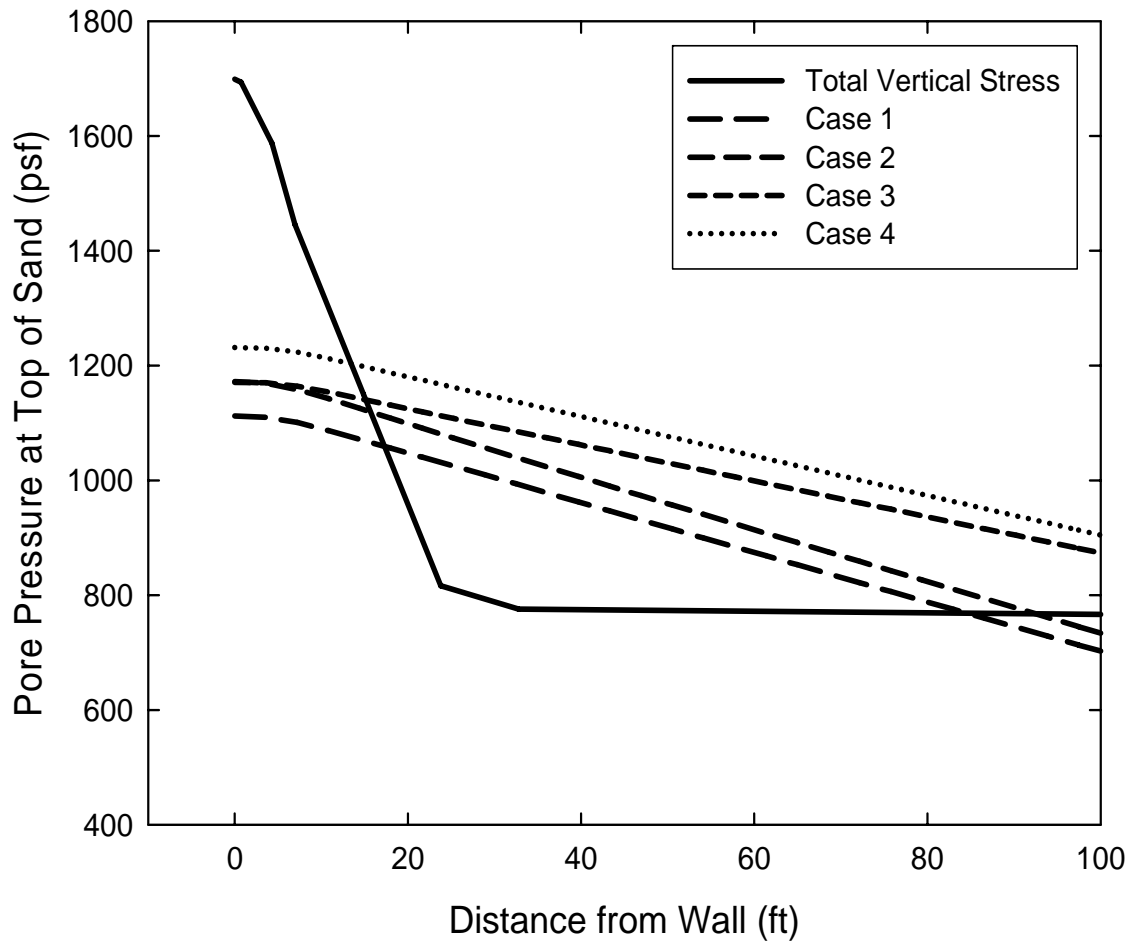
Water pressures at the base of the marsh layer for the north breach area are shown in Figure 19. As in the case of the south breach area, the uplift water pressures exceed the overburden pressures due to the weight of the marsh layer at the landside of the levee, and it would be expected that the marsh layer would be heaved upward and would rupture.

Figure 19 – Calculated uplift pressures and total overburden pressure for London north breach.

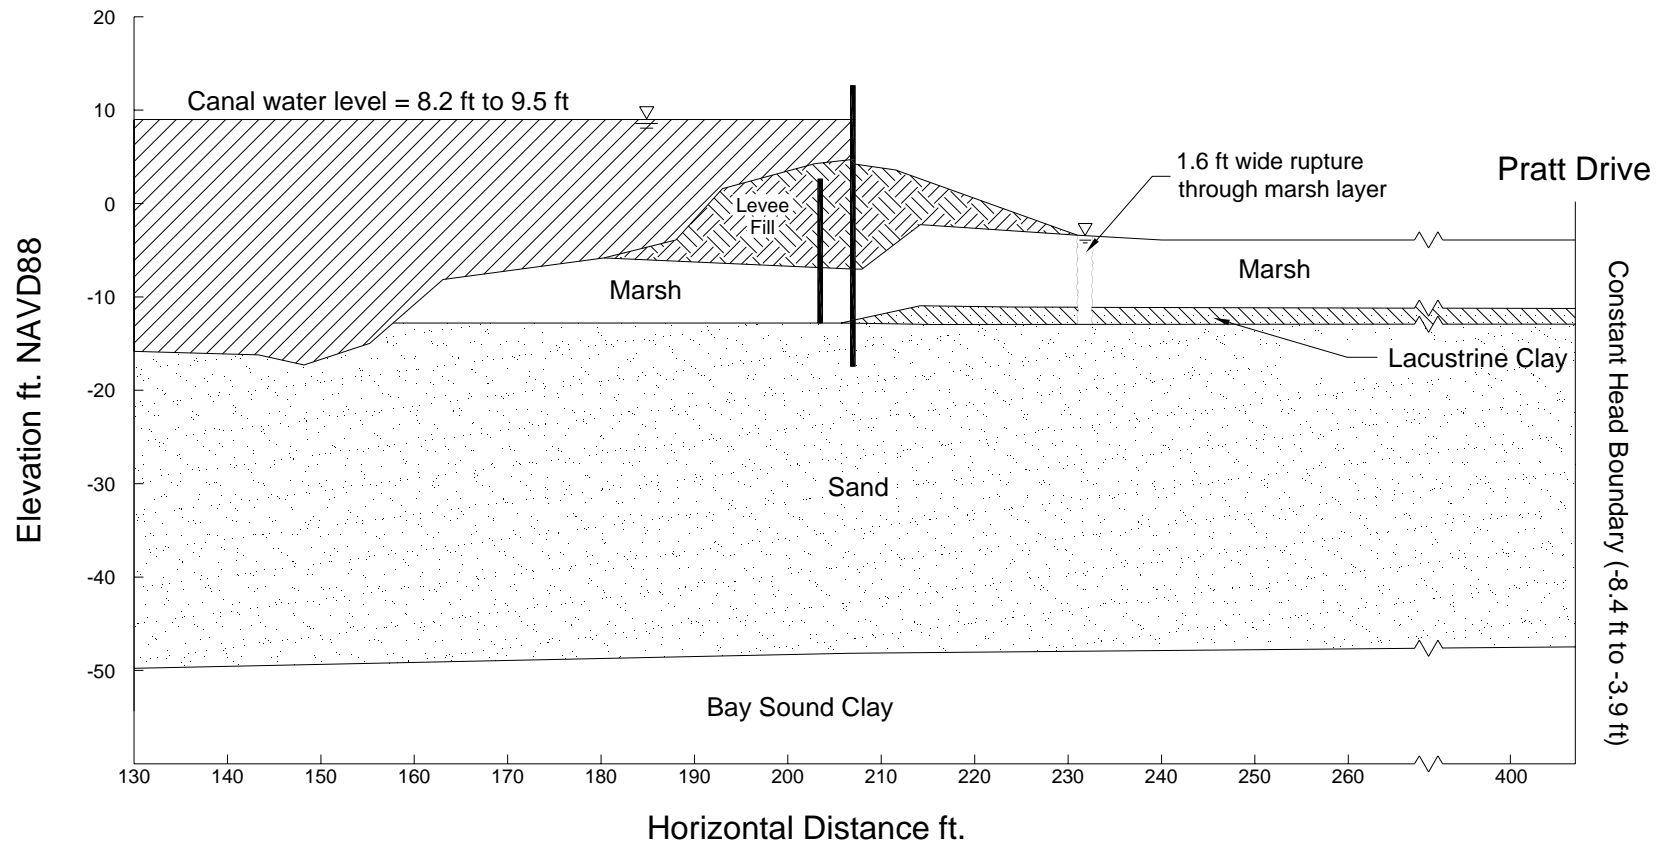
Additional seepage analyses were performed with revised boundary conditions, as was done in the south breach analyses, using the conditions shown in Figure 20. A rupture 1.6 ft wide, extending through the marsh layer and the lacustrine clay layer was assumed, and a hydraulic boundary condition with the water level at the ground surface was applied in the area of the rupture. Total head contours for the area around the assumed rupture through the lacustrine clay and peat are shown in Figure 21. The hydraulic gradients calculated for these conditions are shown in Table 7.

Figure 20 - Schematic cross section at London north breach, showing rupture through marsh layer.

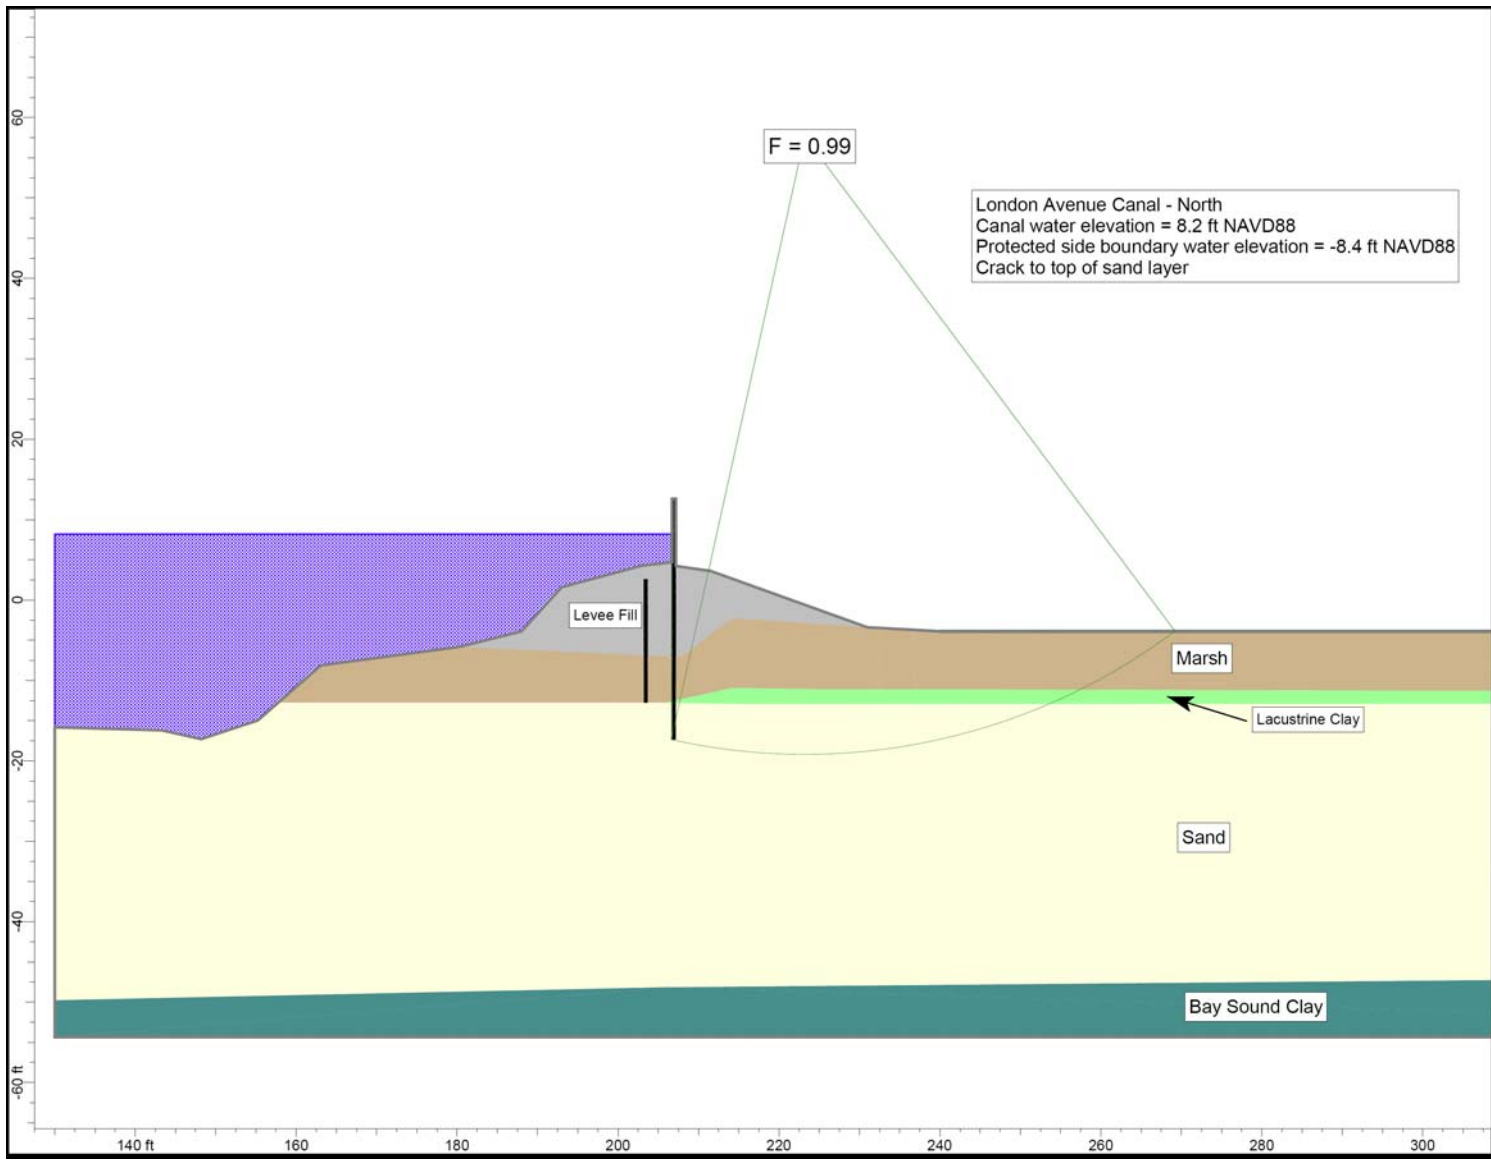
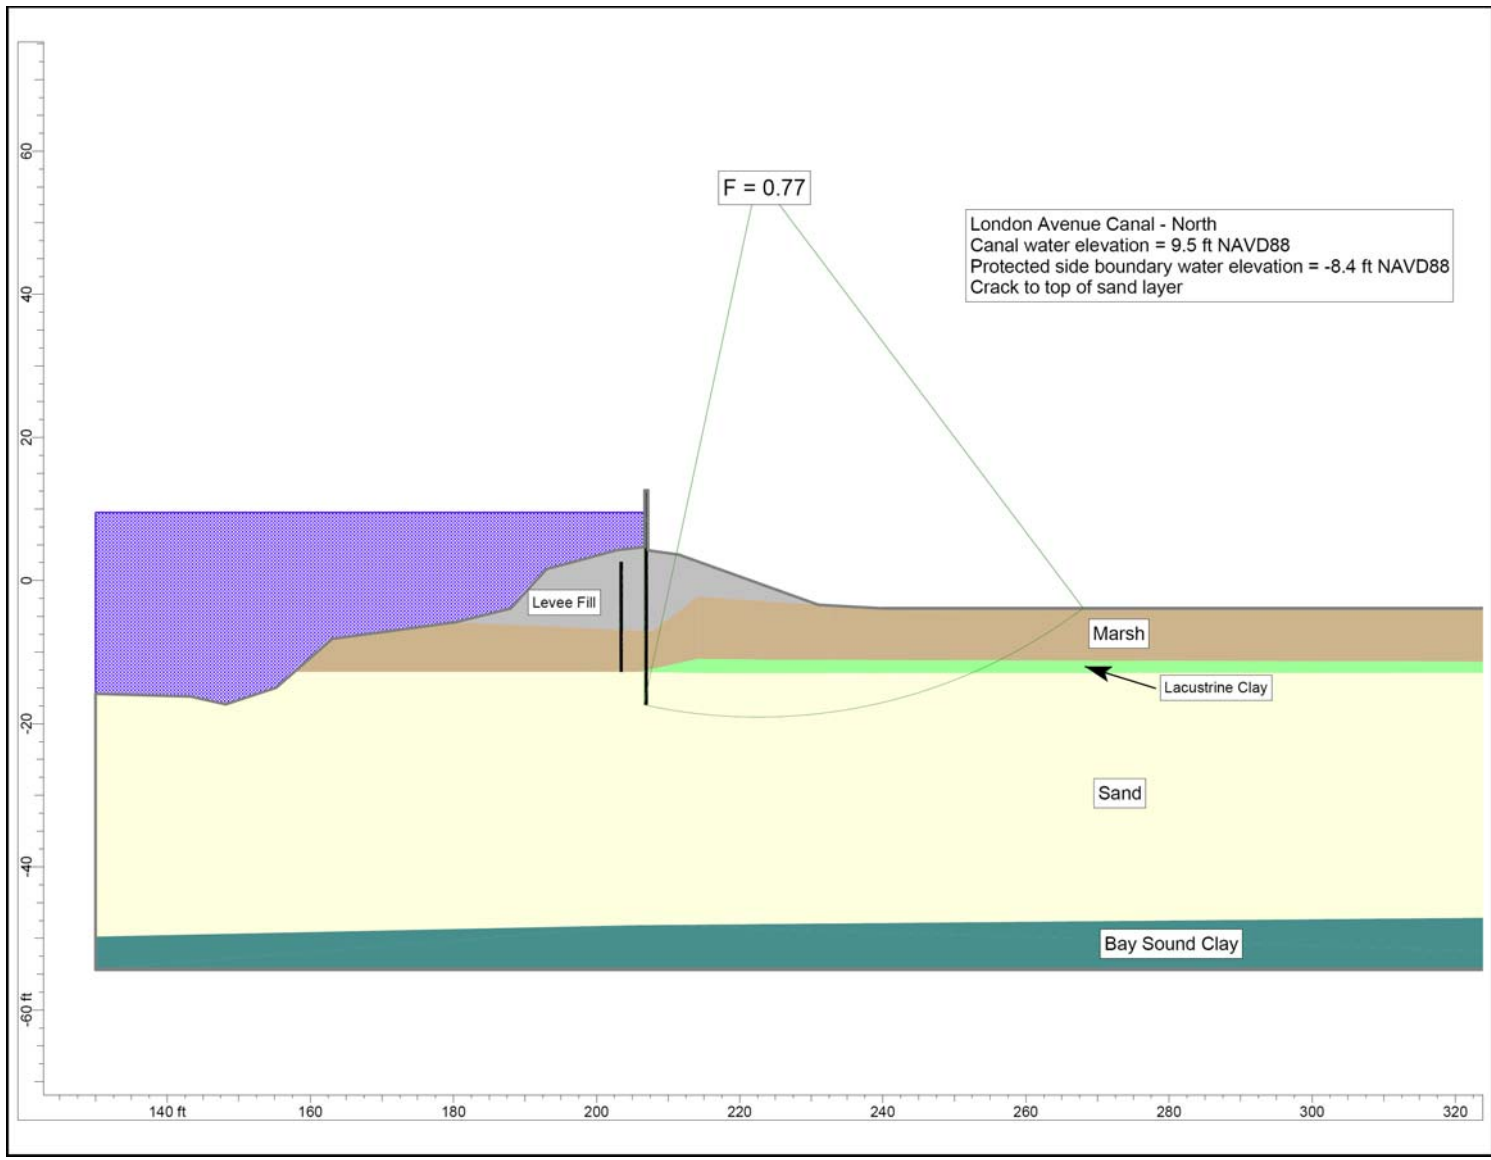
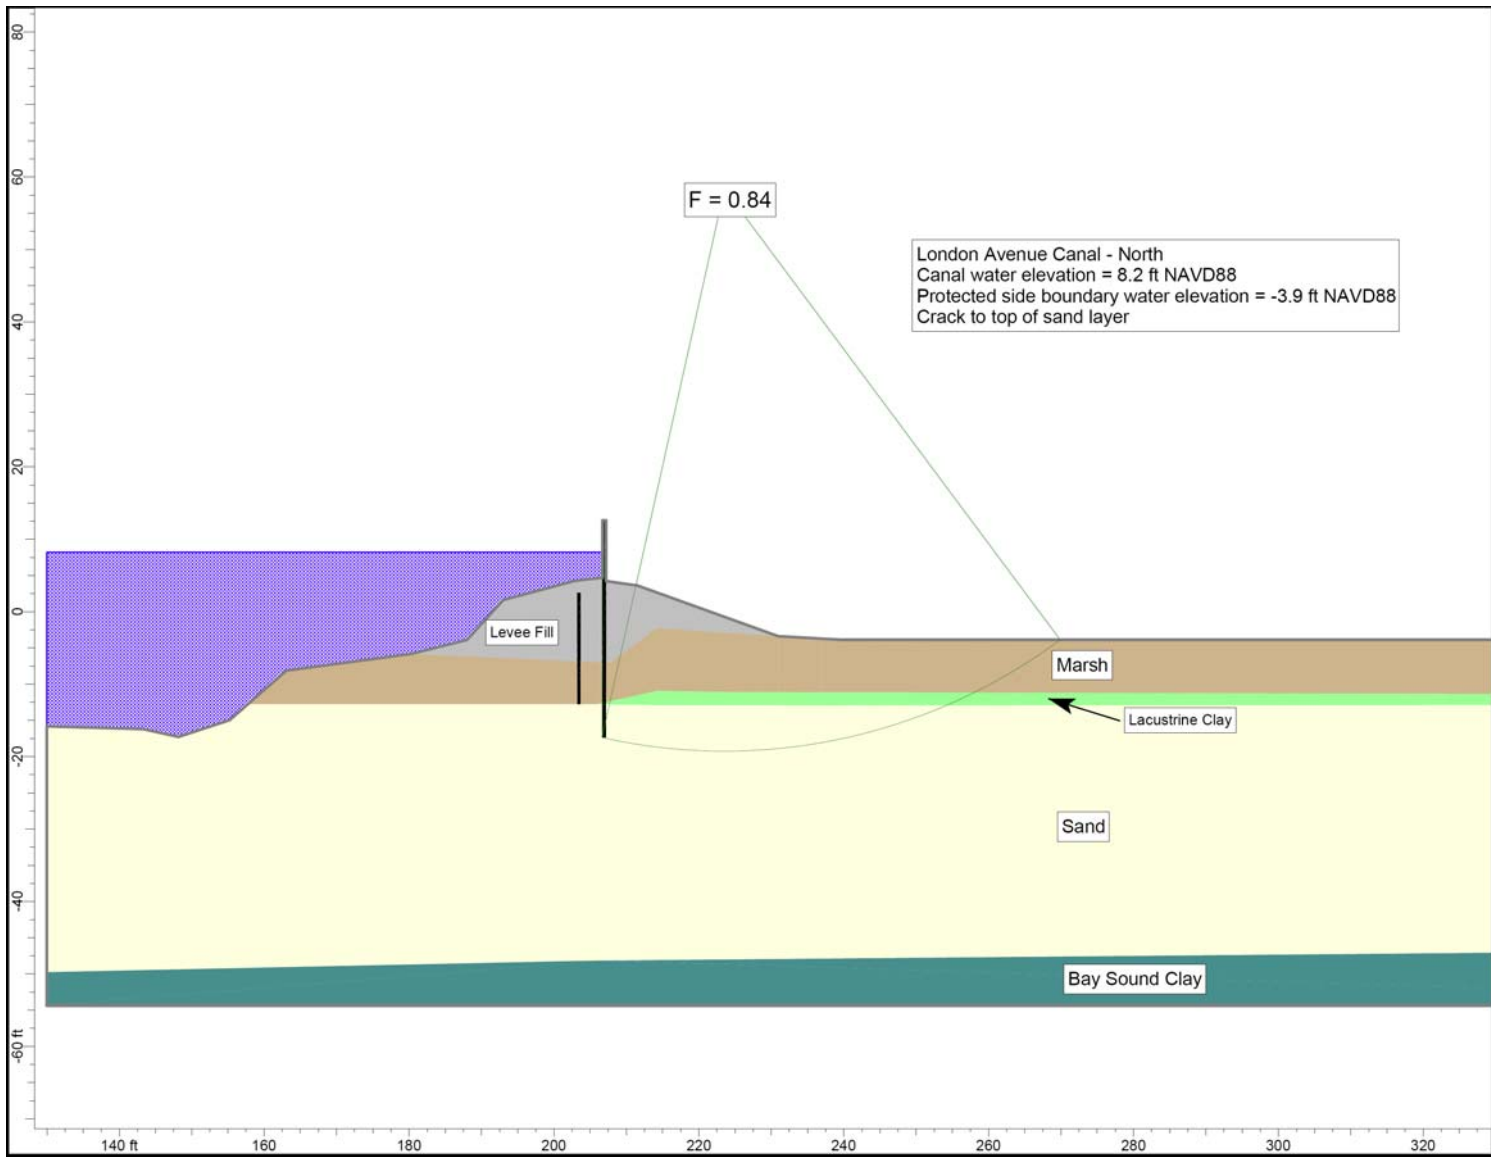
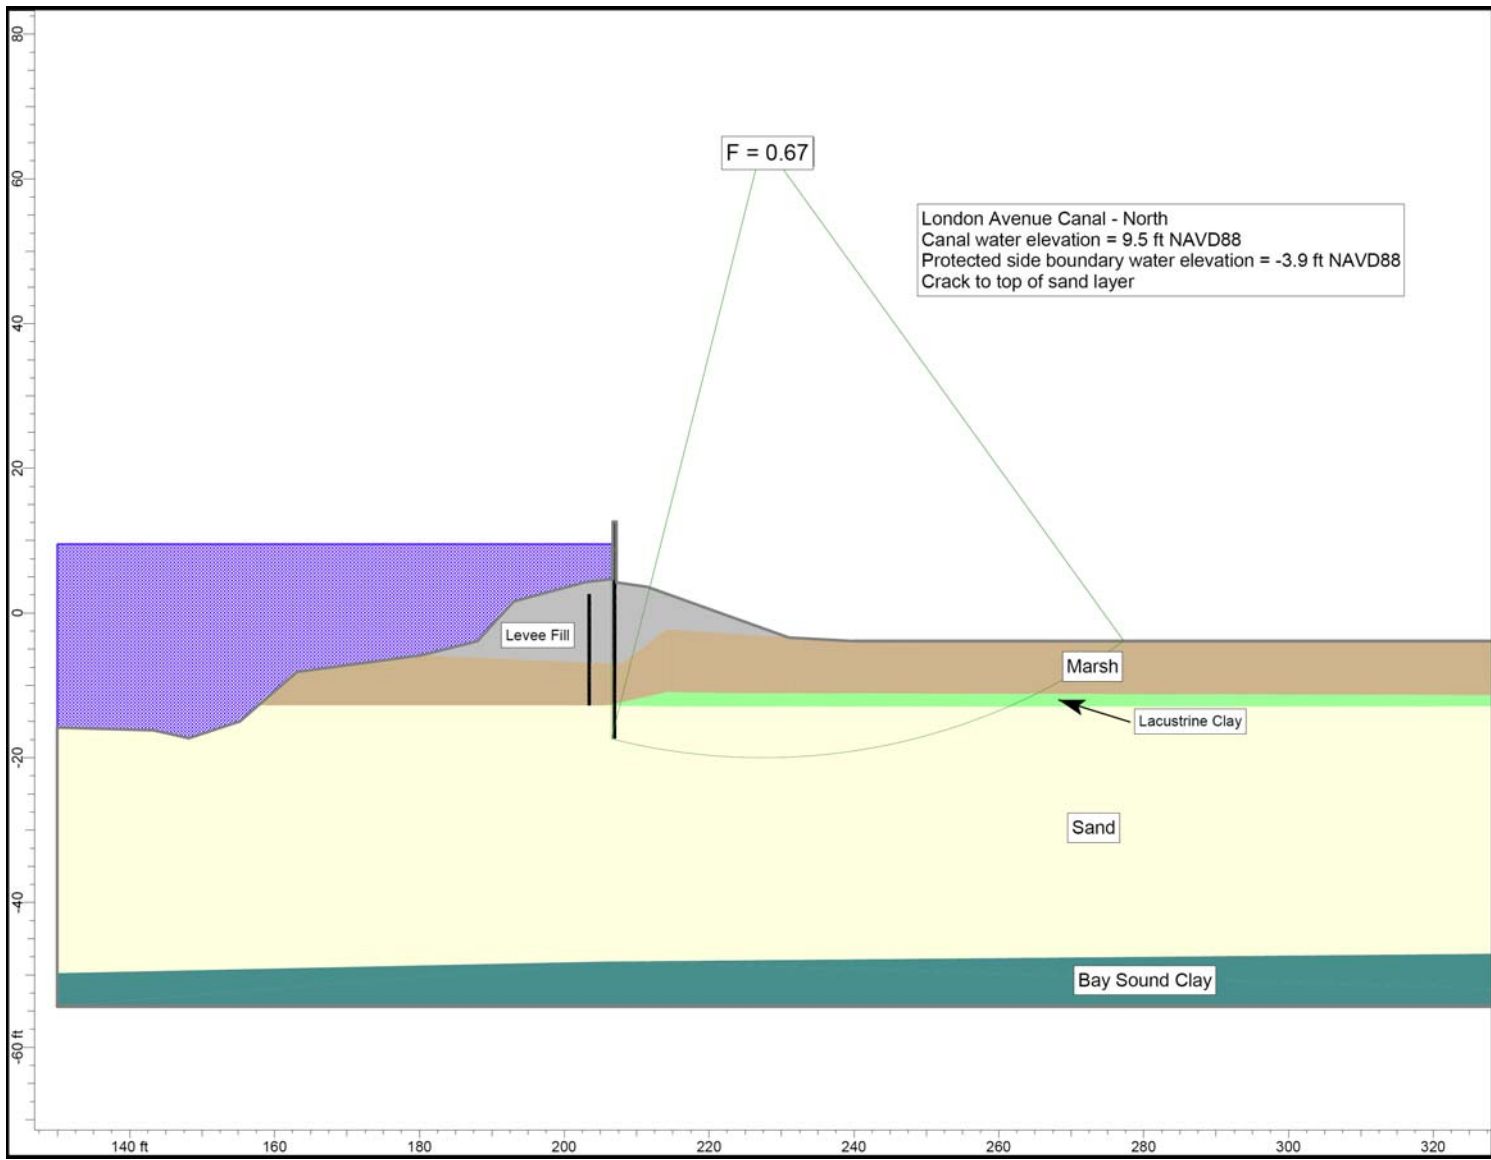
The same half-cracked condition was used in these analyses as was used for stability analyses at the south breach. It can be seen in Figures 22, 23, 24, and 25 that the slip circles extend to the bottom of the sheetpiles. Full hydrostatic water pressure force acts on the sheetpile down to the top of the sand. From the top of the sand to the bottom of the sheetpile, the sheetpile is acted on by water pressures determined from the seepage analyses and active earth pressures.

The factors of safety for Cases 1 through 4 are shown in Figures 22 through 25, and are listed in Table 9. They range from a low value of  $F = 0.67$  to a high value of  $F = 0.99$ . Thus, because the sand is considerably less dense in the north breach area, and would have a smaller friction angle, a mechanism of failure involving slope instability is plausible.

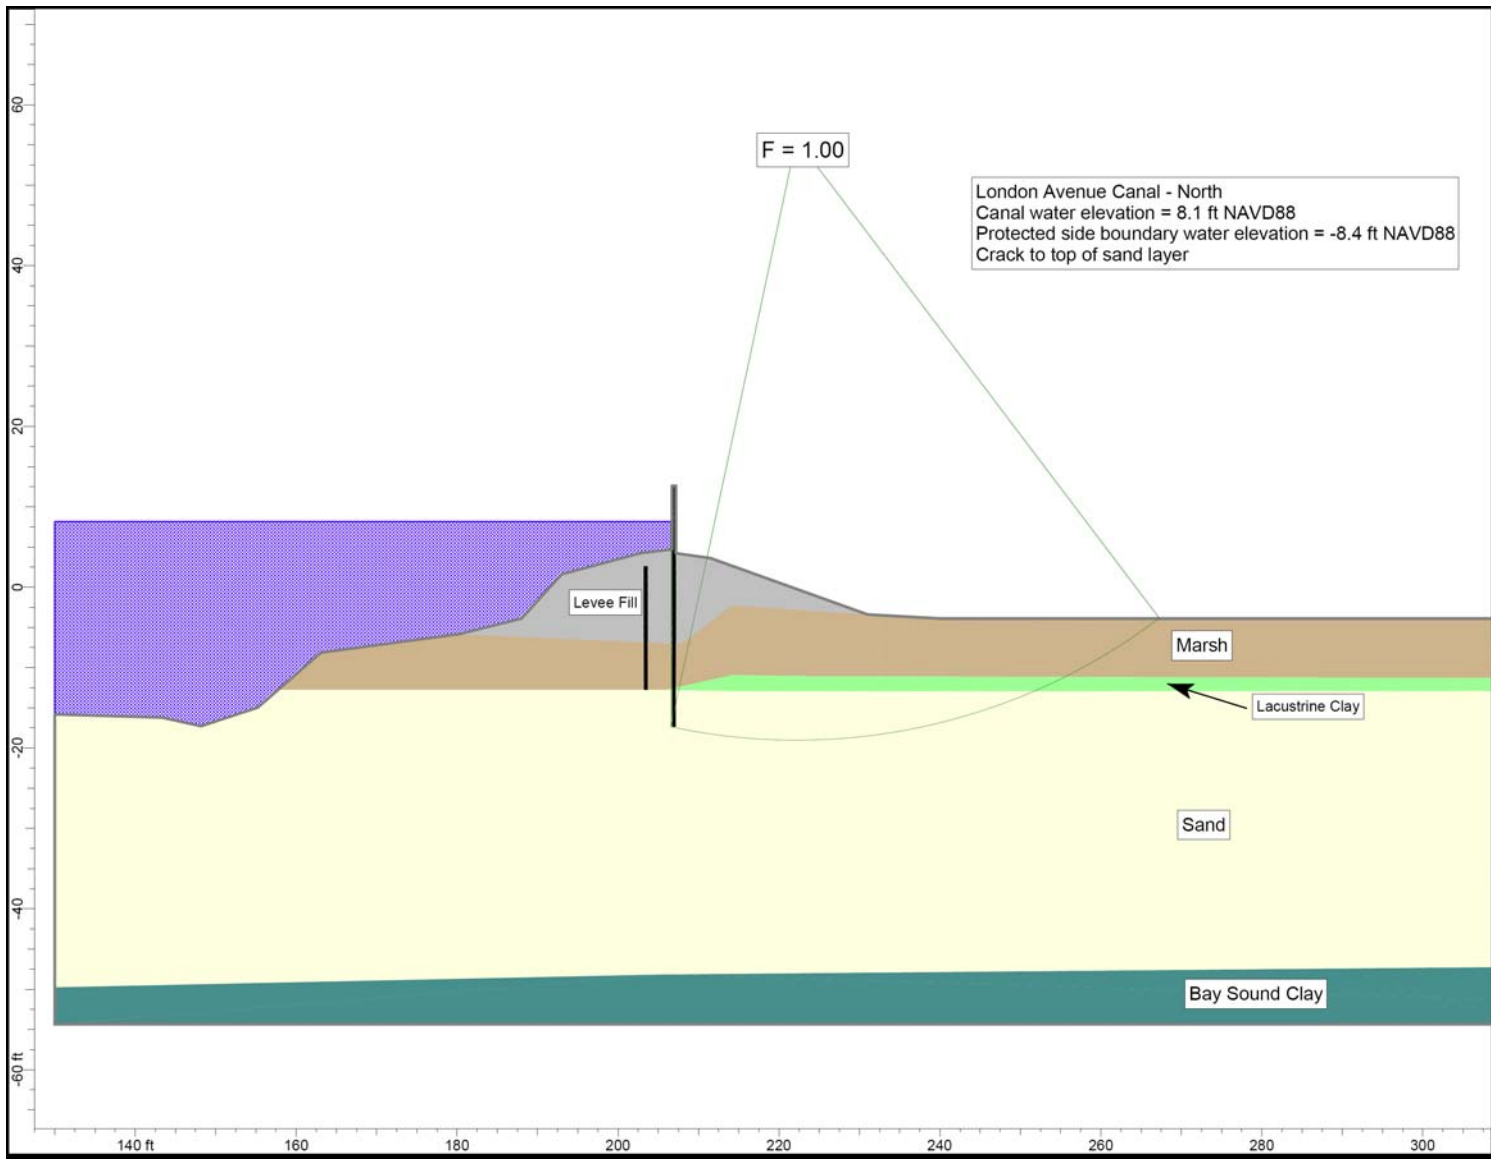
An additional analysis was performed, with the landside water level at -8.4 ft, to determine the canal water level corresponding to a calculated factor of safety equal to 1.00. As shown in Figure 26 and Table 9, a canal water level equal to 8.1 ft corresponds to a factor of safety equal to 1.00. This is very nearly equal to the lowest estimated water level at the time the breach occurred, indicating that instability is a highly likely mode of failure at the north breach.

Figure 26 – London north breach Case 5 stability analysis.
