LAKE PONTCHARTRAIN, LOUISIANA AND VICINITY

BAYOU BIENVENUE  
CONTROL STRUCTURE

PERIODIC INSPECTION REPORT NO. 2

27 JULY 1979

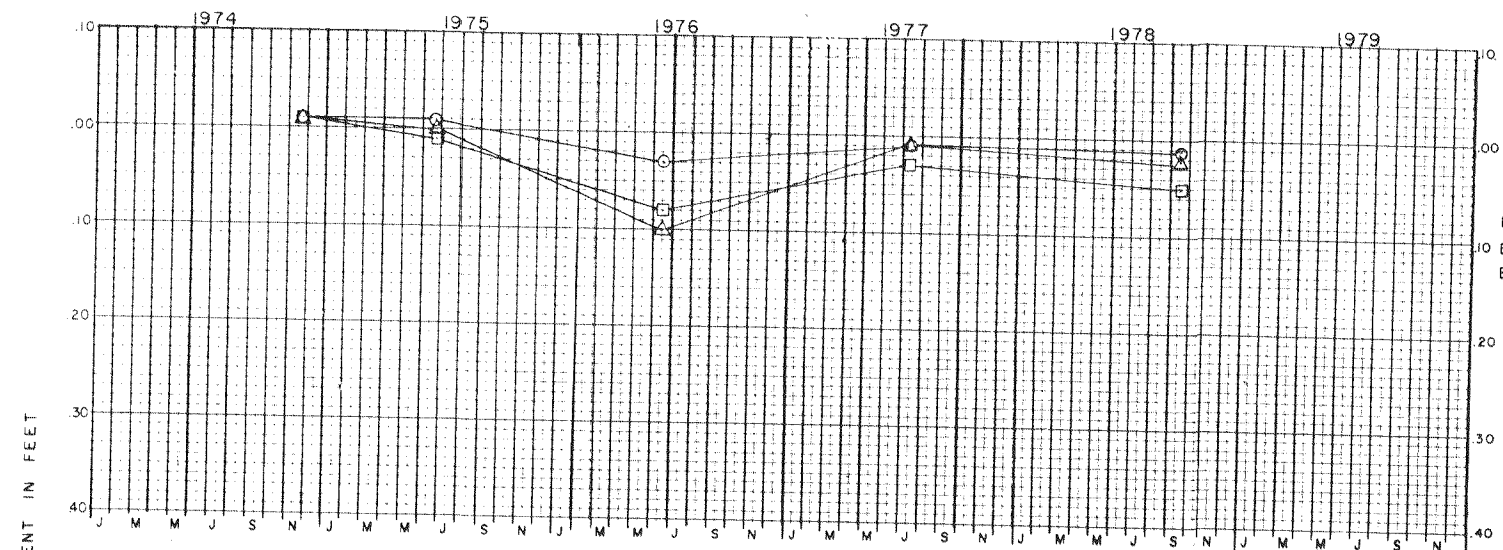
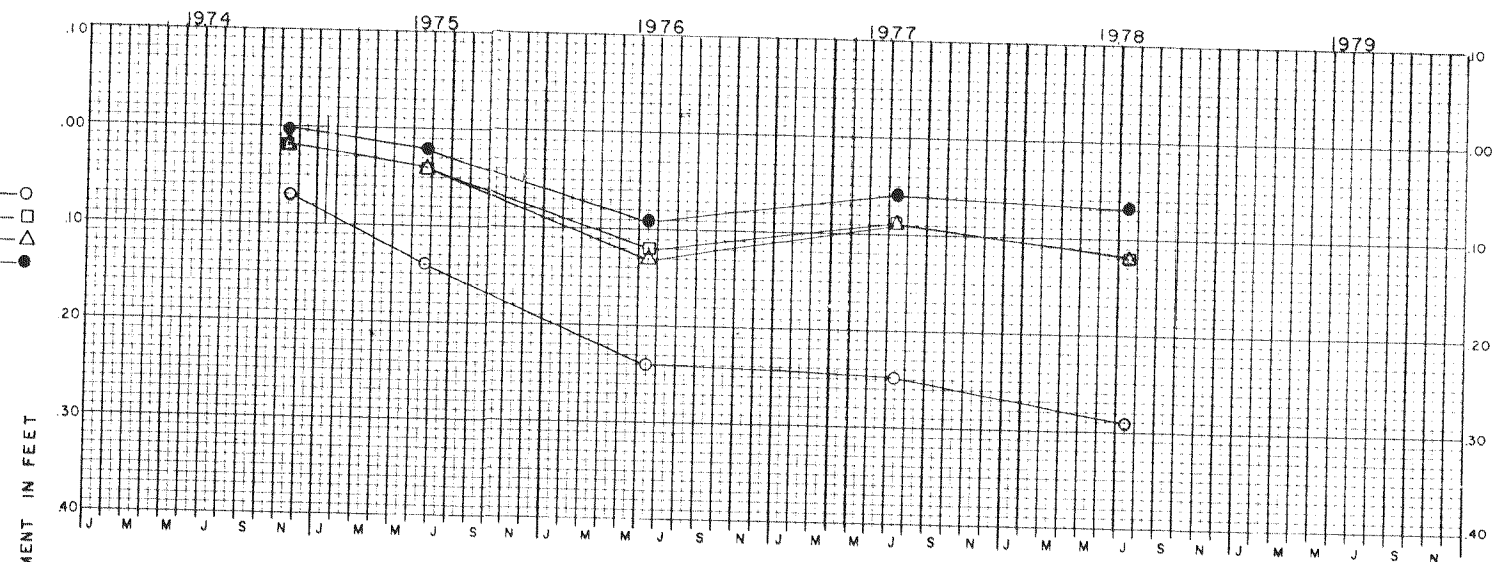
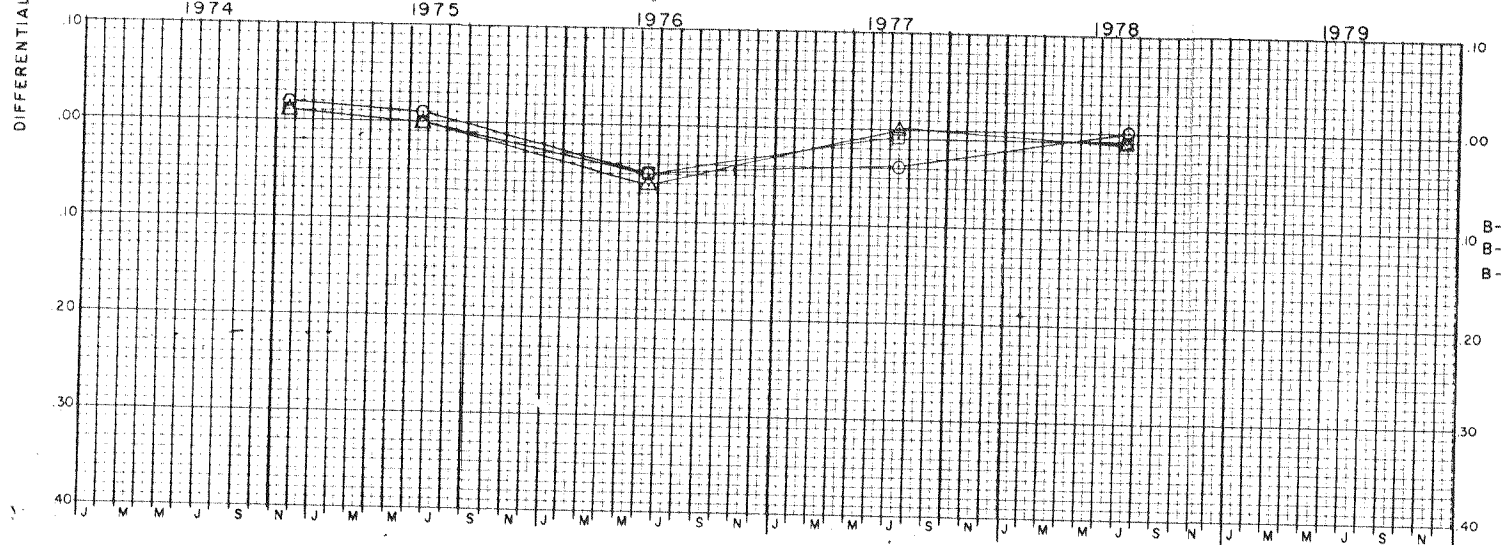
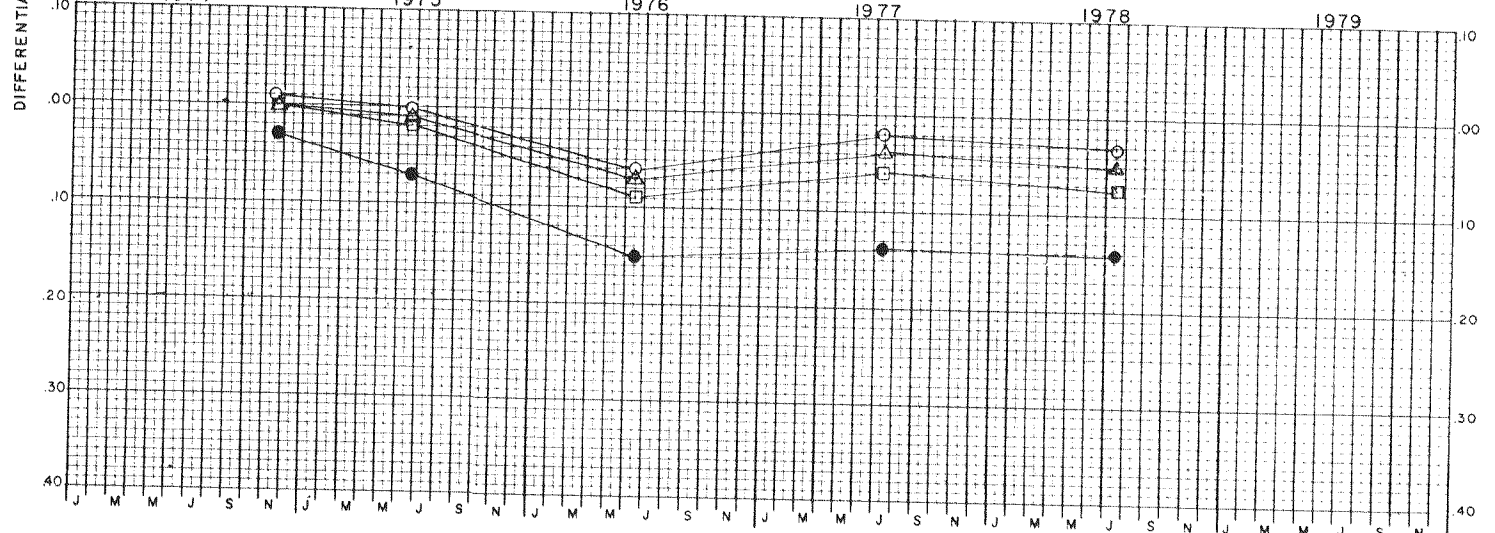
SETTLEMENT REFERENCE MARKS  
DIFFERENTIAL SETTLEMENT CHART

a. Settlement Marks. Present survey shows no unusual settlement or rebound at any point of the structure.

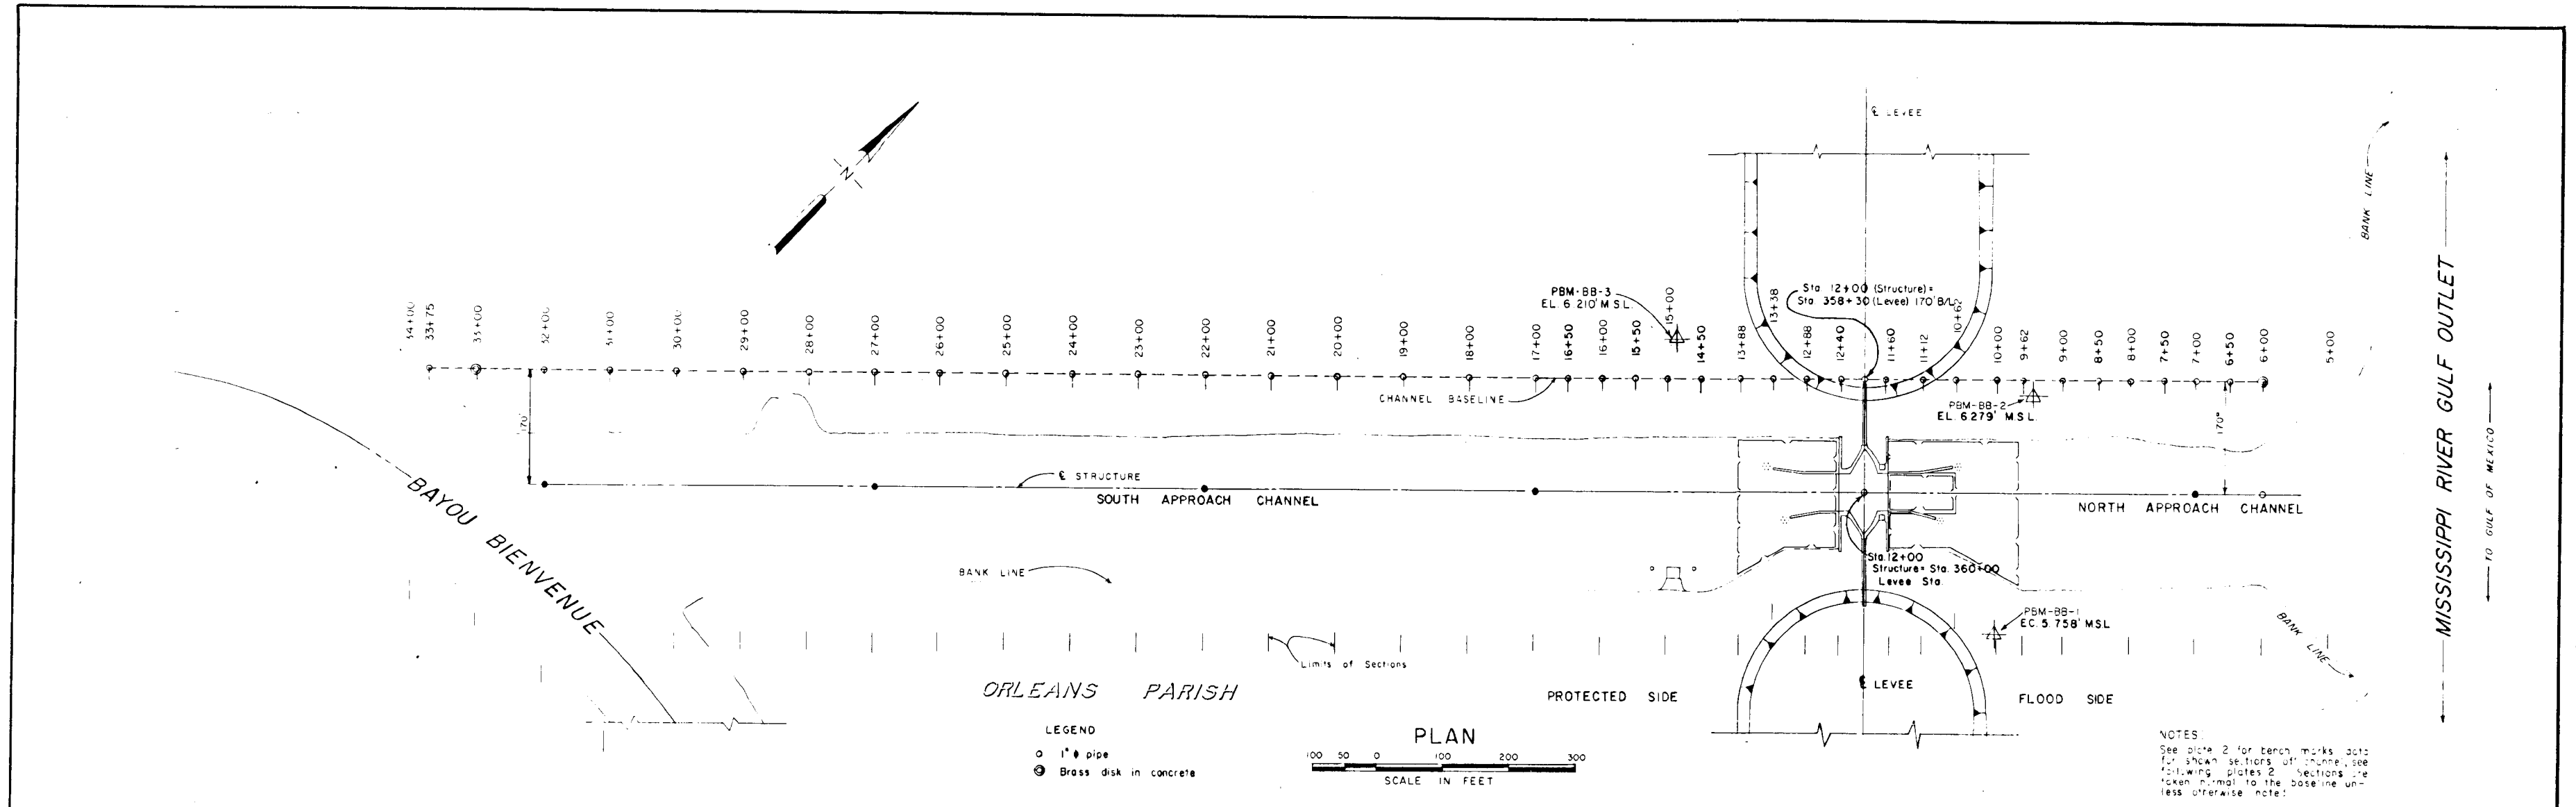
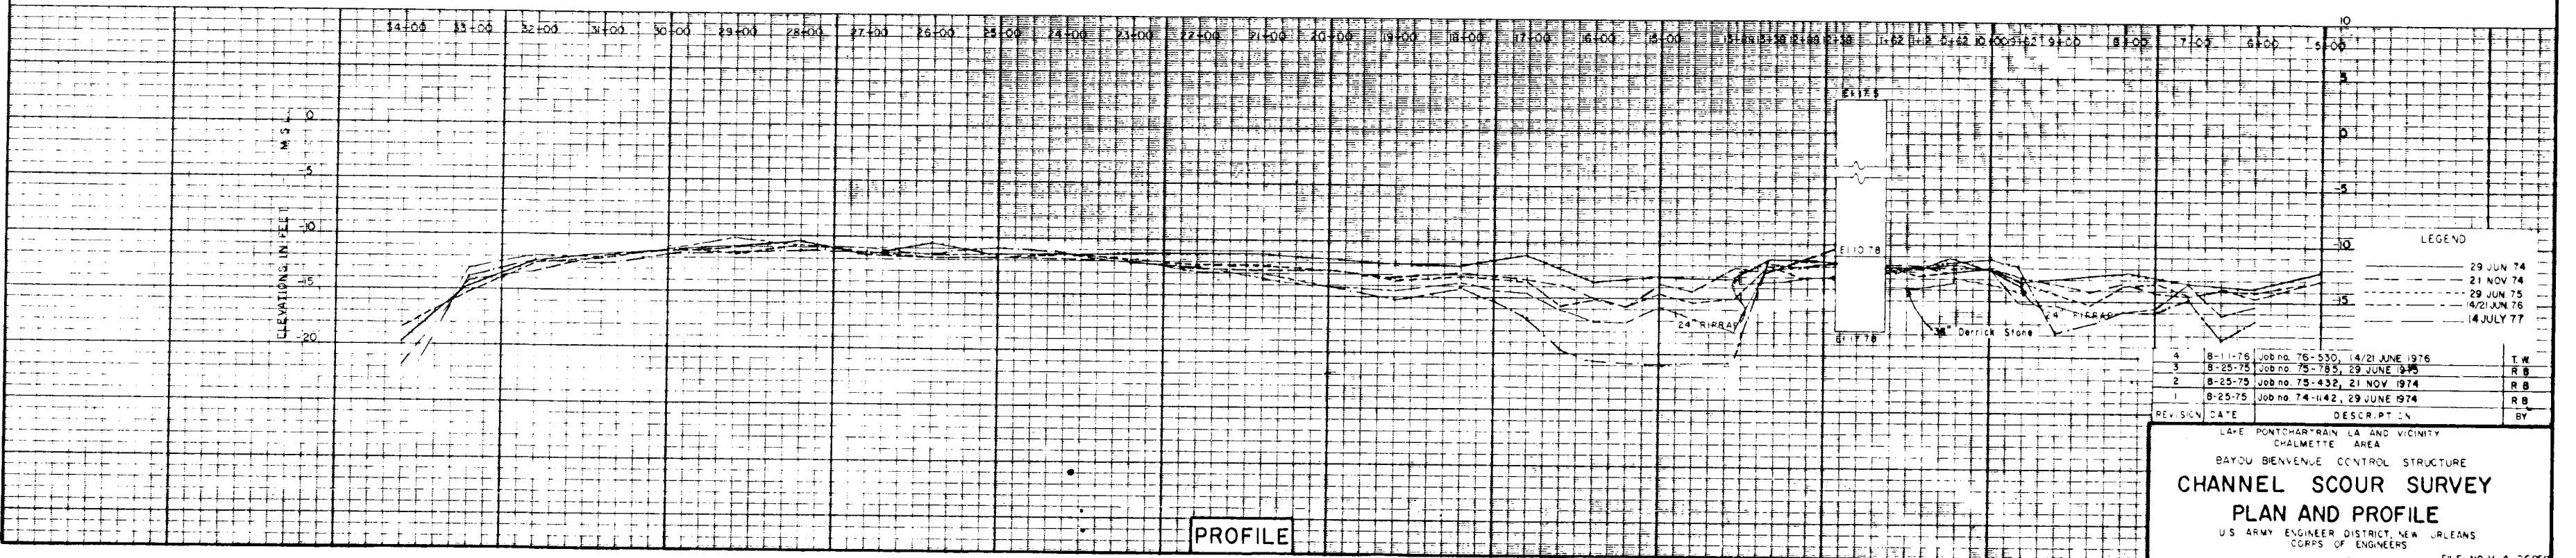
LAKE PONTCHARTRAIN LA AND VICINITY  
 CHALMETTE AREA  
 BAYOU BIENVENUE CONTROL STRUCTURE  
**CHANNEL SCOUR SURVEY**  
**PLAN AND PROFILE**  
 U.S. ARMY ENGINEER DISTRICT, NEW ORLEANS  
 CORPS OF ENGINEERS  
 FILE NO. M-4 2685

b. Para 6-02c, page VI-1. The scour surveys shown on plan and  
profile sheets on Plates 5 and 6 and also on the cross-sections on  
Plates 7 through 15 indicate considerable scouring is occurring from  
year to year in the vicinity of the structure. Although this scour is  
not presently endangering the integrity of the structure, repair work  
should be scheduled and performed within the next calendar year. This  
repair work should consist of a layer of riprap of sufficient size and  
gradation to preclude a similar scour problem in this area in the future.

b. Scour Survey. The 1978 survey shows scour on north and south approach channels. These scour holes lie on the centerline of the structure adjacent to the end of the riprap placement. On the north approach channel, the scour hole extends from station 9+62 to station 8+00. On the south approach channel it extends from station 13+88 to station 17+00. The holes are 10 feet and 20 feet deep respectively, compared to theoretical section line. To a lesser extent, the banks were eroding, but appear to have stabilized.

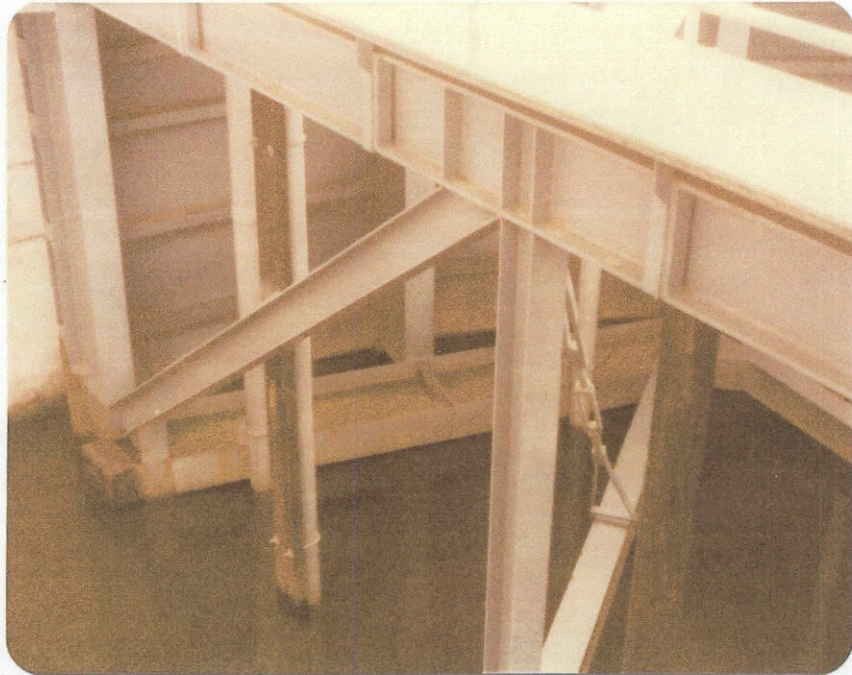
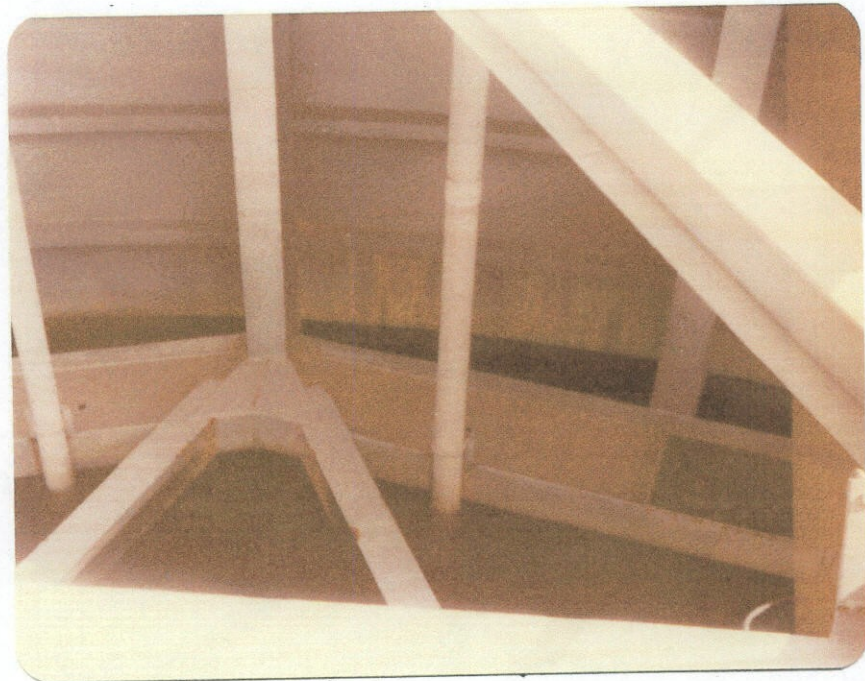
a. Structural. The structure is relatively new and is in good condition. The horizontal members of the sector gates have spot rusting due to water standing on the members. (See photographs Nos. 1 and 2).

Photograph No. 1 - Spot Rust on Structural Steel Members of Sector Gate

Photograph No. 2 - Spot Rust on Structural Steel Members of Sector Gate

a. Spot rusting of sector gates members and corroded surfaces of sector gates and embedded steel members should be cleaned and treated with corrosion preventive materials or painted as necessary.

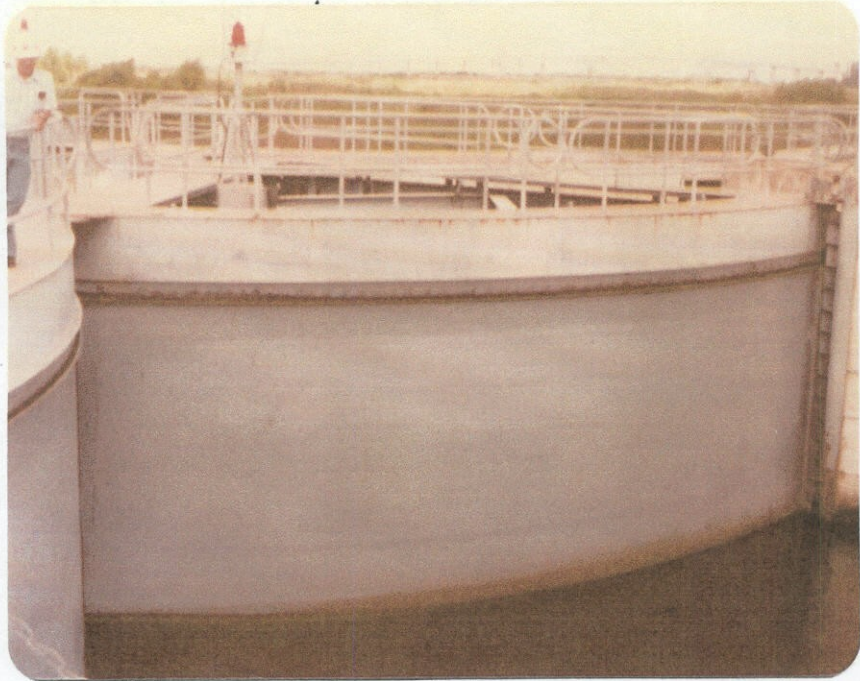
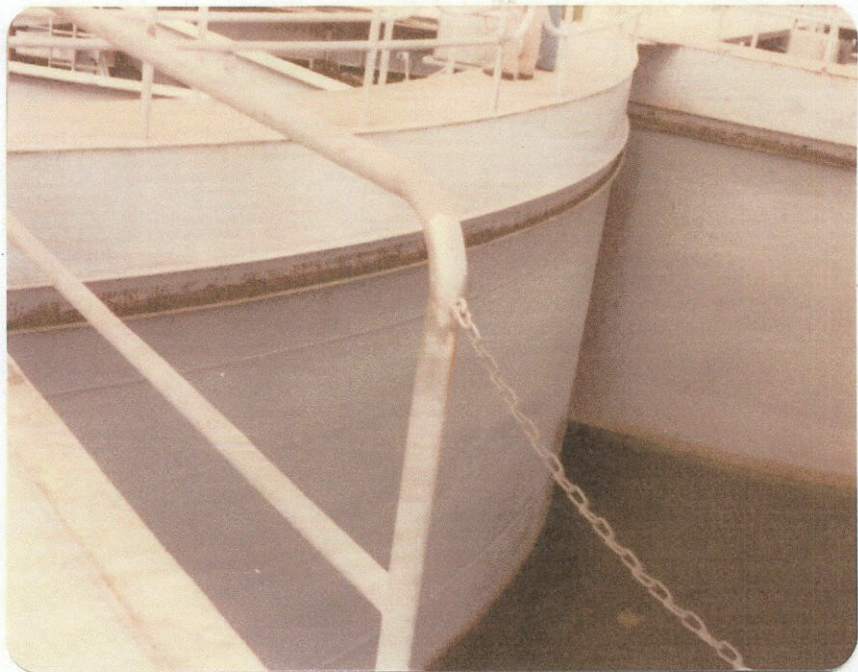
Severe corrosion was found in the area affected by tidal fluctuation on the skin plate of the sector gates and on the embedded steel members of gate bay monoliths. (See photographs Nos. 3, 4, 5, and 6). The Orleans Levee Board, who is responsible for the operations and maintenance of the structure, is in the process of having the corroded areas repaired and treated with corrosion preventive materials.

Photograph No. 3 - Corrosion at Water Line

Photograph No. 4 - Corrosion on Sector Gate at Water Line

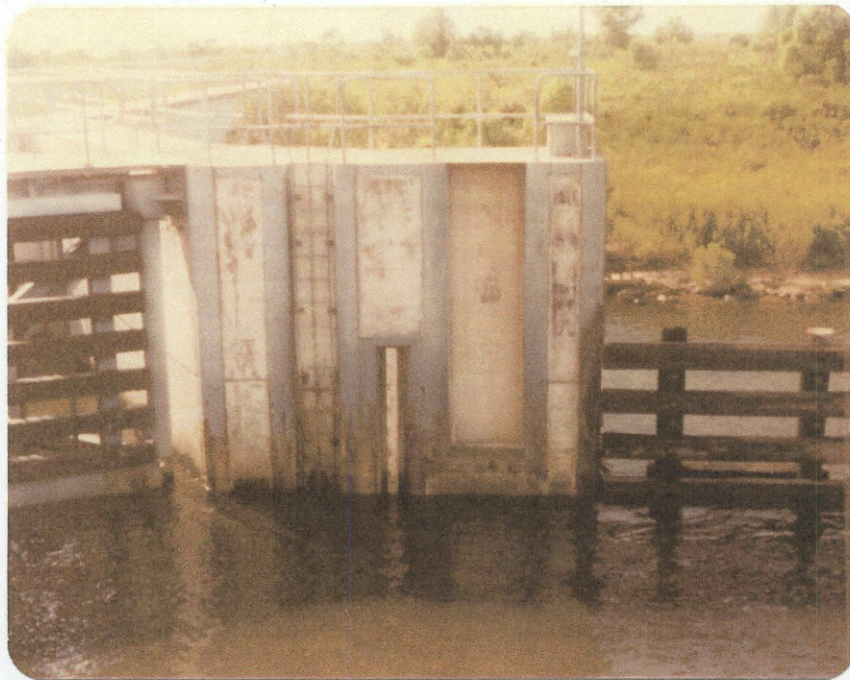
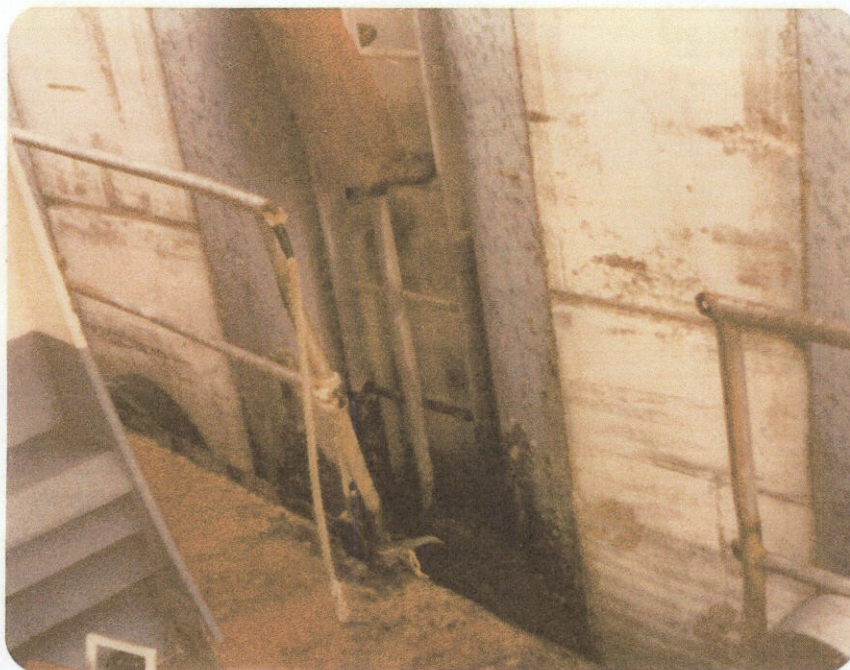
Photograph No. 5 - Rusted Structural Steel Members in Gate Bay Monolith

Photograph No. 6 - Rusted Structural Steel Members in Gate Bay Monolith

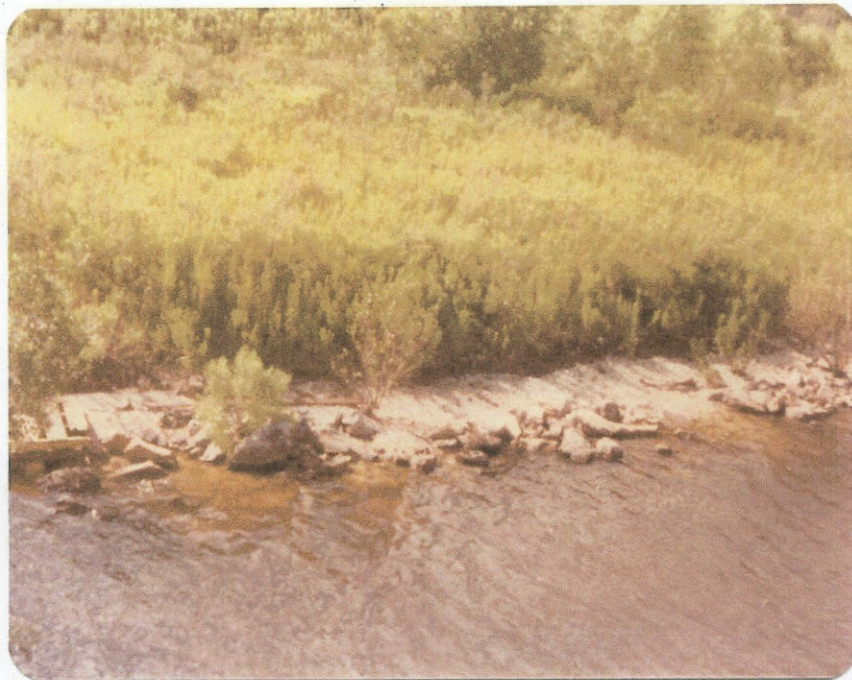
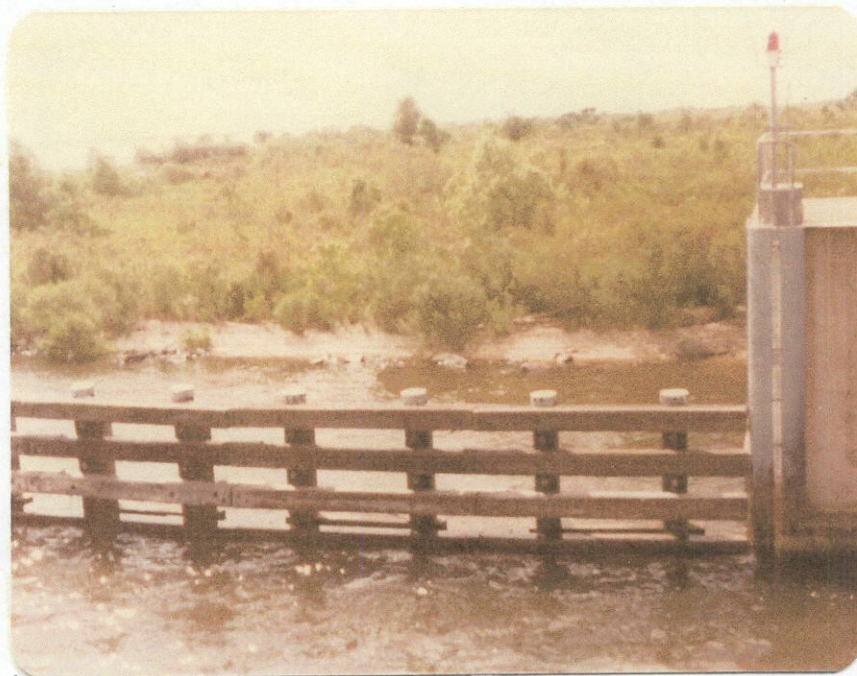
c. Foundation. The structure was in satisfactory condition from a foundations standpoint. The approach channels were missing some riprap but no serious erosion was noted. (See photographs Nos. 7 and 8). The 1978 Scour Survey shows that the north and south approach channels have a scour problem. This is discussed in Section IV "Analysis of Instrumentation".

Photograph No. 7 - Missing Riprap on Bank of Approach Channel

Photograph No. 8 - Missing Riprap on Bank of Approach Channel

c. The missing riprap on both sides of the approach channels will be replaced by the Corps if and when it becomes necessary to place additional riprap in the approach channels.
