LAKE PONTCHARTRAIN, LOUISIANA AND VICINITY
CHALMETTE AREA PLAN

**BAYOU BIENVENUE CONTROL STRUCTURE
PERIODIC INSPECTION REPORT NO. 8**

24 MARCH 1999

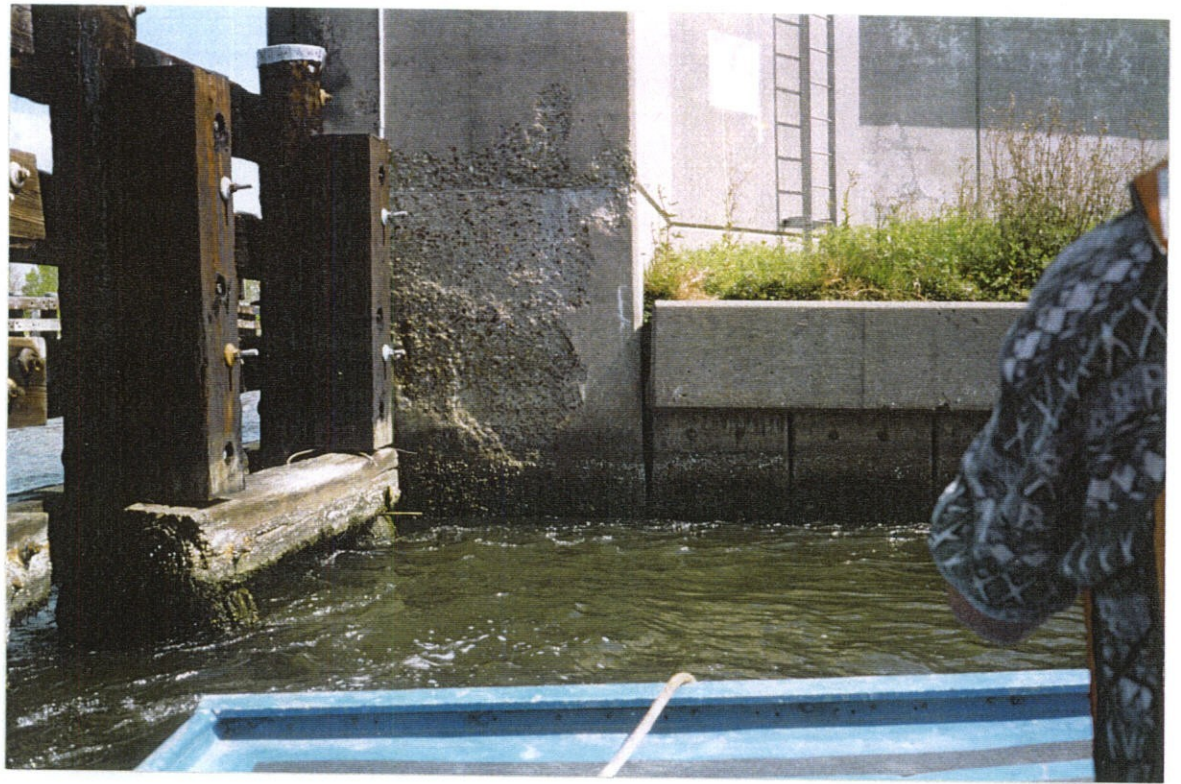
(6) On the protected side vertical face on the south side of the east gate bay monolith there is an old spall from the waterline to 6 to 7 feet above the waterline. See Photo Nos. 5 and 6. No corrective action is required.

PHOTO NO. 5 – SPALL ON SOUTHSIDE PROTECTED SIDE FACE OF GATE BAY WALL.

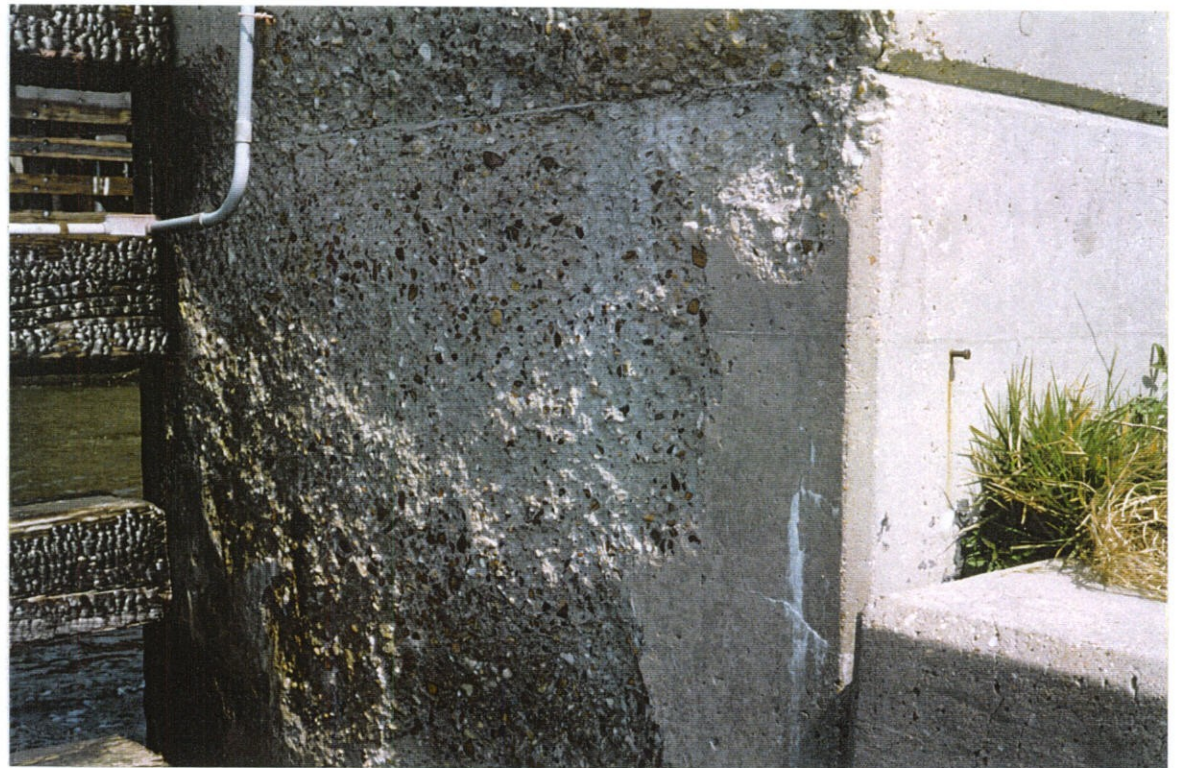
PHOTO NO. 6 – CLOSEUP OF SPALL SHOWN IN PHOTO NO. 5.

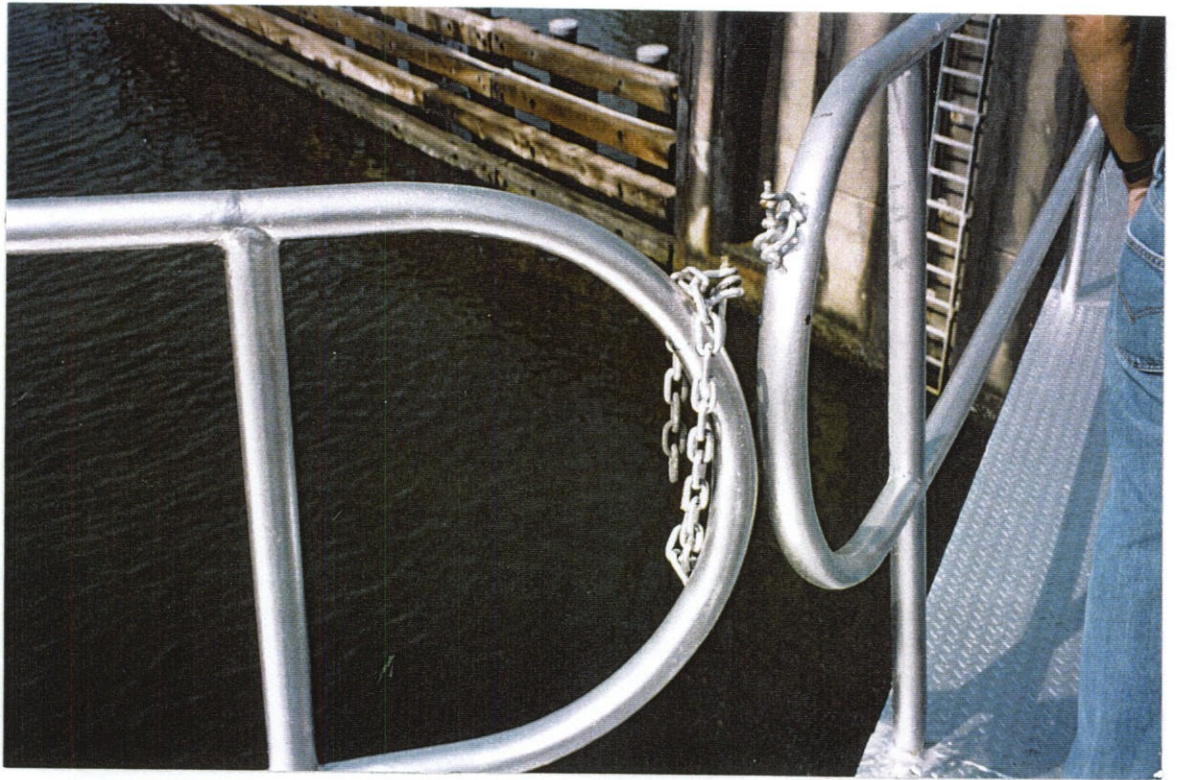
PHOTO NO. 11 – SLIGHTLY BENT (LEANING) HANDRAIL POSTS AT MITER END OF GATE SECTORS.

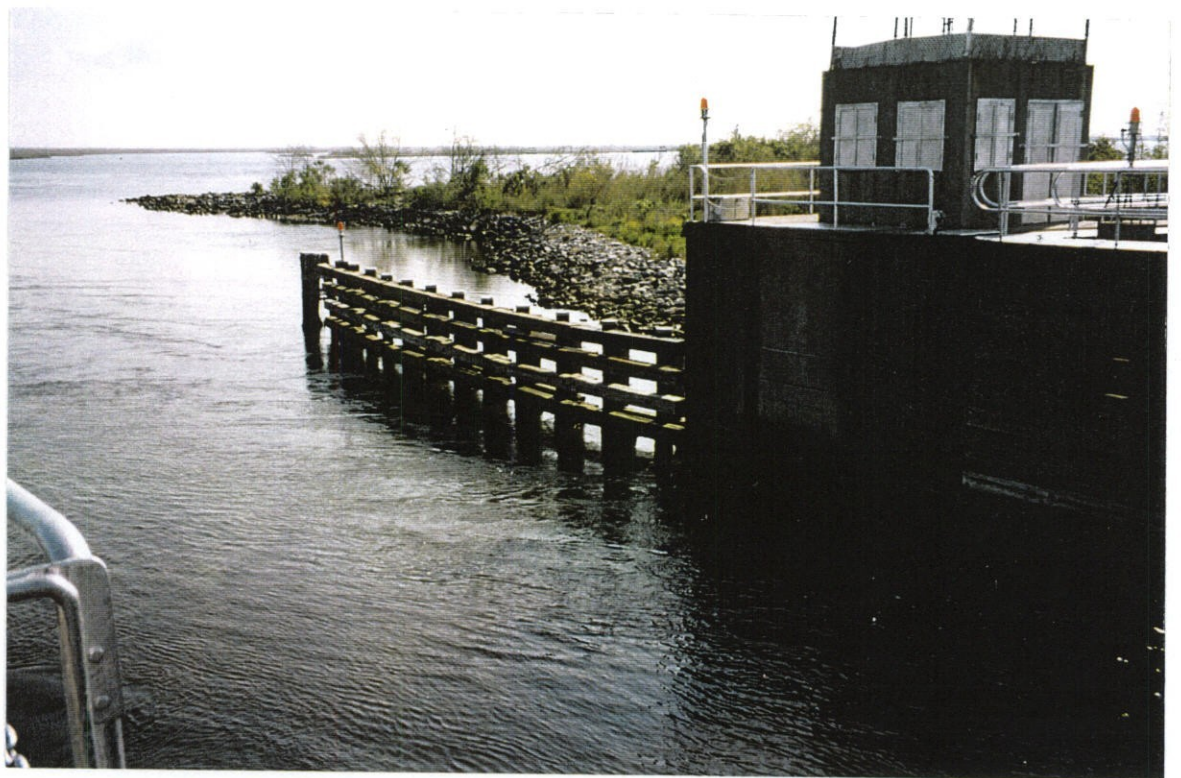
PHOTO NO. 21 – FRESH FILL BEHIND NORTHWEST WINGWALL AT ITS JUNCTURE WITH THE GATE BAY MONOLITH.

g. Embankments. The backfill areas behind the wing walls will continue to be monitored. Any depressions noted will be filled in.

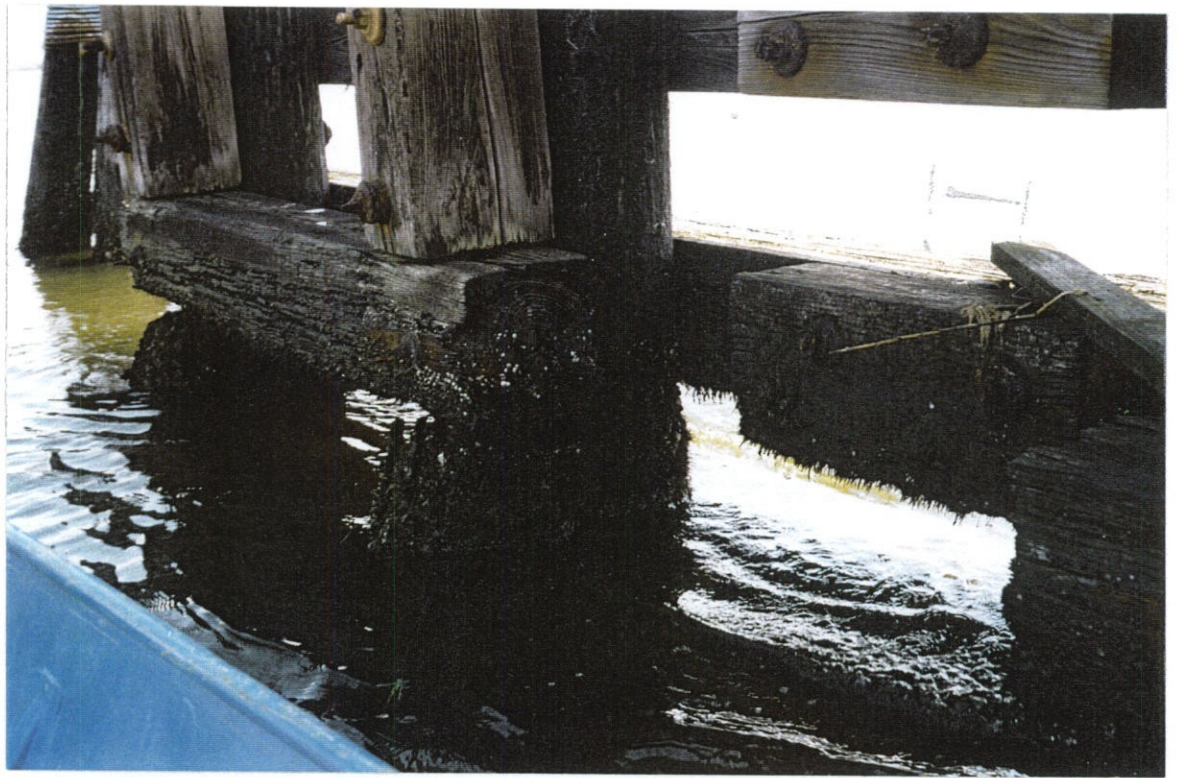
PHOTO NO. 22 – NORTHEAST TIMBER GUIDEWALL.

h. Guidewalls and Dolphins. Guidewall and dolphin members will be closely inspected semiannually, and deteriorated members will be replaced as necessary to maintain the integrity of the guidewalls and dolphins. Prior to the next scheduled unwatering, NOD and OLD will make a detailed inspection and evaluation of the guidewalls and dolphins, and will determine if major repairs or replacement of the guidewalls and dolphins should be undertaken.

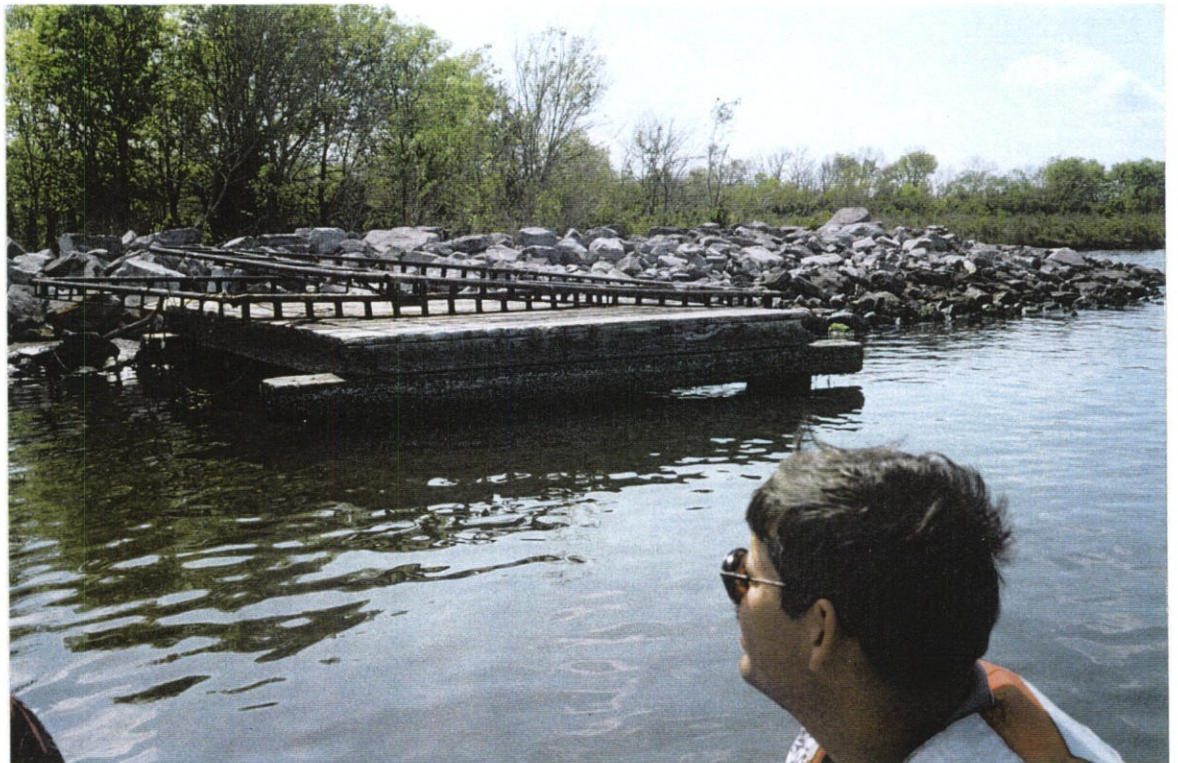
PHOTO NO. 23 – DETERIORATED HORIZONTAL GIRTS AND TOPS OF BATTERED PILES ON TIMBER GUIDEWALLS.

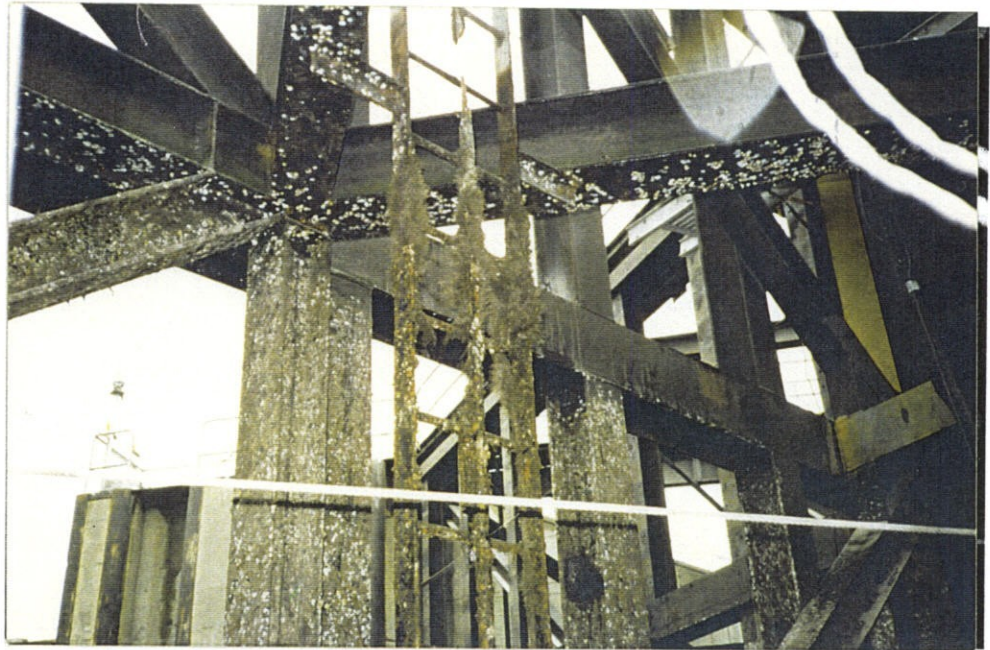
Photo 1. Corroded ladder and marine growth on wide flange members of gate below water line.

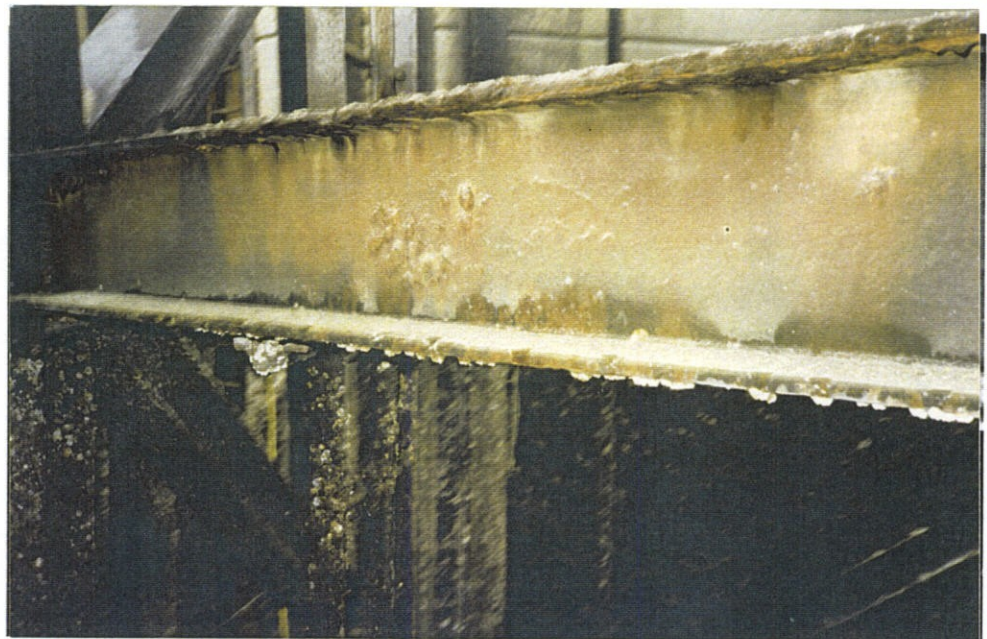
Photo 6. A wide flange member of the sector gate with corrosion.

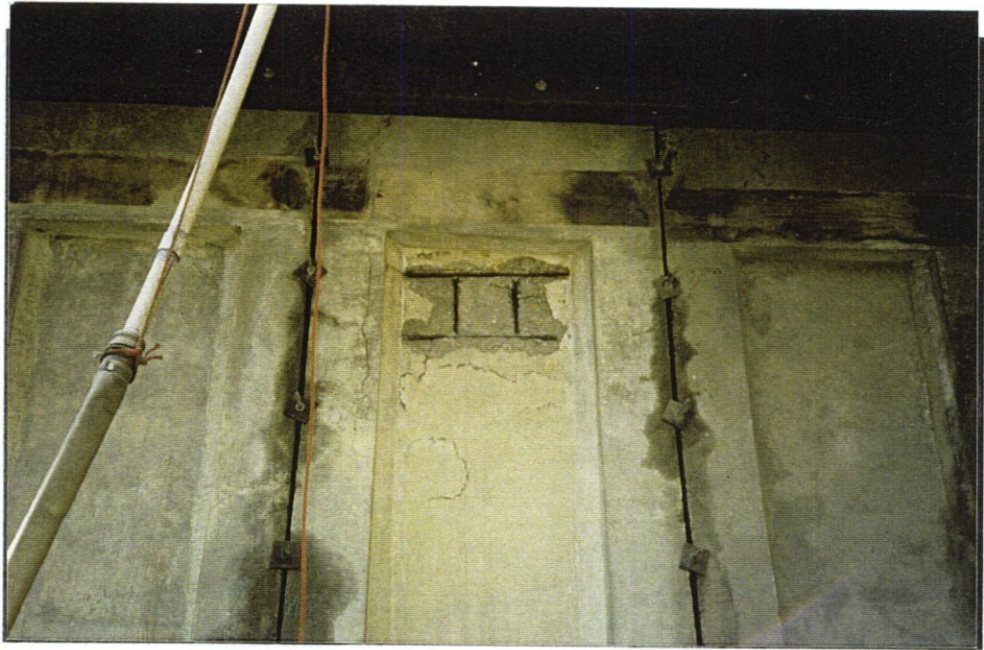
(4) During the dewatering of the structure in March 1997, it was noted that there were some spalls with exposed reinforcing steel on the protected (dry) side of the concrete needles. See Photo No. 7, Appendix B. The spalls were repaired under the OLD contract for dewatering and repairs using epoxy grout.

Photo 7. Spall on protected side of concrete needles with exposed reinforcing steel. Inadequate concrete cover above reinforcing steel.

c. The spall areas on the concrete dewatering needles should be cleaned, exposed reinforcing steel sandblasted, and spall areas covered with epoxy grout.

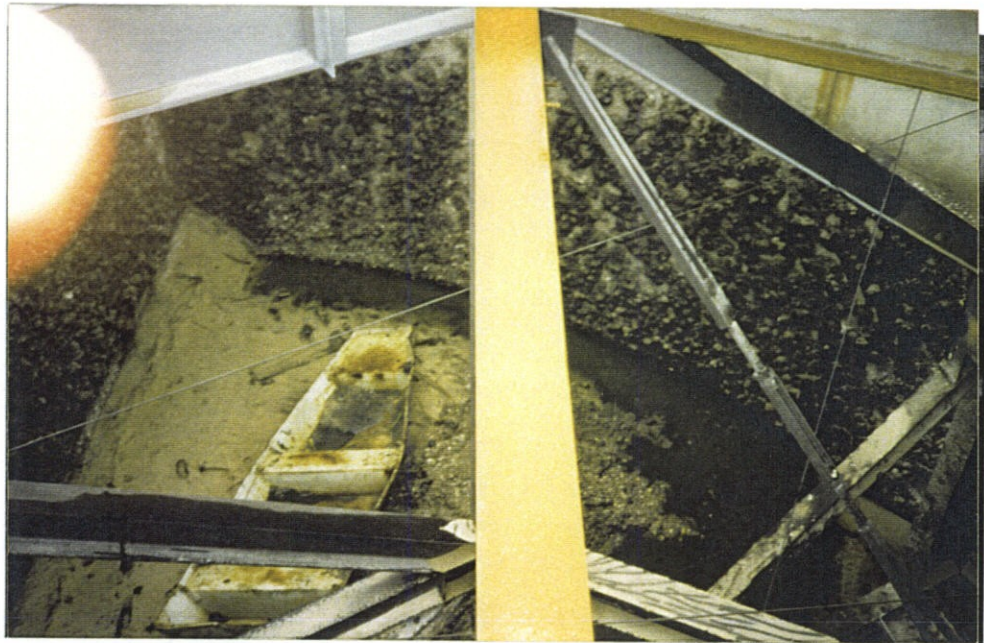
Photo 8. Gate recess area (Typical). Note silt build up against the back wall and marine growth on concrete wall.

d. If build up of silt in the gate bay storage recesses becomes a problem, the gate recess areas shall be cleaned by pressure hose or other approved methods.
