LAKE PONTCHARTRAIN, LOUISIANA AND VICINITY

CHALMETTE AREA PLAN

BAYOU DUPRE CONTROL STRUCTURE

PERIODIC INSPECTION REPORT NO. 4

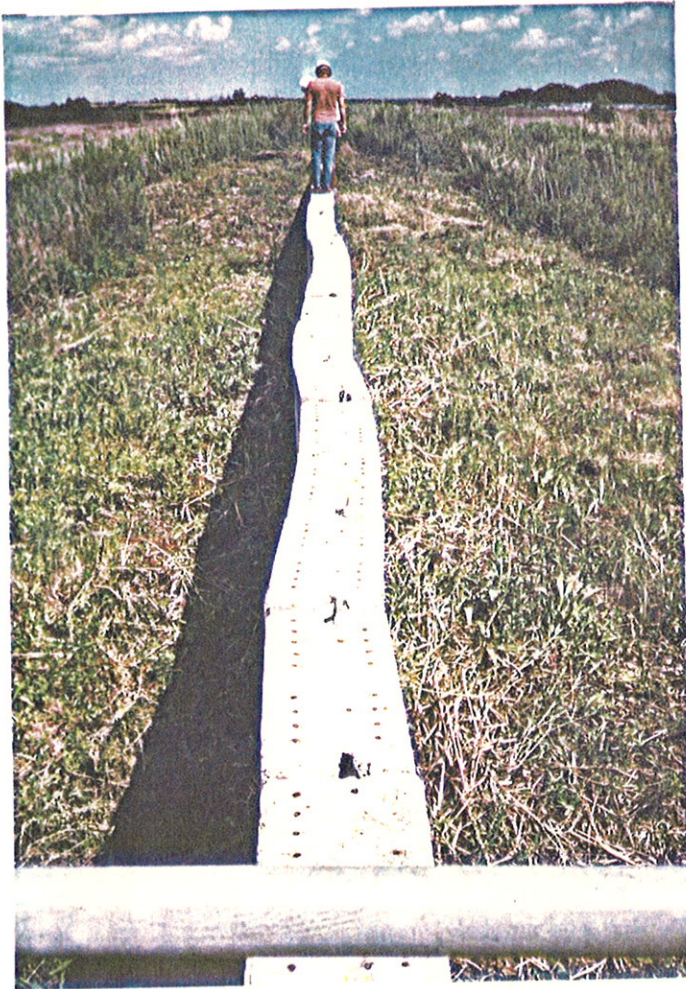
PHOTO NO. 3- Note misalignment of concrete sheetpile panels that occurred during construction.

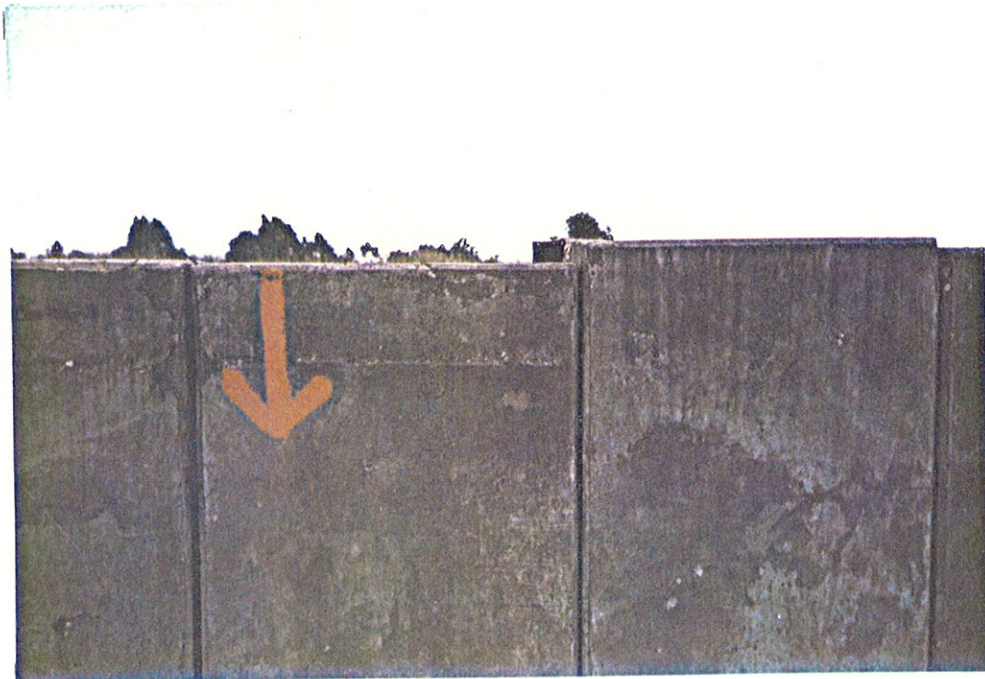
PHOTO NO. 4- Vertical differential movement of concrete sheetpile panels that has occurred over several years.

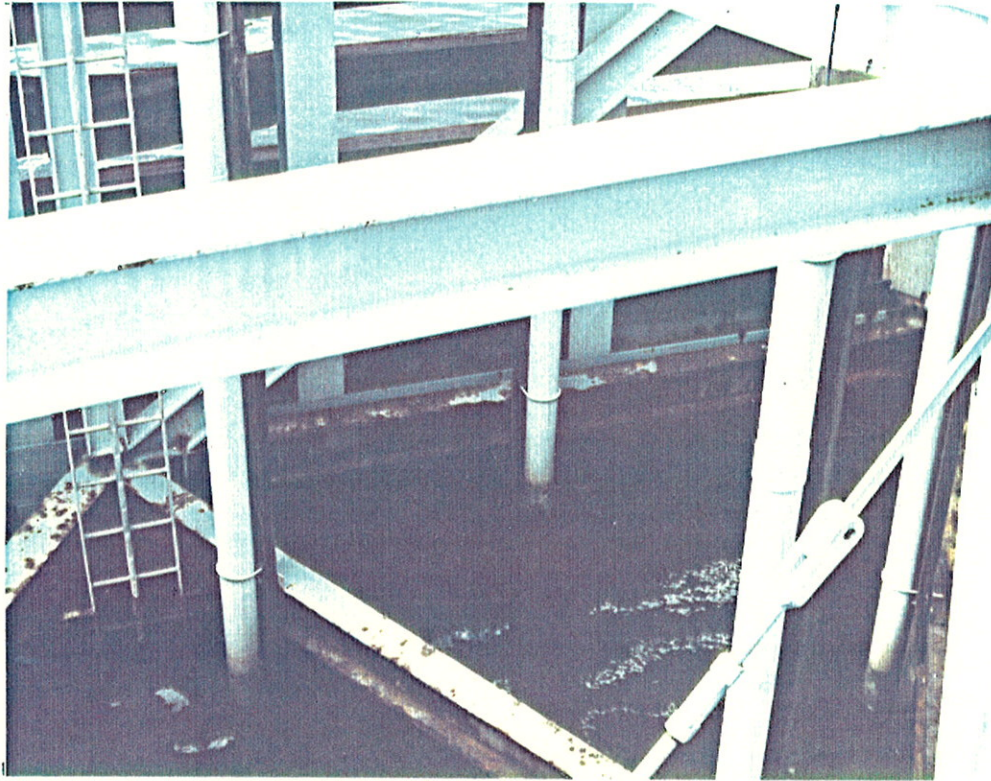
(b) The steel members of the sector gates that are located in the tidal fluctuation zones are noticeably corroded (see photos nos. 1 and 2). Other imbedded materials located in this area are also corroded. All other painted surfaces on the sector gates are in good condition.

PHOTO NO. 1 - Corrosion on structural members of a sector gate.

(a) Both sector gates will be blasted and painted during the next dewatering period scheduled by the LBBLD for February 1987. Ladders and other metal items damaged by corrosion will be repaired or replaced at the same time.

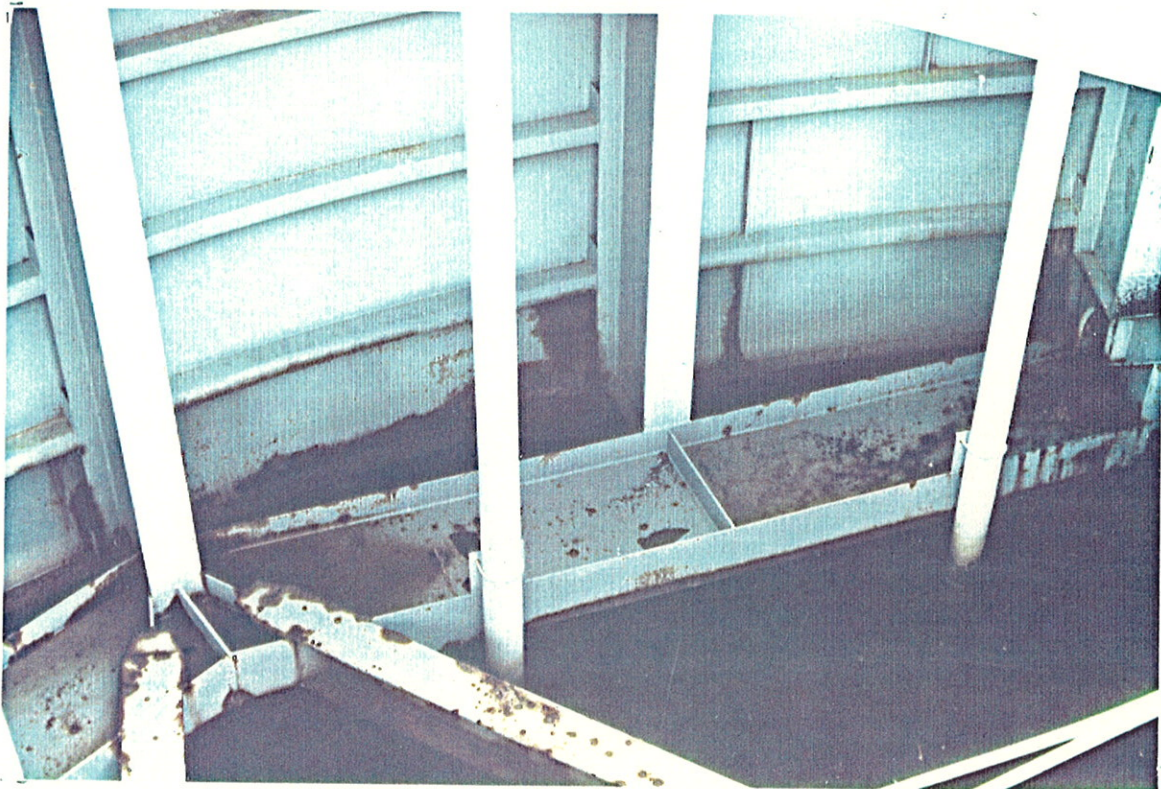
PHOTO NO. 2 - Corrosion on structural members of a sector gate.

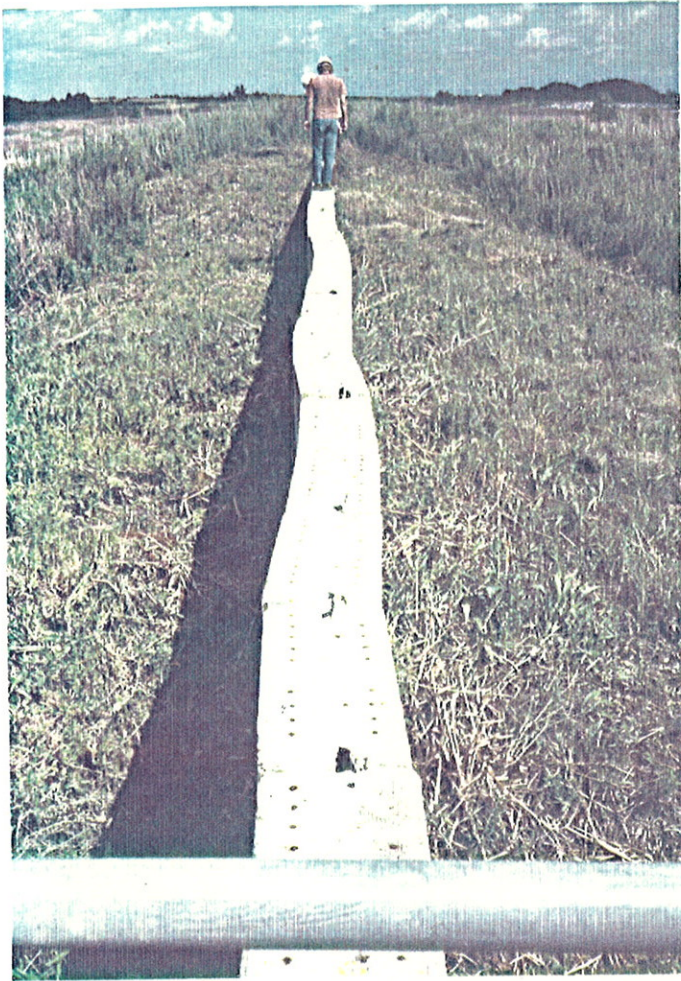
c. Para 5-03 a(3)(b) and Photo No. 3. We concur. Both the caption for Photo No. 3 and Paragraph 5-03 (3)(b) have been revised to indicate that the misalignment of the concrete sheetpile panels occurred during construction. The caption for Photo No. 4 has been revised to indicate that the differential movement shown in the photograph is vertical.

PHOTO NO. 3 - Differential movement
along concrete floodwall.

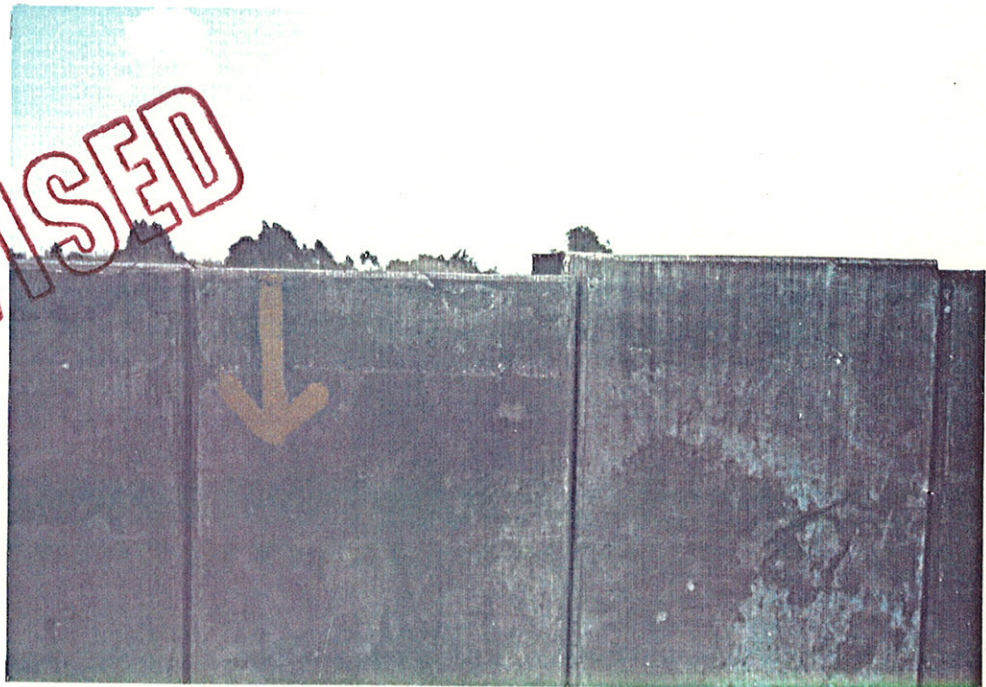
(c) Although settlement and differential movement has occurred along the concrete I-wall, the interlocks between the concrete panels are intact and in good condition. Joints are tight and there are no signs of distress.

PHOTO NO. 4 - Differential
settlement among members
of concrete floodwall.

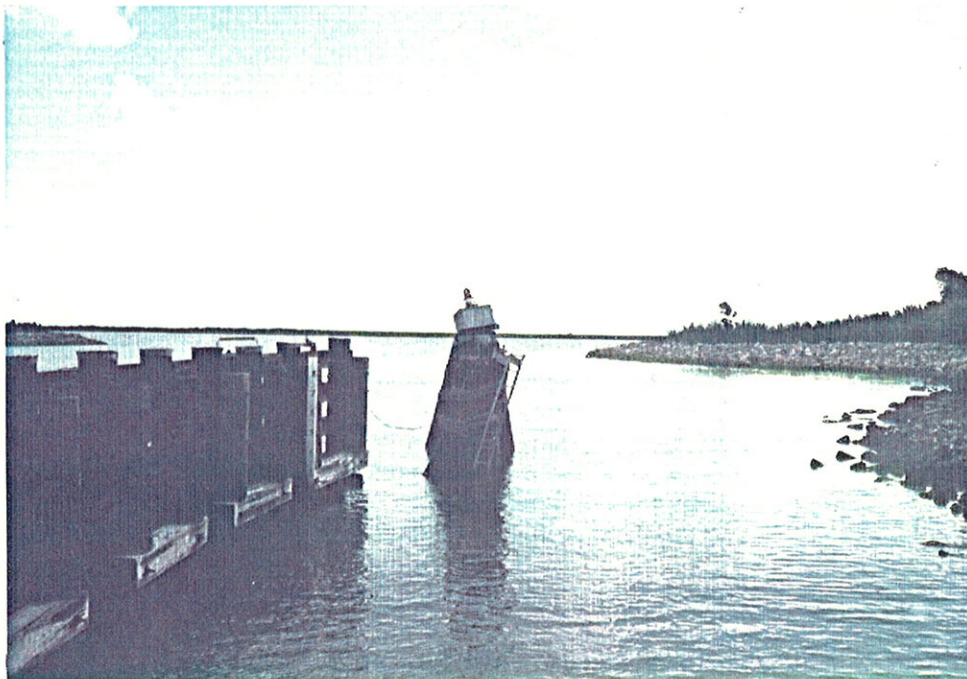
(b) The dolphins on the east side of the structure have been damaged due to impact from tows (see photo no. 6). The dolphins are still capable of providing limited protection.

(c) Navigation lights on the damaged dolphins did not appear to be working.

PHOTO NO. 6 - Damaged timber dolphin.

(b) The dolphins on the east side of the Bayou Dupre Control Structure will be repaired during the February 1987 dewatering.

(c) The navigation lights on the damaged dolphins that are the subject of the previous paragraph will be replaced while the repair work on the dolphins is taking place.

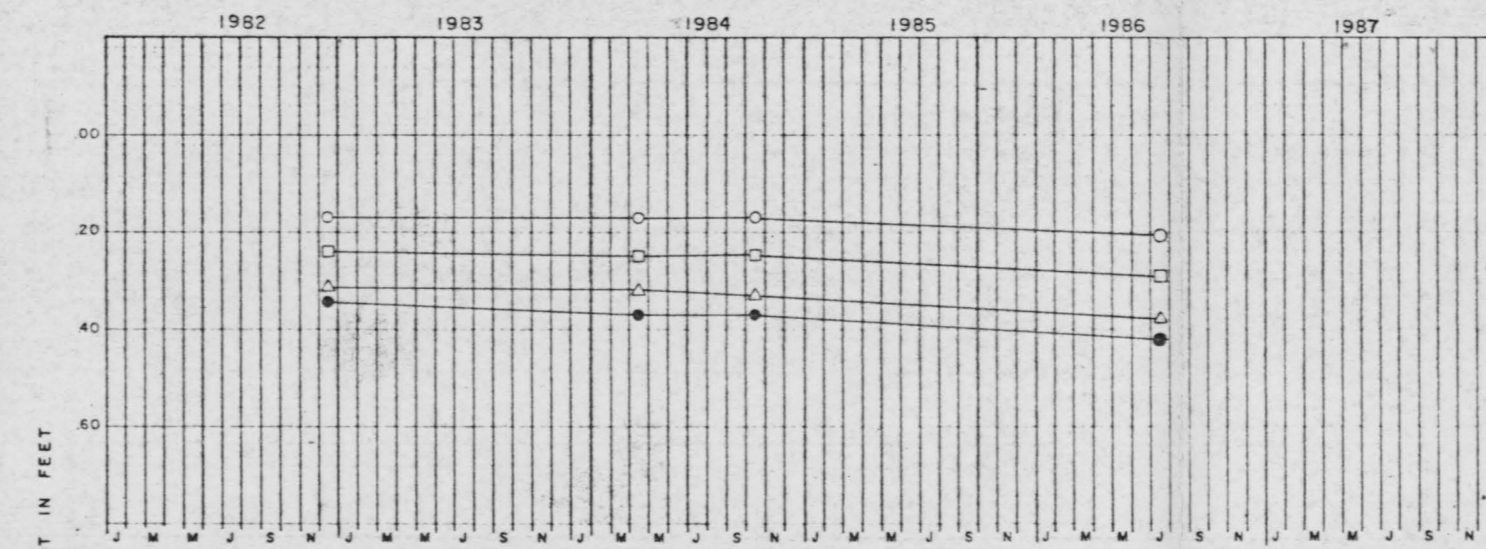
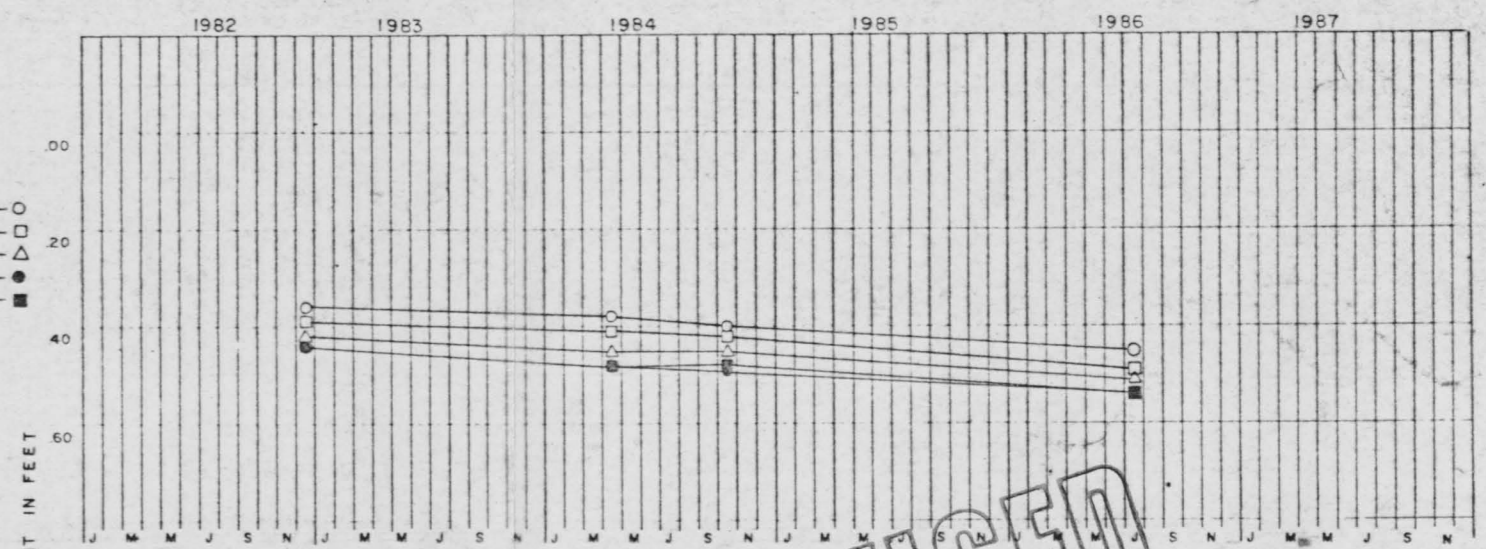
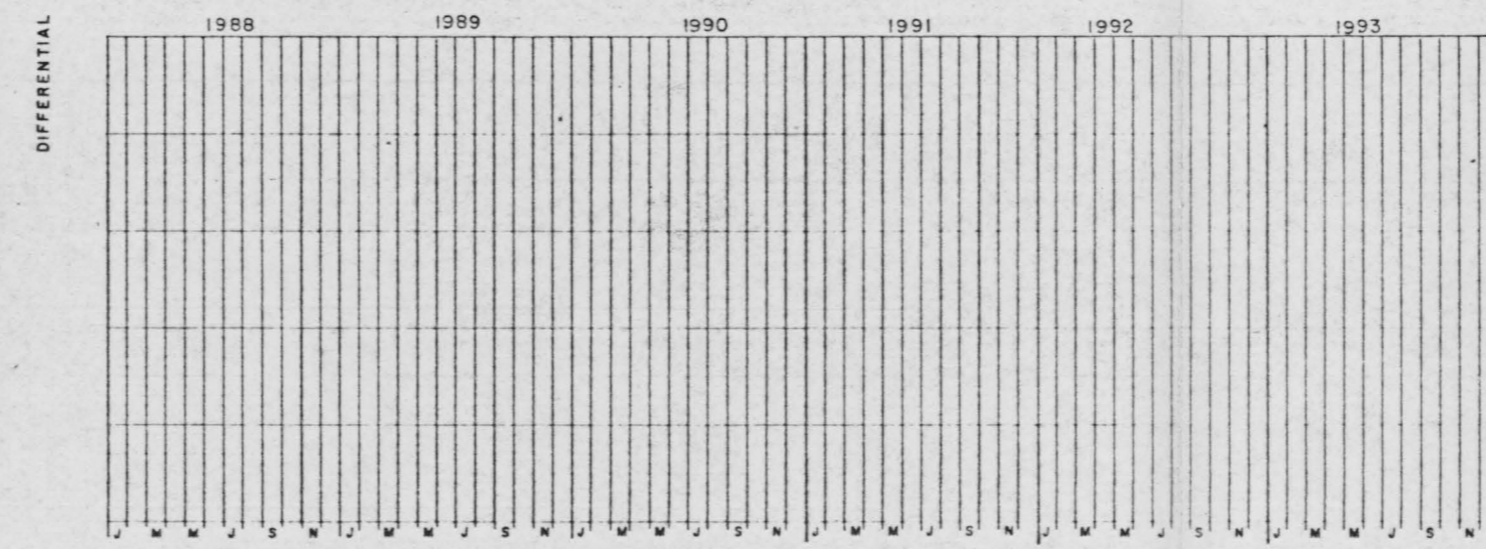
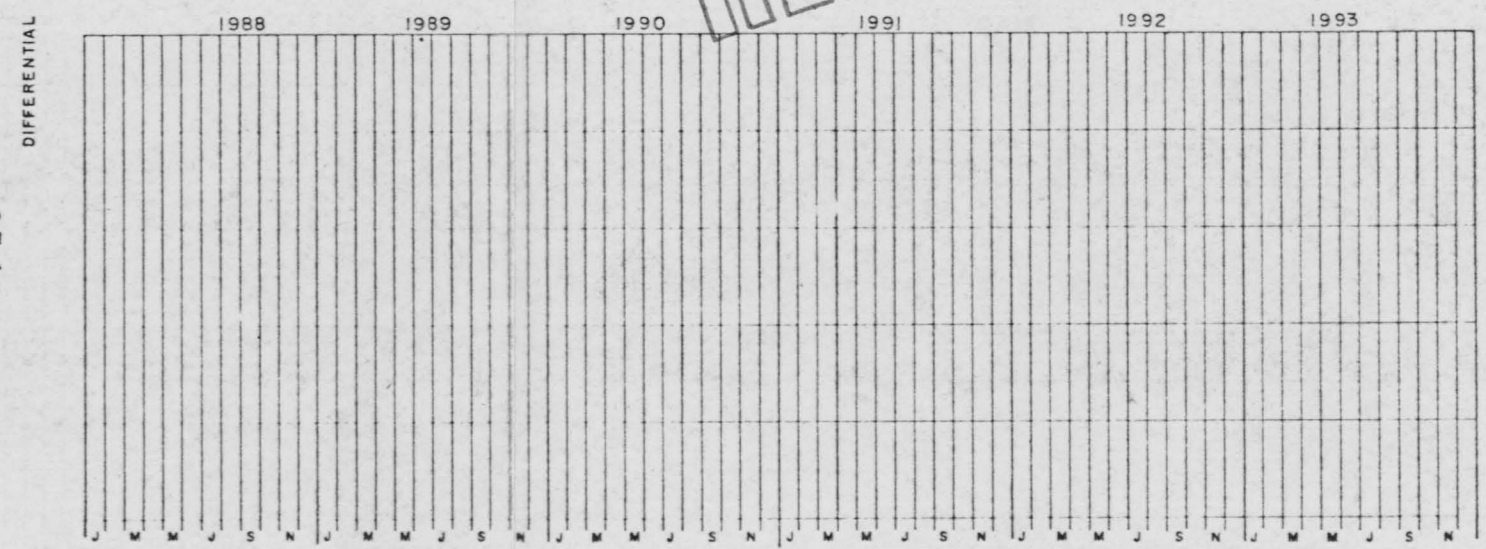
LAKE PONTCHARTRAIN AND VICINITY
BAYOU DUPRE
PERIODIC INSPECTION
SETTLEMENT REFERENCE MARKS
DIFFERENTIAL SETTLEMENT CHART
U.S. ARMY ENGINEER DISTRICT, NEW ORLEANS
CORPS OF ENGINEERS
FILE NO. H-4-26857

a. Para 4-03 a. and Plates 20 and 21. This paragraph should give a better explanation of the observed settlement. It should be noted that more fill has been placed in levee adjacent to the east sheetpile wall than the levee adjacent to the west sheetpile wall which explains the difference in total settlement between these two walls. The paragraph should point out that additional fill was placed near the east sheetpile wall in 1977 and 1982, and this additional fill placement caused additional settlement of the wall. Without these explanations, the reader gets the misleading impression that the same amount of fill placement has caused more settlement and a faster rate of settlement of the east wall than the west wall. It would be beneficial if the dates of the additional fill placements were noted on the plates.
