NEW ORLEANS TO VENICE, LOUISIANA

REACH B-1 - TROPICAL BEND TO FORT JACKSON

# EMPIRE FLOODGATE

PERIODIC INSPECTION REPORT NO. 3

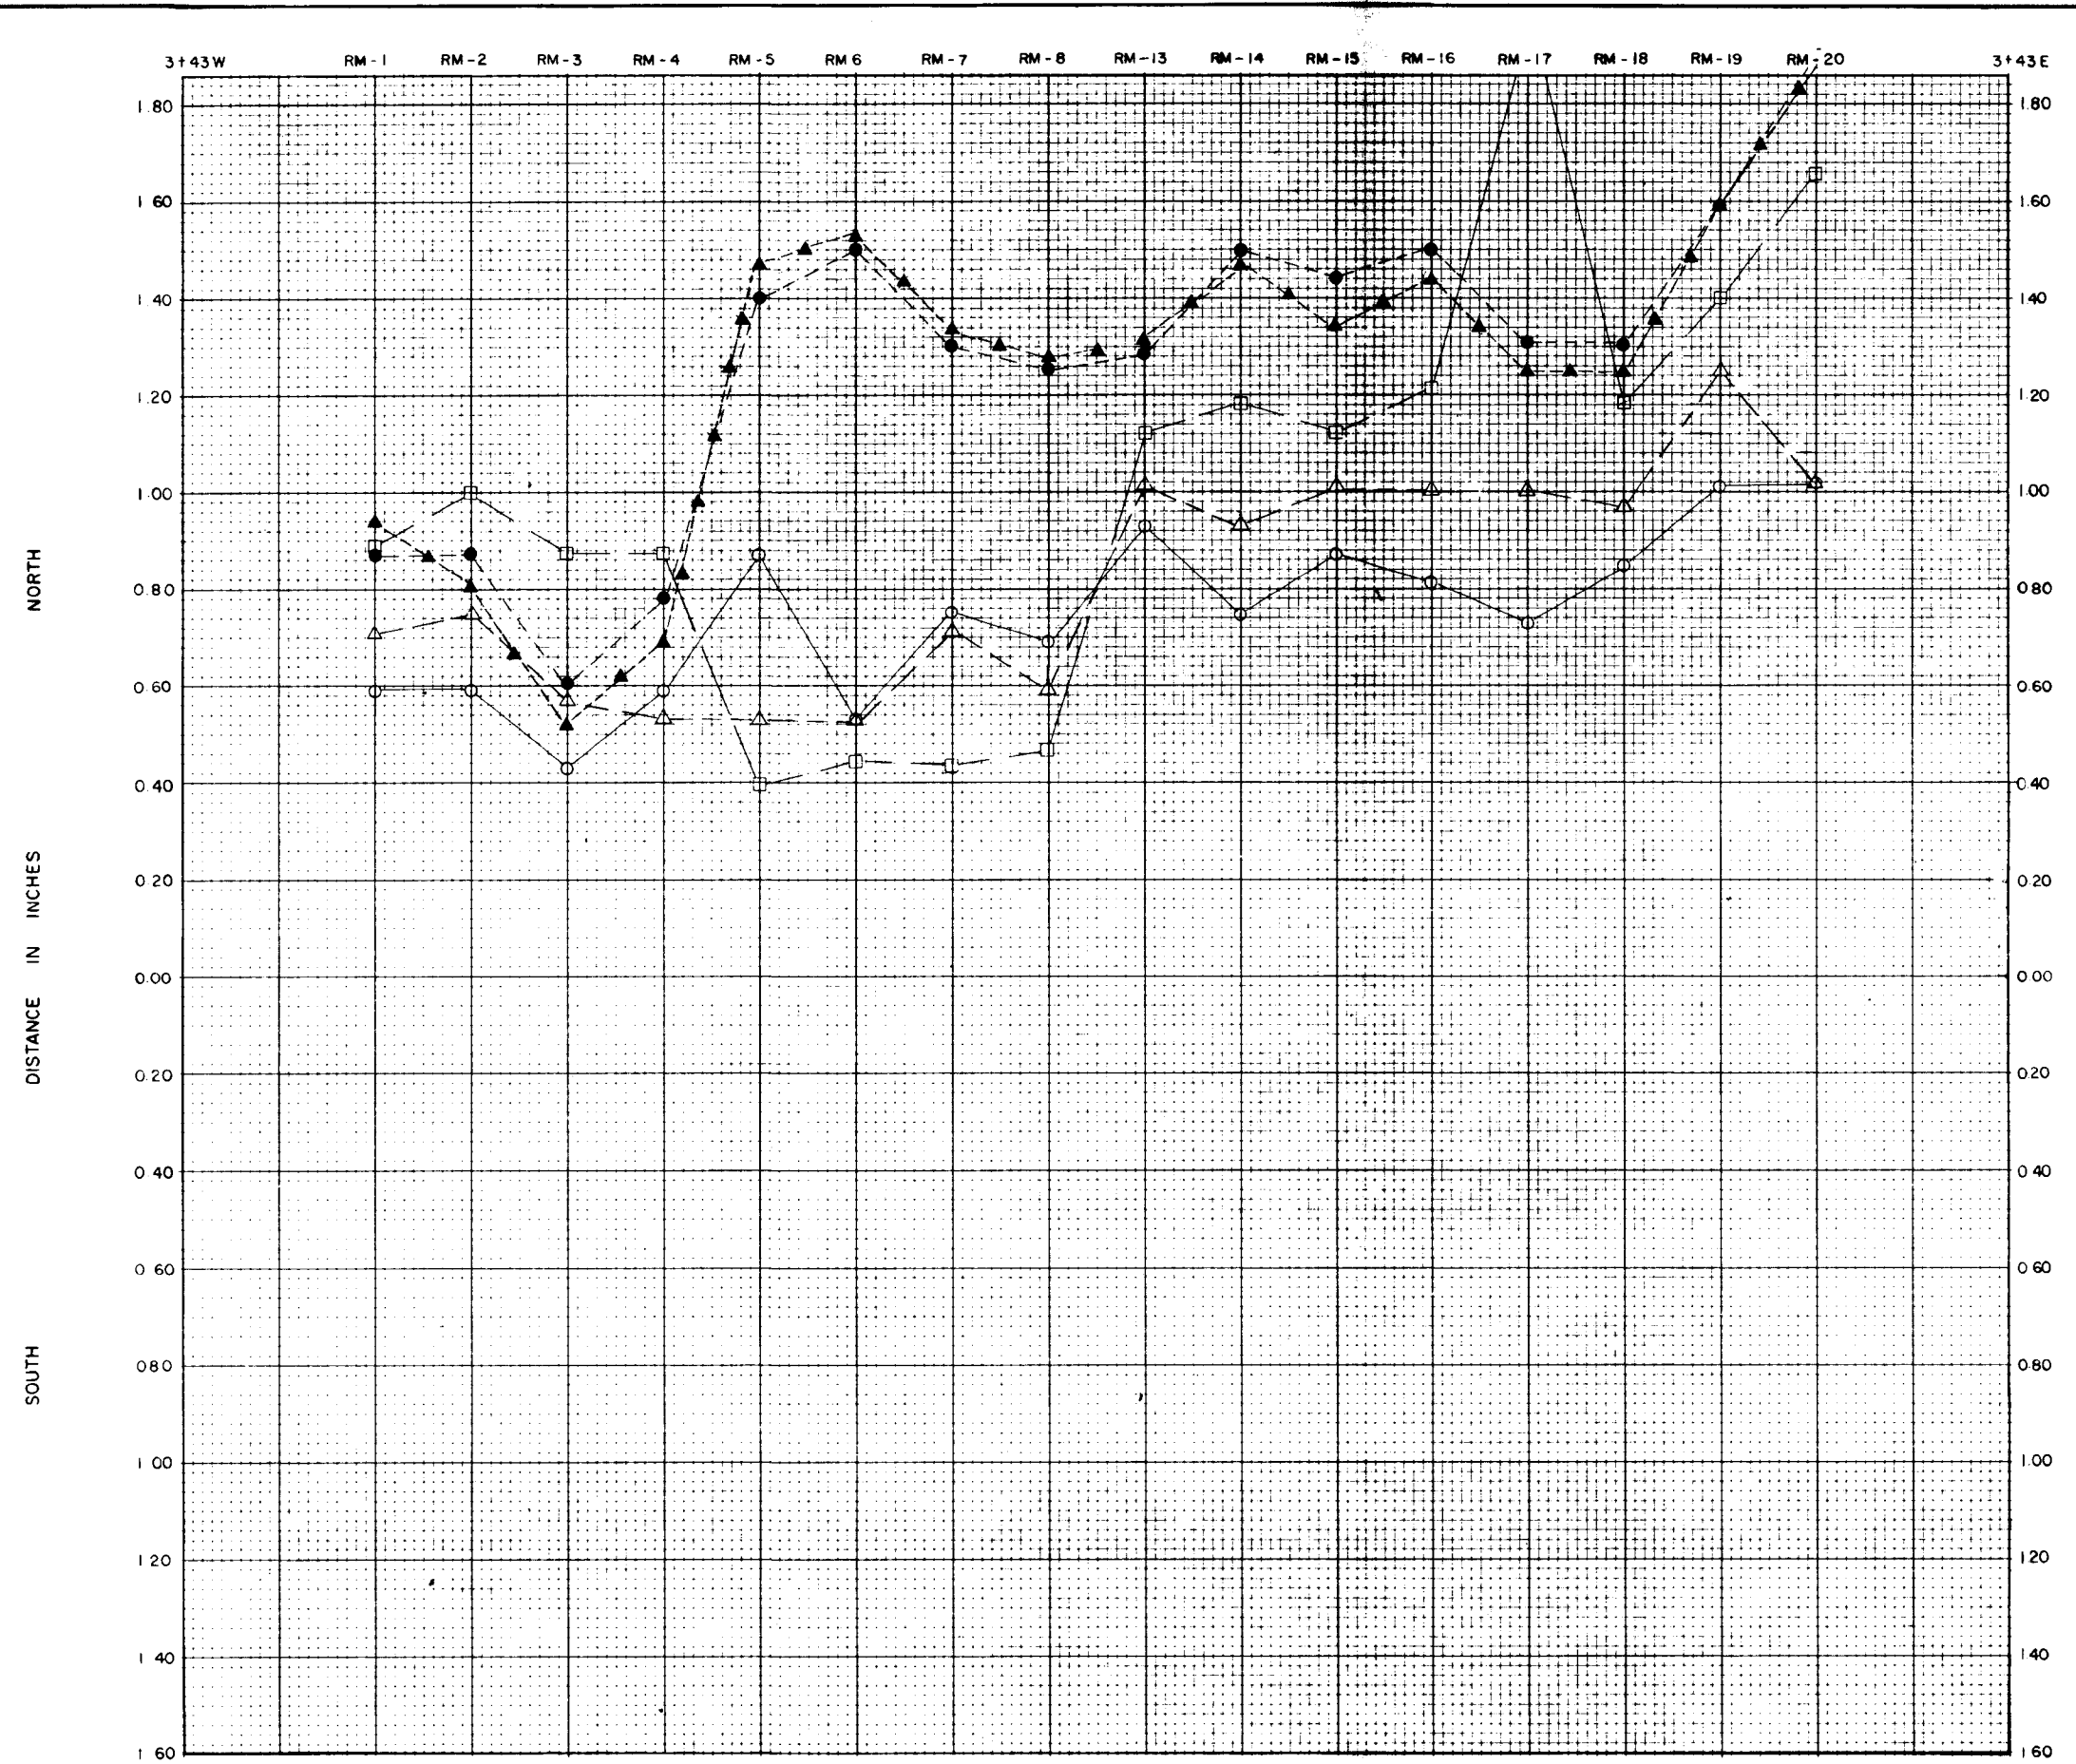
**ALINEMENT**  
**DIFFERENTIAL CHART**  
 U.S. ARMY ENGINEER DISTRICT, NEW ORLEANS  
 CORPS OF ENGINEERS

d. Floodwall Alinement. The alinement surveys, as indicated by plates I-2 and I-2A, show an apparent movement to the north. This condition has not affected the structural integrity of the structure. The Alinement Differential Chart, plate I-2A, indicates that RM-5, RM-6, RM-7 and RM-8 have moved an average of one (1) inch since the last inspection in October 1978. As indicated on plate I-1, these reference marks are located on two adjacent concrete T-wall

monoliths. Possible cause of this movement is unknown but these reference marks will be monitored closely during future surveys.

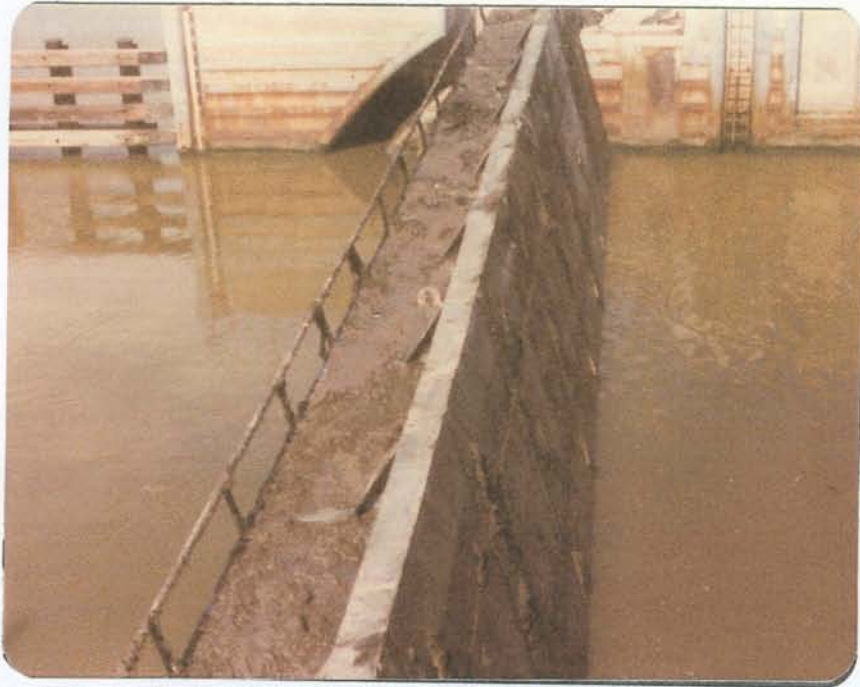
(2) Gatebay Monolith. The ladders and wall armour on each of the channel walls were extensively corroded. The corrosion appeared to be worse between approximate elevation 8.0 NGVD and the water surface. (See photo #1). Water was observed flowing through 8 small holes in the North face of the concrete wall adjacent to the counterweight recess and above the pump platform on the structures East side. These holes were all in close proximity to each other and were located just above the horizontal construction joint as can be seen in photo #2. Both counterweight recesses contained entrapped water in them. The surface of the water in the East recess was approximately 5 feet from the top of the concrete and contained a small amount of floating debris. The water level was receding very slowly. The surface of the water in the West recess contained no floating debris and was approximately 1 foot from the top of the concrete. The water level was not receding in this recess. The high water levels observed in each of the counterweight recesses would seem to indicate that the drain holes at elevation -9.5 NGVD were not functioning properly. There was an area of concrete which had spalled-off from the top of the concrete underneath a handrail anchor plate on the Northeast corner of the structures West side channel wall. Additionally, on the West side channel wall on the Southeast corner underneath another handrail anchor plate there is an area of concrete which is cracked and could also possibly spall-off. On both sides of the T-wall tie-in to the gatebay monolith on the structure's West side, there were some form liner bolt holes approximately 2 feet from the top of the concrete which had water leaking through them. (See photo #5). Overall the gatebay

PHOTO NO. 1 - CORRODED WALL ARMOUR & LADDER: SOIL DEPOSITS ON FLAP GATE WALKWAY

c. The ladders and wall armour on each of the channel walls will be cleaned of all corrosion by sandblasting and be repainted.

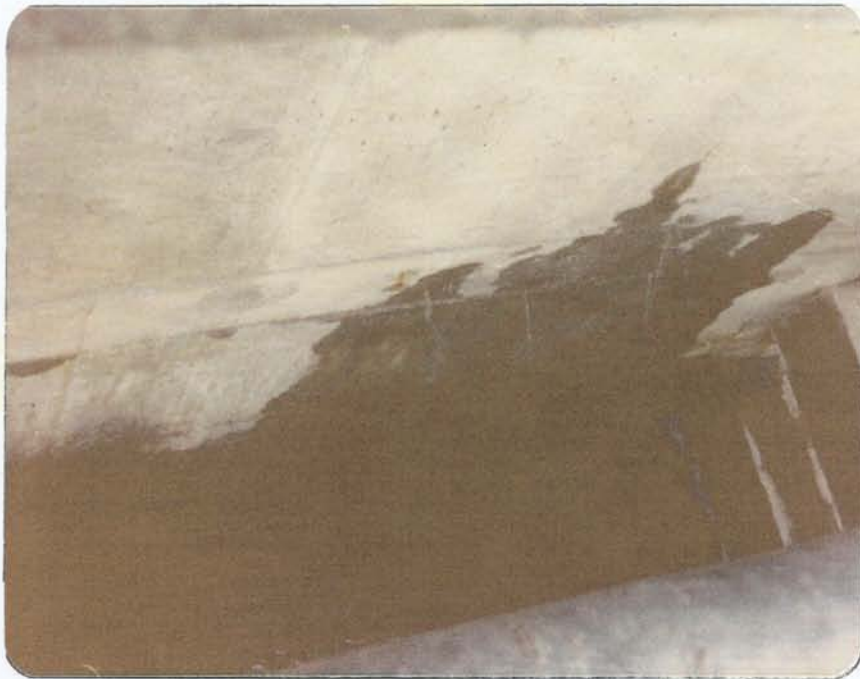
PHOTO NO. 2 - SMALL HOLES IN CONCRETE WALL

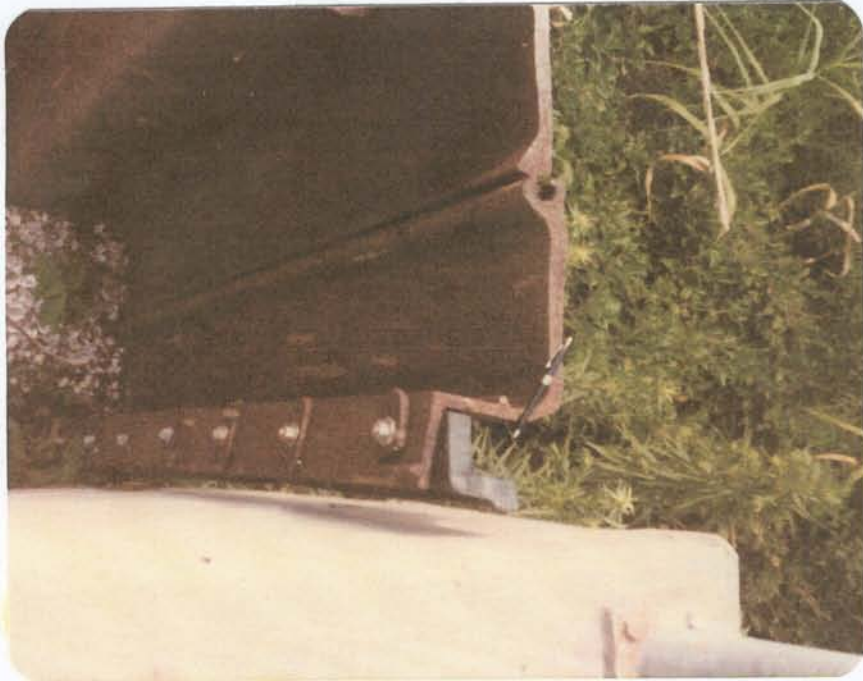
PHOTO NO. 3 - SEPARATION OF WATERSTOP BETWEEN I-WALL AND T-WALL INTERFACES

b. Sheetpile. The sheetpile I-wall was corroded and has settled on both sides of the structure near the tie-in levees. As a result of the settlement, the waterstops between the I-wall and T-wall interfaces no longer make contact. These resulting open spaces are approximately 1 to 2 inches at the joints. (See photo #3).

accomplished when settlement of the levee is essentially complete, the joint between the I-wall and concrete T-wall will be modified so that the waterstop on the I-wall will be in contact with the concrete T-wall. If this is the case, para 5-03b should be revised to indicate this and para 6-02b should be modified accordingly.

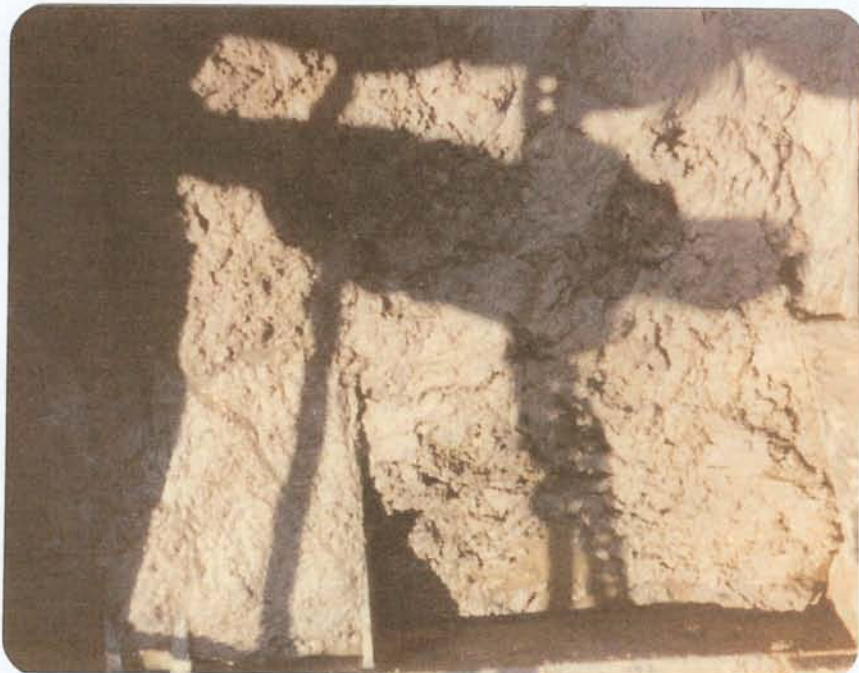
PHOTO NO. 4 - SOIL DEPOSITS IN THE GATE LIFTING RECESSES

\*i. In Aug 82, the Plaquemines Parish Commission Council had the accumulated soil deposits underneath the flap gate and the gate lifting recesses cleaned out by contract dredging and labor forces. This short term method will be used periodically to assure that the gate will seat properly when in its fully opened position, thereby eliminating further damage to the gate by being struck by large vessels passing over. Long term alternatives are suspended and subject to the availability of future funds.\*

i. The accumulating soil deposits underneath the flap gate and the gate lifting recesses shall be cleaned out so that the gate will seat properly when in its fully opened position, thereby eliminating further damage to the gate by being struck by large objects passing over it.

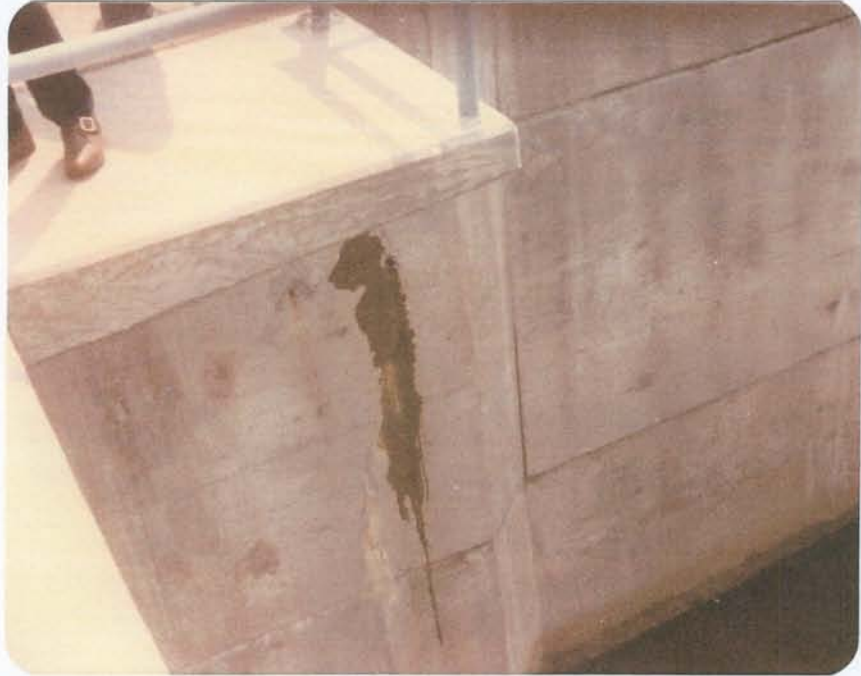
PHOTO NO. 5 - WATER LEAKING THROUGH FORM LINER BOLT HOLES

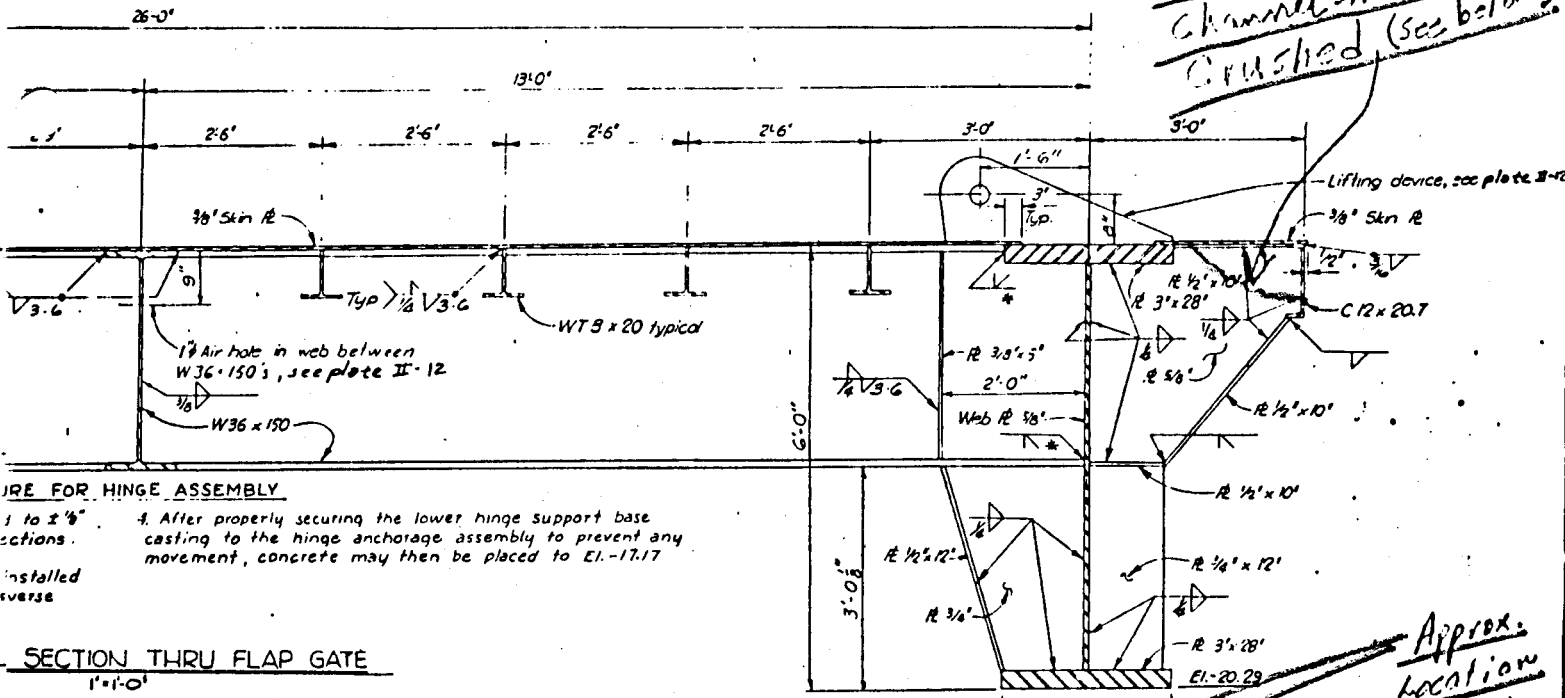
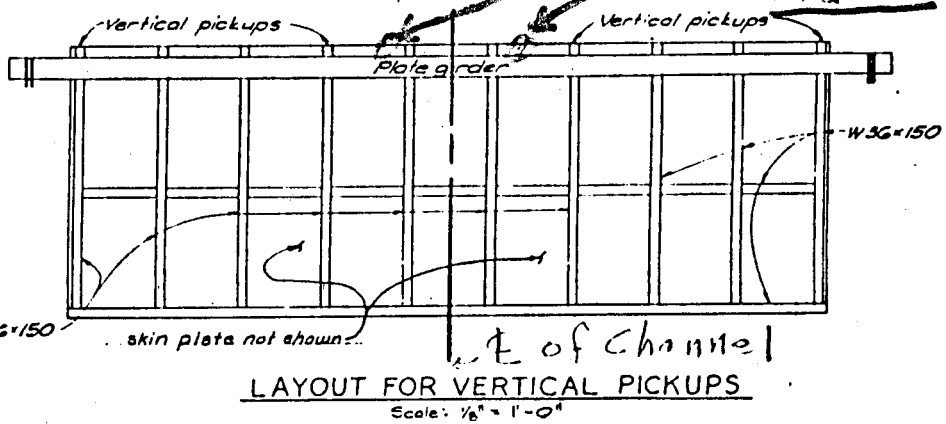
**SECTION THROUGH FLAP GATE**  
1'-1'-0

(2) After the gate was well out of the water and the silt layer had slid off, two large dents were noted on the leading edge of the gate (see Incl 2). This damage was apparently caused by a passing tow dragging a couple of spuds. The damage was confined to the skin plate and the structural channel member and did not affect the operation of the gate in any way. Further conversations with Mr. Henry Urban (the project manager) indicated that the gate does not seat properly on the end sill (see Incl 3) due to a build up of silt. Mr. Urban told us that he had tried washing the material out with the water pump but the discharge from the pump was not great enough to make any significant difference in the build up. Mr. Urban said he had even hired a large tug boat to tie off in the gate bay and direct the wheel wash in the silted area of the end sill but again with no success. He said that the most effective method for seating the gate so far is to simply "slack" the hoist chain after lowering the gate. The weight of the gate then pushes the gate down into the mud until the slack in the chain is used up. Successive "slackings" of the chain over a period of from several hours to a full day will allow the gate to settle into the silt as far as possible but still leaving the leading edge of the gate approximately 2 ft above the top of the end sill. The gate was probably in this position when it was struck by the tow.

*5/16" Skin Plate and Channel member Crushed (see below)*

*Approx. location of dents*

(3) NOD will study the above problem further and make recommendations in the inspection report. Periodic dredging would appear to be the ultimate solution, however, in the interim it would seem appropriate to issue a navigation bulletin informing mariners of the problem. Large signs placed in both directions along the waterway well in advance of the structure may also be helpful. Now that the hurricane season is here, it is of the utmost importance that serious damage to the gate be avoided.
