Technical Memo

Project 0-6132: Task 6 – Test Sections in the Districts

Subject: Field Performance Monitoring Report# 01 for the TTI Sections on US 83, Loop 20, US 59, & Spur 400 (Webb County, Laredo District)

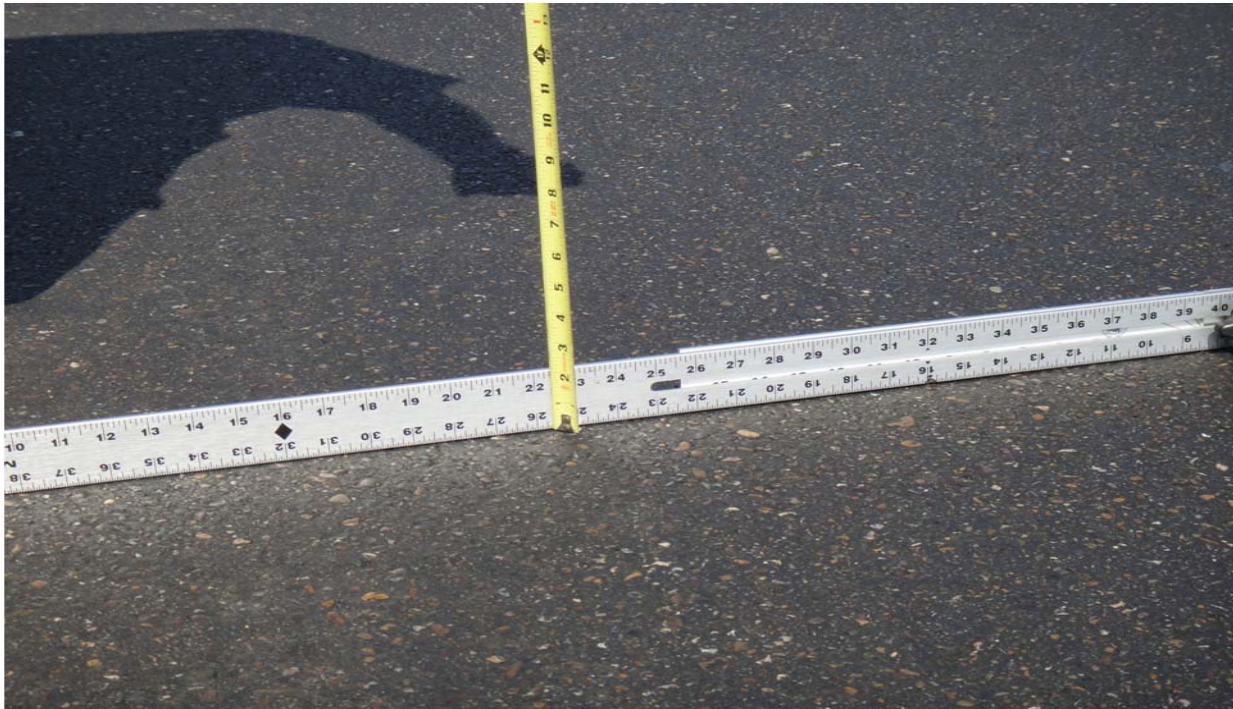
Figure II-1. Surface Rut Measurements with a Straightedge on US 59.

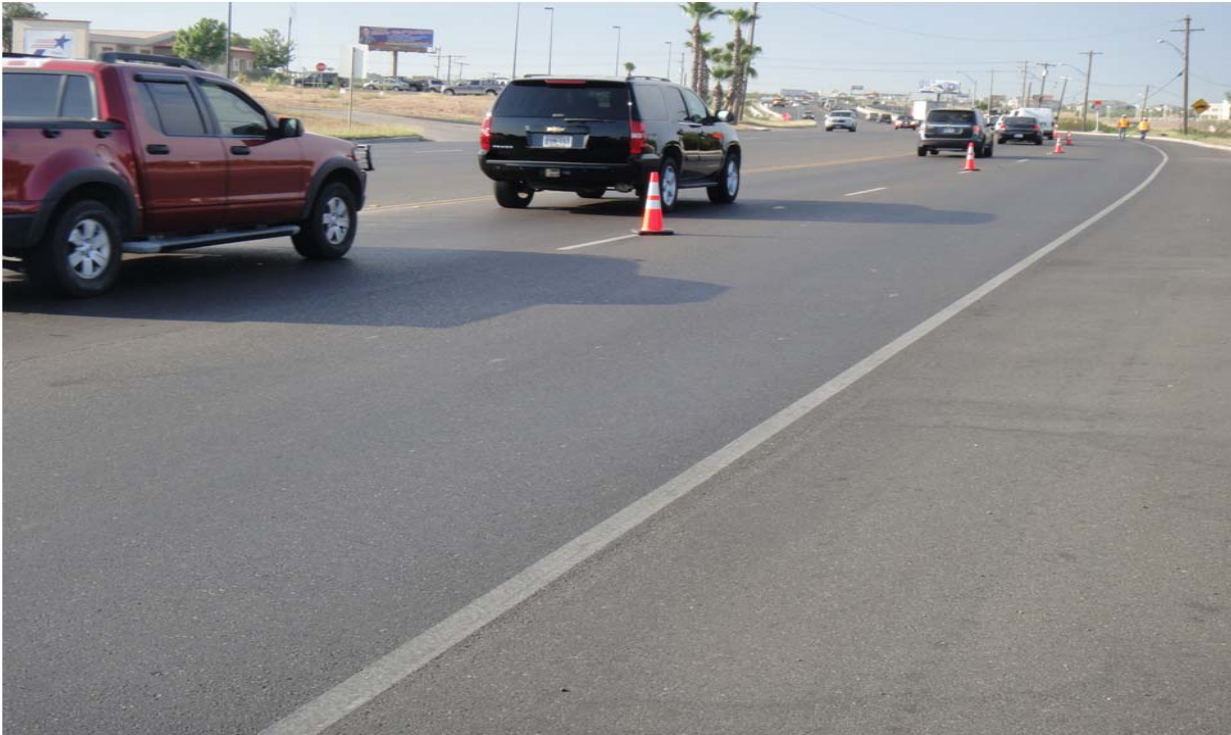
Figure III-1. Loop 20 SB Direction – No Cracking or Rutting Observed.

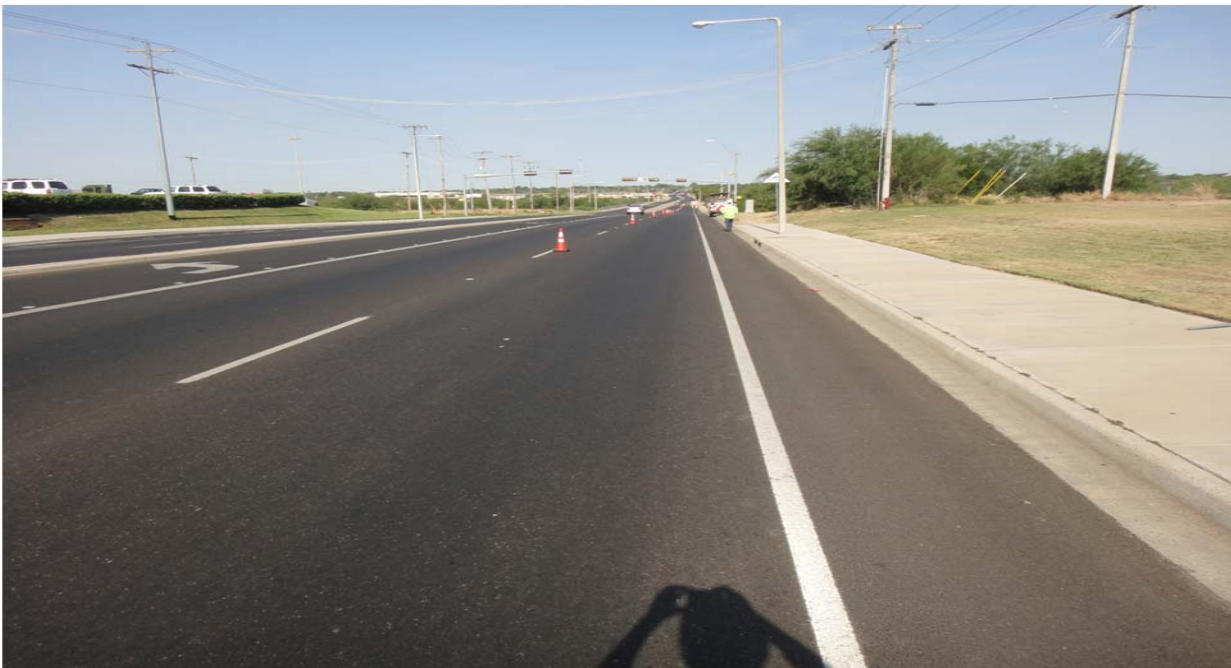
Figure III-2. Spur 400 WB Direction – No Cracking or Rutting Observed.

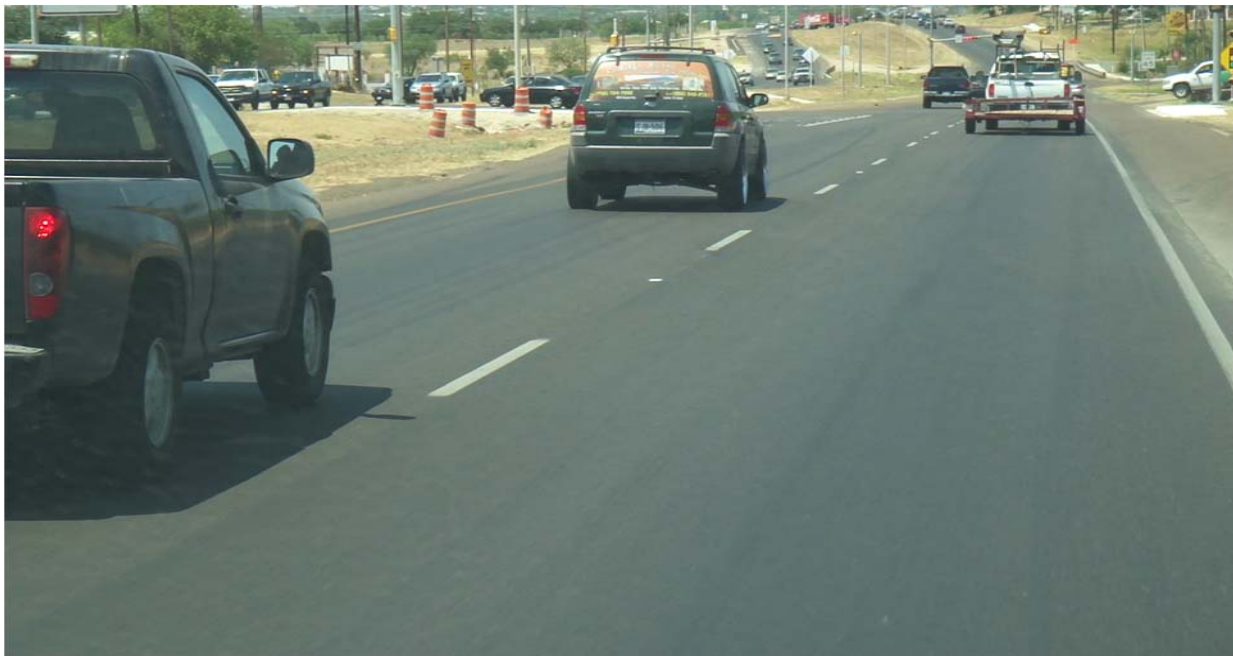
Figure III-4. US 83 SB Direction (Control) – No Cracking or Rutting Observed.

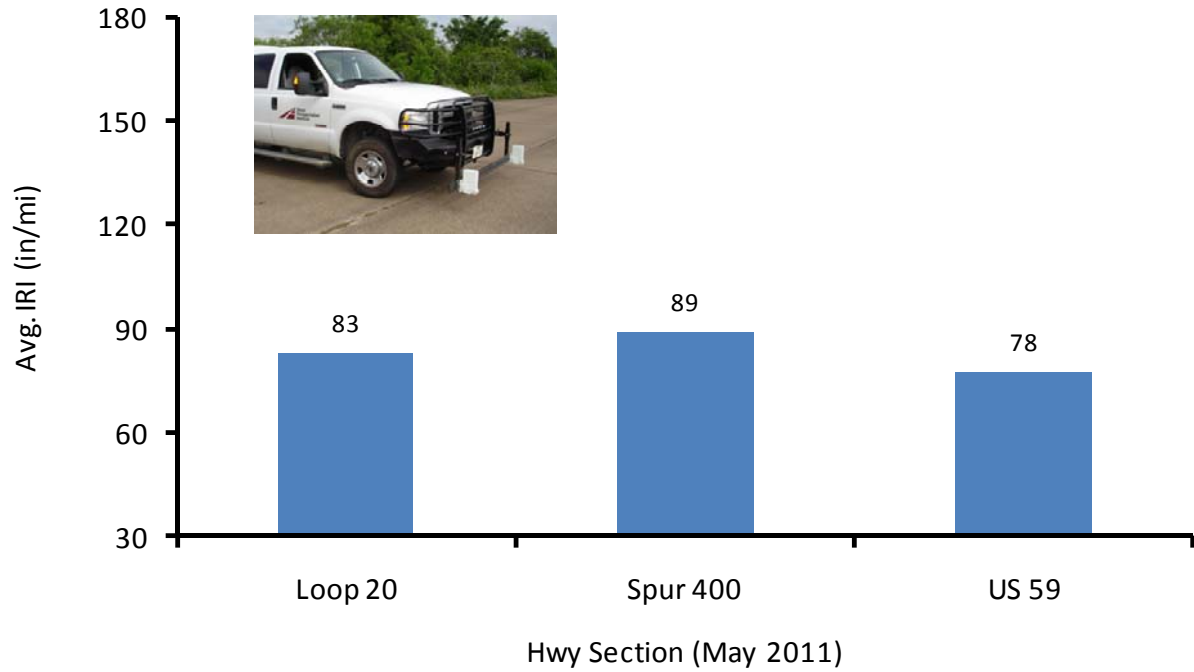
Figure IV-1. Surface Profiles (Outside Lane) – Avg IRI (RWP+LWP) as of May 2011.

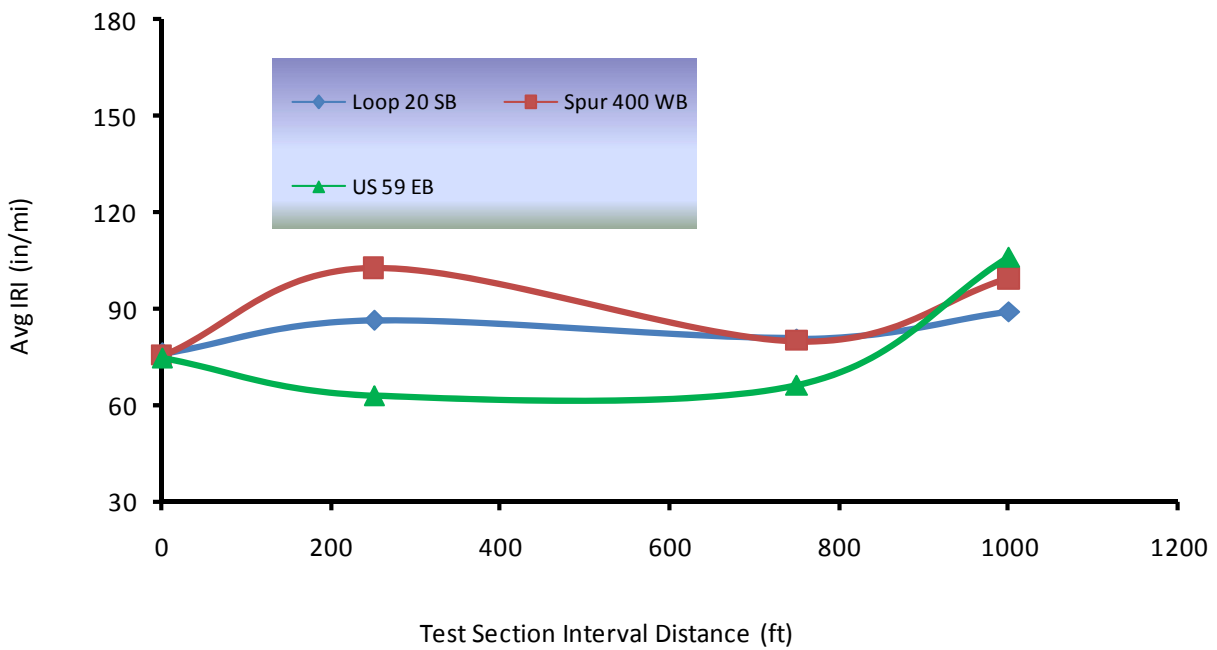
Figure IV-2. Surface Profiles (Outside Lane) – Avg IRI (RWP+LWP) Plot as a Function of Test Section Length (May 2011).

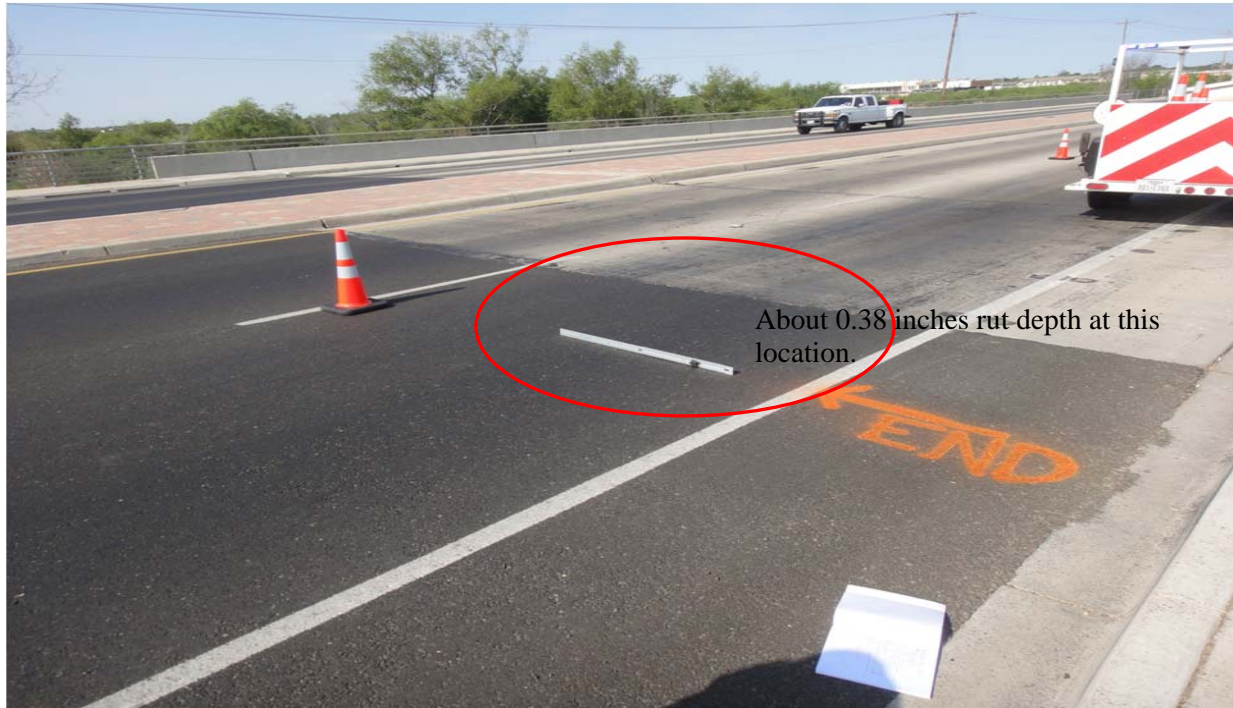
Figure V-1. HMA to Bridge Concrete Deck Transition \cong 0.38 Inches Rut Depth (Spur 400).

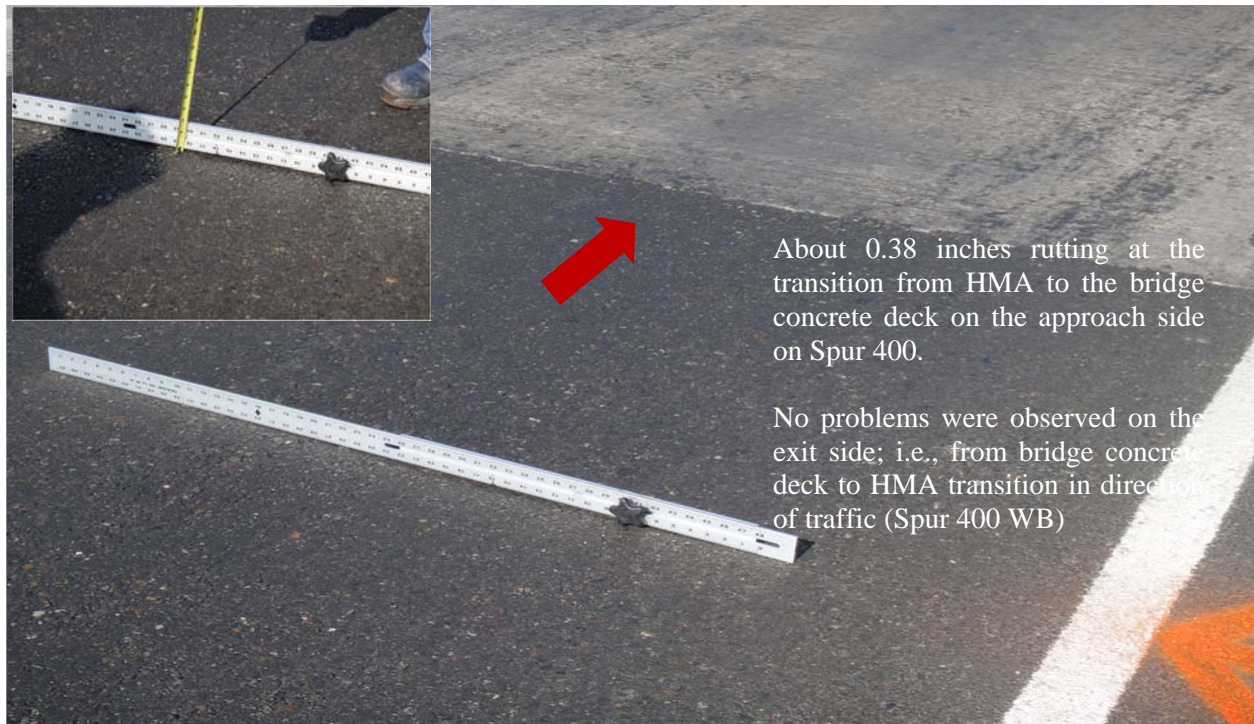
Figure V-2: Rut Measurements at the HMA-Bridge Transition on Spur 400 on the Traffic Approach Side; No Problems were Observed on the Traffic Exit Side.
