Technical Memo: Project 0-6132 (Task 6)

Subject: Construction & Lab Test Reports for US 59
(Panola County, Atlanta District)

CRACK SURVEY & CONSTRUCTION REPORT

US 59 S, Outside Lane; Carthage, TX [Date of Construction: March 26th, 2010]

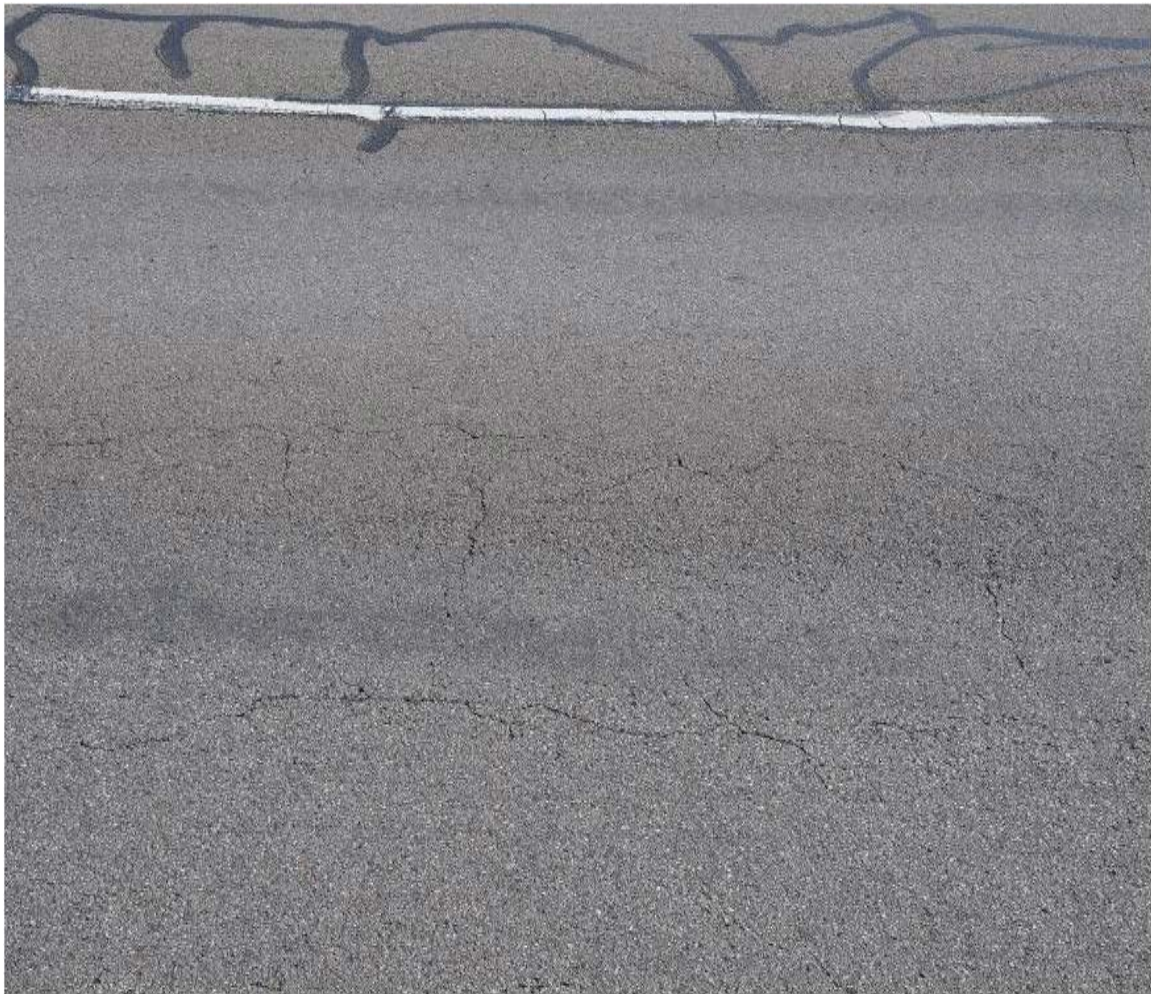
Crack#	Location from Crack#1	GPS Location	Remark	Severity
1	0 ft	N 32° 02. 660'; W 094° 17. 286'	Right side - Driveway/ Left side - Turnaround	
2	133 ft	N 32° 02. 642' W 094° 17. 269'		
3	655 ft	N 32° 02. 577' W 094° 17. 206'		
4	833 ft	N 32° 02. 552' W 094° 17. 182'		
5	1197 ft	N 32° 02. 506' W 094° 17. 135'	Driveway/Gated property on opposite side (US 59 N. bound)	
6	1306 ft	N 32° 02. 494' W 094° 17. 122'		
7	1393 ft	N 32° 02. 483' W 094° 17. 111'

Figure 4. Example of Cracks on Control Section 01.

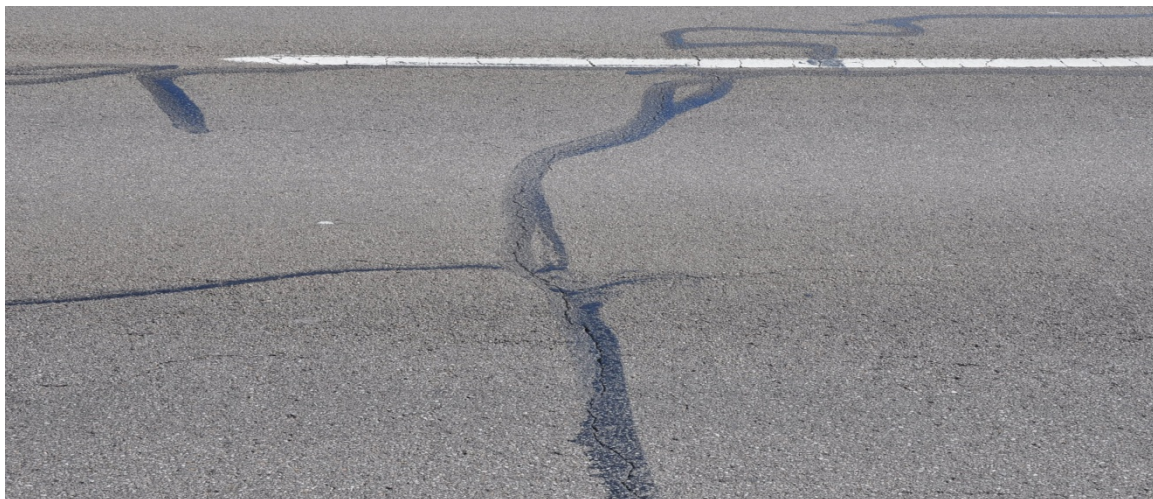
Crack#	Location from Crack#1 (Section 1)	GPS Location	Remark	Severity
1	0 ft	N 32° 02. 078'; W 094° 16. 709'	Left side (US 59 N bound) – Fresh Water Pond and Turnaround	
2	365 ft	N 32° 02. 032'; W 094° 16. 664'		
3	383 ft	N 32° 02. 029'; W 094° 16. 658'		
4	553 ft	N 32° 02. 009'; W 094° 16. 638'		
5	567 ft	N 32° 02. 007'; W 094° 16. 634'		
6	655 ft	N 32° 01. 995'; W 094° 16. 628'		
7	727 ft	N 32° 01. 985'; W 094° 16. 618'		
8	807 ft	N 32° 01. 976'; W 094° 16. 606'		
9	918 ft	N 32° 01. 962'; W 094° 16. 623'		
10	1266 ft	N 32° 01. 918'; W 094° 16. 551'		
11	1350 ft	N 32° 01. 907'; W 094° 16. 551'		Very
12	1434 ft	N 32° 01. 897'; W 094° 16. 530'		
13	1700 ft	N 32° 01. 864'; W 094° 16. 496'		
14	1780 ft	N 32° 01. 854'; W 094° 16. 486'		
15	1813 ft	N 32° 01. 849'; W 094° 16. 483'

Figure 7. Example of Severe Cracks on Modified Section.

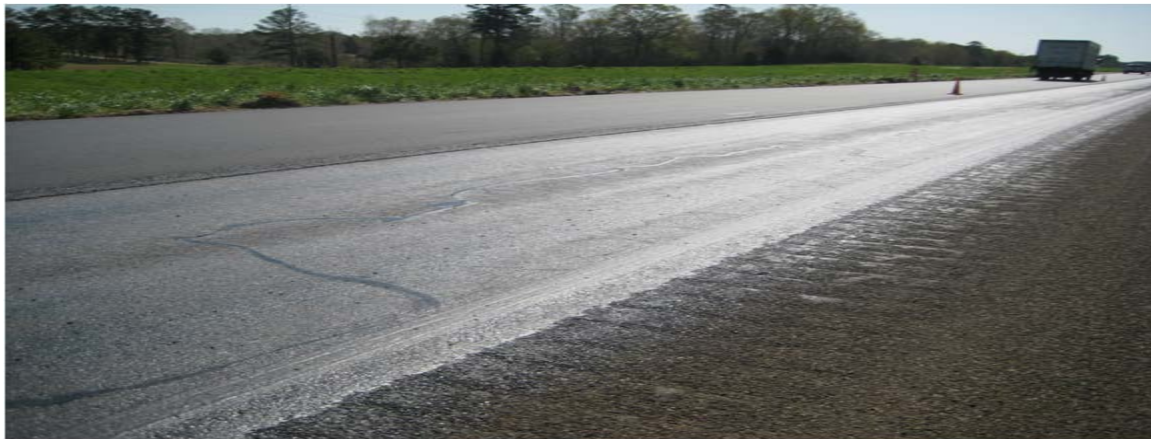
Figure 9. Example of Transverse cracks in Section 02.

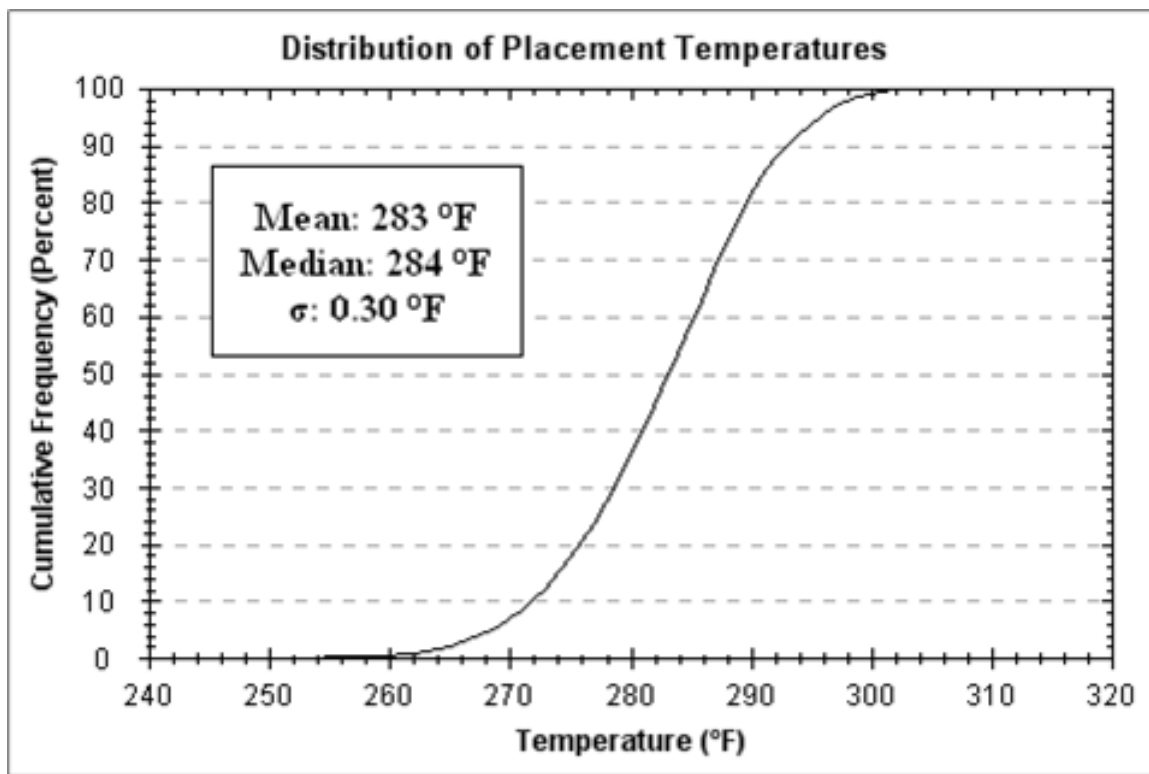
Thermal Profile Results Summary				
Number of Profiles	Moderate 25.0°F < differential <= 50.0°F		Severe differential > 50.0°F	
	Number	Percent	Number	Percent
130	47	36	0	0

Figure 11. Cummulative-Frequency IR Thermal Plots.

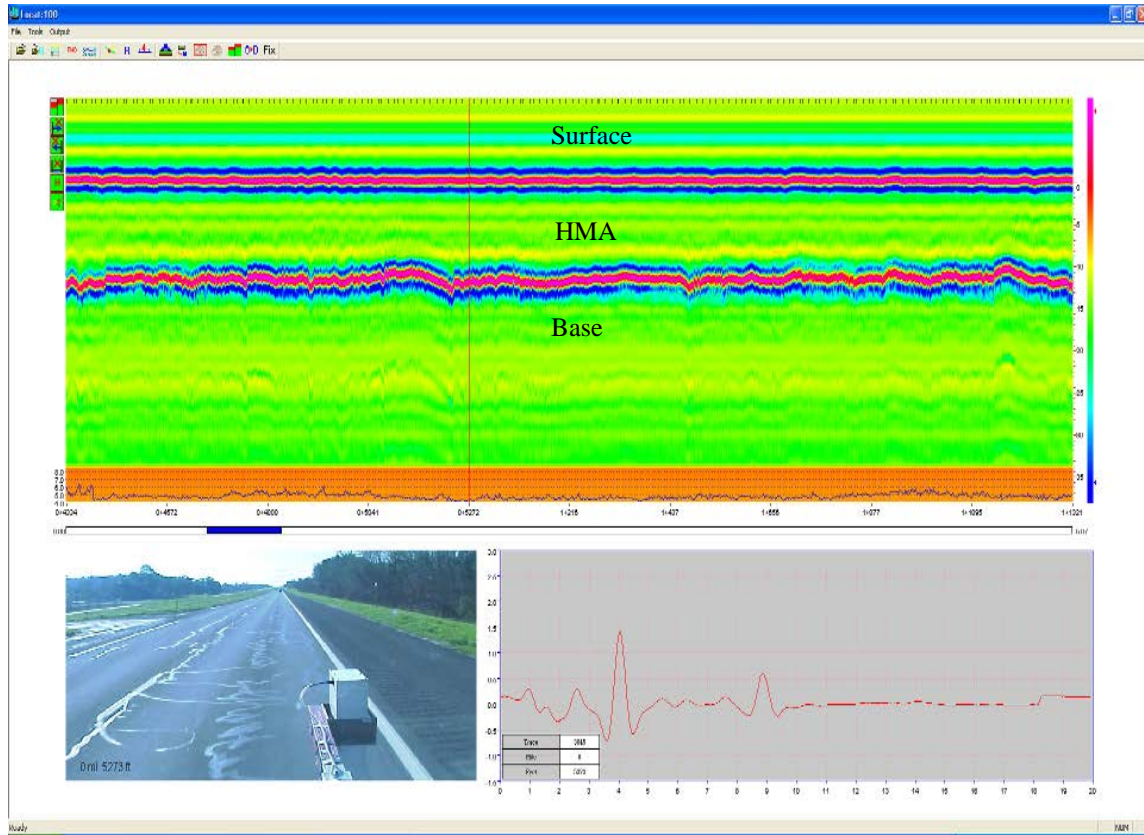
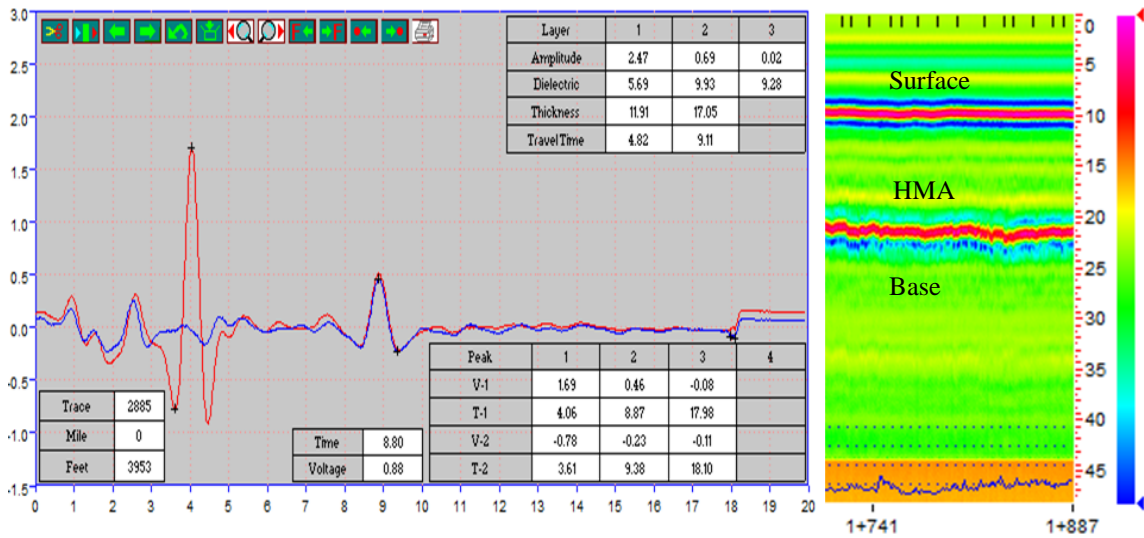
*Existing structure: Approx. 10 inches HMA + about 12 inches base (based on GPR)

Figure 12. GPR Measurements Prior to HMA Overlay Placement.
