Technical Memo

Project 0-6132: Task 6 – Test Sections in the Districts

Subject: Field Performance Monitoring Report# 02 on the TTI
Sections on US 59 (Panola County, Atlanta District)

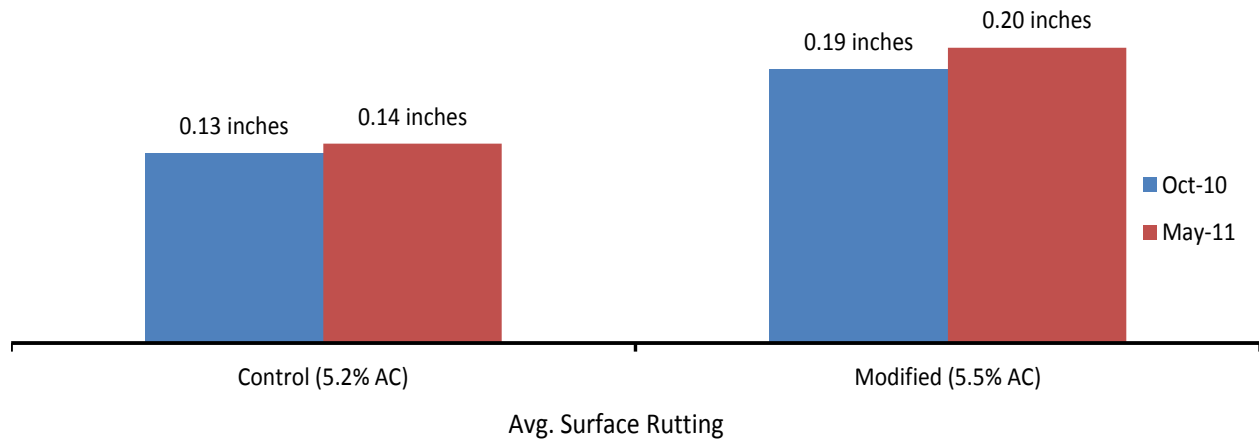
No distresses were observed during this site visit. Rutting on all the sections including the *TTI Modified section with 5.5% target AC designed at 98% lab TGC density* was very marginal (< 0.25" [6.25 mm]) after one year of service. The construction joints also did not exhibit any defects that could be of concern.

Figure II-1. Avg. Surface Rutting After One Year of Service.

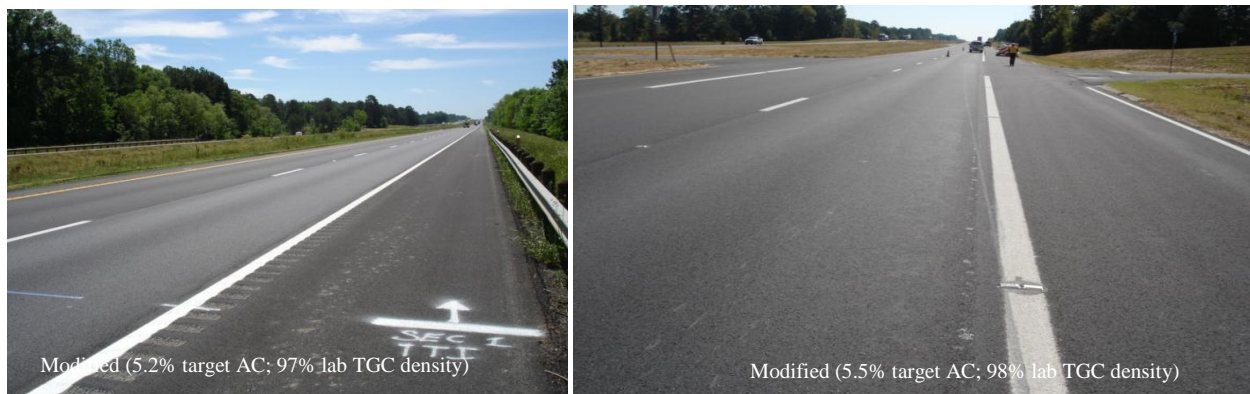
Figure II-2. View of the Test Sections – No Visible Surface Rutting (After 5 Months; Oct 2010).

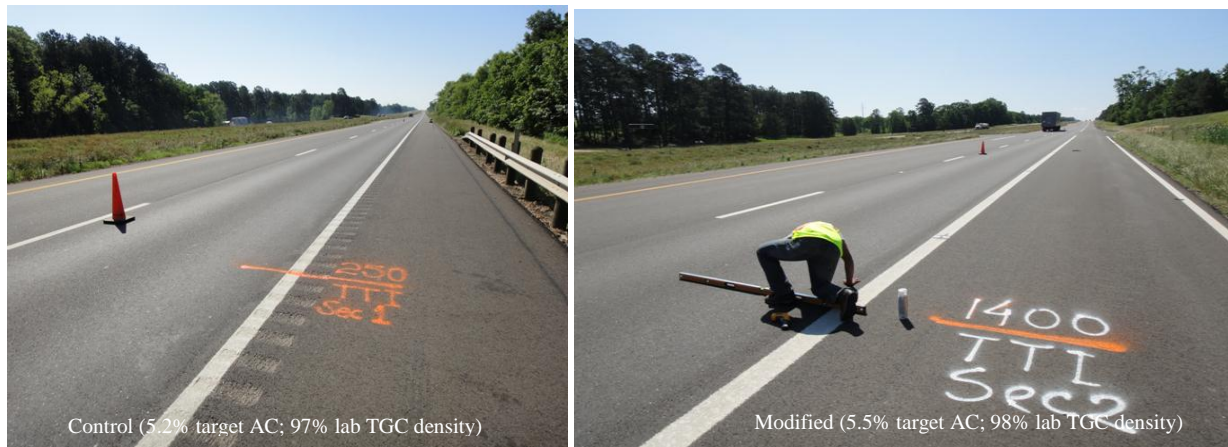
Figure II-3. View of the Test Sections – No Visible Surface Rutting (After 1 Year; May 2011).

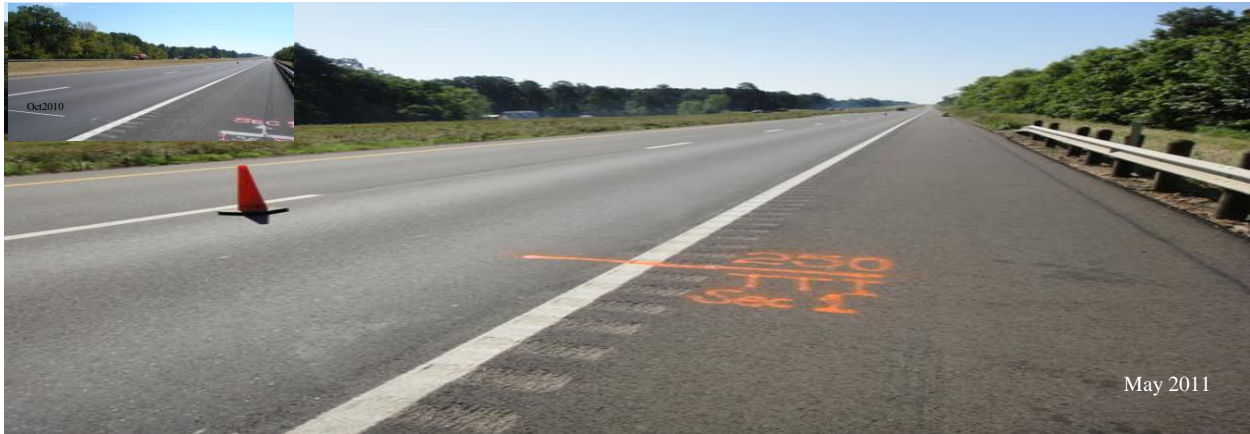
Figure III-1. Test Section 1 (Control: 5.2% Target AC) – No Surface Cracking Observed.

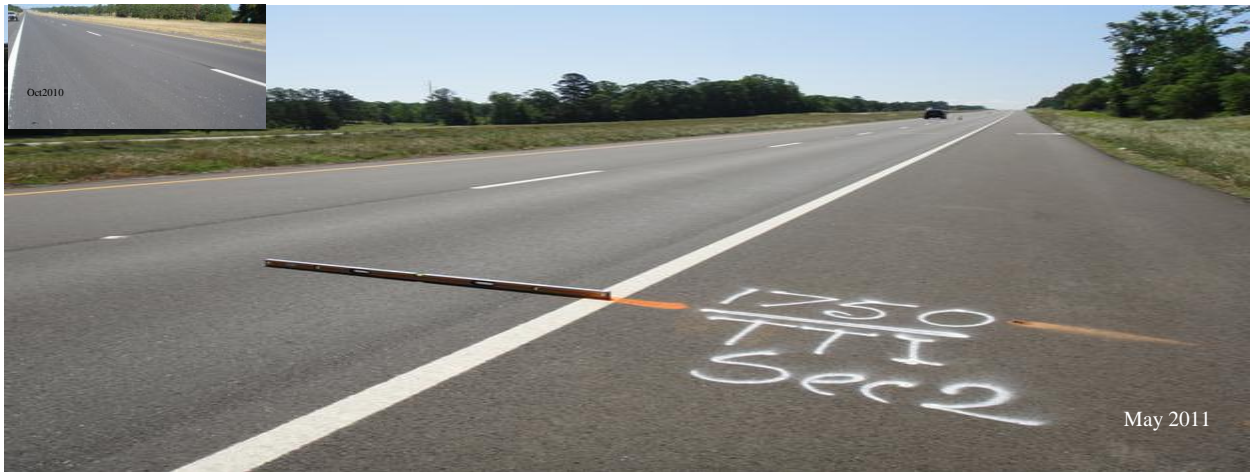
Figure III-2. Test Section 2 (Modified: 5.5% Target AC) – No Surface Cracking Observed.

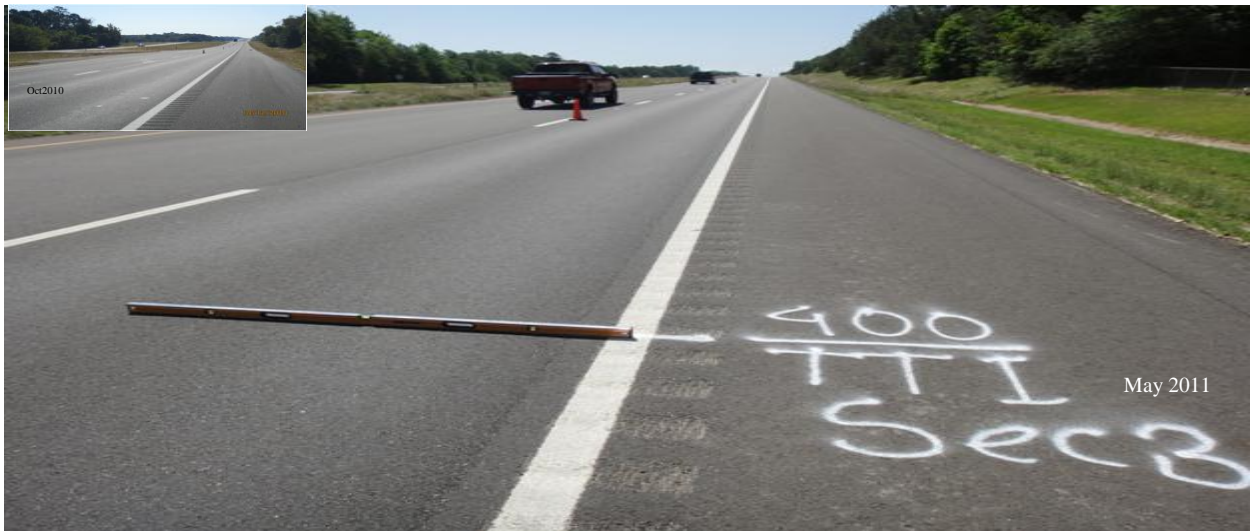
Figure III-3. Test Section 3 (Control: 5.2% Target AC) – No Surface Cracking Observed.
