Patient Safety Alert

AL09-23

June 16, 2009

Item: Philips IntelliVue G1/G5 Anesthesia Gas Modules:
Model Numbers M1013A and M1019A and
Dräger Apollo Anesthesia Machines and Multigas Monitor:
Model SCIO

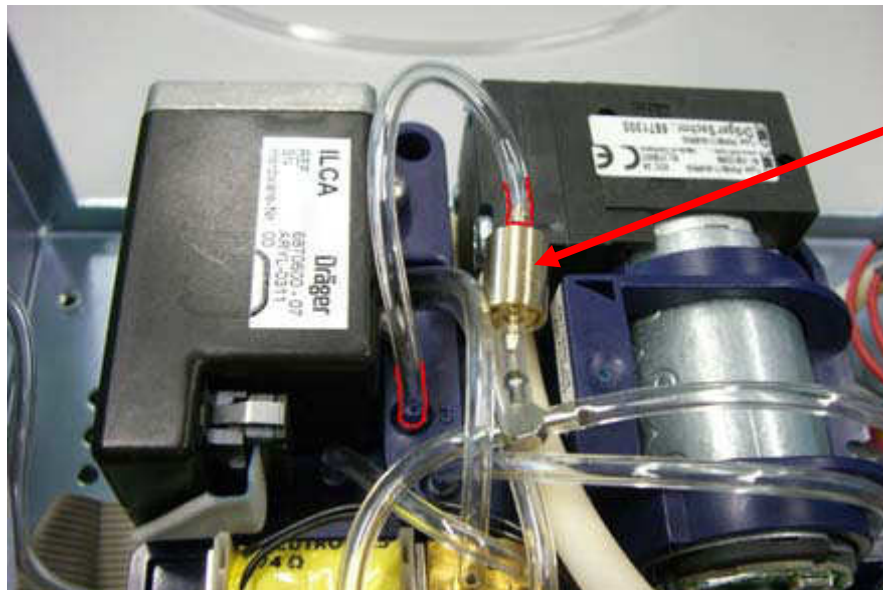
Reason: - Increased extraction rate of anesthetic gas metering
 - Frequent occurrence of 'Water trap / Scavenging line' message
 - Zeroing error of Pato O2 sensor with error code 6014
 - Pump error code 3705 (pressure drop too small)

Solution/Procedure: **1. Units under service contract:** Installation of a new flow restrictor
2. Units without service contract: Installation of new flow restrictor in case of repair
