Patient Safety Alert

AL10-04 December 14, 2009

Possible blood contamination in hemodialysis machines

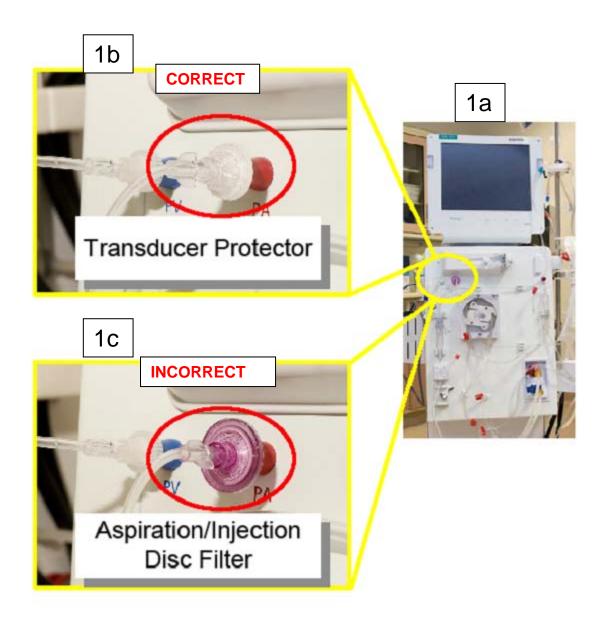
At one VAMC using B. Braun Dialog Plus Dialysis System machines blood contamination was detected inside multiple machines during scheduled maintenance. It was found that at this one dialysis site, staff purchased and used disposable disk filters (see Photographs 1c & 3) instead of the external transducer protector (see Photographs 1b & 4) for the arterial, venous and blood pump exit pressure monitoring lines. The disk filter, unlike the transducer protector, permits two-way flow and allowed passage of blood into the interior of the machine and contaminated a short portion of the internal tubing and the internal transducer protector (see Photograph 5). Since normal practice is that only the external blood set tubing, including the external transducer protectors, are changed between patients, the possibility of cross-contamination between patients exists as blood from subsequent patients could contact the contaminated components of the machine's internal pressure tubing.

Photograph 1 Dialysis machine with empty blood set [1a], depicting the correct external transducer protector [1b] & incorrect disk filter [1c]

- 2. By COB December 16, 2009, **Dialysis Unit Managers (or designee)** will assure that their staff are:
 - a) using only the manufacturer's recommended external transducer protectors

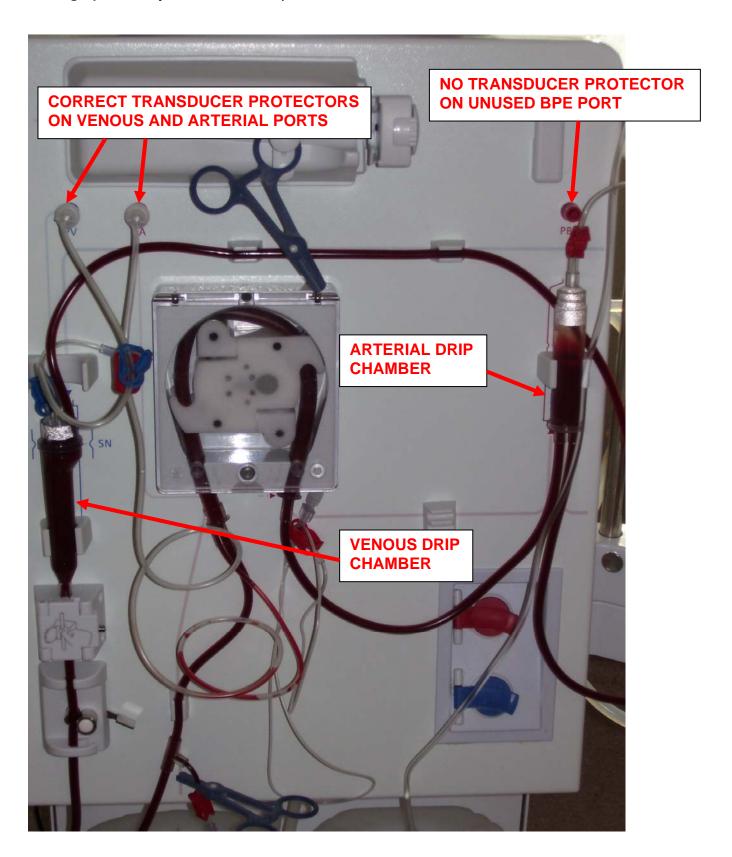
Photograph 2 Dialysis machine in operation with blood in the blood set

- b) monitoring the level of blood in the pressure monitoring lines to avoid contamination and breakthrough (sometimes referred to as strikethrough) of the external transducer protectors and examining the external transducer protectors at the end of the treatment.

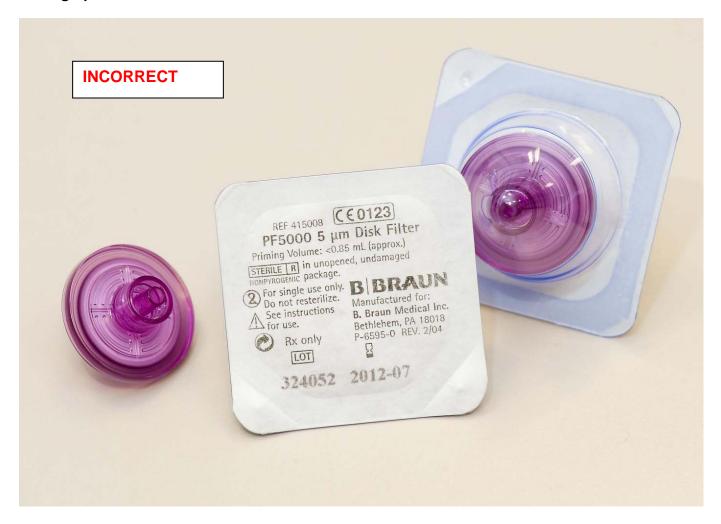
Photograph 3 Incorrect 5 Micron Disk Filter

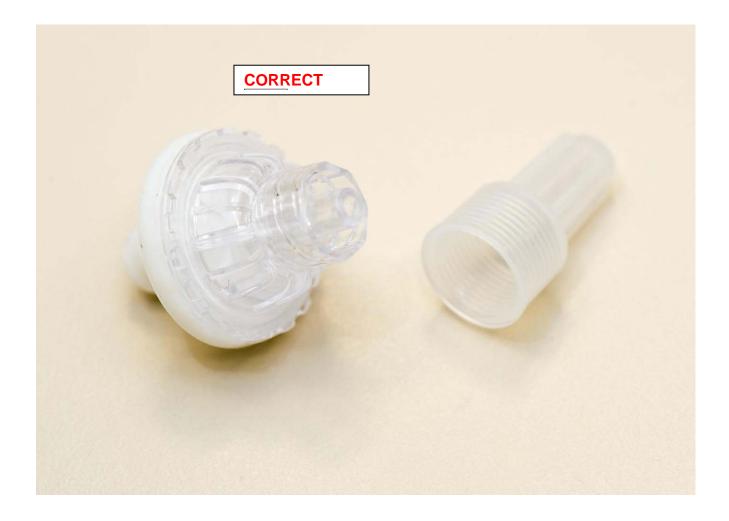
Photograph 4 External transducer protector with protective cap

- c) immediately replacing any external transducer protector that comes into contact with blood during the treatment and inspect it .
 - d) If during, or at the conclusion of the treatment on that patient, blood is visible on the side of an external transducer protector that faces the machine:

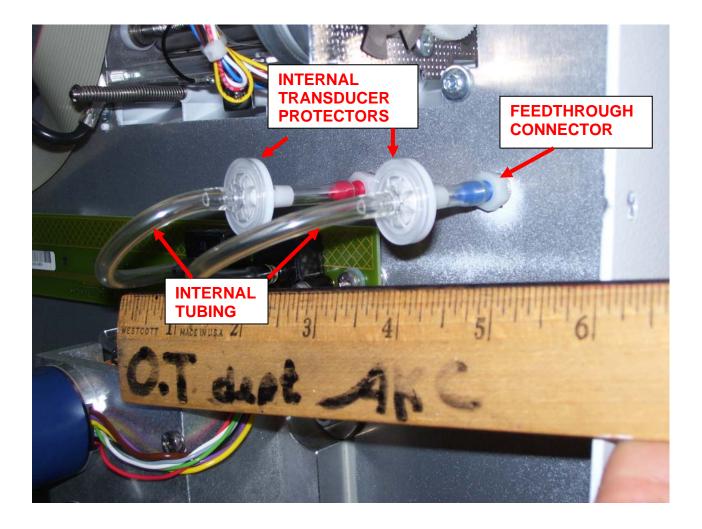
Photograph 5 – Internal transducer protectors

- 3. By COB December 18, 2009, the **Biomedical Engineering staff** shall have qualified personnel inspect all machines including the internal pressure tubing, feed through connectors and internal transducer protectors for signs of blood contamination (see Photograph 5).

- a) By COB December 23, 2009, **Biomedical Engineering** shall have qualified personnel replace all affected parts and disinfect the surfaces and pressure monitoring pathways before the machine is returned to clinical use and
- b) By COB December 23, 2009 **Facility Leadership** must prepare an Issue Brief describing the situation to be forwarded through their VISN Director to Central Office.
