Lessons Learned

Environmental Impacts - Spills & Discharges

NOVEMBER 2011

Internal Tank Transfers... Worth Some Thought

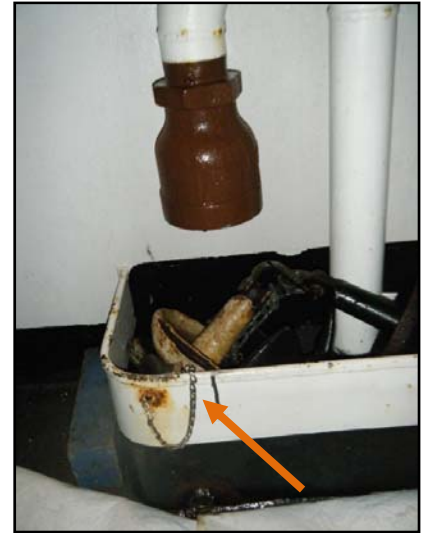
One hour into the clean-up, a sheen was discovered on the starboard side of the main deck. Diesel had discharged from the starboard vent pipe, into the coffer dam, through the unplugged coffer dam drain, across the deck, and overboard (Figure 1).

Figure 1: STBD cofferdam (note: plug is not inserted)

Coffer dams were not plugged, allowing burps and overflow to discharge over the side.

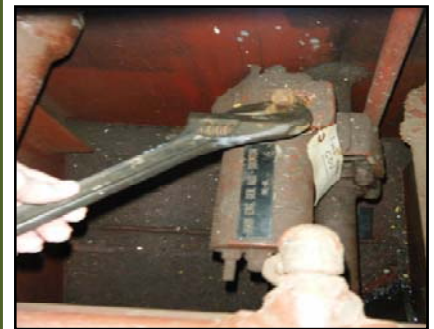
Figure 2: Valve fitting makes it difficult to determine if the valve is open or closed.

The fittings on the fuel valves provide no visual indicator if the valve is open or closed (Figure 2).
