NOAA Ship
Significant Spill Report
2012-01

EXECUTIVE SUMMARY

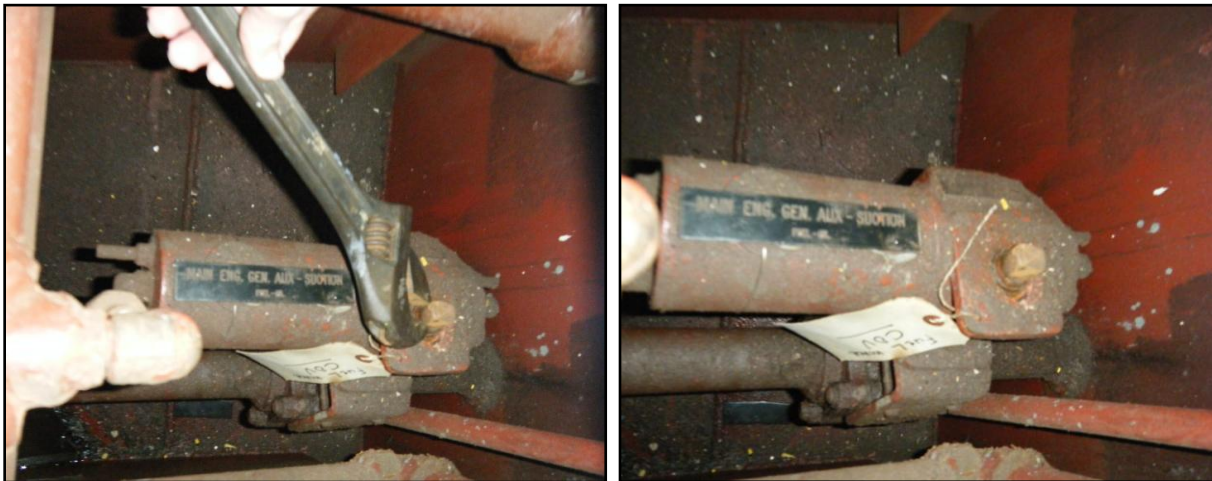
Additionally, valve configurations do not make it apparent which valves are opened and which are closed (see figures below). Installing more accessible valve handles that clearly indicate the open/close status could prevent such an incident from occurring again. The Ship had tank level indicators (TLIs) installed six years ago, which were never fully commissioned. The Ship's installed tank level indicators, notifying the EOW of changes in the amount of fuel in each tank, were not utilized because there is no available read-out in the control station.

Shown above is an example of a suction valve on this Ship. It is not apparent whether the valve is open or closed because of the nut fitting.

The Ship command intends to hold meetings with CME and the Port Engineer, to investigate ways to make it more readily apparent whether valves on fuel tanks are opened or closed.
