FAST RESCUE BOAT (FRB) INCIDENT INVESTIGATION REPORT

1. **LOCATION:** NOAA Ship; In port
2. **DATE OF INVESTIGATION:** Summer, 2011
3. **IDENTIFICATION:**
 - 3.1. **Type of Incident:** Serious - Disabling (Lost Work Days); Struck By Rotating Manual Winch Handle
 - 3.2. **Date of Incident:** Summer 2011
 - 3.3. **Time:** 13:15 Local Time
 - 3.4. **Area Involved:** Fast Recovery Boat (FRB) Launch and Recovery Station
 - 3.5. **Exact Location:** Immediately adjacent to the winch motor on the inboard side
 - 3.6. **Employee Involved:** wage mariner
 - 3.7. **Job Title:** Skilled Fisherman
 - 3.8. **Equipment Involved:** Winch motor equipped with adaptor sleeve; sleeve cover, proximity limit switch, and manual crank arm

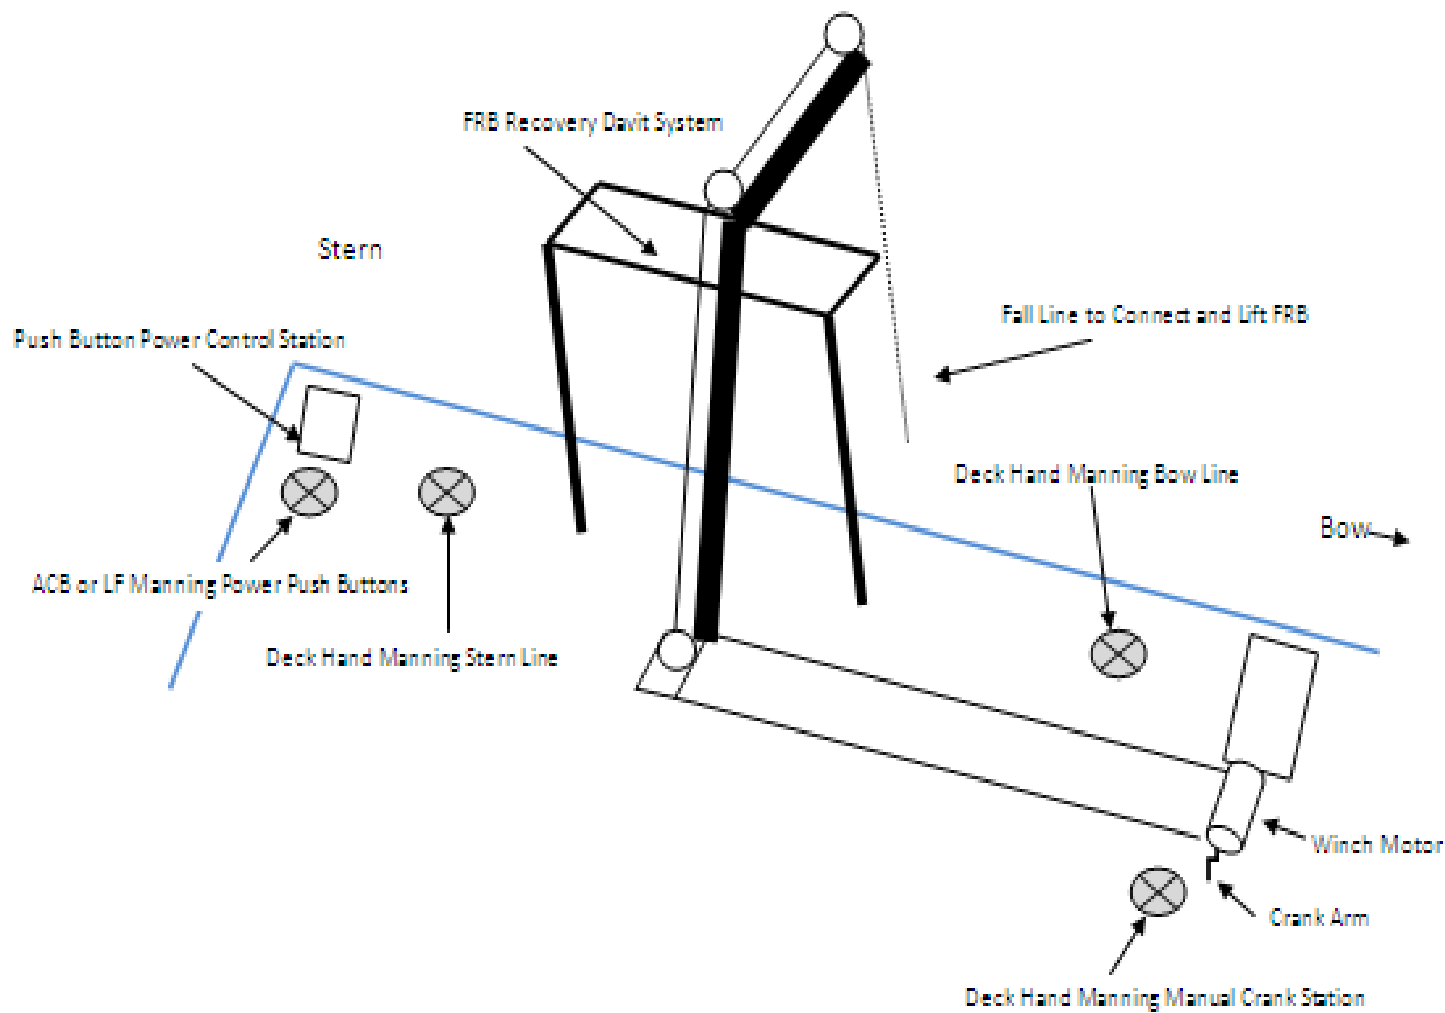
Figure 1. Sketch showing approximate positioning of crew involved in recovery of the FRB

The Fast Rescue Boat (FRB) returned to ship side after launching to conduct a man overboard drill as part of the Fleet Inspection process. A crew of four assembled to recover the FRB – the Acting Chief Bosun (ACB) manned the power control station, an AB Deck Hand manned the Bow Line, another AB Deck Hand manned the stern line, and the injured employee manned the manual winch crank station (see **Figure 1** for a sketch indicating the position of the crew and **Figure 2** for a photo showing the locations).

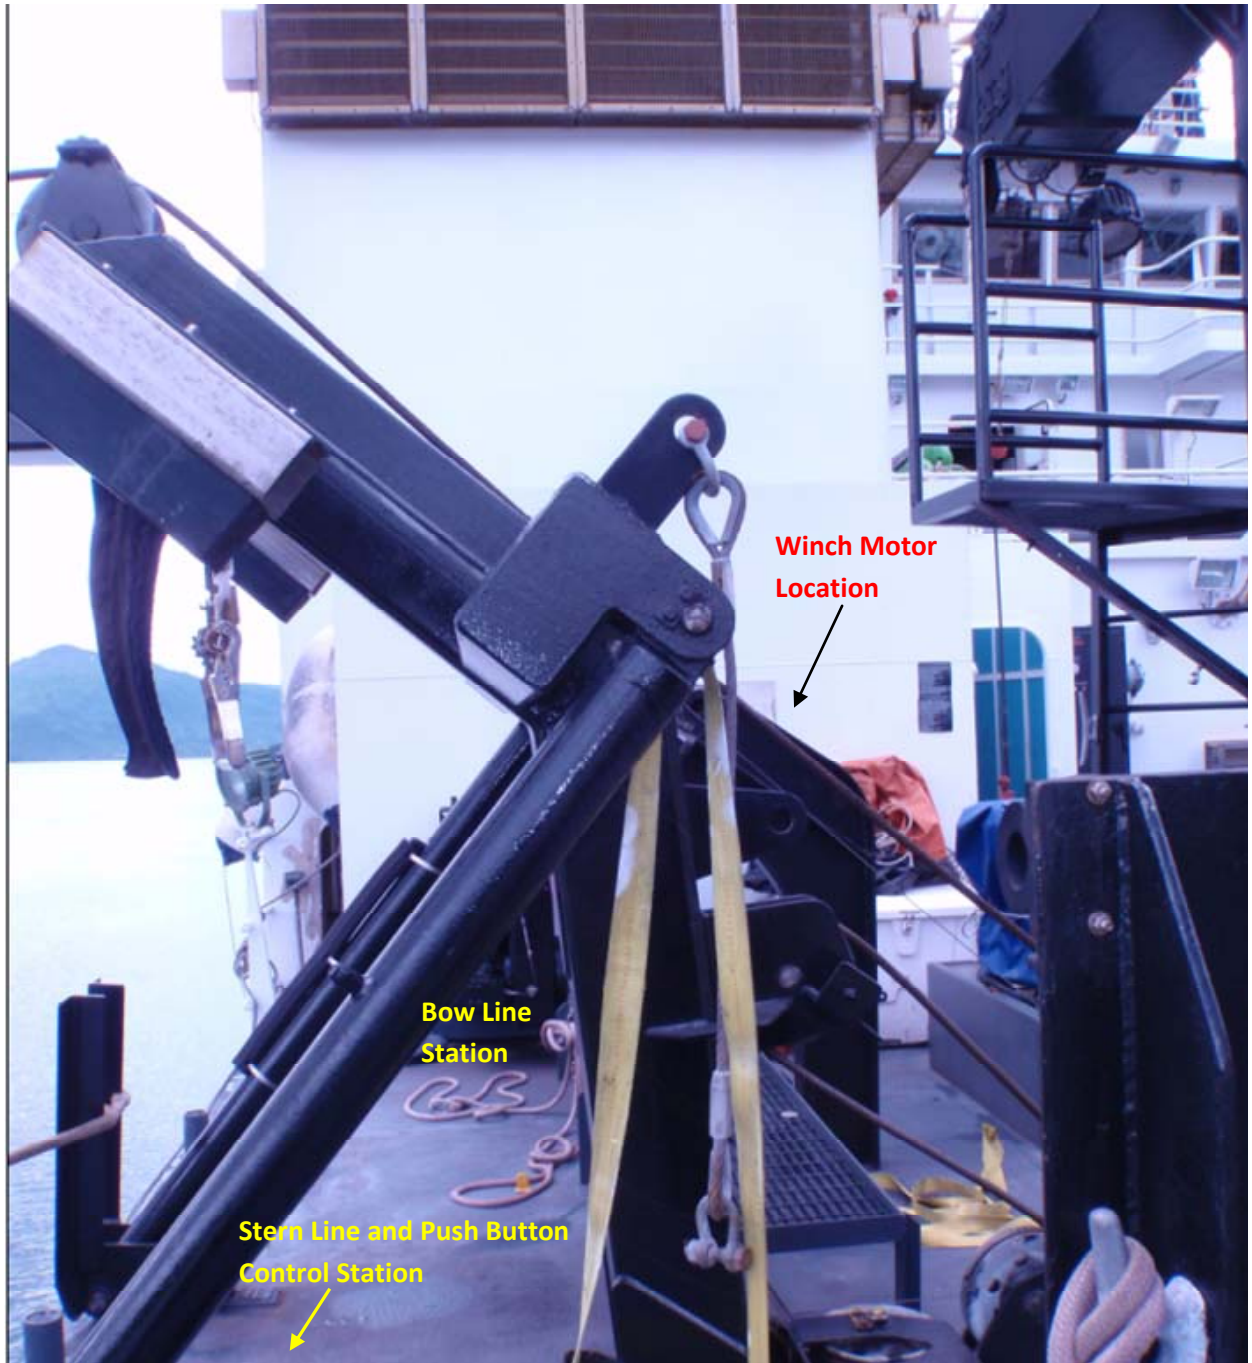
Figure 2. View of Davit System looking from the push button power control station toward the winch motor.

- 6.5.** All members of the crew manning the positions for recovery of the FRB were experienced in launch and recovery of small boats including FRBs.
- 6.6.** The person manning the power controls does not have a clear line of site to the winch motor/handle location. At the beginning of FRB recovery, the ACB observed that the manual winch handle was not inserted. It appears that the manual crank handle was inserted during the brief time when the lines were being straightened, just prior to applying power to the winch.

- 9.4. Design the adaptor sleeve/cover plate/limit switch so that it rotates only in the correct direction. **(Addresses 8.2.2.1)**
- 9.5. Move the manual crank arm location from next to the motor to the push button control station so that the power operator has control of the crank arm until the FRB has been recovered to the deck position. The person operating the manual winch crank arm will need to obtain it from the person at the controls. **(Addresses 8.2.6.1)**

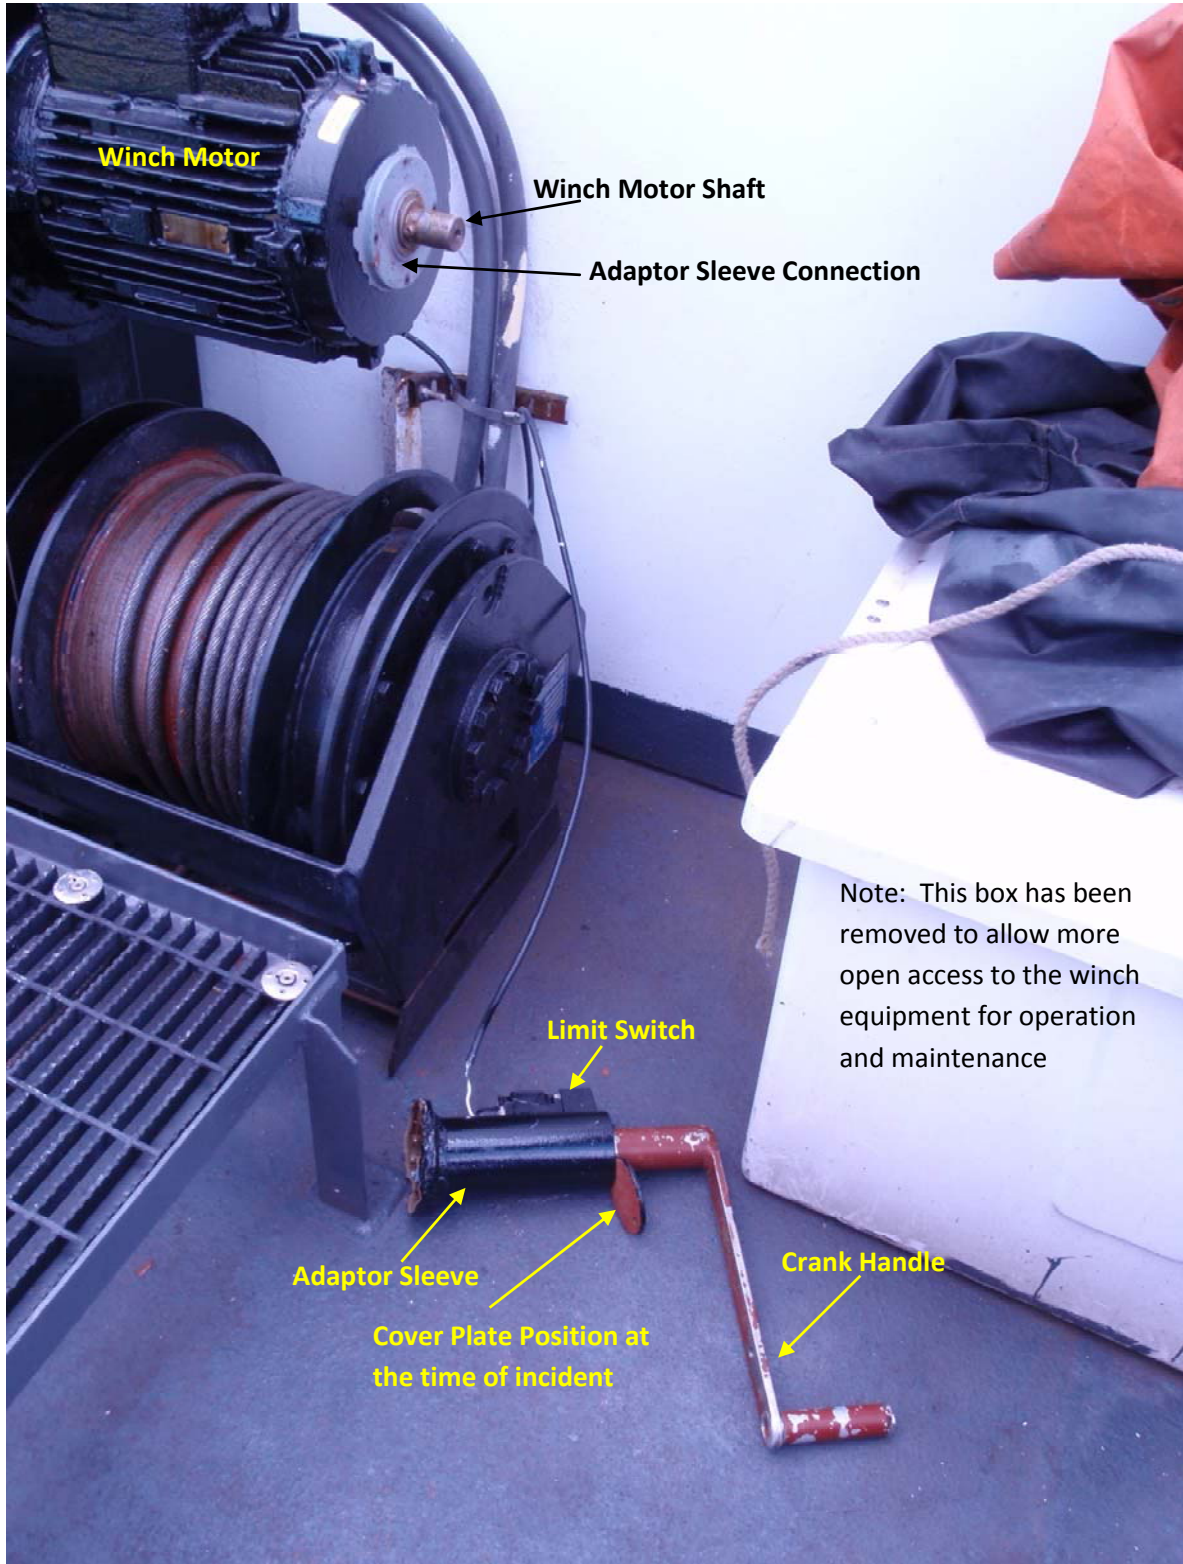
- 4.1. **Nature of Injury:** Compound fracture of upper right arm near elbow; bruised radial nerve
- 4.2. **Part of Body:** Right Arm
- 4.3. **Property/Equipment Damage:** Adaptor sleeve broken from winch motor; wiring to limit switch pulled out; winch motor shaft bent; winch motor needed to be sent to shop for rewire/repair
- 4.4. **Process Loss:** Employee transport to local hospital and air evacuated; ship could not sail until employee could be replaced, winch motor repaired, and incident investigation/corrective action completed.

Just before jogging the power to remove slack from the fall system, the ACB observed that the lines were twisted. The ACB stopped the recovery at this point and had the fall lines straightened (approximately 30 seconds). The ACB then asked again for, and received verbal feedback that the deck hands were ready for recovery of the FRB. The ACB proceeded to jog the power to remove slack prior and ensure that all lines were secure. Immediately after applying power, there was a loud “bang” sound. The injured employee moved toward the ACB position with obvious arm injuries having been struck by the manual crank arm that rotated quickly when power was applied to the winch. The impact caused the adaptor sleeve and manual crank arm to break away from the winch motor and when it struck the deck caused the loud “bang” sound heard by all in the vicinity. (See **Figure 3** for position of manual crank arm and adaptor sleeve location immediately after the incident).

- 8.1.1.** Injured employee Inserted the manual crank arm onto winch motor prior to the FRB being recovered to the deck position and was struck by the crank arm when power was first applied to recover the FRB.

Figure 3. Photo of Winch Motor and Manual Hand Crank Assembly Immediately after Incident. (Note: Adaptor sleeve broke away from the winch motor upon impact with the injured employee).

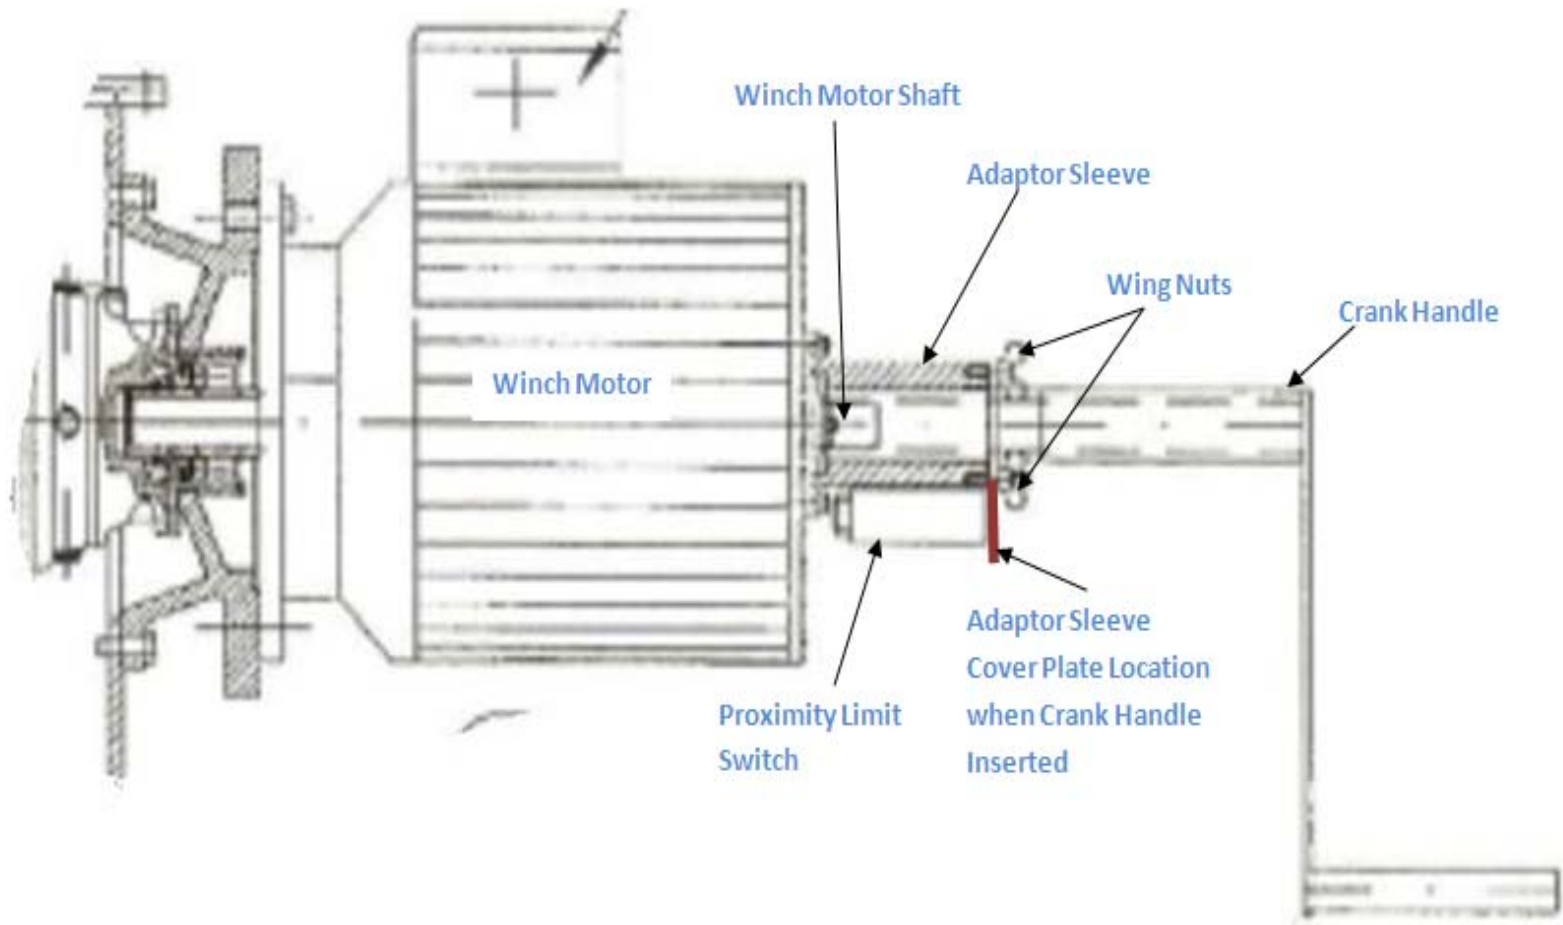
Figure 4. Side views of manual crank handle assembly and limit switch

and wing nuts. When ready to insert the manual crank handle, the cover plate is designed to be rotated downward to trigger the limit switch and kill power to the motor. (See **Figure 4** for a drawing of the winch motor showing limit switch/cover plate location and **Figure 5** for a sketch of the cover plate and limit switch configurations). For this incident, the cover plate was configured in the opposite direction where it did not activate the safety limit switch. (See **Figure 3** for a photo of the configuration immediately after the incident). The winch motor limit switch is a redundant safety control since the davit limit switch would be triggered first in normal operation when the FRB reaches position to be manually cranked into final position.

- 6.4.** After the incident and prior to removing the motor and crank arm adaptor for repairs, the limit switch on the adaptor sleeve was determined to be functional.

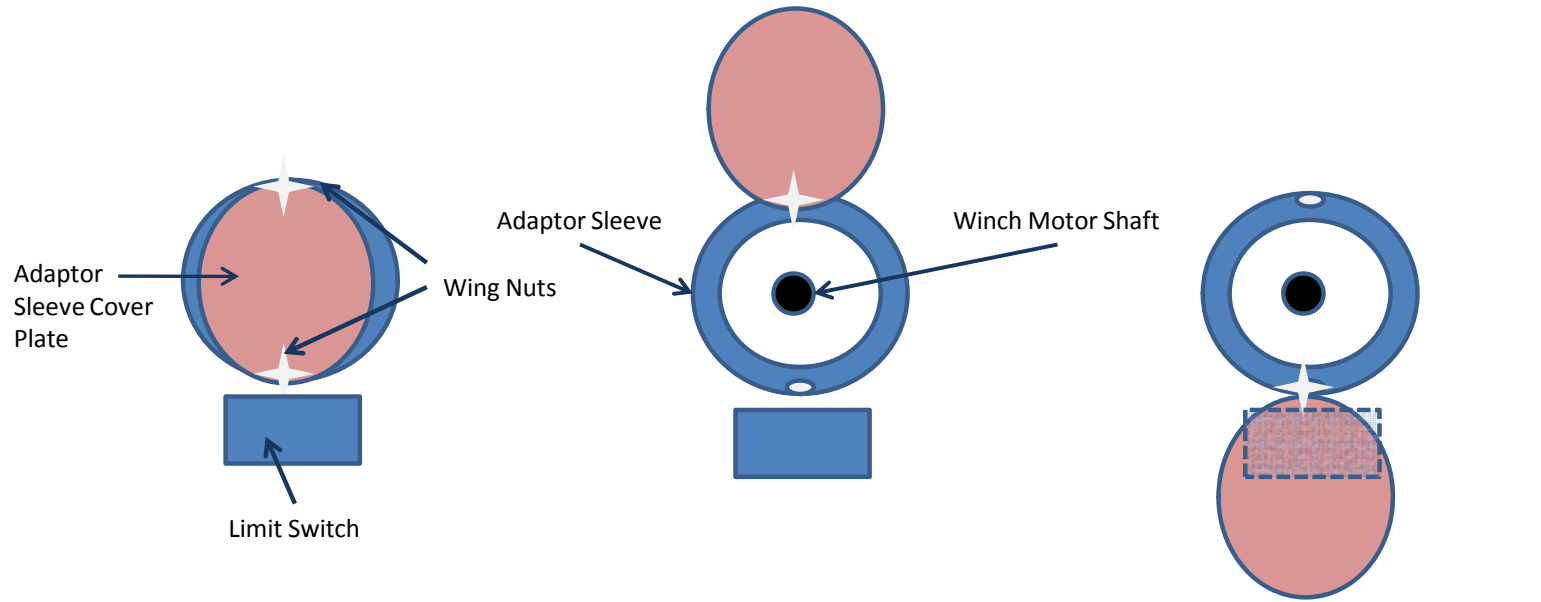
Figure 5. Sketch of Winch Motor Adaptor Sleeve Cover Plate Configurations

- 6.3.** The lower stud did not have a wing nut and was painted over indicating that the plate was normally rotated up. The design of the cover plate and securing mechanism (two wing nuts) allows rotation and securing in the wrong position and there are no visual cues on the assembly to prompt a person to align properly. (It should be noted that the adaptor sleeve/limit switch/cover plate could not be examined as part of this investigation since it had been sent with the winch motor to a shop for repair).

- 8.1.2. Injured employee did not configure the adaptor sleeve cover plate to engage the limit switch that would have ensured that power was cut to the winch motor.

- 8.2.2.1. The design of the adapter sleeve/limit switch/cover plate did not ensure that the plate is configured in the correct position.

Winch Motor Adaptor Sleeve Cover - Normal Operating Position when Using Power to Winch Unit

Winch Motor Adaptor Sleeve Cover - Rotated to Allow Insertion of the Manual Crank Arm – Wrong Position

Winch Motor Adaptor Sleeve Cover - Rotated to Allow Insertion of the Manual Crank Arm – Proper Position to Activate the Limit Switch that Kills Power to the Winch Unit

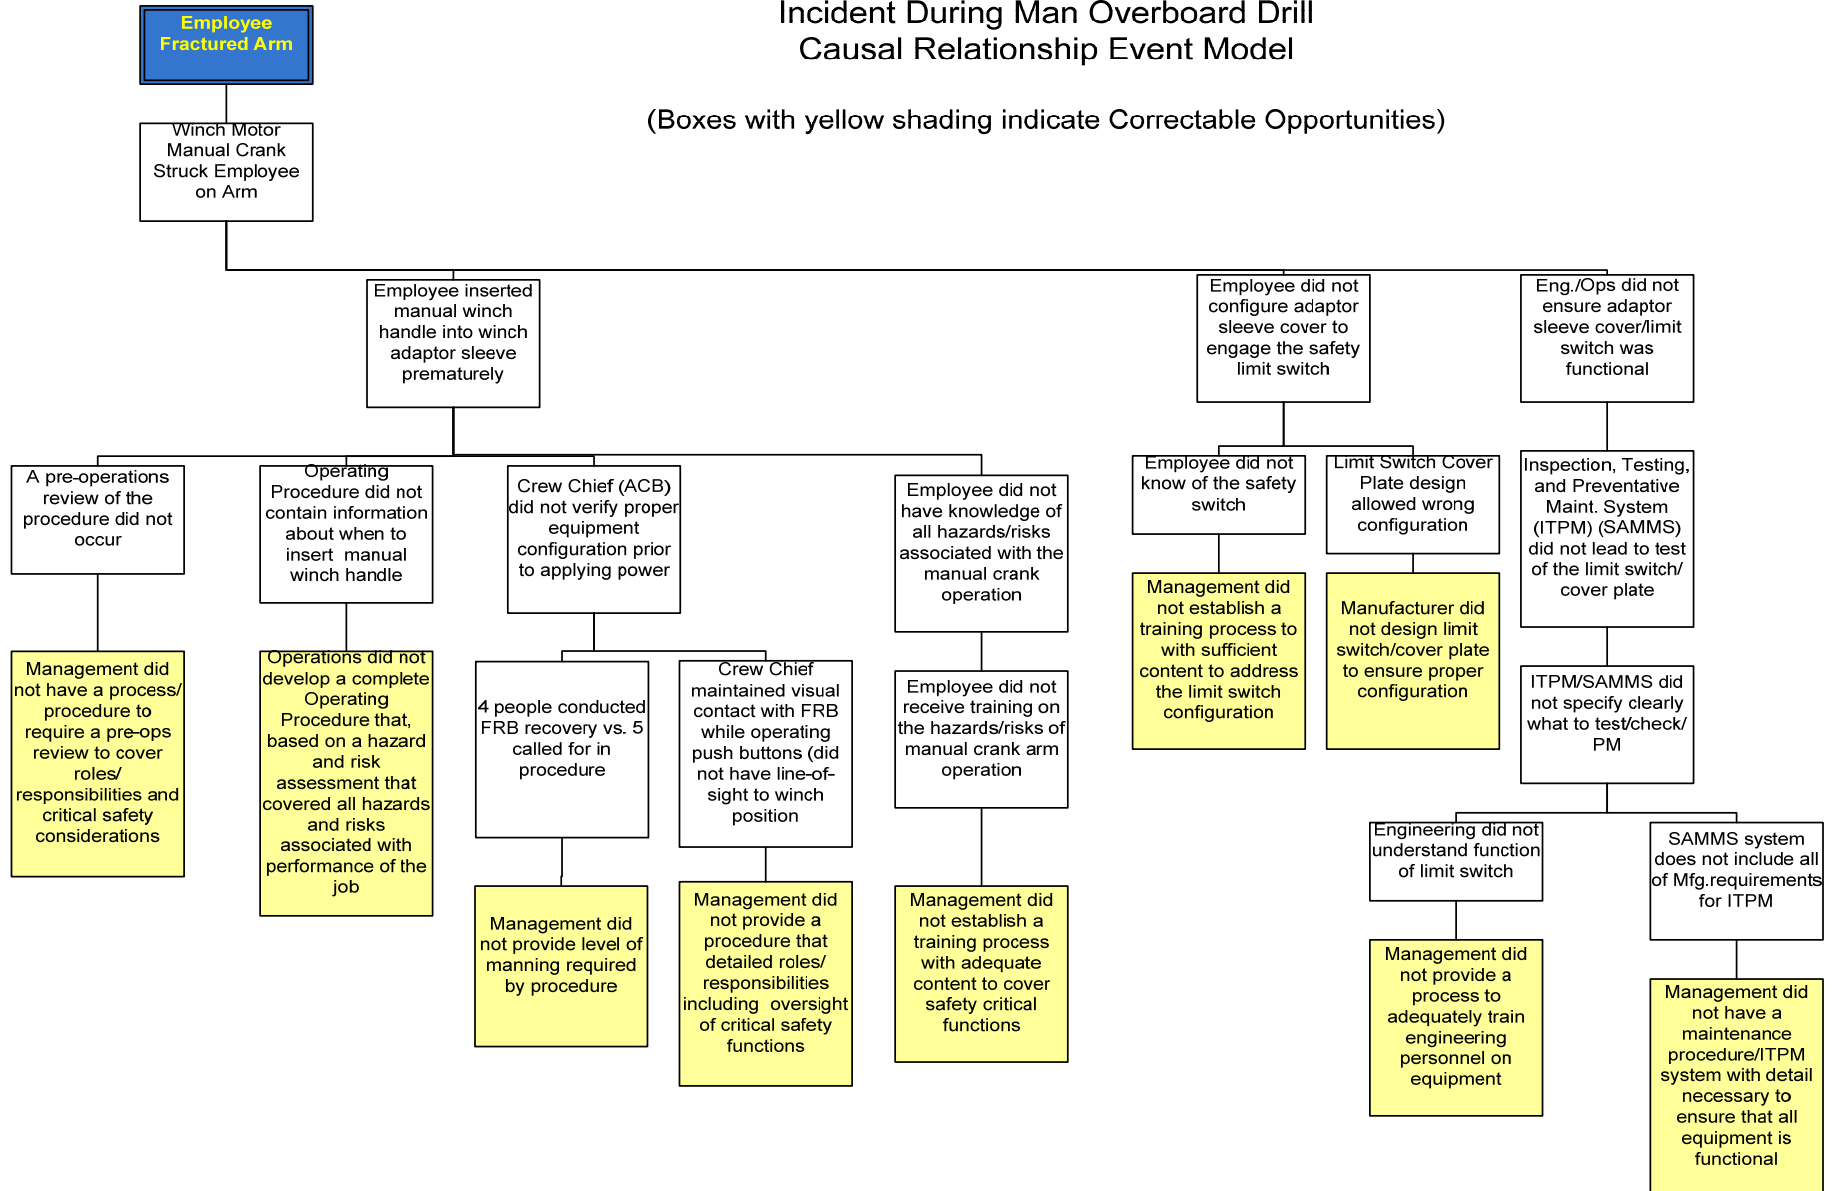
Incident During Man Overboard Drill Causal Relationship Event Model

- 7.1.** A causal relationship model was constructed to facilitate determination of basic (root) causes and identify correctable opportunities from a management system perspective. The model is presented in **Figure 6**. Immediate and basic causes are summarized below.
