# Lesson Learned

## Parted Wire Dropped a Work Boat

*The following is an edited version for distribution of a recent incident aboard a NOAA ship.*

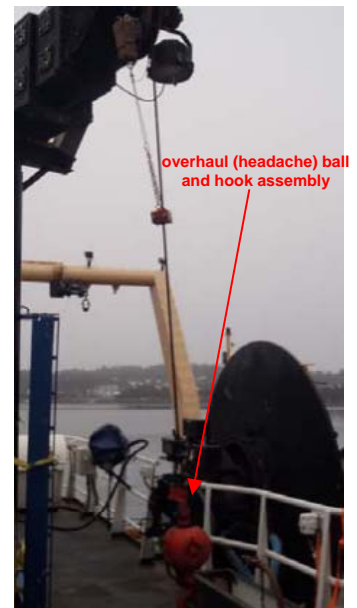
During the recovery of the ship's work boat with the crane, the crane hoisting wire parted, dropping the boat 12-14 feet while suspended over the water. The boat dropped into the water, clearing the side of the ship on the way down, with the sea painter and forward and aft frapping lines still attached. Minor damage was sustained to the boat from the impact of the crane's overhaul ball and hook assembly. (see figure 1) Personnel involved in the boat recovery operations were clear and sustained no injuries. ❖

Figure 1 – Crane and headache ball

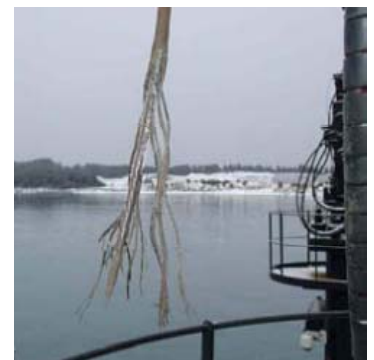
The wire rope parted, dropping the boat. (see figures 2 and 3)

Figure 2 – Parted wire

5. Post mishap inspection of the parted wire rope strands indicated an irregular fracture of the individual wires; which is caused by a combination of bending fatigue and tensile overload. (see figure 2) An abnormal bend was documented during the post mishap visual inspection of the existing wire rope on the STBD crane. This deformation occurred after the defective section of wire rope had been cut off, re-terminated and the headache ball reattached. The current deformation occurred over a one month time span. (see figure 6) Corrosion of the internal strands was documented during the inspection. Maintenance records and crew interviews indicate the parted wire rope had been greased by hand.

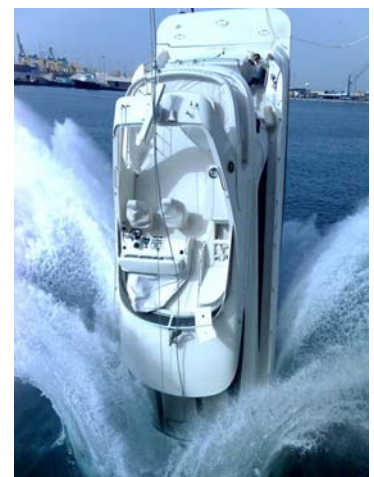
Figure 3 – NOT actual boat dropped in this case.

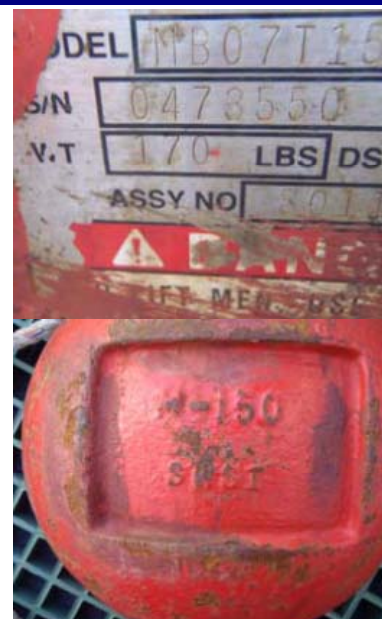
Figure 4 – Headache balls (port and starboard)

- The headache ball was changed out by past crewmembers without referring to the manufacturer's technical manual.
- The existing crane's wire rope (SWL of 6,720 lbs) installed during the winter 09/10 dry-dock period was rated well below the 8,100 lbs SWL limit posted on the crane and listed in the manufacturer's technical manual.
- Cranes, davits, winches, and associated equipment on board are no longer being maintained to industry standard (since 2008) and are not being inspected to ABS or OSHA standards by a certified inspector.
- SAMMs lacks procedures for maintenance and care of all steel wire ropes. Power slushing is a sound marine engineering practice and standard used throughout the military, marine, and construction industries to reduce corrosion of the ropes internal stranded cores and is not currently being utilized.

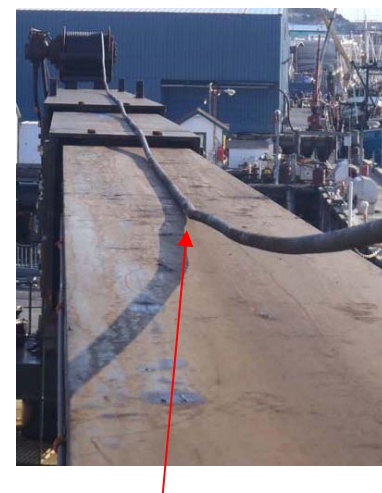
3. Crane wire ropes are secured to deck pad eyes under 2,000 lbs of tension when not in use to reduce lateral movement of the crane's boom in its cradle while at sea. This was a common deck practice not documented in ship policy. Excessive tension on the wire rope while lying in the sheaves causes the wire rope to flatten, which over time reduced the wire's tensile strength. The point at which the wire parted was at the same distance from the headache ball as where it lies on the sheaves.

Figure 6 – Note abnormal bend in wire where stored.

- Applying 2,000 lbs of tension to the crane's wire rope when made ready for sea contributed to flattening and deformation of the wire.
- Technical manuals and manufacturers recommendations were not consulted and strictly adhered to when replacing weight handling gear.
