## Fast Rescue Boat Davit Lesson Learned

# Lesson Learned

## More than Situational Awareness

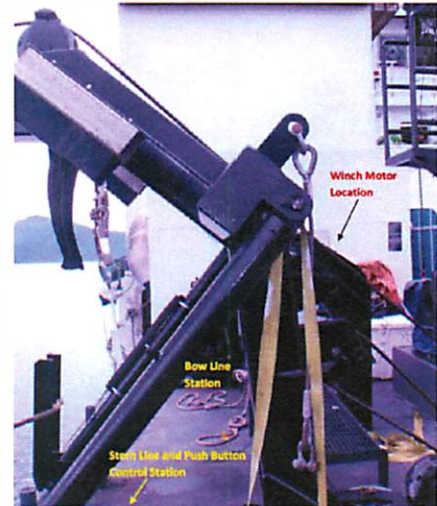
The Fast Rescue Boat (FRB) returned to ship side after launching to conduct a man overboard drill as part of the Fleet Inspection process. A crew of four assembled to recover the FRB – the Acting Chief Bosun (ACB) manned the power control station, an AB manned the Bow Line, another AB manned the stern line, and another AB manned the manual winch crank station (see Figure 1).

Figure 1 – Davit and station locations

3. The person manning the power controls does not have a clear line of site to the winch motor/handle location (Figure 1). It appears that the manual crank handle was inserted during the brief time when the lines were being straightened, just prior to applying power to the winch.

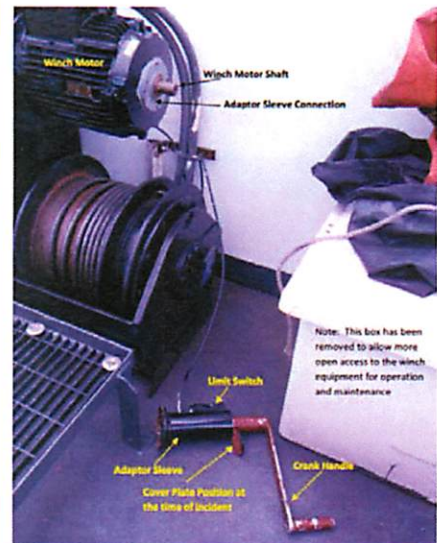
Immediately after applying power, there was a loud “bang”. The injured employee moved toward the ACB position with obvious arm injuries having been struck by the manual crank arm that rotated quickly when power was applied to the winch. The impact caused the adaptor sleeve and manual crank arm to break away from the winch motor and fall to the deck causing the loud “bang” (Figure 2). ❖

Figure 2 – Winch arm after incident
