## NOAA WORKBOAT RECOVERY INCIDENT

### BACKGROUND:

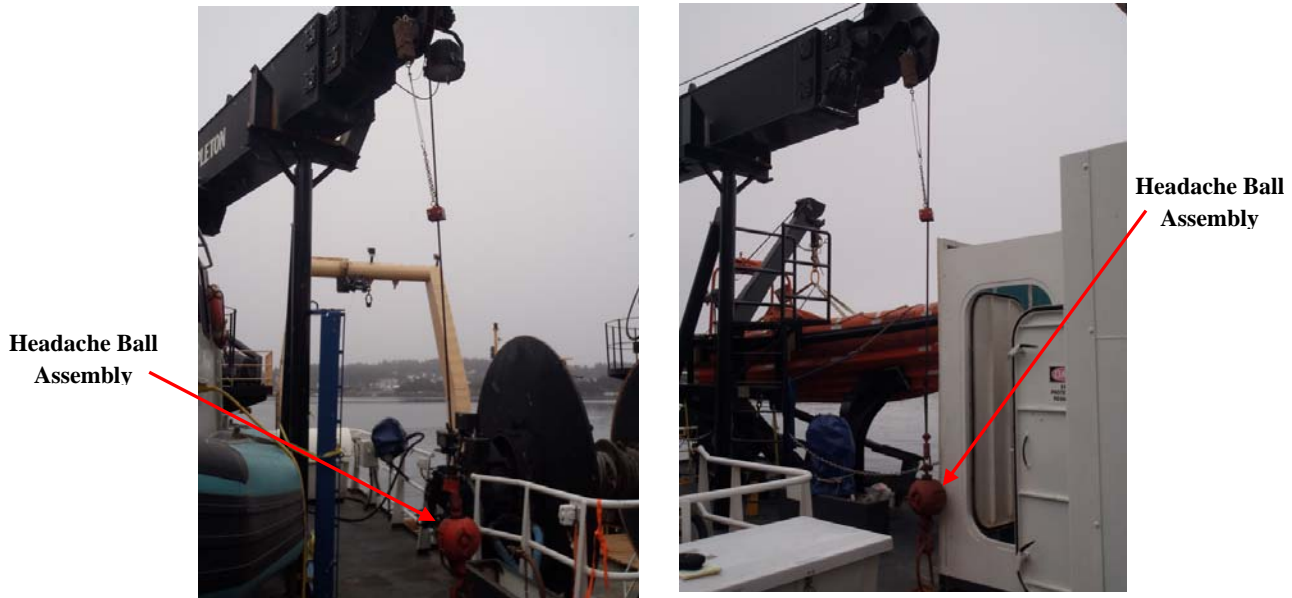
3. The crane involved in the mishap was manufactured by Appleton Marine, and is a telescoping hydraulic crane; model EB70-60-25S, located on starboard side of the 01 level deck. The vessel has an identical crane mounted on the port side (*see figure 2*). The crane involved in the incident was installed onboard the ship, January 5, 2005, during initial ship construction and was certified by American Bureau of Shipping. Certified Safe Working Load (SWL) is 8100lbs for a radius of 25'-42' and 5000lbs at 60' extended with 0 degree boom angle. The installed wire rope at the time of the mishap was a 5/8" diameter steel stranded core. The overhaul ball (headache ball) and hook assembly were stamped with a weight of 150lbs (*see figure 3*). The crane is equipped with an Allen Bradley panel view 300 loading cell and alarm panel system. The loading alarm panel has 4 weight limiting modes of operation; "Dockside Static (8100lbs)," "At Sea on Vessel 2.5m waves (8100lbs)," "At Sea off Vessel 2.5m waves (5000lbs)," and "At Sea on Vessel 4.0m waves (5000lbs)." The launching and recovery of the boat is restricted to protected water only, and only when panel *mode is in* "Dockside Static" or "At Sea on Vessel 2.5m wave" modes as per the ship's written operational procedures. The loading alarm panel was calibrated in FY-2009 dry-dock. The last load test was conducted by the ship's crew on Jan. 5, 2012. The last documented maintenance was on Feb. 27, 2012 and included a visual inspection and greasing of the wire rope performed by ship's personnel. Weight verification was conducted approximately a week after the incident utilizing a calibrated load cell used for scientific research and the loading alarm panel was found to be displaying the applied weight accurately within 3%.

Figure 2. Left photo – Starboard Crane; right photo – Port Crane

5. Recommend eliminating the 3-5" of movement occurring between the boom and its associated cradle, thereby decreasing the additional tension on the wire when the crane is made ready for sea.

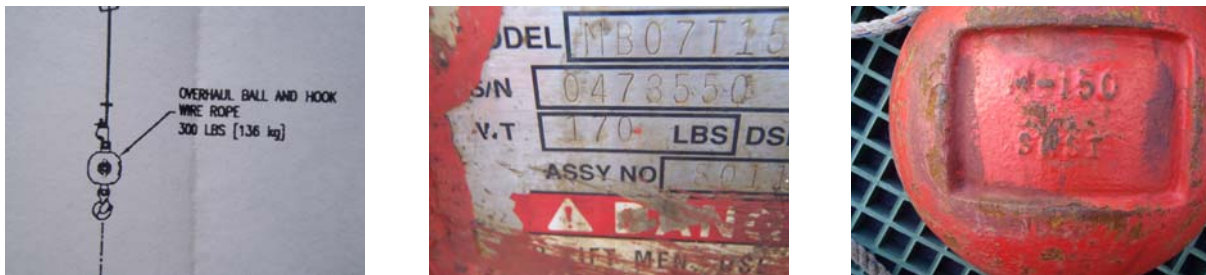
1. Appleton Marine crane manual EB70-60-25S drawing, BWD-502, indicates both cranes were engineered and designed with a 300 lbs overhaul ball (headache ball) and hook assembly. Port crane has 170 lbs headache ball assembly and starboard cranes assembly is 150 lbs. (see Figure 3). The headache ball and hook assembly does not have enough weight to maintain constant tension with no load attached to crane, which allows slack in the rope throughout its travel. Crew reports that the wire rope has repeatedly jumped off the boom head sheave and become caught between the sheave and sheave block. (see figure 4) Crew also reported the wire, when being payed in, does not always lie properly on the winch drum and tends to rat nest or cross lay.

Figure 3. Overhaul (headache) ball weights  
(left - crane manual diagram; center - port crane; right - starboard crane)

1. The headache ball (see figure 3) is under rated for the application and was changed out by past crewmembers without referring to the Appleton Marine technical manual EB70-60-25S drawing, BWD-502. Appleton Marine designed and engineered the crane as a package to utilize the 300 lbs vice 150 lbs headache ball and hook assembly. As a result of the lighter headache ball, constant tension is not being applied to the wire rope when paying in and out. Constant tension must be applied to the wire rope to reduce the chance of repeated slacking of wraps on the winch drum and wedging between the sheave and sheave block, which ultimately resulted in bending, twisting, and deformation of an already under rated wire rope.

1. Remove and install correctly weighted headache ball and hook assembly on both cranes in accordance with the manufacturer's technical manual.
2. Conduct a NOAA fleet wide verification of current crane configuration; including the correct headache ball assembly and wire ropes for their specific lifting apparatuses in accordance with the manufacturer.

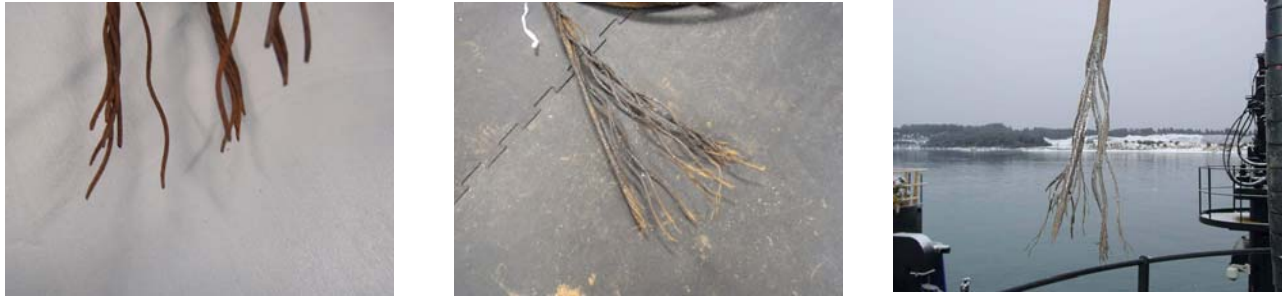
6. Post MISHAP inspection of the parted wire rope strands indicated an irregular fracture of the individual wires; which is caused by a combination of bending fatigue and tensile overload. (*see figure 5*) Corrosion of the internal strands was documented during the inspection. (*see figure 5*) Maintenance records and crew interviews indicate the parted wire rope on the ship had been greased by hand.

**Figure 5. Close up of parted wire rope**  
*left - internal strands; center - whole wire photographed during investigation; right - whole wire photographed immediately following incident*

5. The corrosion noted in the wire rope inner strands in conjunction with the deformation of the wire noted in conclusion #1, #3, and #4, severely decreased the tensile strength of the wire causing it to part when a load was applied.

6. Review current procedures for maintenance and care of all steel wire ropes, and consider power slushing to reduce corrosion of the ropes internal stranded cores where that practice is not currently being utilized. Power slushing is a sound marine engineering practice and is the common standard used throughout the military, marine, and construction industries.

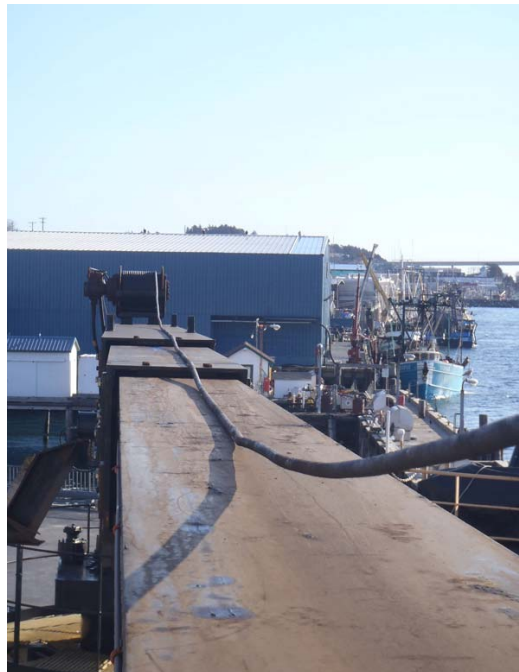
7. An abnormal bend was documented during the post MISHAP visual inspection of the existing wire rope on the STBD crane. This deformation occurred *after* the defective section of wire rope had been cut off, re-terminated and the headache ball reattached. The ship used the crane to re-secure the boat on deck for transit and secured the crane for sea. The current deformation occurred over a one month time span. (*see Figure 6*)

**Figure 6. Deformed existing wire rope on Starboard crane**

3. Applying 2,000 lbs of tension to the cranes wire rope when made ready for sea contributed to flattening and deformation of the wire. (Reinforced by finding #7 above)

4. The excessive movement created by improperly securing the crane in the cradle added excessive strain to the wire far beyond the 2000 lb tension applied when the crane is attached to the deck. The lack of lateral support on the cradle structure added to this excessive tension. (Reinforced by finding #7 above)

4. Recommend the ship crew reduce the amount of tension applied to the wire rope when attached to the deck and made ready for sea. The wire should be visually taut without any slack when attached to the deck pad eye to ensure the proper amount of tension.
