Better Contract Oversight Could Have Prevented  
Deficiencies in the Detention Facility in  
Parwan, Afghanistan

SUBJECT: Better Contract Oversight Could Have Prevented Deficiencies in the Detention Facility in Parwan, Afghanistan (Report No. DODIG-2012-089)

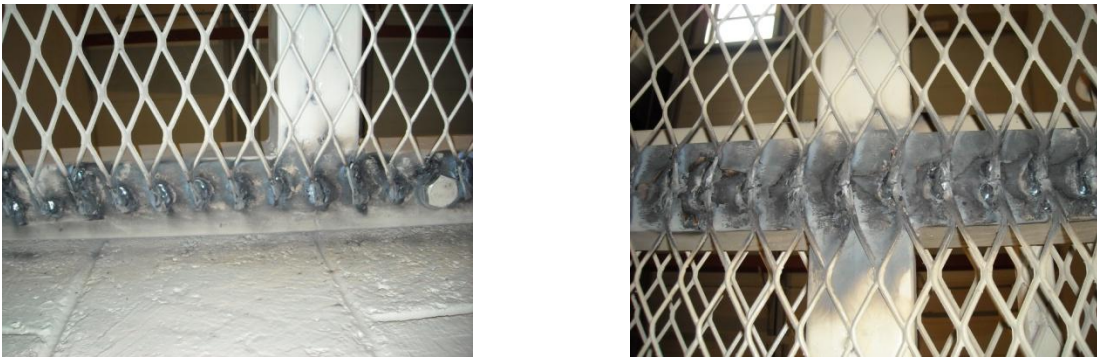
**Figure 3. Re-Welded Cell Doors**

According to the Task Force Rocky Mountain presentation, the quality of welding required the facility engineers to do extensive rework. Figure 3 shows the rework that DoD OIG engineers inspected in July 2010.

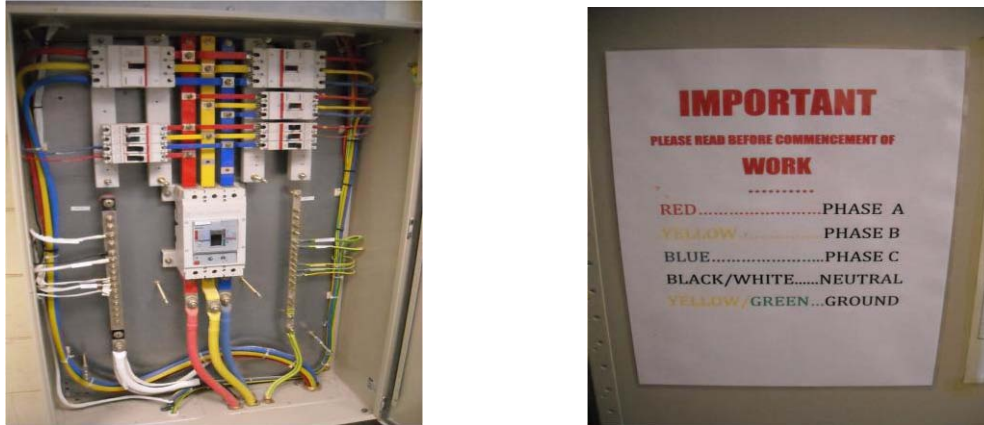
**Figure 7. The Electrical System Panel (left) and Explanation of the System (right)**

Personnel who had experience with the British Standard installed the British Standard electrical system during construction, and posted the explanation of the British Standard inside the electrical panels (see figure 7 [right]).

Contractors, once U.S. personnel started operating the facility, made changes to the British Standard wiring convention so that it conforms as close as possible to the American Standard. According to DoD OIG and USACE TAN engineers, an experienced electrician should know the difference between the two standards before performing maintenance. However, our engineers concluded that personnel who work with or around the electrical equipment at the DFIP were not safeguarded from electrical safety hazards.

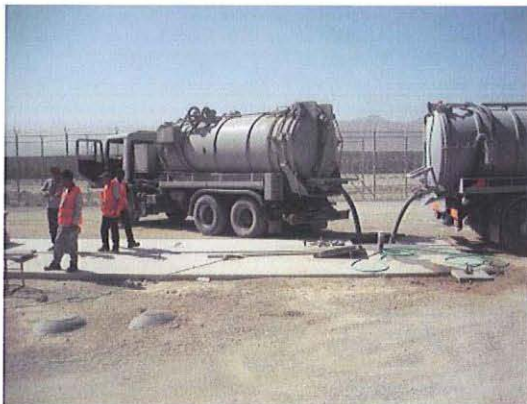
To prevent the two sewage lift stations from overflowing, Fluor must bring four sewage removal trucks (see Figure 4) a day into the compound. Because the DFIP is a secure location, every time the trucks have to enter the facility the risk of a security incident increases.

**Figure 4. Contractor trucks removing sewage from DFIP lift stations.**

To maintain the health and security of the individuals working and housed at the DFIP, USACE AED-N should require the contractor to immediately repair the lift stations in accordance with the warranty provisions in the contract and ensure the lift stations meet the requirements set forth in the contract.
