U.S. Election Assistance Commission

Formal Investigation Report

Election Systems and Software Unity 3.2.0.0

December 20, 2011

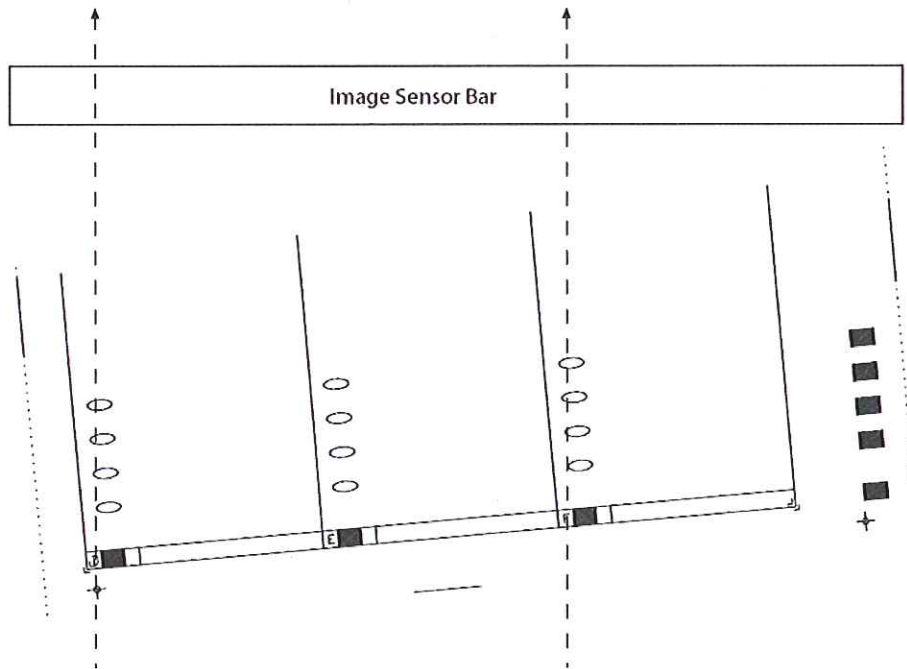
The following drawing is a slightly exaggerated illustration of skew. Skew can occur, when, for a variety of reasons, the ballot travels past the contact image sensor at an angle. This condition produces a data image with varying distances of the voter mark positions from the edges. Version 1.3.8.0 and 1.3.10.0 DS200 firmware compensates for the varying distances. However, on longer ballot stock (17" and 19") at the locations where the skew is most pronounced, it is possible for the firmware to mistake a small portion of the text next to an oval as part of the oval area itself. This can result in the firmware interpreting an unmarked oval as a mark.

To completely avoid the problem, it is critical that users do not place any text or graphics closer than 0.20 inches from the edge of the oval and not allow it to extend more the 1.44 inches from that "no print zone" as shown. Contest titles and referenda can still use the full column width.

ES&S has modified the DS200's firmware to correct this issue in version 1.3.11.0 and will submit the updated firmware for EAC federal certification testing in October 2009.

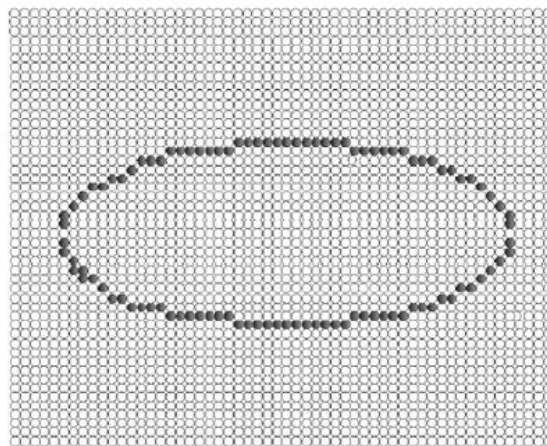
Figure 1 - Mark Evaluation Cell Window

The DS200 is a digital scanner that utilizes bitonal imaging technology. It scans at a rate of 200 pixels per inch with a dpi of 200 (200 x 200) using an ES&S patented intelligent mark recognition algorithm. The scanner utilizes contact image sensor technology to create a digitized pixilated image of the ballot. Using the ballot channel markings (column, code channel and timing channel marks) the orientation of the ballot images is first determined. The DS200 then determines vote mark evaluation areas (cell areas or windows) at the intersections of each of the 6 column channels (three on each side of the ballot) and timing marks based on ballot layout definition data. Figure 1 represents a pixilated view of a mark evaluation cell window typical when an unmarked oval is scanned. This entire rectangular area is used and evaluated by the DS200 in the mark analysis.

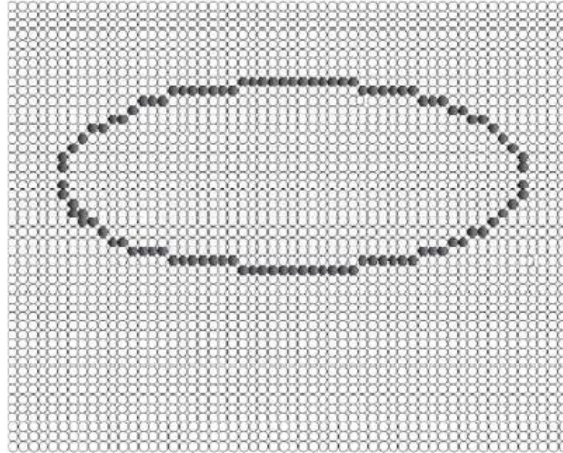
Figure 2 – Mark Evaluation Cell Window with Oval Shifting

Because of these variables the oval evaluation cell window may not always be centered fully on or around the oval, and could be shifted left, right, up or down as much as 10 pixels off of center, especially in the vertical dimension or y-axis. Therefore, the evaluation cell window is designed to be sufficiently larger than the oval to ensure a valid mark within the oval area will be consistently detected even with maximum shift. Figure 2 illustrates an evaluation cell window where the oval appears shifted off of center, slightly toward the upper region of the cell window.
