**Boom Hoist Wire Rope Line Failure Results in Fatality  
High Island Area Block A557, Platform “A”  
OCS-G 03484  
16 August 2011**

**U.S. Department of the Interior  
Bureau of Safety and Environmental Enforcement  
Gulf of Mexico OCS Regional Office**

**New Orleans  
January 2013**

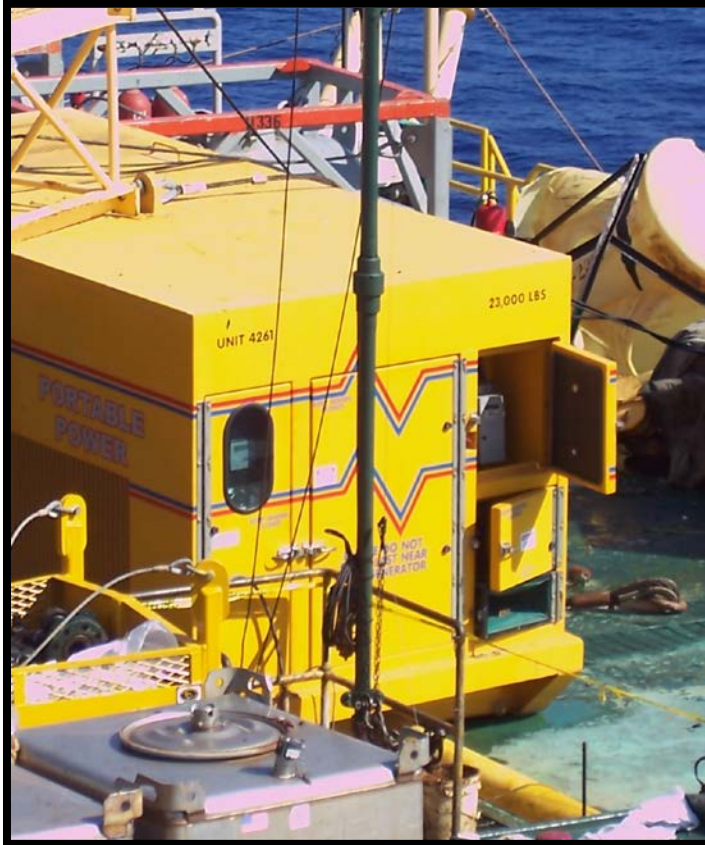
From observations, the lubricator (*see figure 11*) would not be able to withstand contact from the load without risk of damage. Any such contact would risk toppling and subsequent damage to the well head, Platform equipment, and personnel. No statements or documents indicated a reason

**Figure 11: Proximity of lubricator to lift**

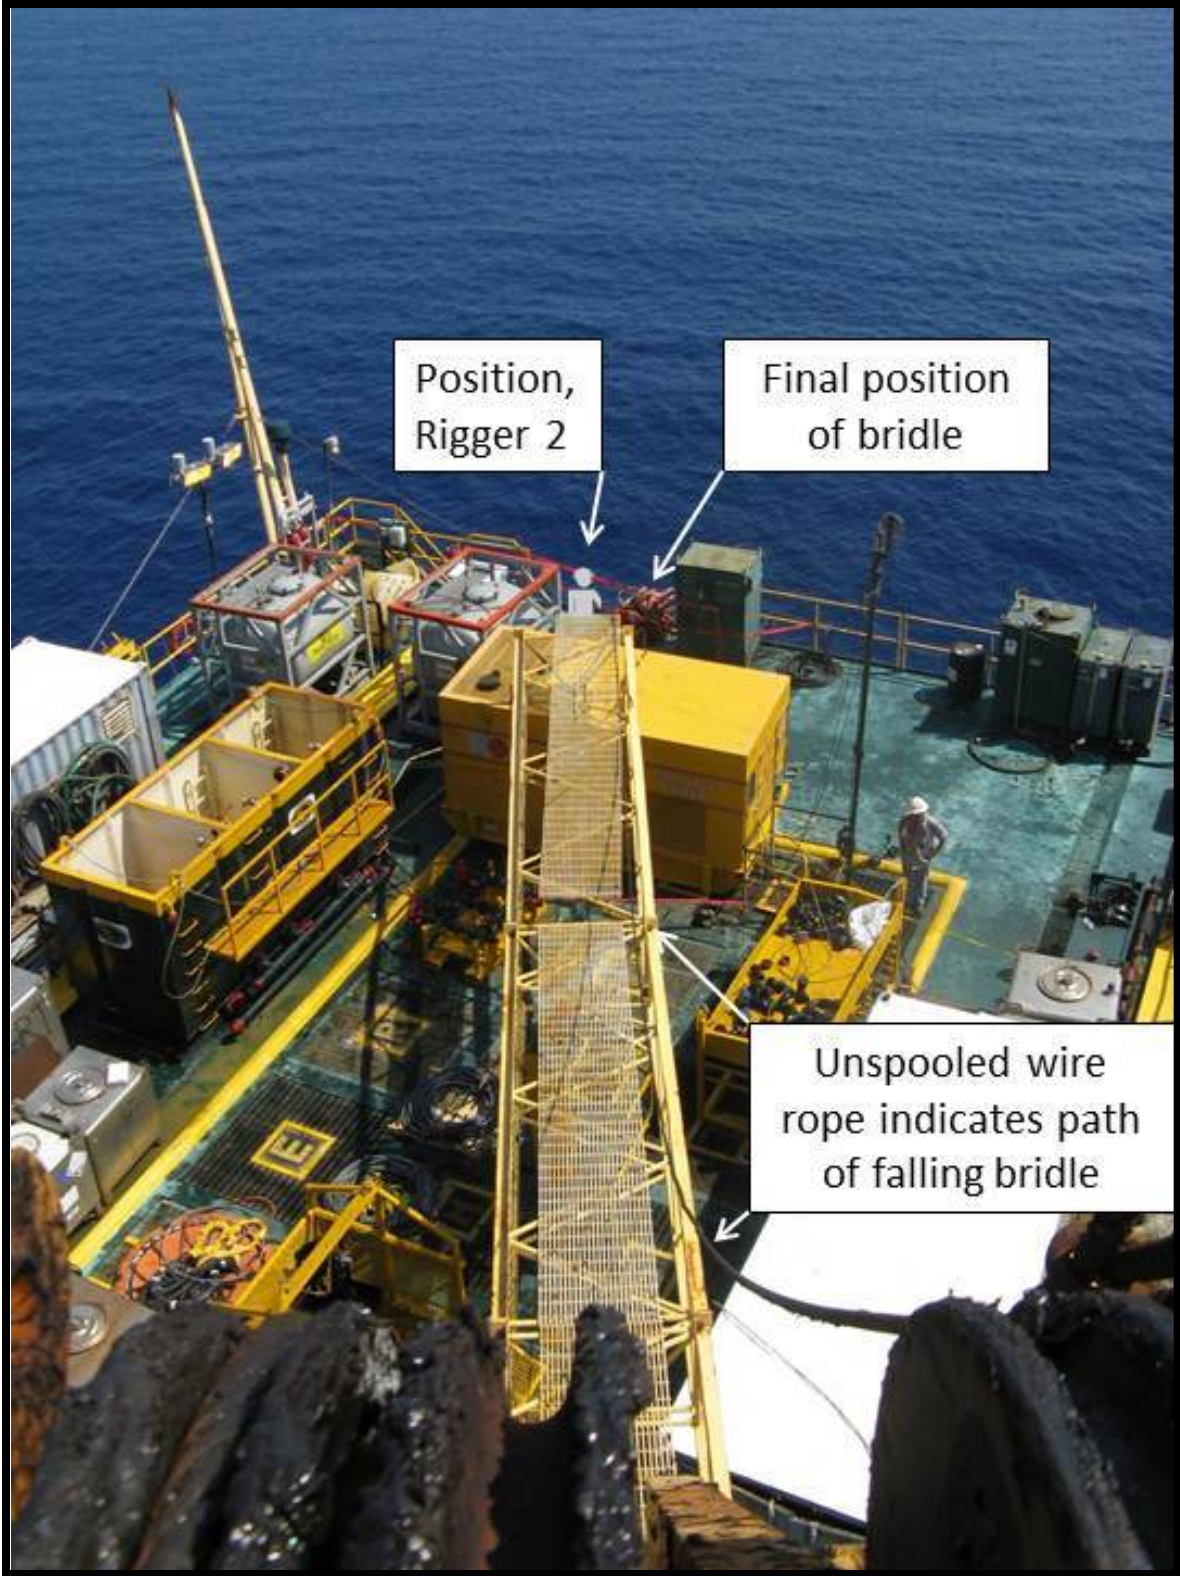
**Figure 19 - Boom location after failure, and bridle/sheave path**

Figure 19 shows the positioning of Rigger 2 in line with the fall path of boom and the track of the falling bridle. Figure 20 illustrates the approximate location of the failure of the boom hoist wire rope. It also identifies the sectioning of the boom upon impact with the generator and the path followed by the falling bridle.

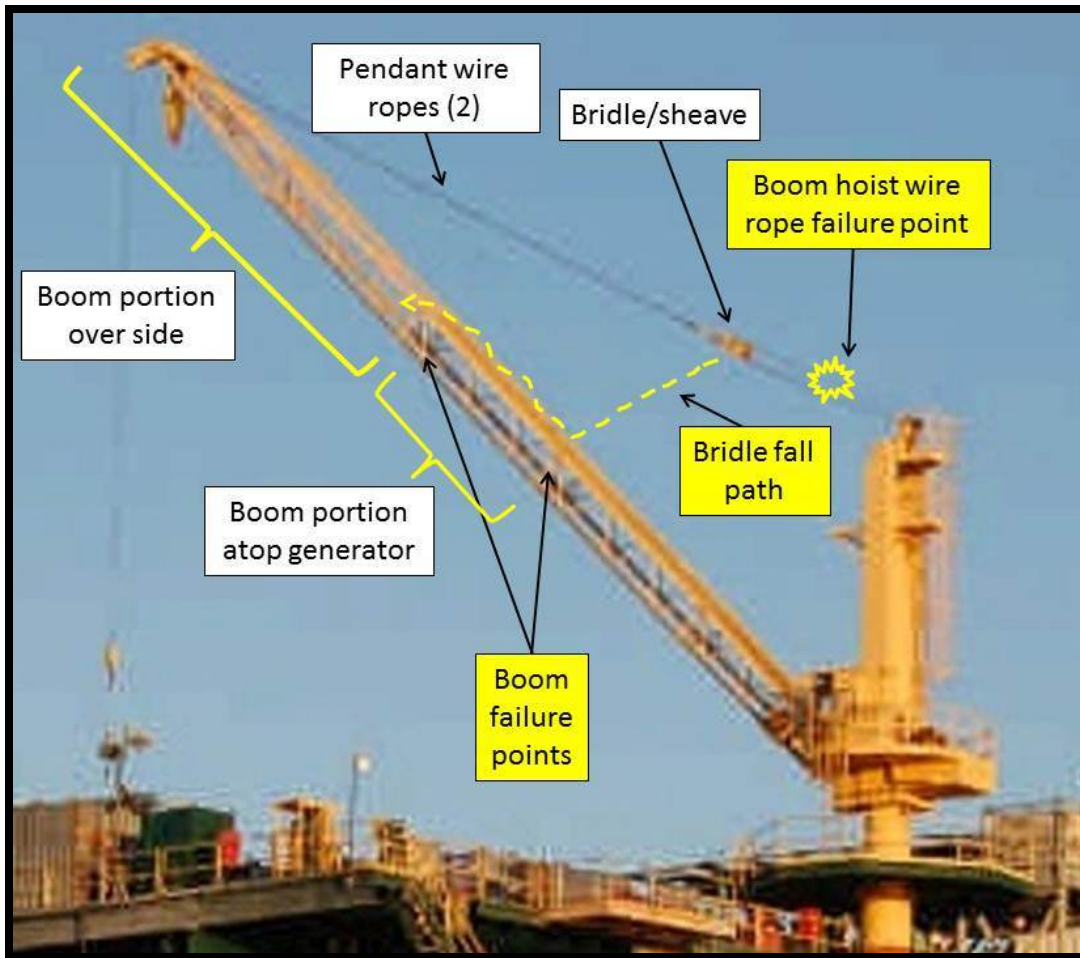
**Figure 20 - Crane and failure points**

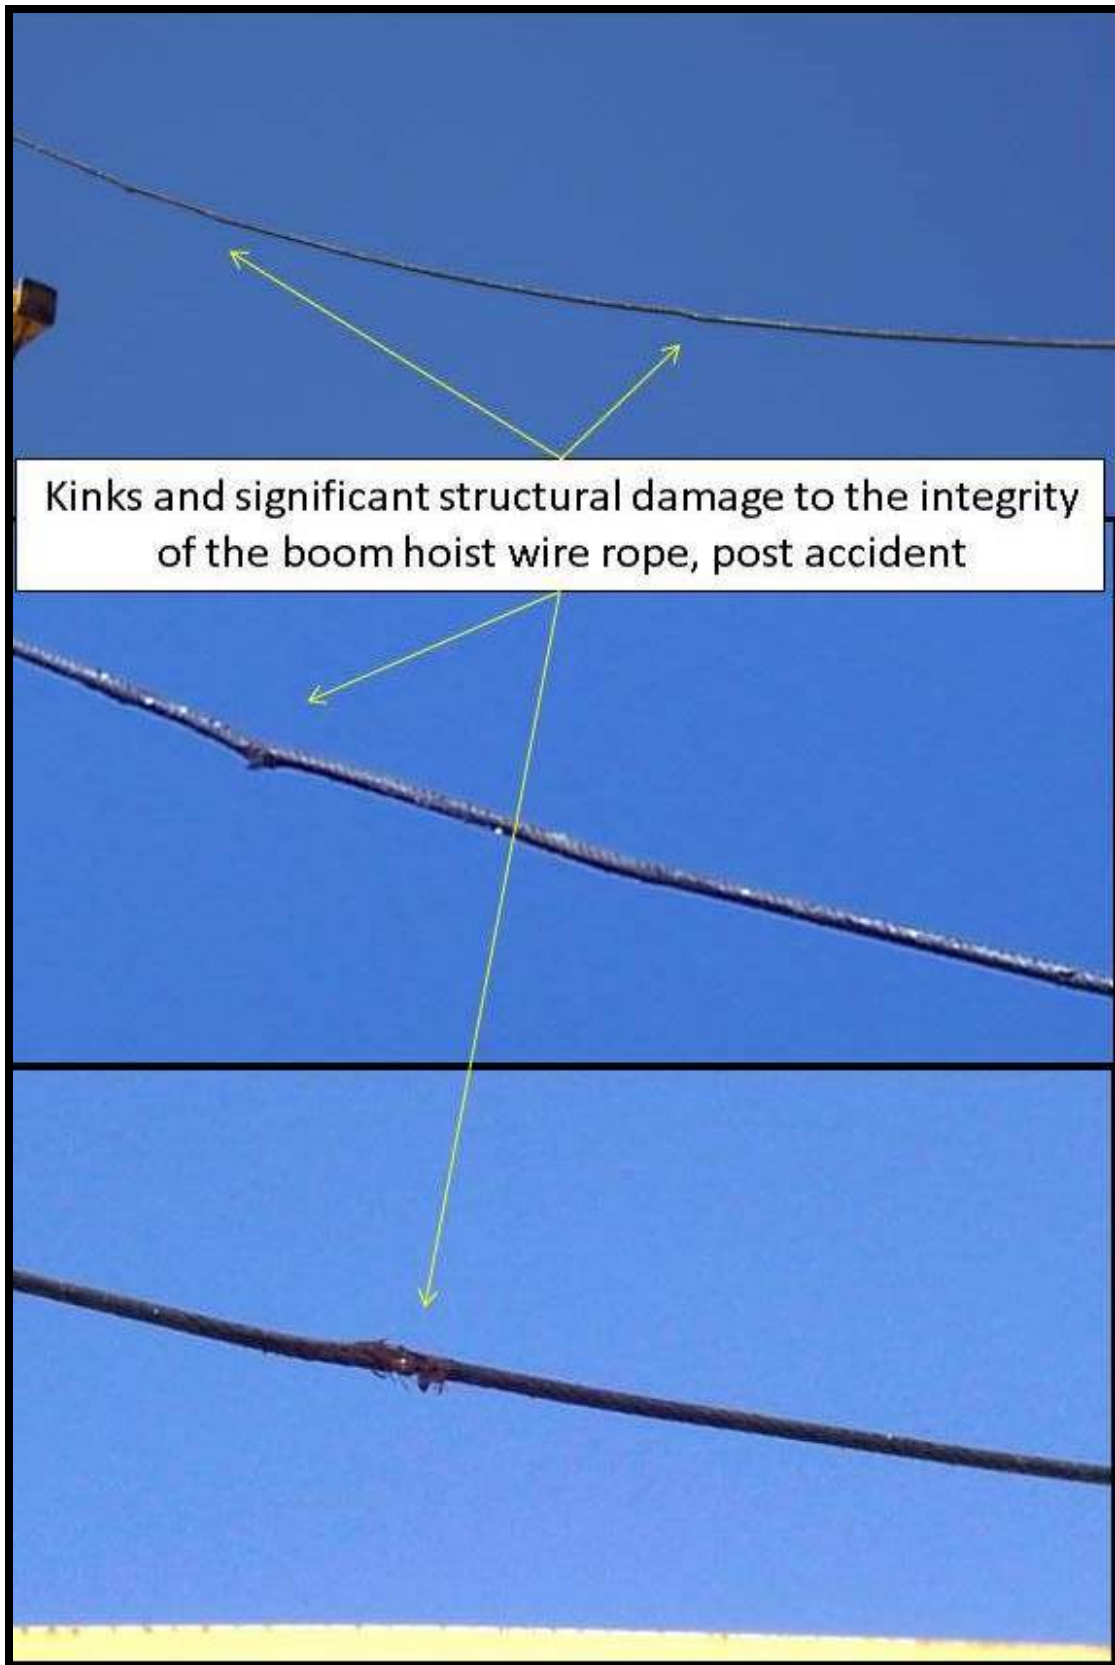
The Inspector stated that he examined the wire rope ends at the break point and there appeared to be evidence of corrosion on the inside of the boom hoist wire rope. The Inspector took photographs of the Platform, accident site, Crane, and wire ropes to supplement photographic documentation later made available from other sources. Selected photographs from various sources are shown in *figures 21-25* to illustrate the condition of the boom hoist wire rope after the accident.

**Figure 21 – Middle section of boom hoist wire rope, post-accident**

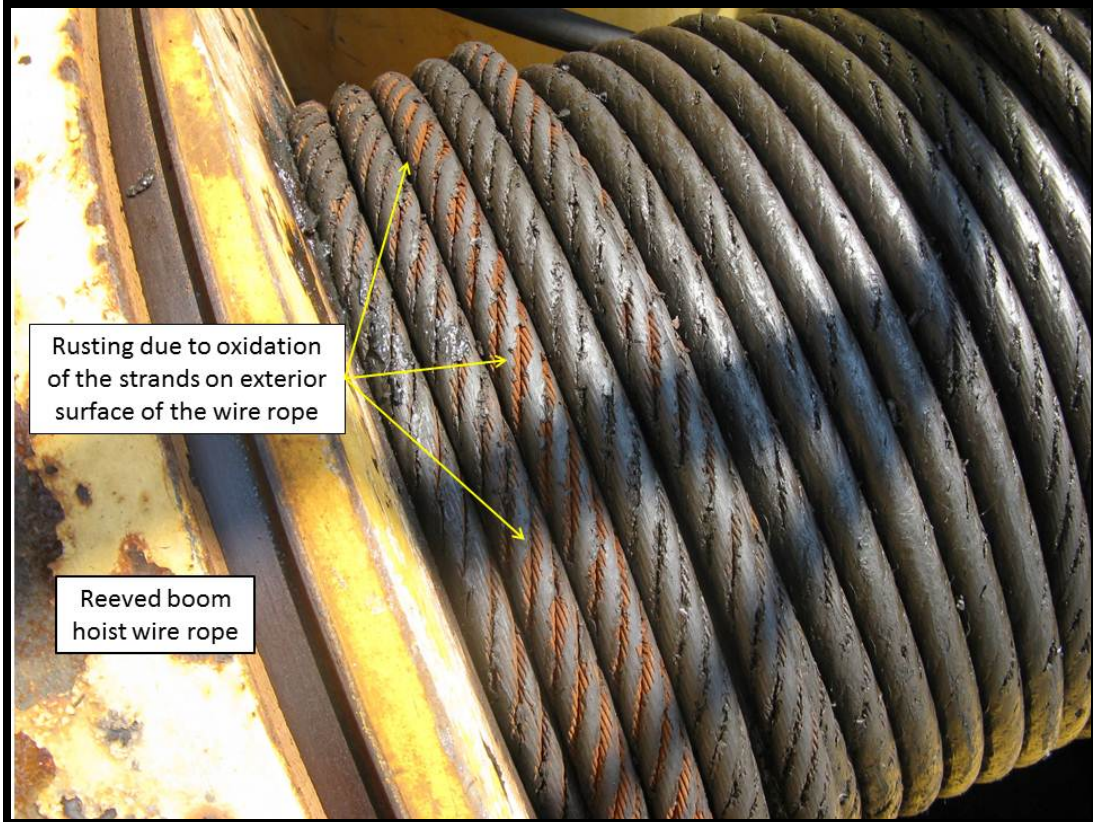
Rusting due to oxidation of the strands on exterior surface of the wire rope

**Figure 22 – Reeved drum of boom hoist wire rope, evidence of external strand corrosion**

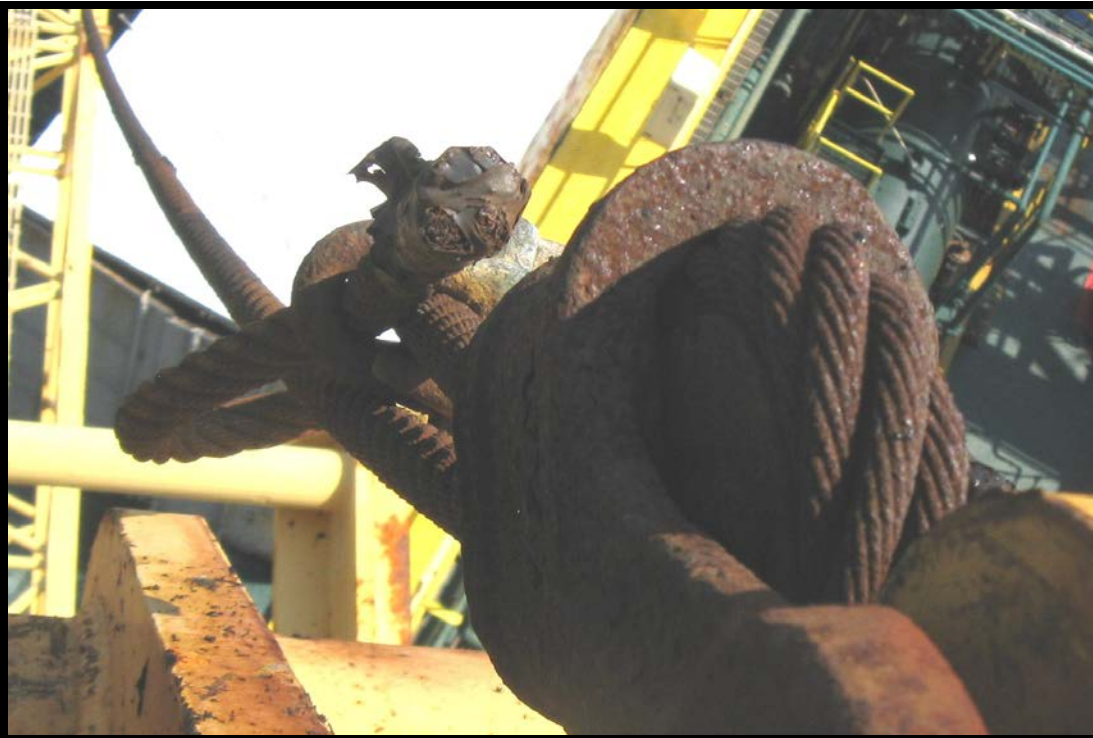
**Figure 23 – Corroded boom hoist wire rope, wedge socket, pinned to gantry dead end connection**

*"...the end of the boom hoist wire rope with the wedge socket and attached to the bale/yoke is severely corroded and lacks evidence of any remaining lubrication..."*

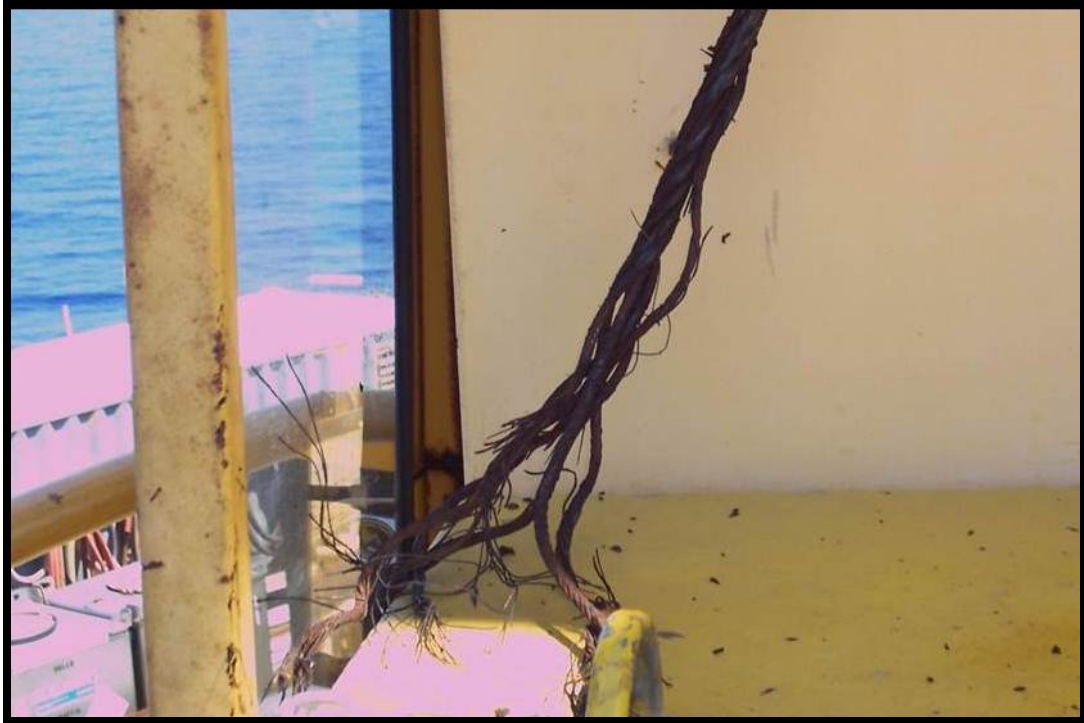
**Figure 24 – End section of failed boom hoist wire rope**

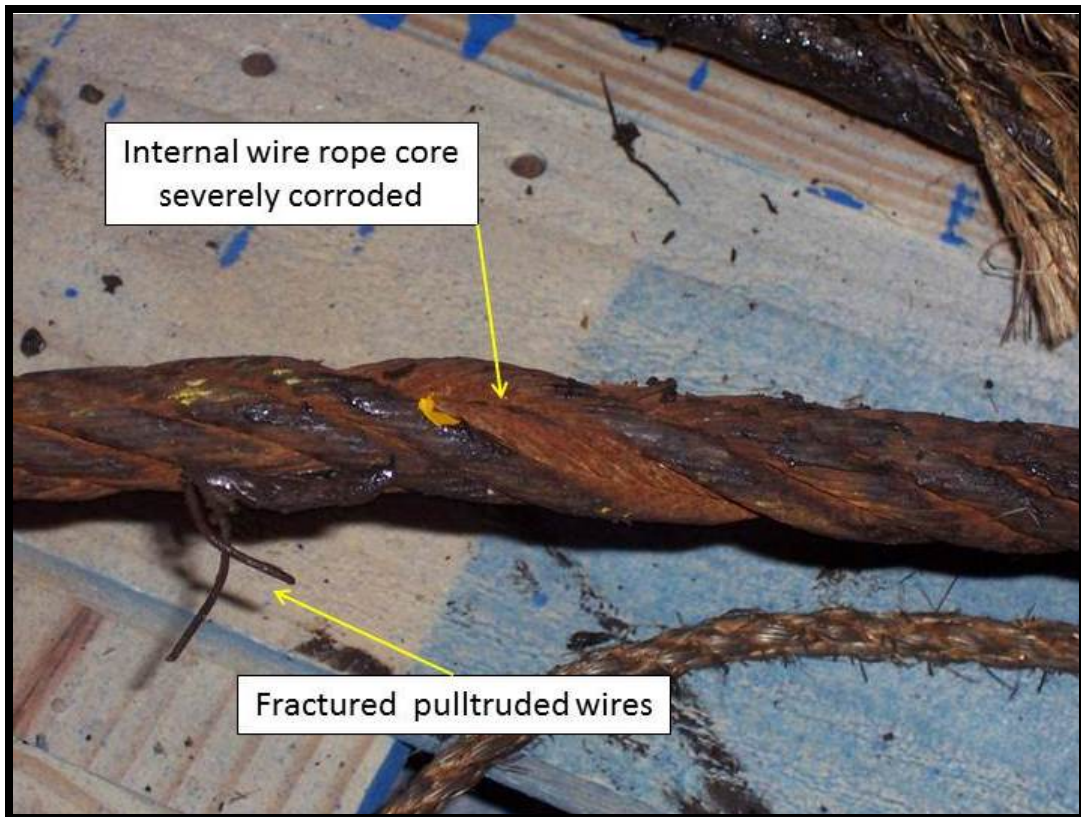
**Figure 25 – Section of failed boom hoist wire rope with evidence of severe oxidative corrosion to the core**

The report further notes that laboratory examination of the boom hoist wire rope found the following: *“... severe pitting corrosion on the external and internal wires of the outer strands and IWRC; pre-existing wire fatigue breaks that have been distorted subsequent to breaking; and partial cuts/crushing in several outer wires. Microscopic inspection reveals that many of the damaged and broken wires were caused from previously broken wires lying across other wires as the wire rope operated through the sheaves ... prior to the wire rope breaking.*

*“...it is evident that severe, pitting corrosion exists throughout the wire rope strands and the IWRC. There is evidence of only a small amount of lubrication on the center strand of the IWRC.*

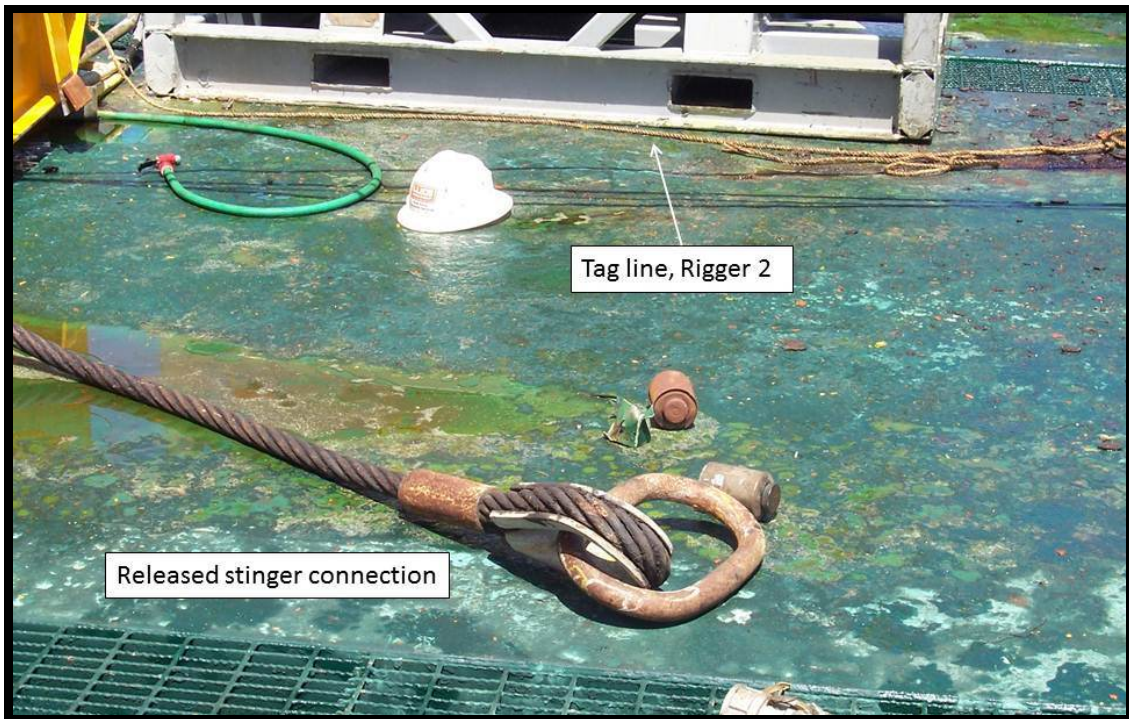
After the incident, the stinger's Crosby hook remained attached to the generator rigging (see figure 26), but the Crane's main block hook became detached from the master link on the other end of the stinger (see figures 27, 28).

**Figure 27 – The stinger detached from the Crane's main hook**

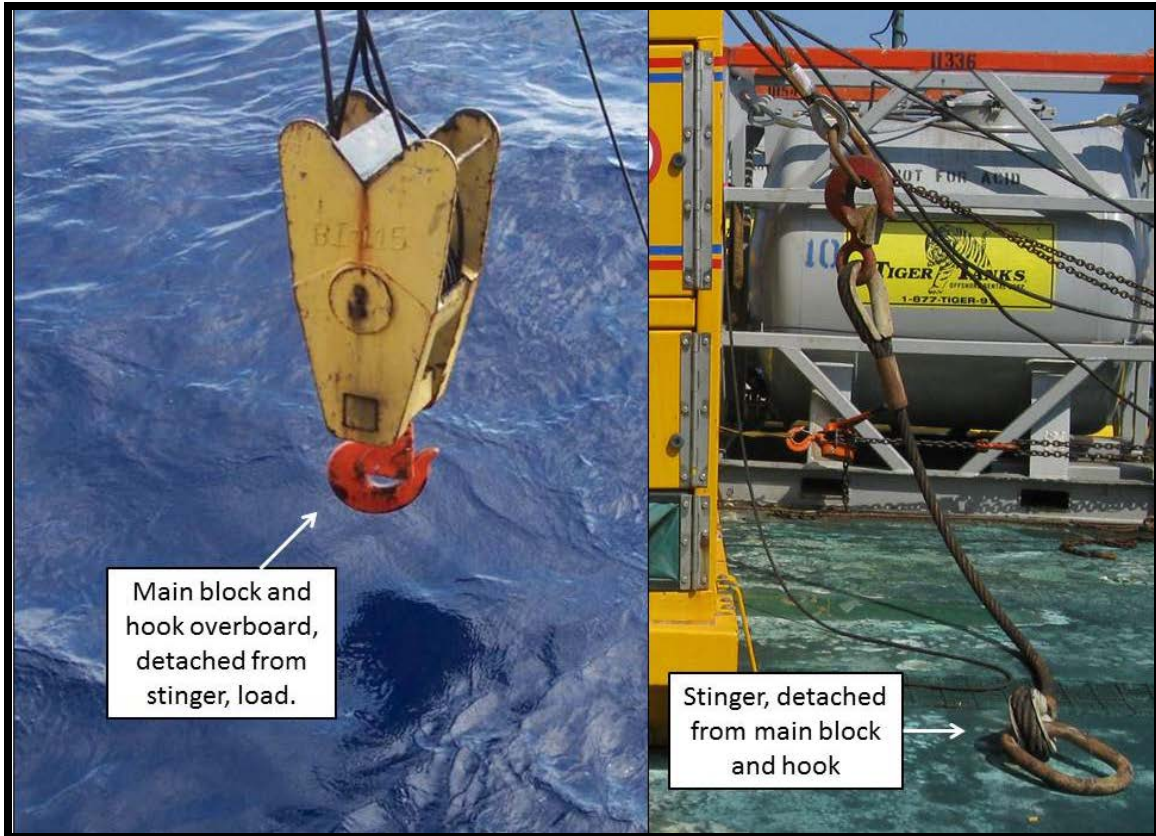
**Figure 28 - Main hook detached from stinger/sling**

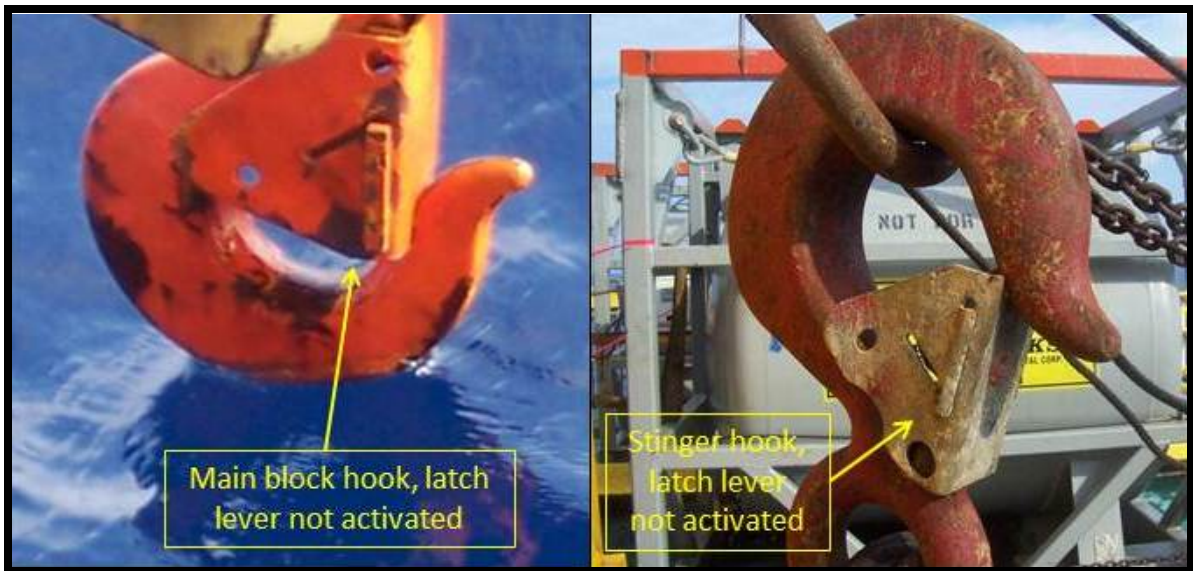
Statements from the Crane Operator and “A” Operator were received that both the Crosby hooks PL latches were “latched” or “locked.” However photographs taken immediately post-accident indicate neither hook had the latching lever engaged (*see figure 29*).

**Figure 29 – Crosby hooks post-Accident, “latching” levers not engaged**
