National Transportation Safety Board

Crash During Test Flight
Gulfstream GVI (G650)
Roswell, NM
April 2, 2011

Boeing Test & Evaluation
Quarterly Safety Meeting
January 9, 2013

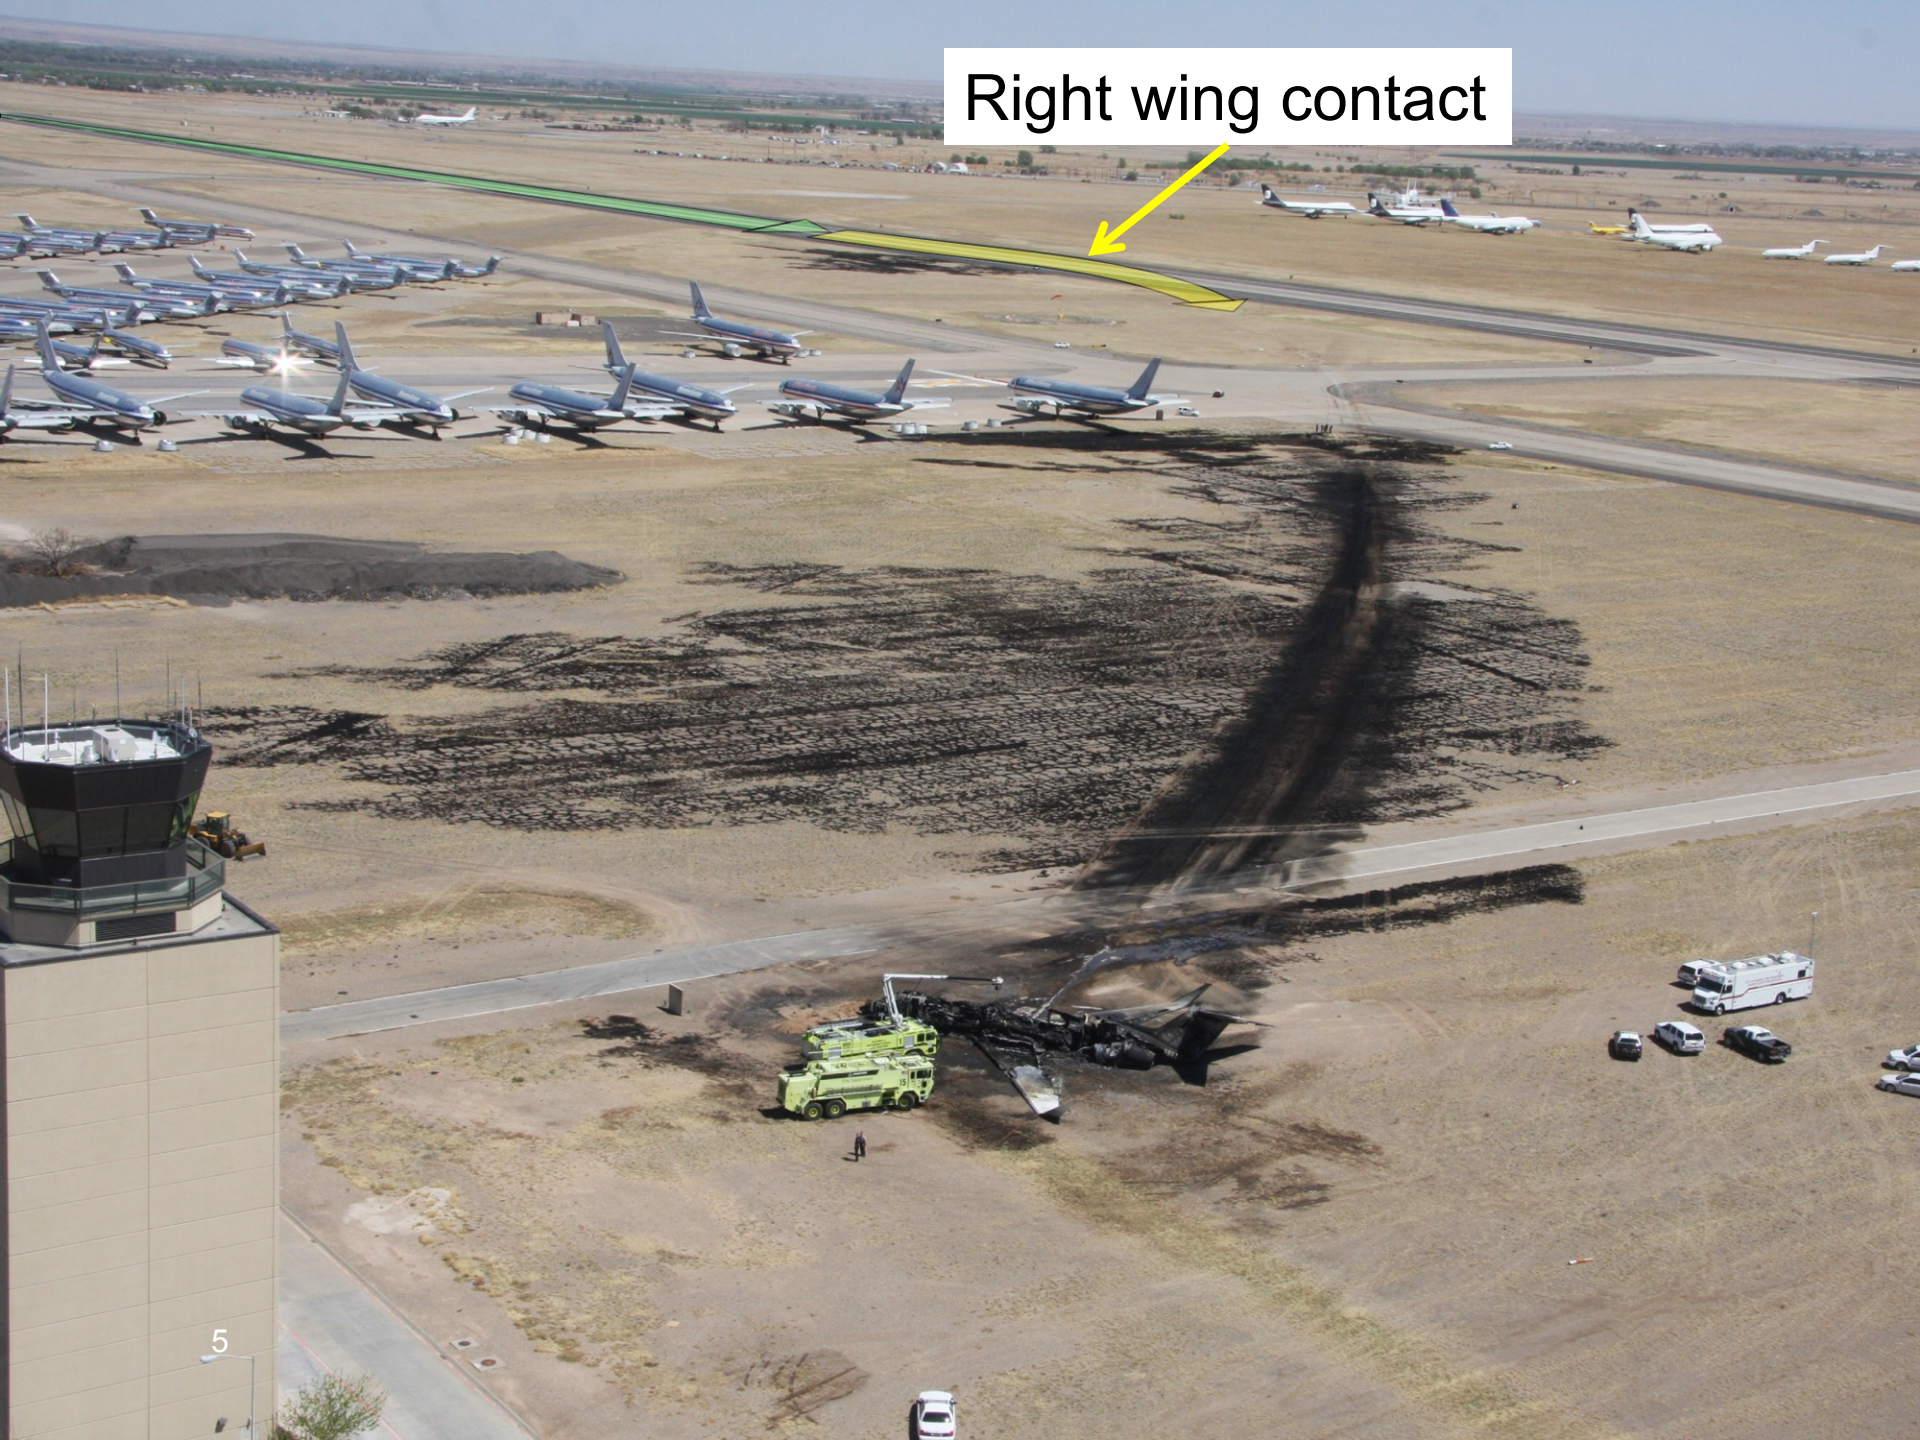
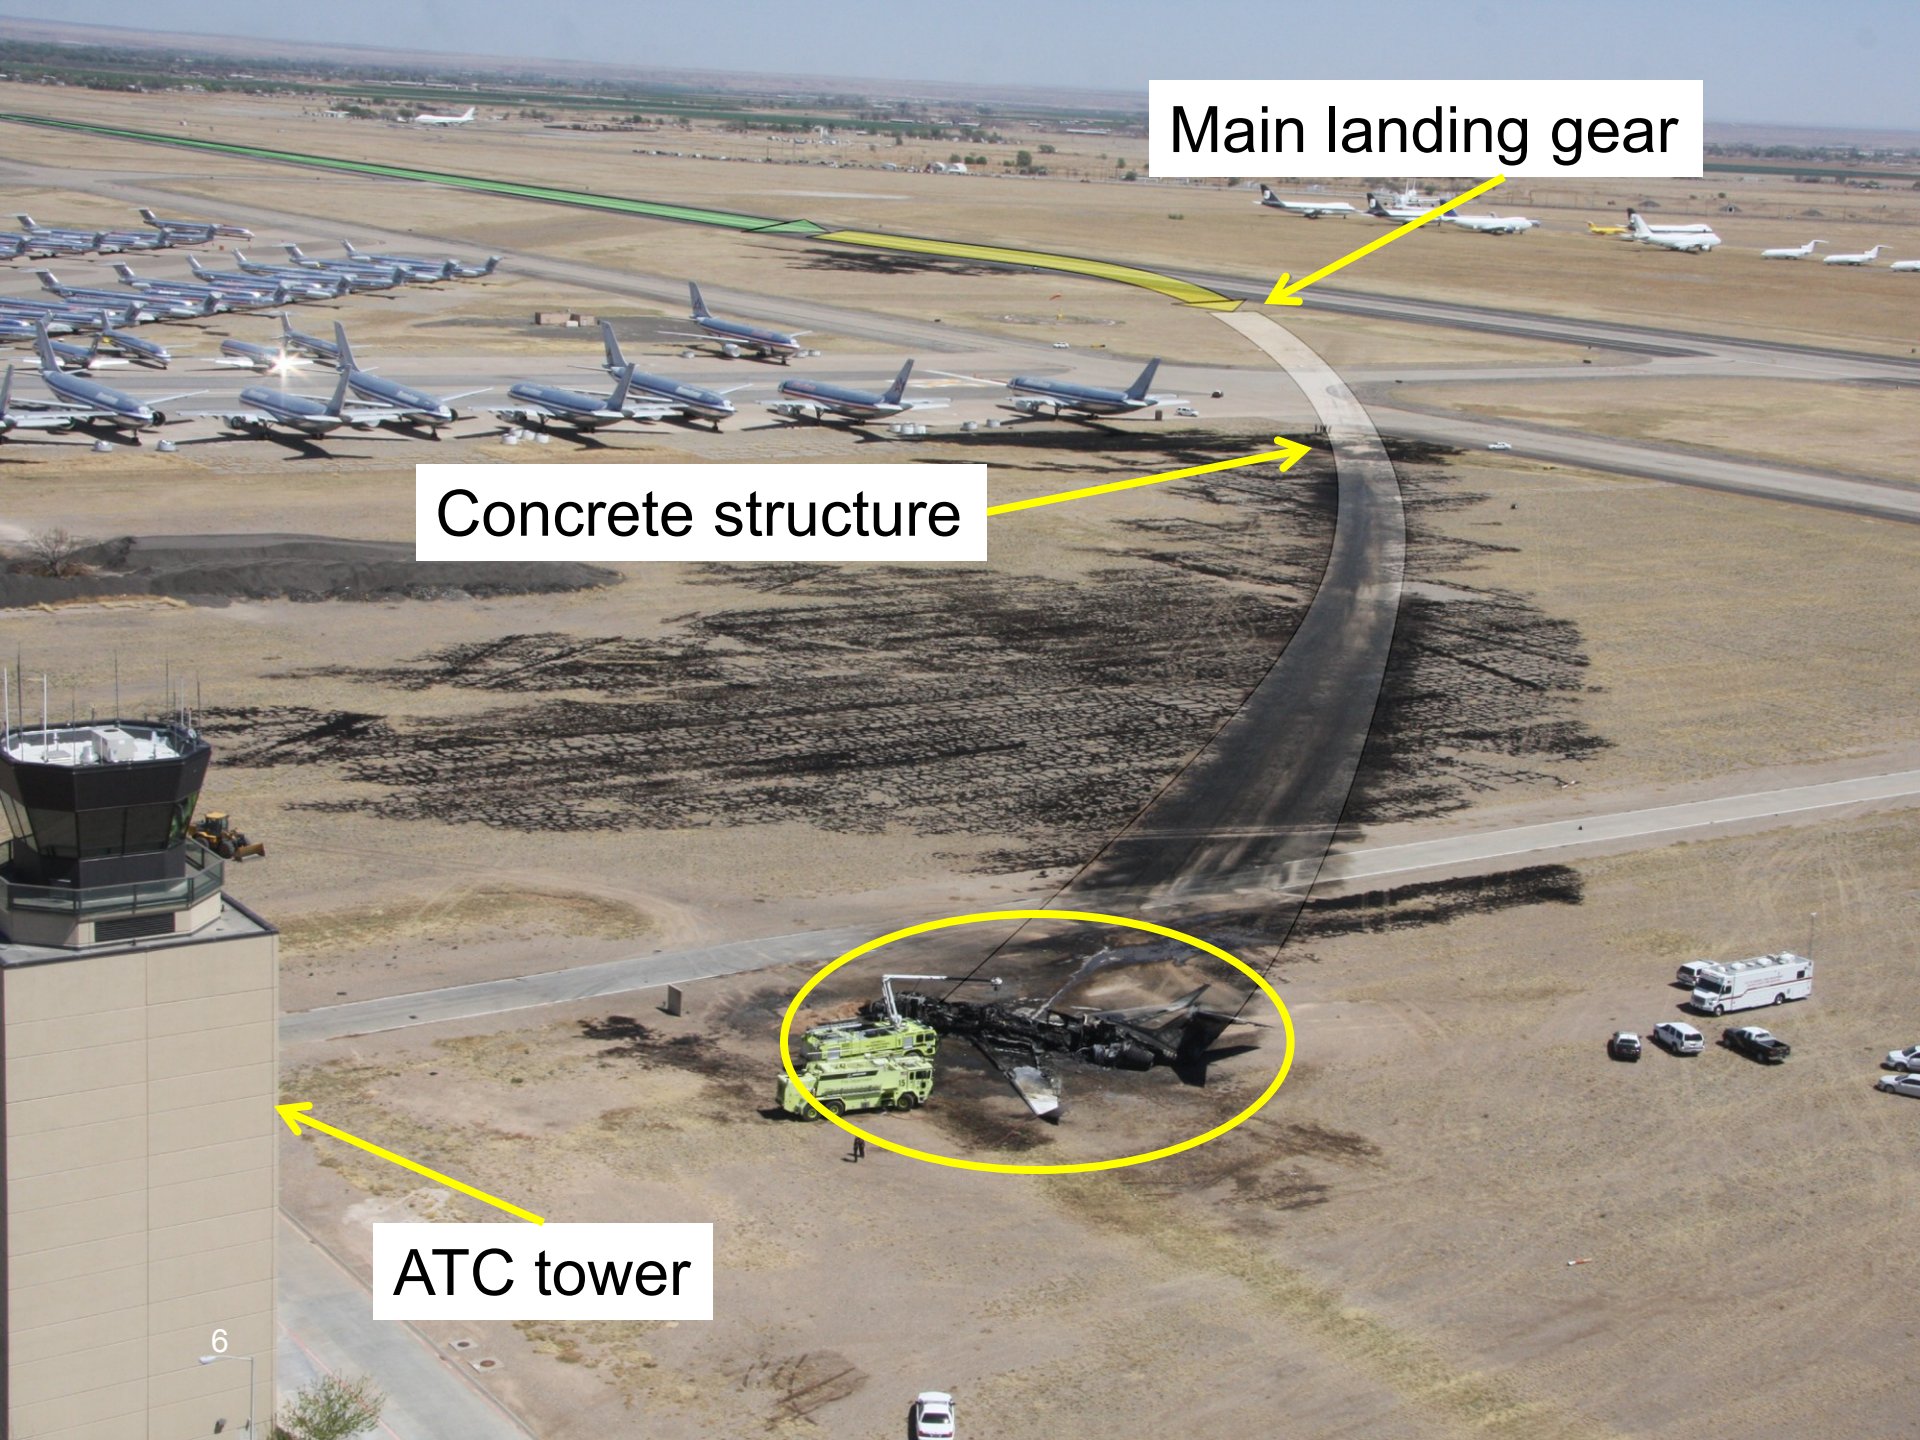
Right wing contact

- Planned one-engine-inoperative continued takeoff
- Flight crew tried to achieve takeoff safety speed (V_2)
- Stall occurred before stall warning system activated
- Right wing contacted runway

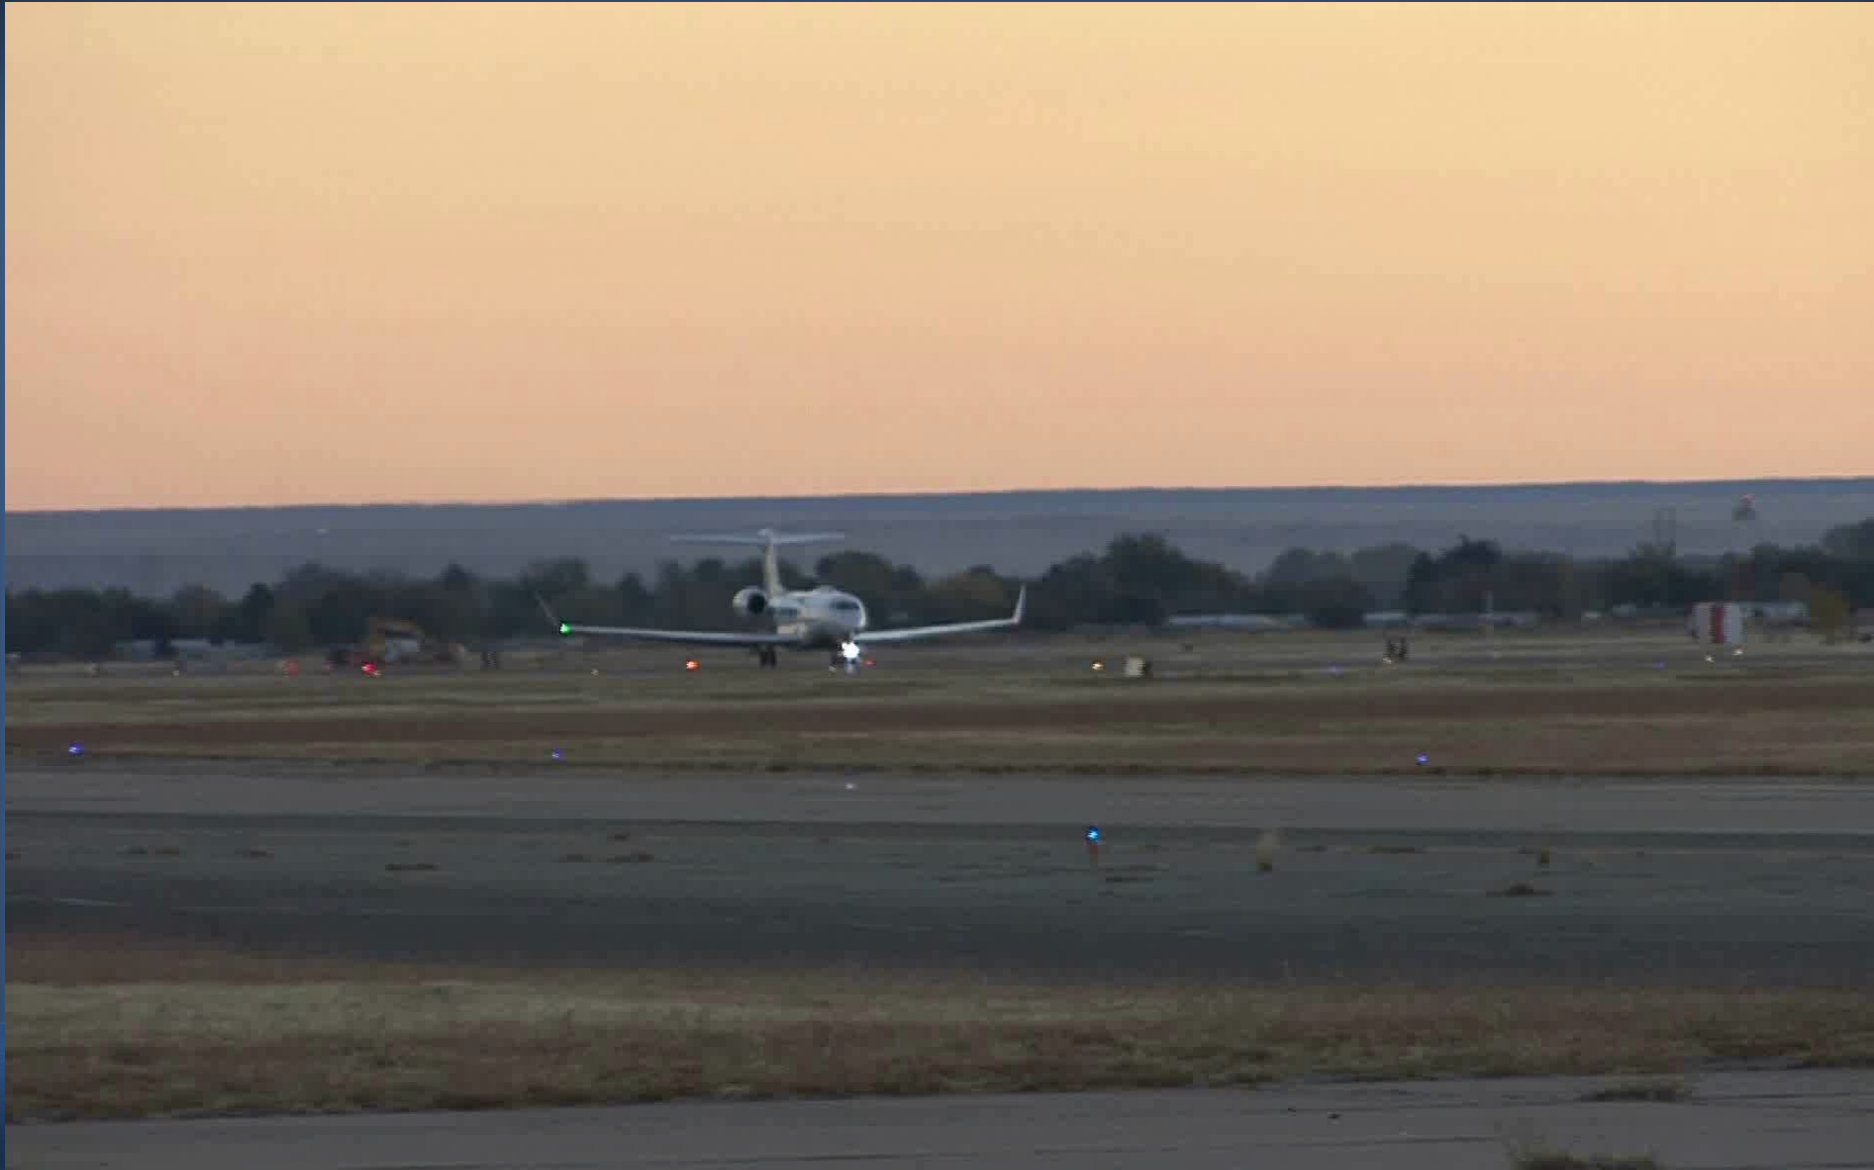
Uncommanded Roll Event (88)

- Flight 88, November 16, 2010: minimum unstick speed (V_{MU}) test
 - Flown by pilot-in-command (PIC) of accident flight
 - Flight crew recovered airplane
 - Testing not stopped
 - Attributed to over-rotation
 - Postaccident data review showed airplane stalled below predicted stall angle of attack

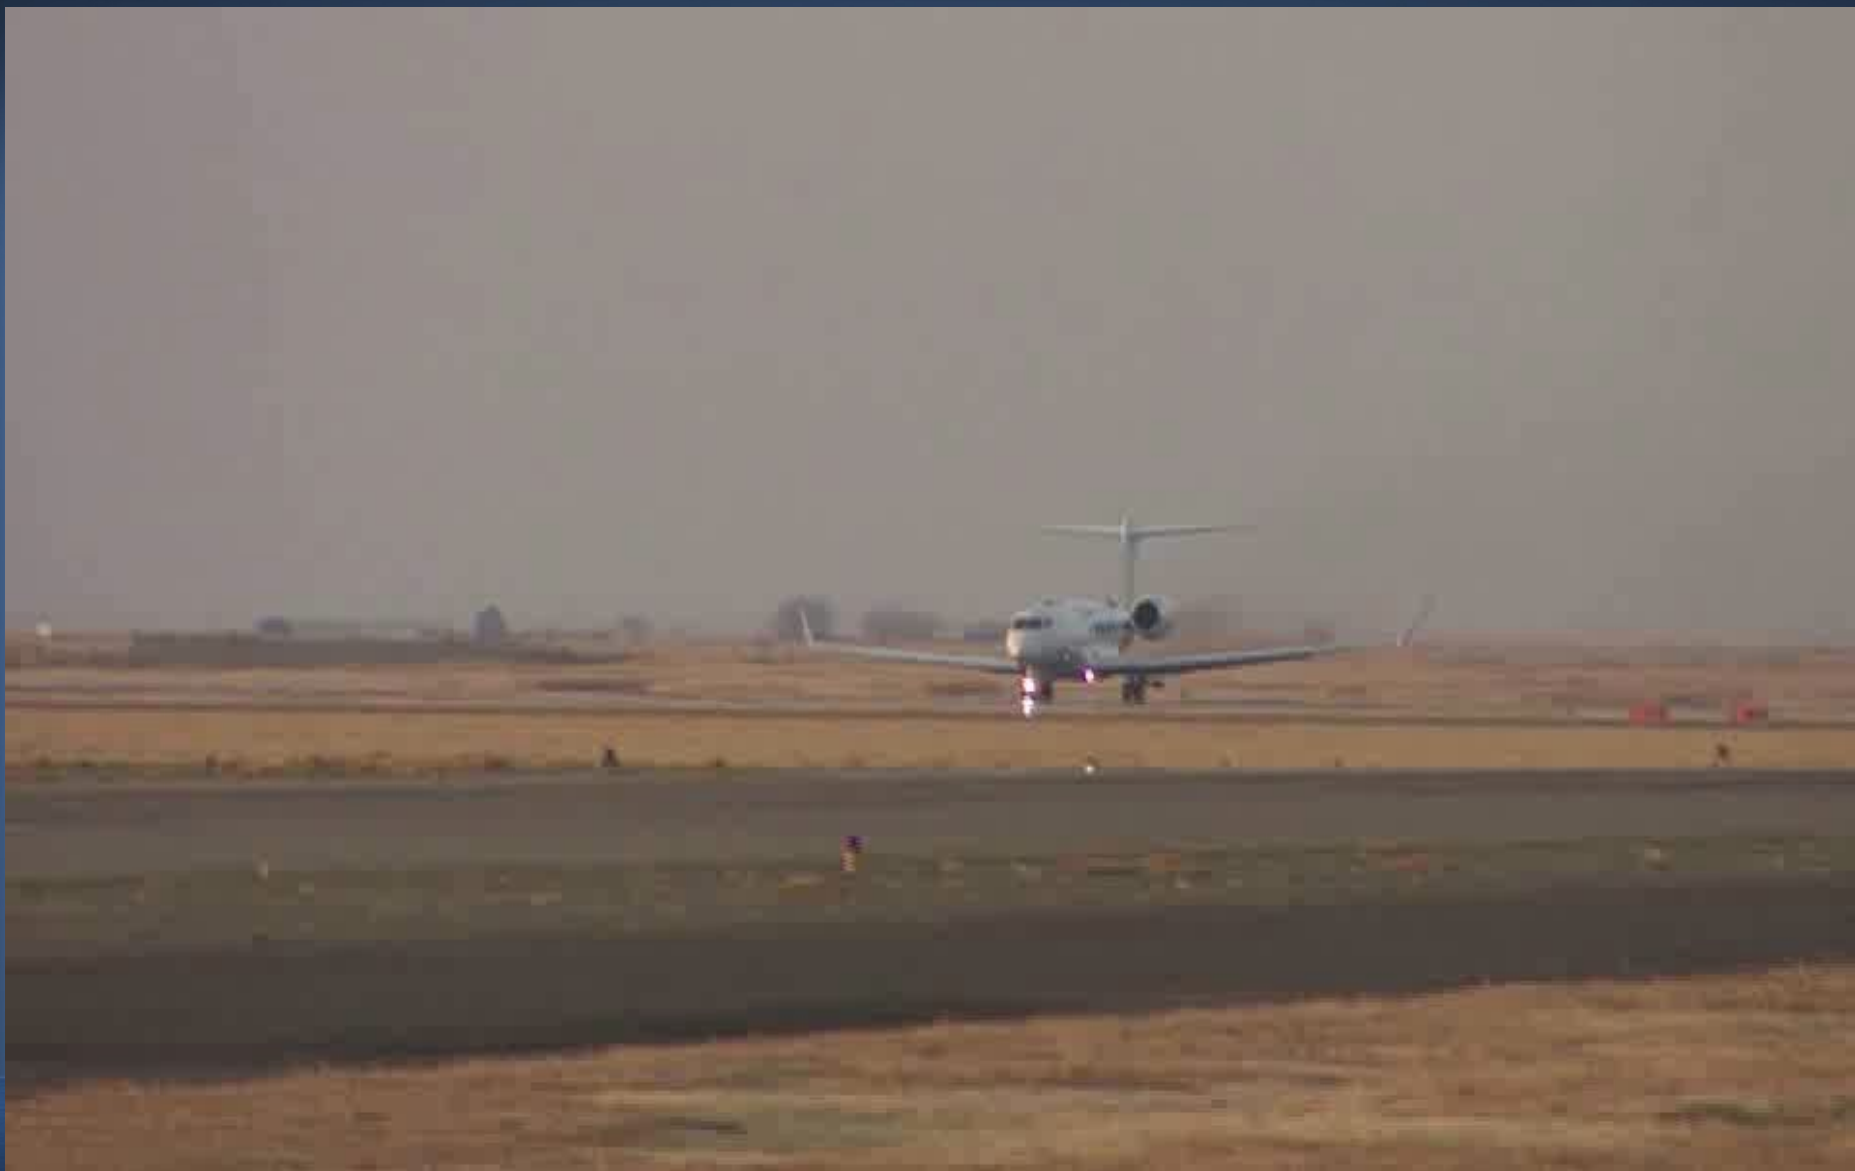
Uncommanded Roll Event (132)

- Flight 132, March 14, 2011: flaps 20, one-engine-inoperative test
 - Flown by second-in-command of accident flight
 - Flight crew recovered airplane
 - Testing not stopped
 - Attributed to “lateral-directional” event
 - Postaccident data review showed airplane stalled below predicted stall angle of attack

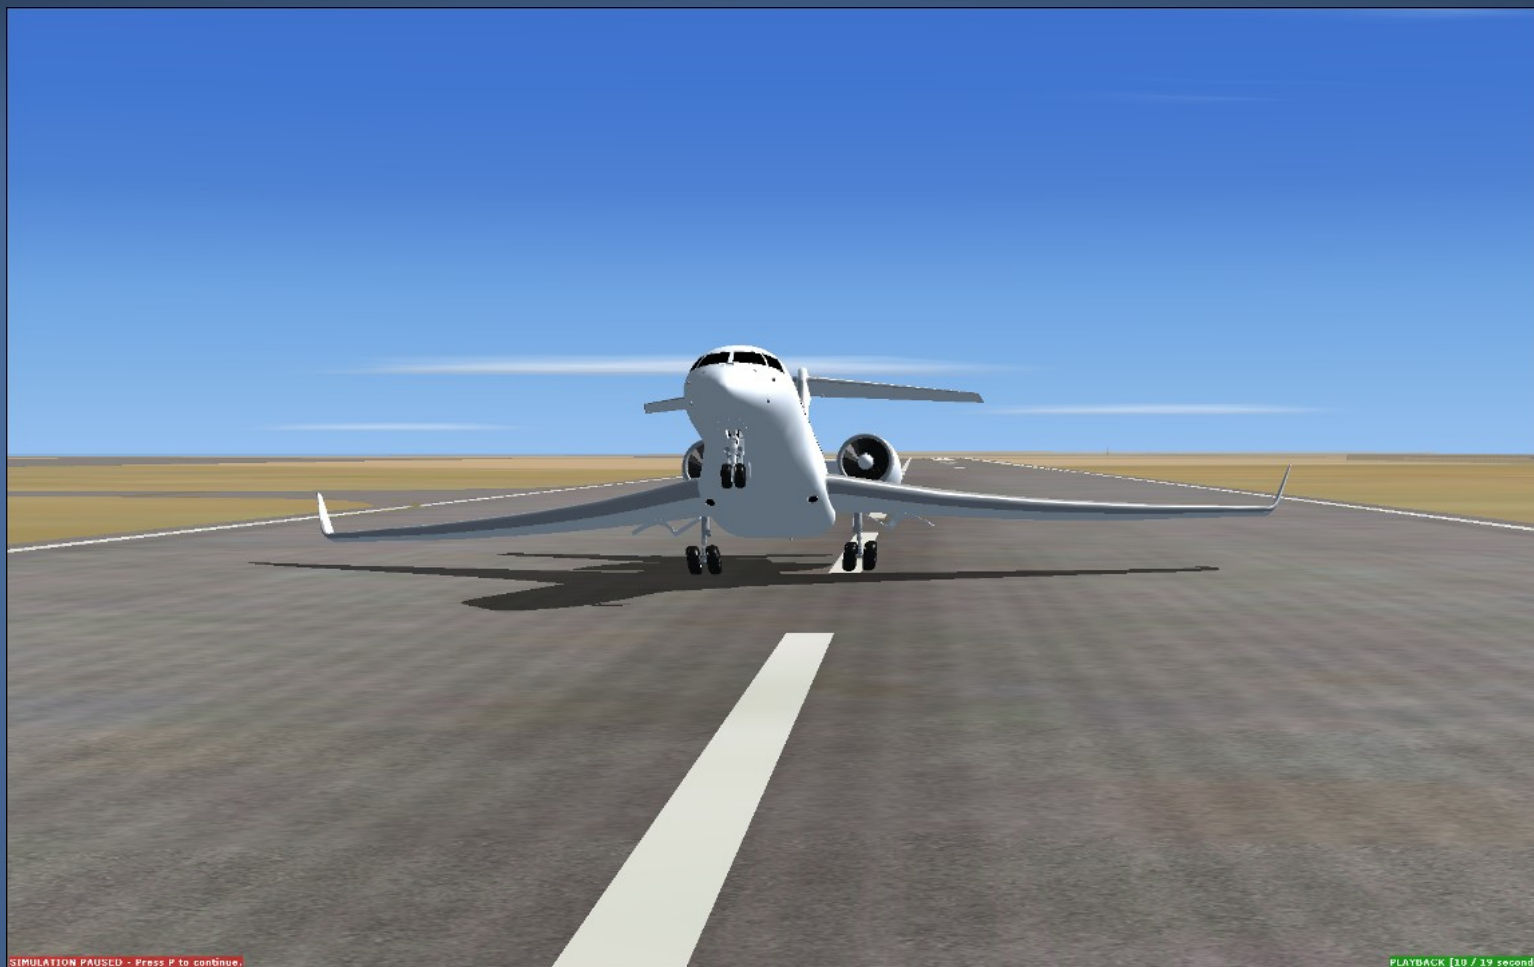
Liftoff (09:33:50.6)

- No pause at 9° pitch target, and pitch rate slowed through 9°
- Slight roll to right began 2 seconds before liftoff
- Airplane stalled below predicted stall AOA and stick shaker activation setting
- Pilots had no warning before stall

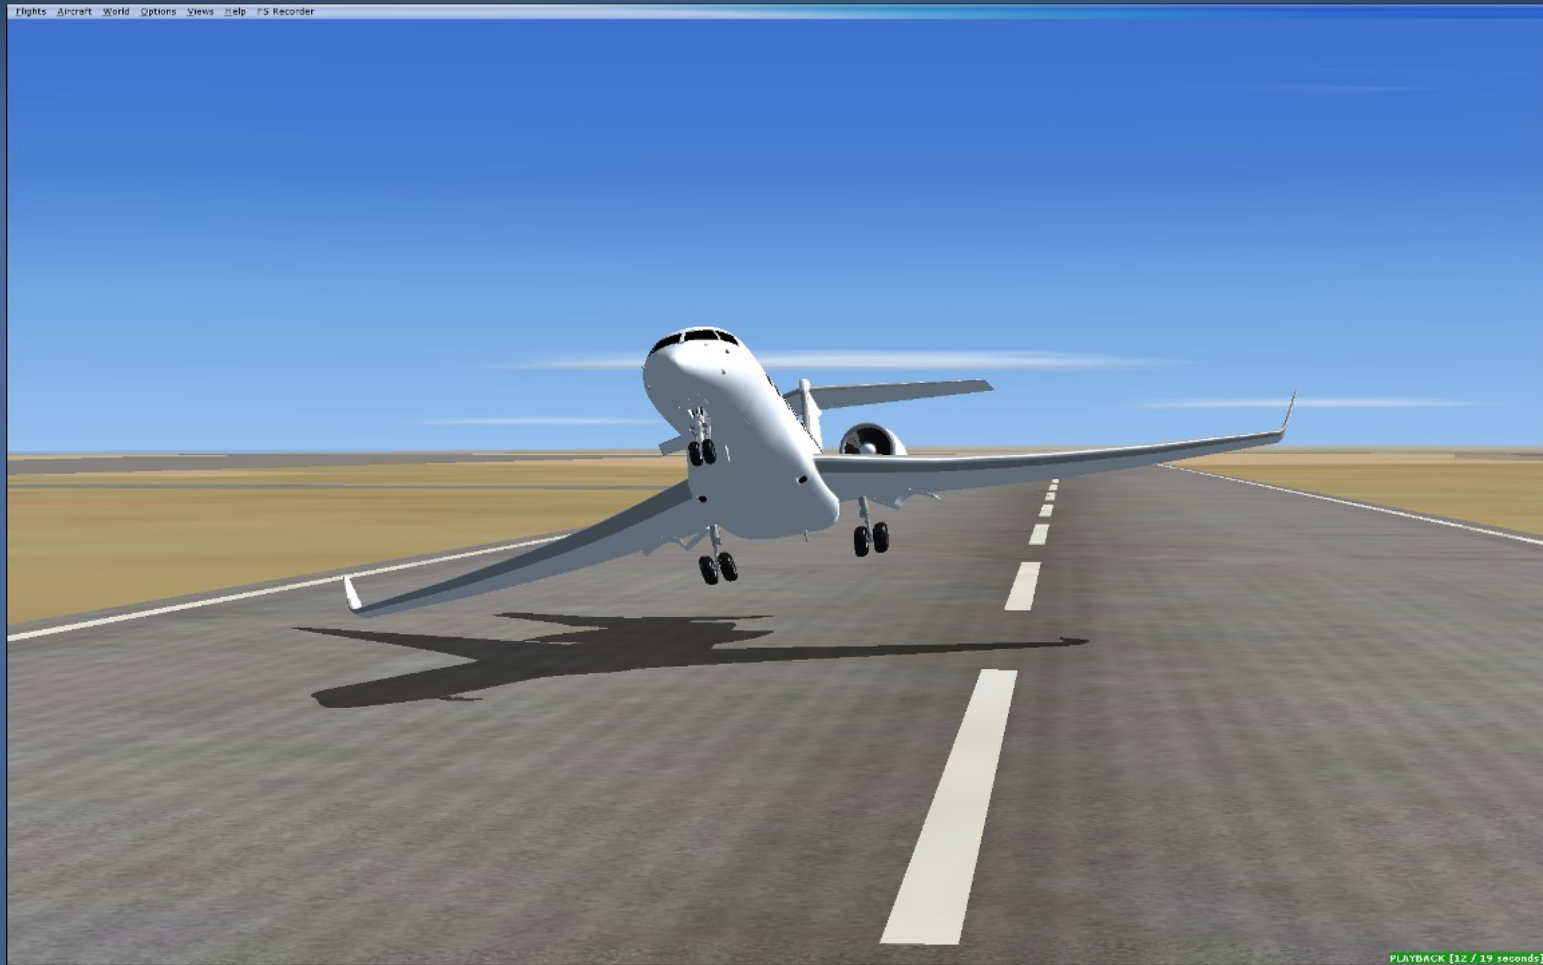
First Stick Shaker Activation (09:33:52.3)

- PIC's column push after first stick shaker activation was appropriate
- Pitch was reduced below PLI, and stick shaker activation ceased
- Airplane remained in a stall that overpowered lateral controls
- PIC was likely confused by airplane's response

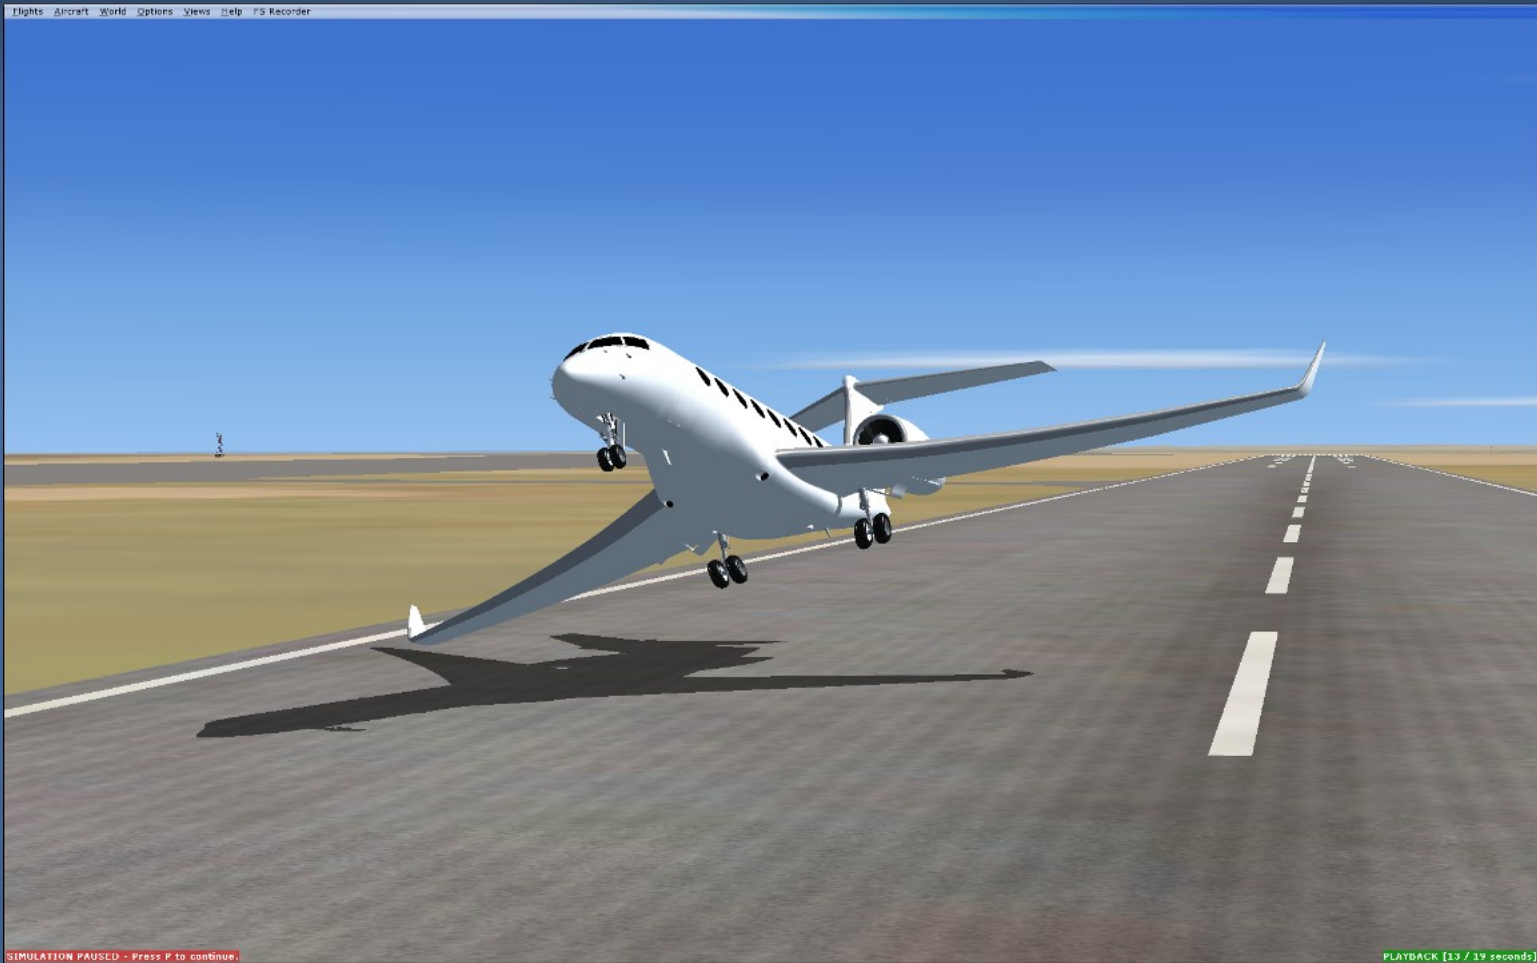
Second Stick Shaker Activation (09:33:53.6)

- PIC's column pull after second stick shaker activation was inappropriate
- Airplane was departing runway
- Conflicting cues, stress, and time pressure likely influenced PIC's response
- Recovery after second stick shaker activation was highly unlikely

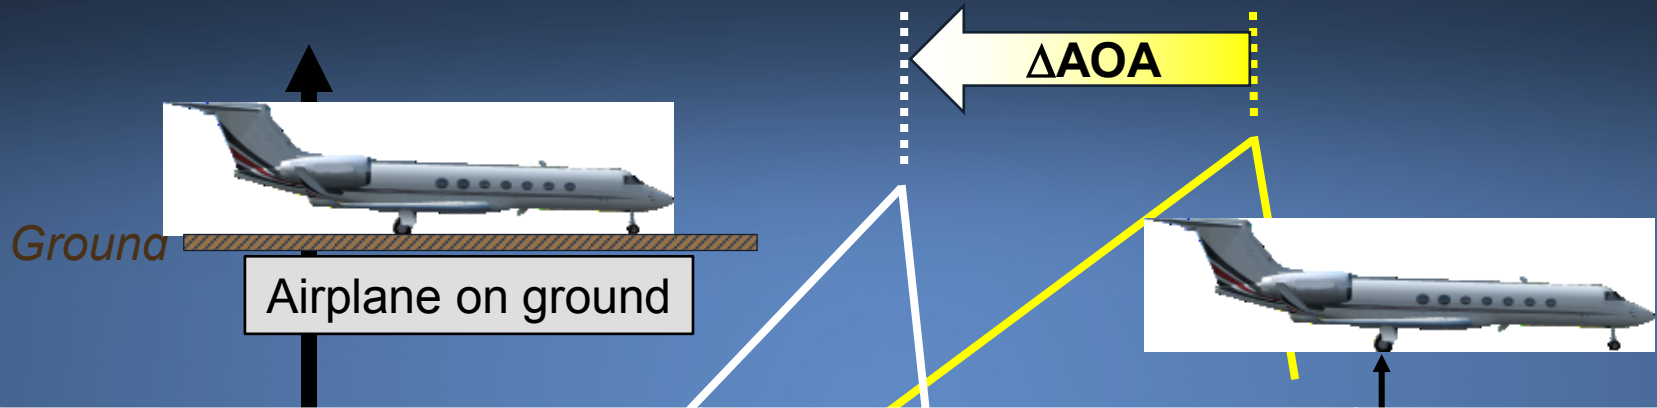
Stall AOA
reduced in ground effect

Estimated ΔAOA (from V_{MU} tests)	Actual ΔAOA (from postaccident CFD)	Difference
1.6°	3.25°	1.65°

RESULT: No warning before stall in ground effect

Missed opportunity: Actual ΔAOA indicated by two previous roll events

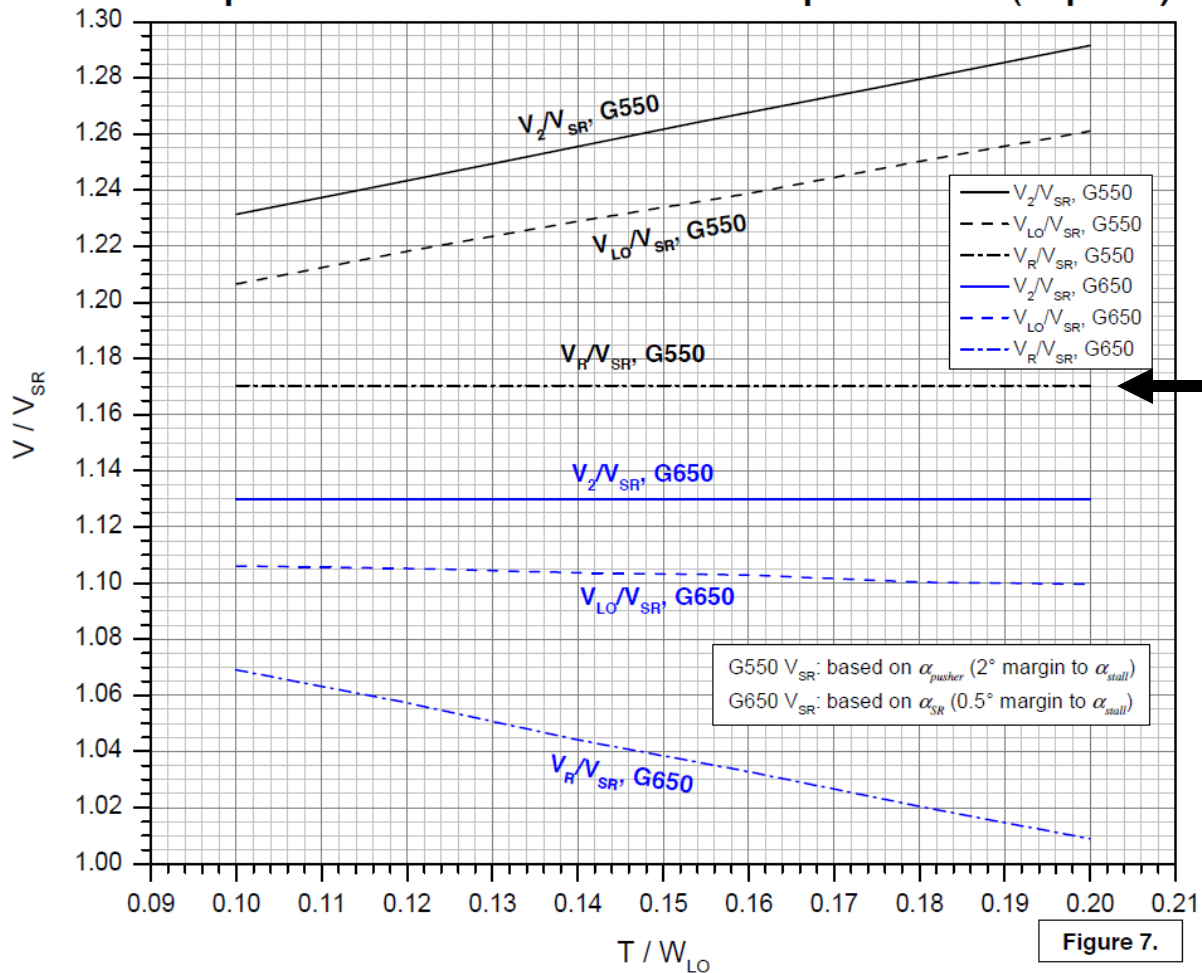
Comparison of G550 & G650 takeoff speed ratios (flaps 10)

Tail Power Limited

G550 Decrements Applied to Lower G650 V2 Targets

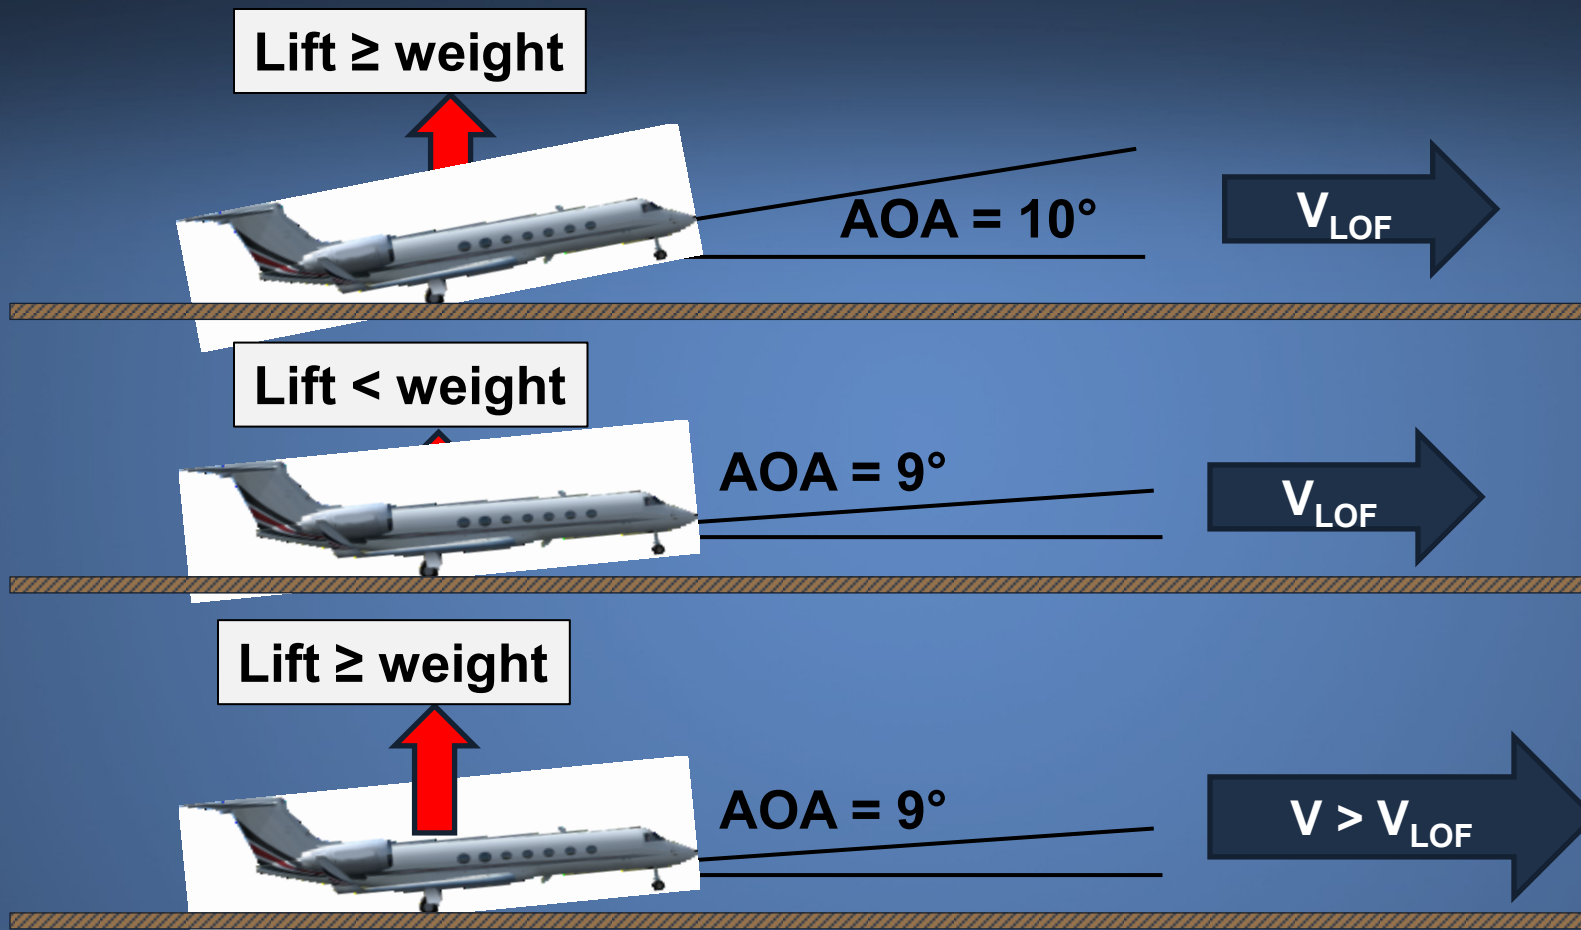
Change in Flaps 10 Target Pitch Angle

Reduction in pitch without increase in speed exacerbated V_2 overshoots
