**Lee's Ferry Access Road  
Glen Canyon National Recreation Area  
AZ PRA GLCA 5(2)**

**Final  
Drainage Report**

**Federal Highway Administration  
Central Federal Lands Highway Division**

**Prepared by  
*HDR Engineering, Inc.***

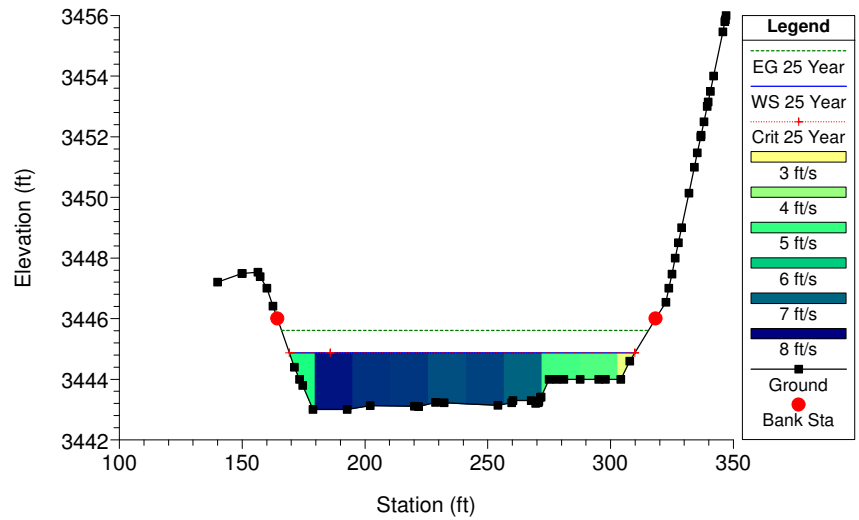
Erosion of the roadway embankments is also prevalent in selected areas. Southwest of Cathedral Wash is an unnamed wash traverses from south to north along the access roadway from approximately Sta 167+55 to Sta 170+37. The existing roadway embankment along the wash is eroding and migrating towards the back of curb along the access road. There are two existing spur dikes located within the wash at Sta 164+35 and Sta 165+12. Both features are showing signs of erosion and have failed to improve the conditions developing along the embankment. The unnamed wash converges with Cathedral Wash and is discharged across the alignment through a 12X12 RCBC. The 12X12 RCBC at Sta 175+00 is for Cathedral Wash, the largest of the delineated basins. The fill surrounding the outlet apron has extreme degradation associated “head cutting” from the discharge. A roadside ditch discharging southeast of the outlet apron has also eroded into a well incised channel and continues to degrade the roadway embankment.

LeesFerry\_FINAL Plan: Existing Conditions 11/21/2011  
XSEC - 07 Existing erosion prevalent

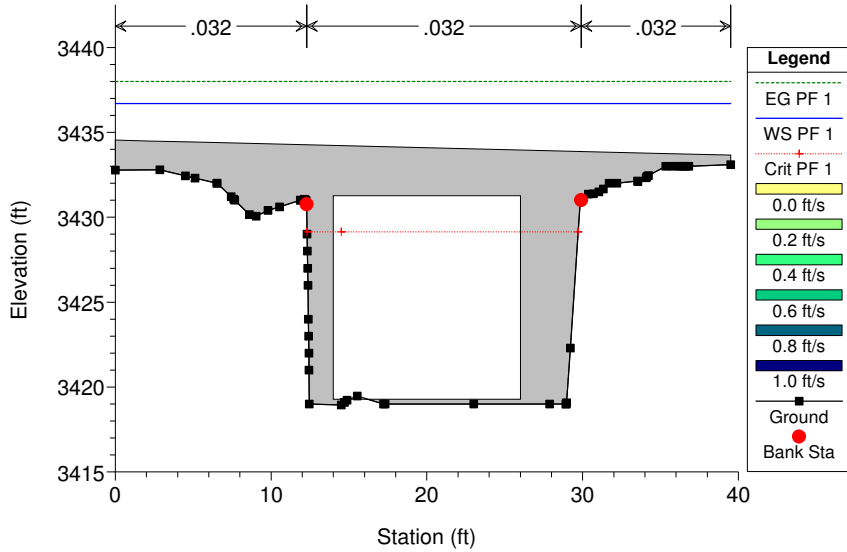
Geotechnical reports for the region indicate conditions within the Lee's Ferry area are characterized as very loose soil with sparse vegetation. The channel dynamics of Cathedral Wash combined with a 20' high bluff immediately downstream of the 12'X12' RCBC outfall have compounded these conditions to produce extreme erosion within the region. Head cutting has migrated back to the outlet apron and surrounding embankment. The existing conditions model indicates that the culvert is under inlet control and velocities increase over 50% at the outlet.

10X12 Box Culvert Plan: Plan 08 5/4/2012  
Existing 12 X 12 RCB w/ Headcutting Damage

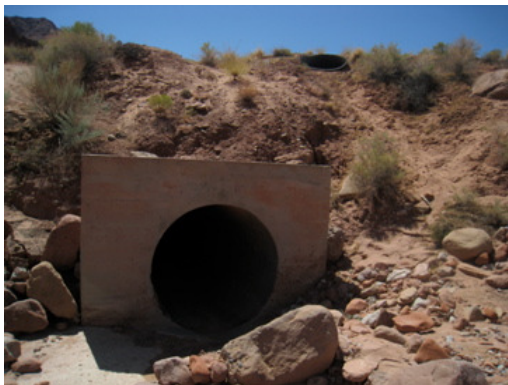
**72” Culvert Inlet**

Under current conditions, the existing culvert crosses under Lees Ferry Access Road with a single 72” diameter corrugated metal pipe (CMP) pipe with a concrete headwall only at the inlet; the outlet is bevel cut to approximately match the fill slope. There is an existing overflow pipe located approximately 50’ west of the 72” culvert. The downstream end (outlet) of the overflow pipe is buried by soil dumped over it. The 72” existing culvert is in need of repair due to evidence of pitting within the walls and displacement of the pipe at the distressed (failed) point with accumulated sediment upstream. As one progresses downstream, the deposition increases again through the outlet. Based on observations from a site visit on August 12, 2011, the downstream end of the existing culvert appears to be constricted for an undetermined length (see photo below on right). This section of pipe was repaired and is approximately dimensioned at 60” to 62” horizontally and 60” to 68” vertically. The existing invert elevation upstream is 3,149.38’ and downstream is 3,142.84’, based on survey data performed in March 2011. The depth of the existing 72” culvert is approximately 25’ below existing ground. There is an existing drainage crossing approximately 600’ downstream, SW from the 72” culvert outlet.

Within the project limits there is a 72" culvert crossing that is in need of repair. A technical memorandum that documents various repair alternatives was developed. The repair to the existing 72" culvert would be made separate from the Lee's Ferry roadway project.

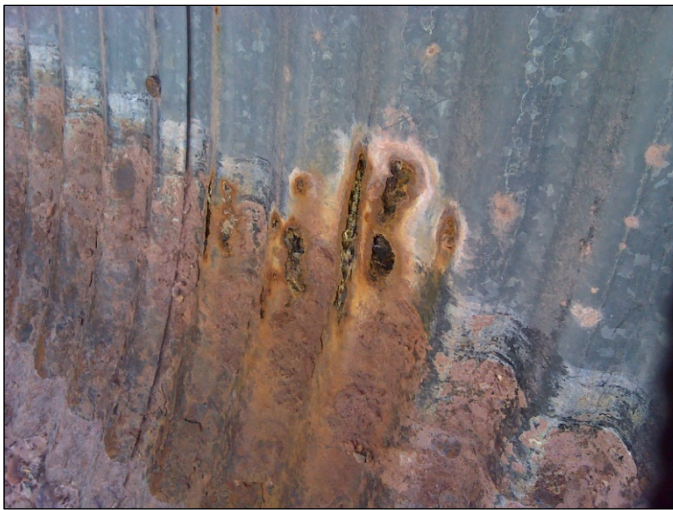
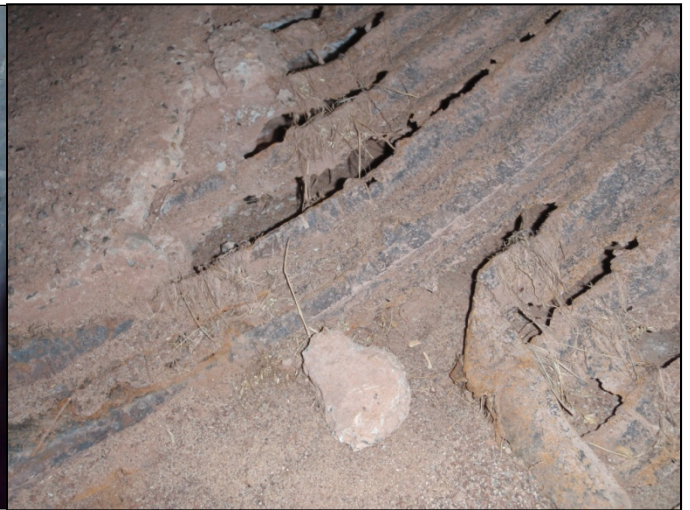
Sta 324+54 72" CMP corrosion and perforation and invert deterioration

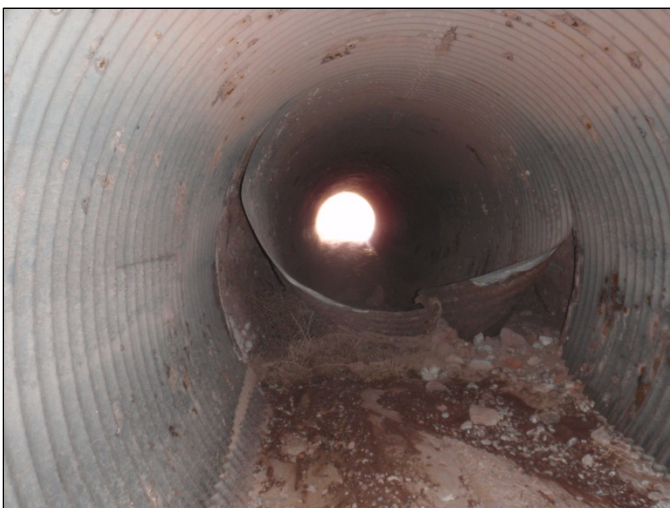
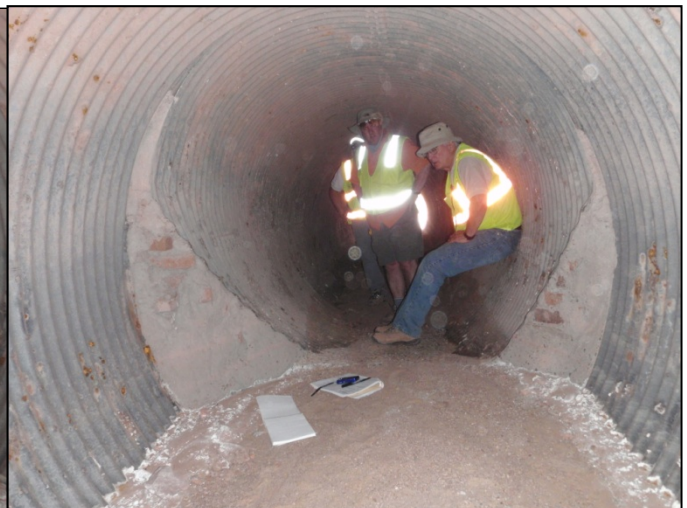
Sta 324+54 72" CMP failed joint (view upstream) before temporary repair (left) and after repair (right)

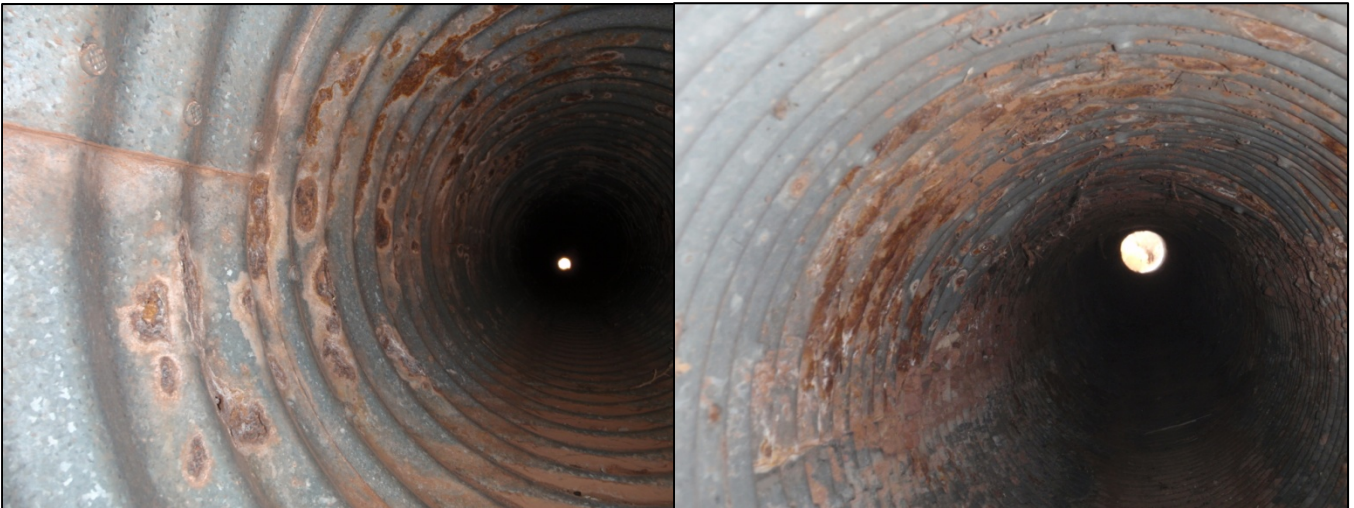
Typical corrosion observed in the 18" CMPs near the campground (Sta 331+24 through Sta 340+60)

Additional culvert replacements were added based on the CFLHD culvert assessment report. The culverts were either upsized based on the available pipe cover for replaced in kind. No hydrology or hydraulics was performed for the culvert replacements with the exception of the culvert recommendation at Sta 403+08. The analysis showed that the 2-48" culverts were adequate for the 25-year design storm.

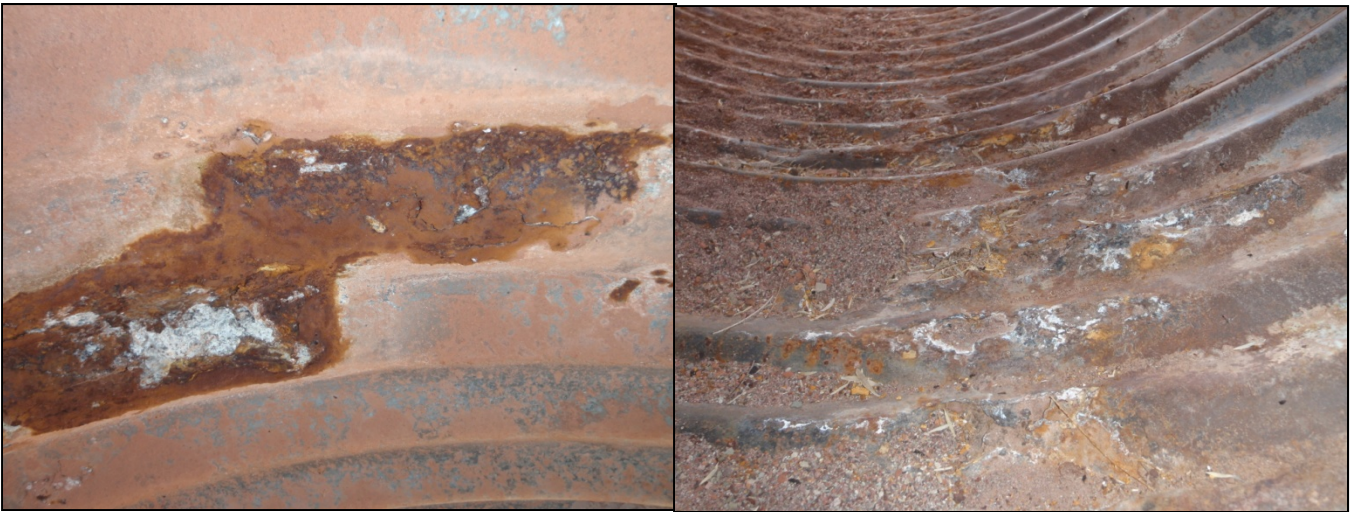
Typical corrosion and invert deterioration observed in the two 48" CMPs at Sta 403+08 (end of project near the boat launch)

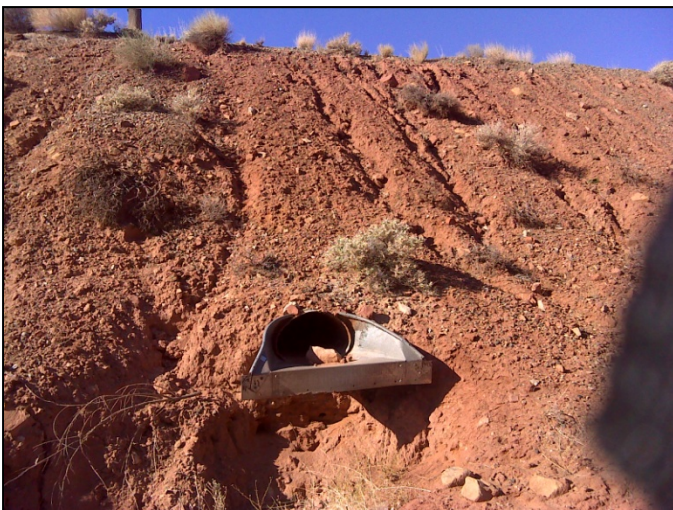
Typical culvert outlet where a gabion drop and  
revet mattress are recommended for erosion protection
