**Date:** September 13, 2012  
**To:** Lee Kunselman, P.E. – Atkins  
**From:** Tom Allen, P.E. – Yeh and Associates, Inc. TA  
**Subject:** Final Geotechnical Evaluation Memorandum  
Sage Creek Road, WY PFH 26-1 (3) Final Design  
YA Project: 211-218

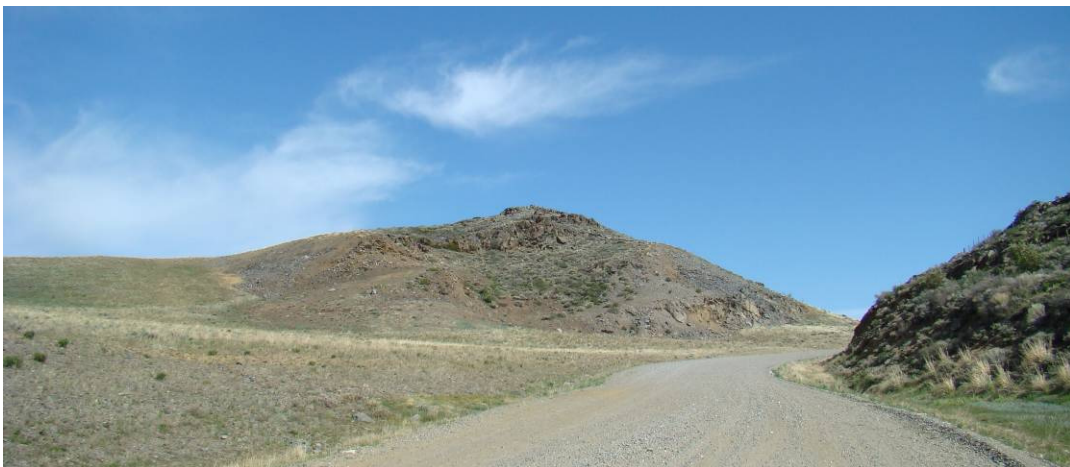
Along Sections C and D the terrain is open and sparsely vegetated with some rolling hills and rounded ridges characterized by alluvial features including arroyos, alluvial fans and outwash plains. The rocks in this area are relatively young, mostly Miocene age, sedimentary rocks consisting of soft sandstone, claystone and conglomerates. Near the south end of Section C the road crosses a formation of ancient Precambrian metamorphic granitic gneiss. Figure 1 is a photo of the Precambrian gneiss formation.

**Figure 1: Precambrian Gneiss viewed from the south.**

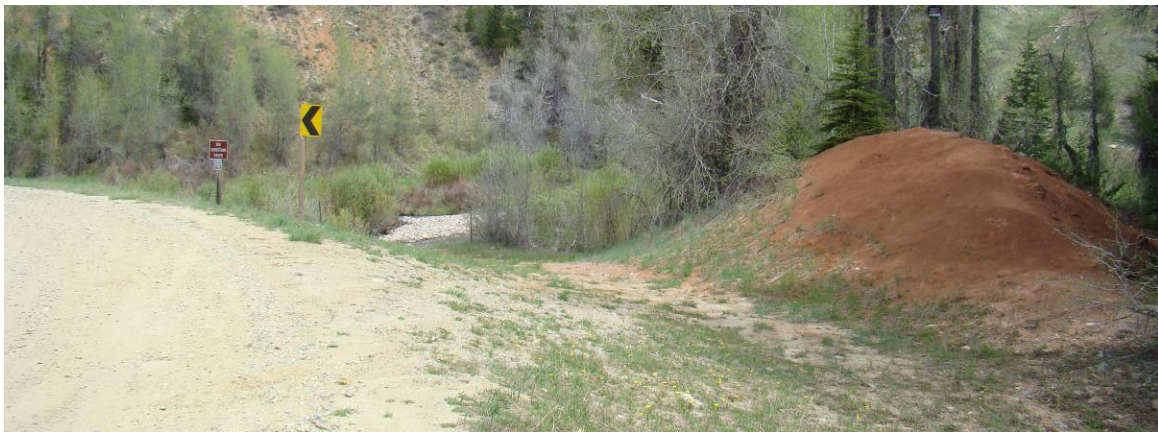
**Figure 2: Chugwater Formation at Big Sandstone Creek**

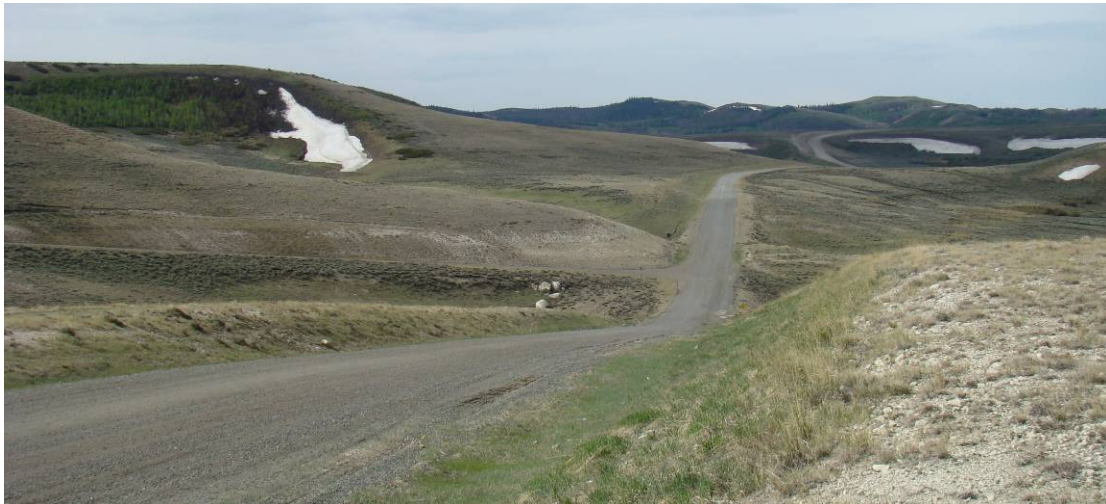
Subgrade materials encountered between Sta. 2525+50 and Sta. 2557+50 consisted of weathered sandstone with good pavement support characteristics. Figure 3 is a photo showing the sandstone outcrops in this area.

**Figure 3: Sandstone exposed in cuts at approximate Sta. 2530+00 to Sta. 2558+00**
