DEPARTMENT OF THE NAVY  
OFFICE OF THE CHIEF OF NAVAL OPERATIONS  
WASHINGTON, D.C. 20350

SECOND ENDORSEMENT on Rear Admiral s ltr of  
31 December 1975

Subj: Investigation to inquire into the circumstances  
surrounding the collision between USS JOHN F.  
KENNEDY (CV 67) and USS BELKNAP (CG 26) which  
occurred on 22 November 1975 (U)

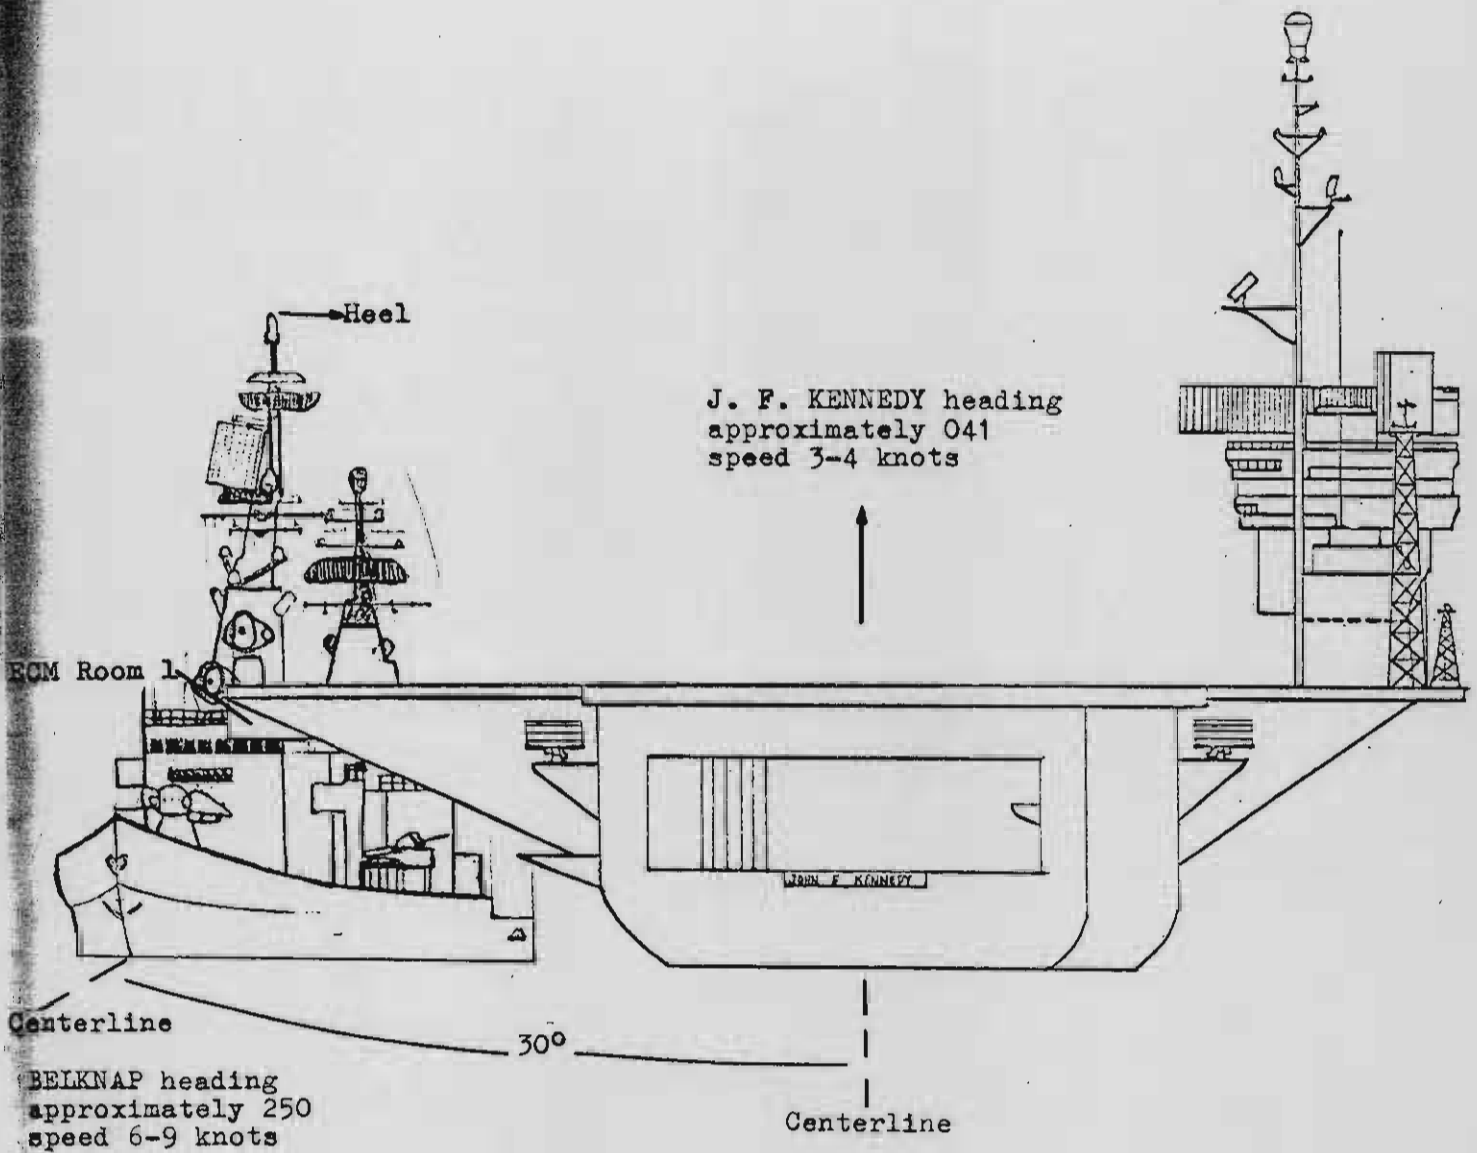
Figure II

J. F. KENNEDY turning right, stern swinging left  
 BELKNAP turning right, stern swinging left  
 Relative speed 10-12 knots.

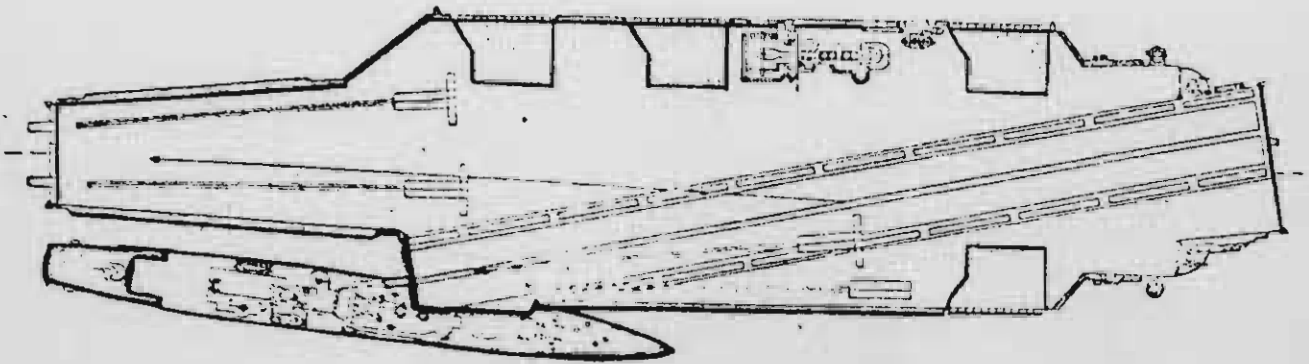
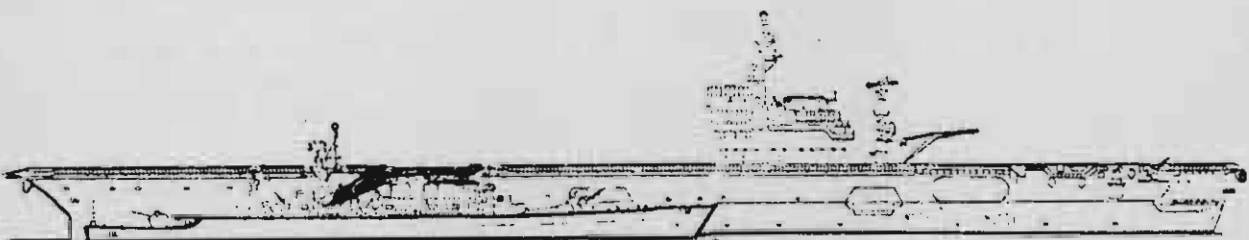
Figure III

First flash of fire came from switchbox in BELKNAP CIC as the pilot house and CIC were laid open.

Initial contact occurred at Frame 78 J. F. KENNEDY, Frame 73 BELKNAP, BELKNAP turning hard with angle of incidence of approximately  $30^{\circ}$ .

View adjusted to reflect approximate position as determined from line of destruction and coincides with normal swing of BELKNAP.

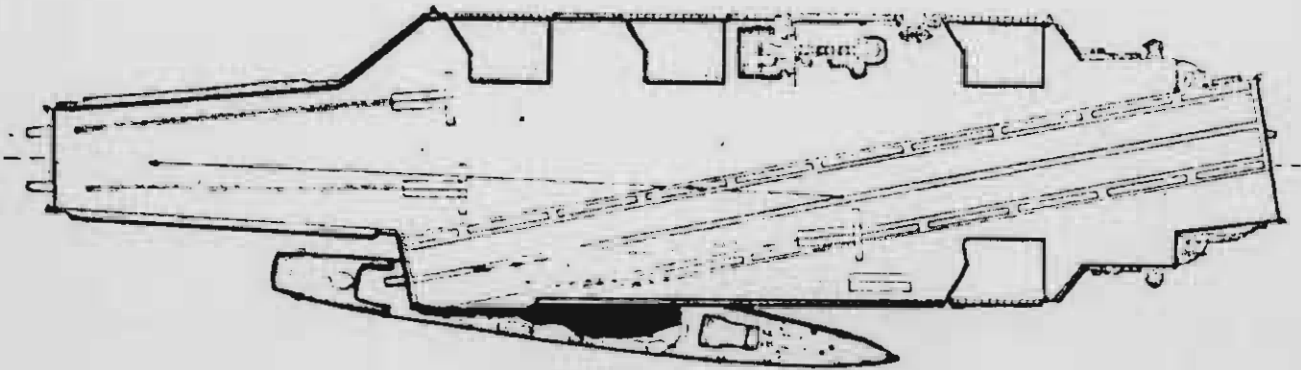
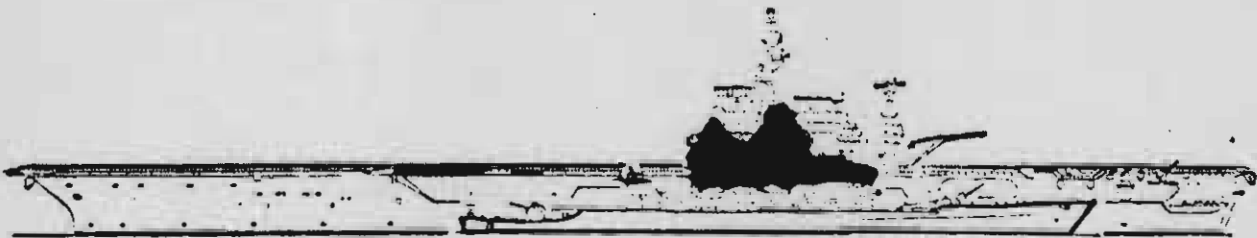
Figure IV

As BELKNAP proceeded down J. F. KENNEDY's port side, JP-5 Stations 8 and 12 poured about 1500 gallons of JP-5 onto BELKNAP, which ignited.

Flight deck crewmen of J. F. KENNEDY were pouring light water from an MB-5 onto BELKNAP.

The superstructure of BELKNAP was laid open and JP-5 poured into the uptakes of the forward and after fire rooms.

BELKNAP crewmen could look up and see J. F. KENNEDY looming above them.

View reflects the "stopped" position of BELKNAP. The drag of the collision would tend to pull the bow to the left as seen above.

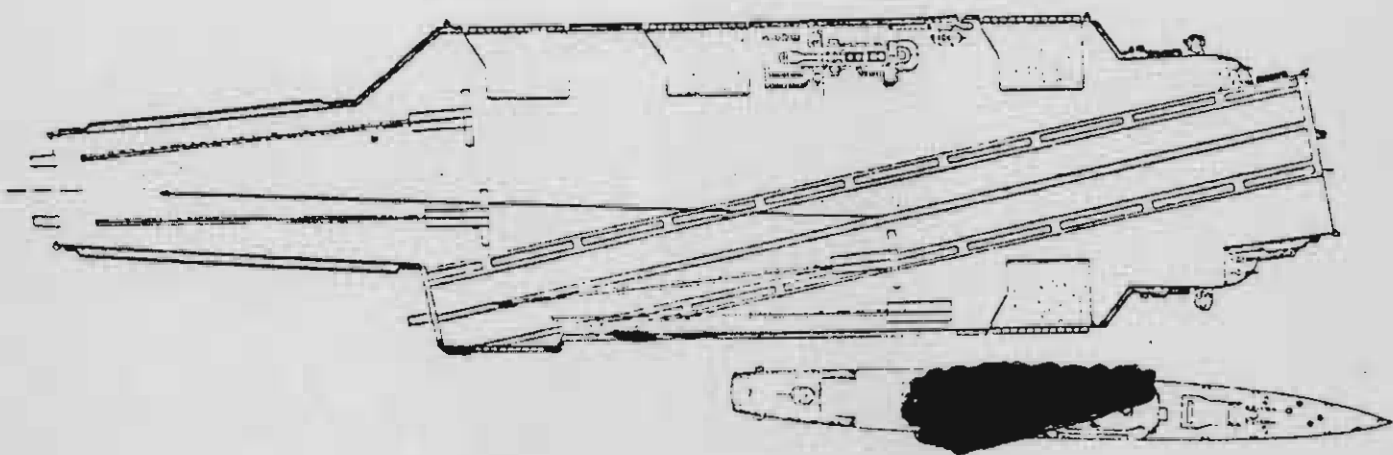
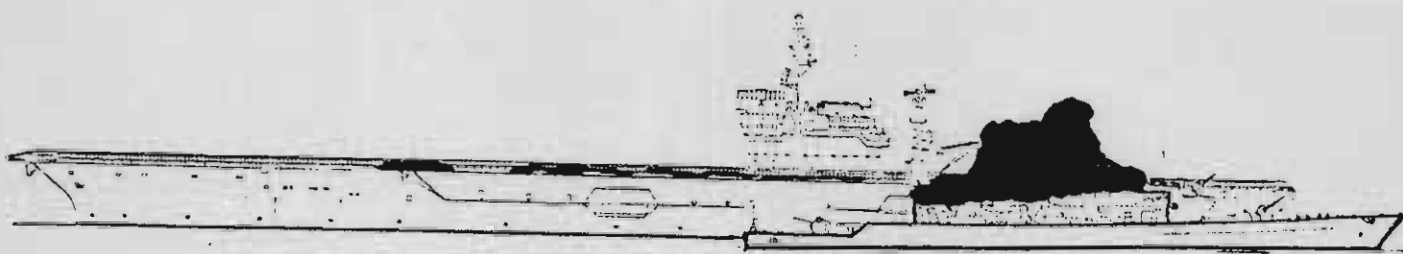
Figure V

As the ships broke clear  
BELKNAP was already fighting fires  
J. F. KENNEDY engineering spaces were  
inundated with heavy black smoke

BELKNAP had come to all stop  
all engineering spaces were evacuated
