GEOLOGIC CHARACTERISTICS AND MOVEMENT OF THE MEADOW CREEK LANDSLIDE, PART OF THE COAL HILL LANDSLIDE COMPLEX, WESTERN KANE COUNTY, UTAH

FRANCIS X. ASHLAND¹ AND GREG N. McDONALD²

ABSTRACT

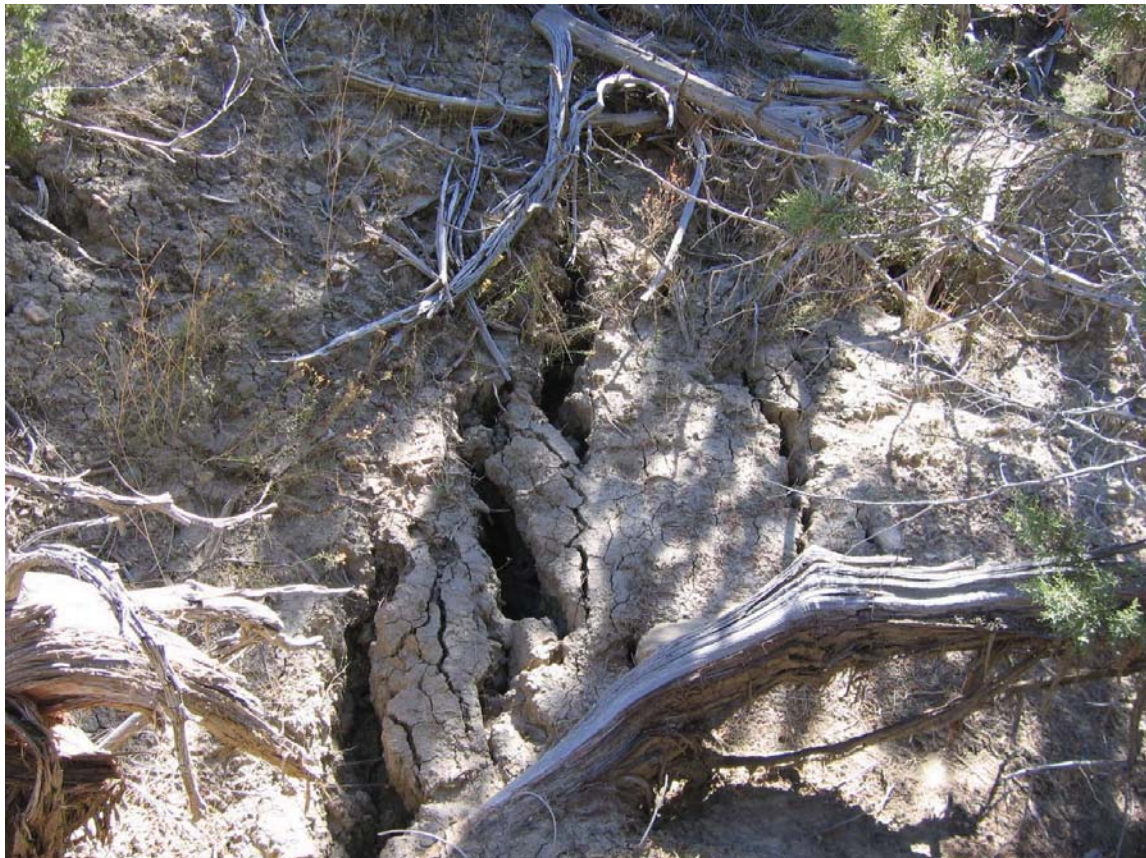
The east- and west-flank shear zones are characterized by en echelon, right- and left-stepping ground cracks, respectively (figure 7). Movement in 2005 resulted in nearly continuous ground-crack zones along both flanks from the head to the toe of landslide 1. The east-flank shear zone intersects Meadow Creek where the toe of landslide 1E deflects the creek about 43 feet (13 m) (figure 8). The west-flank shear zone intersects Little Meadow Creek a short distance upstream from a sinkhole that captures the entire creek flow. From that point, the creek flows through a natural tunnel in landslide debris for about 210 feet (64 m). Doelling and Davis (1989) described this tunnel, suggesting that it has existed for at least 20 years (their field observations date from the mid-1980s).

Figure 7. Right-stepping ground cracks along the left-flank shear zone of landslide 1.

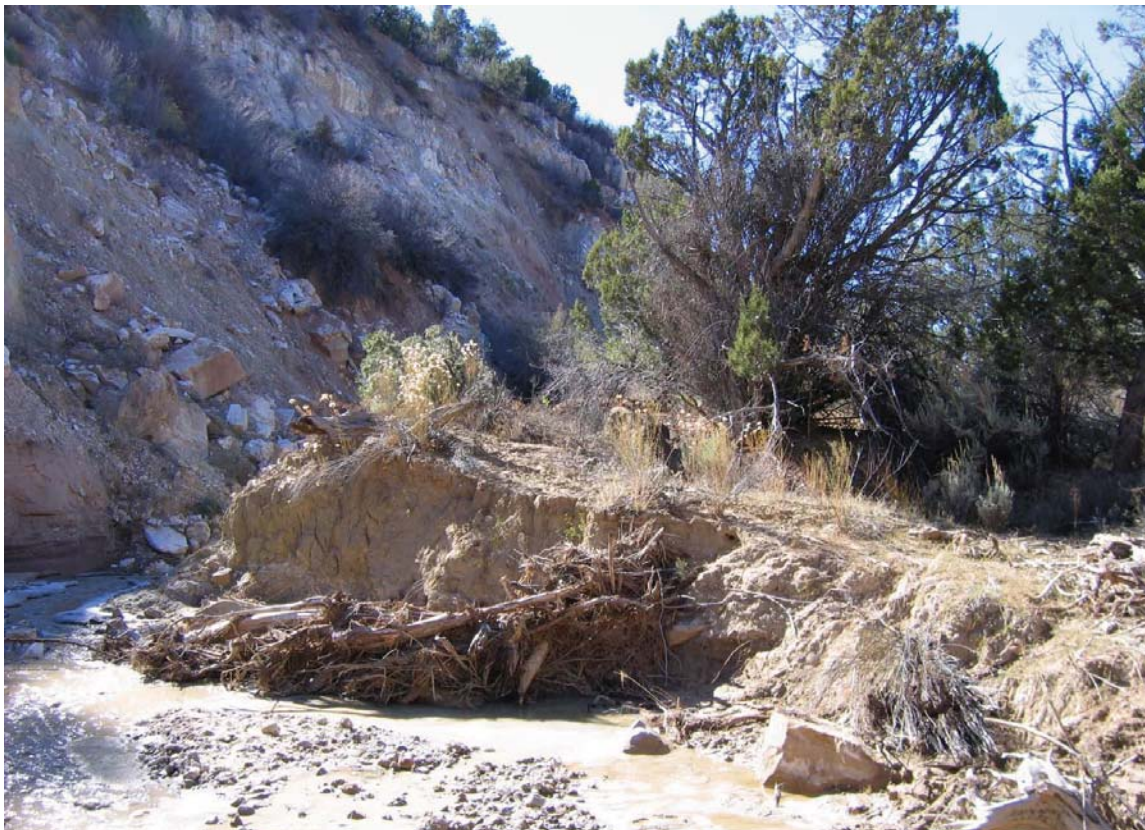
Figure 8. View downstream of southeast corner of landslides 1 and 1E where Meadow Creek is deflected about 43 feet (13 m).

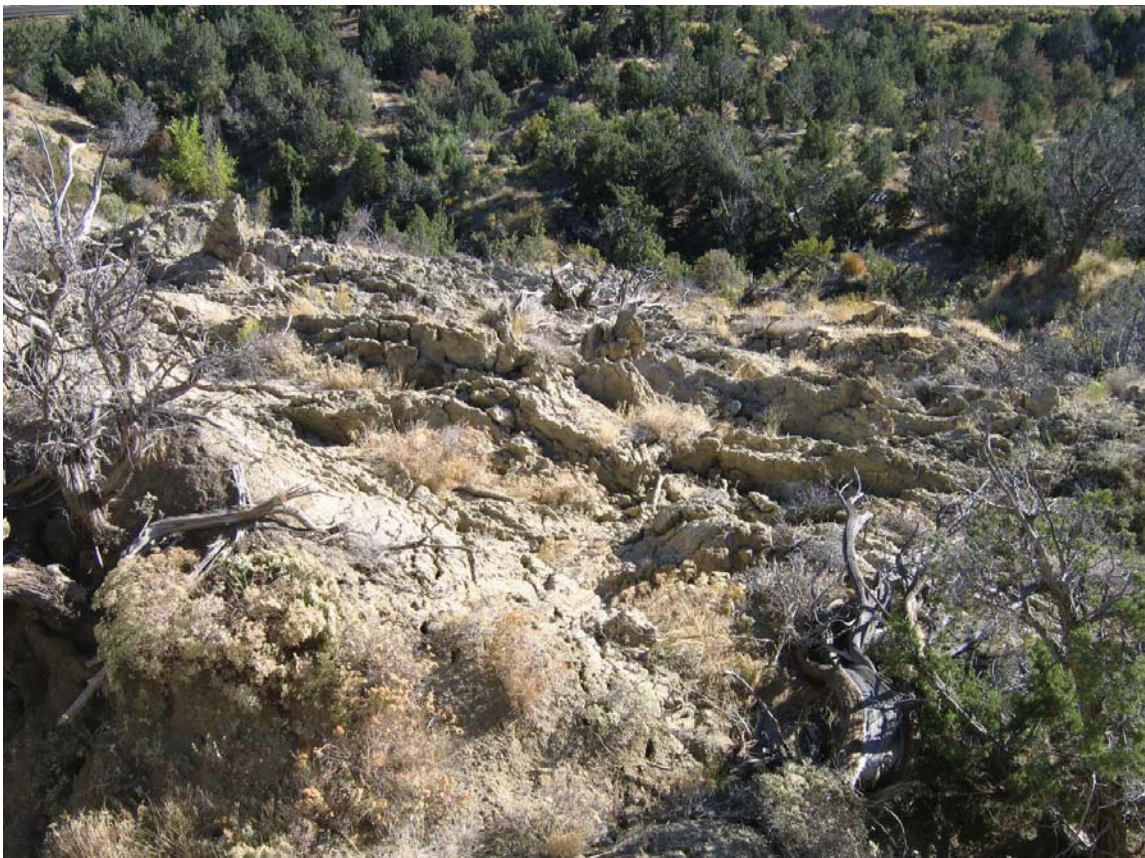
We mapped five slides (landslides 1A through 1E) within landslide 1, but other small, shallow, unmapped slides exist, particularly on local steep slopes along incised drainages. Landslide 1A is the largest of these landslides and its toe is about 165 feet (50 m) upslope of SR-9. The landslide is characterized by a prominent main scarp zone that follows an irregular trace and locally exceeds 20 feet (6 m) in height; a back-tilted area with a sag pond at its head; and an irregular, discontinuous toe thrust system. Movement of the landslide has displaced power poles on the lower part of the slide about 21 feet (6 m) by 2005. Locally, the ground surface is intensely deformed and disrupted (figure 9).

Figure 9. Local intense ground deformation along east flank of landslide 1A.

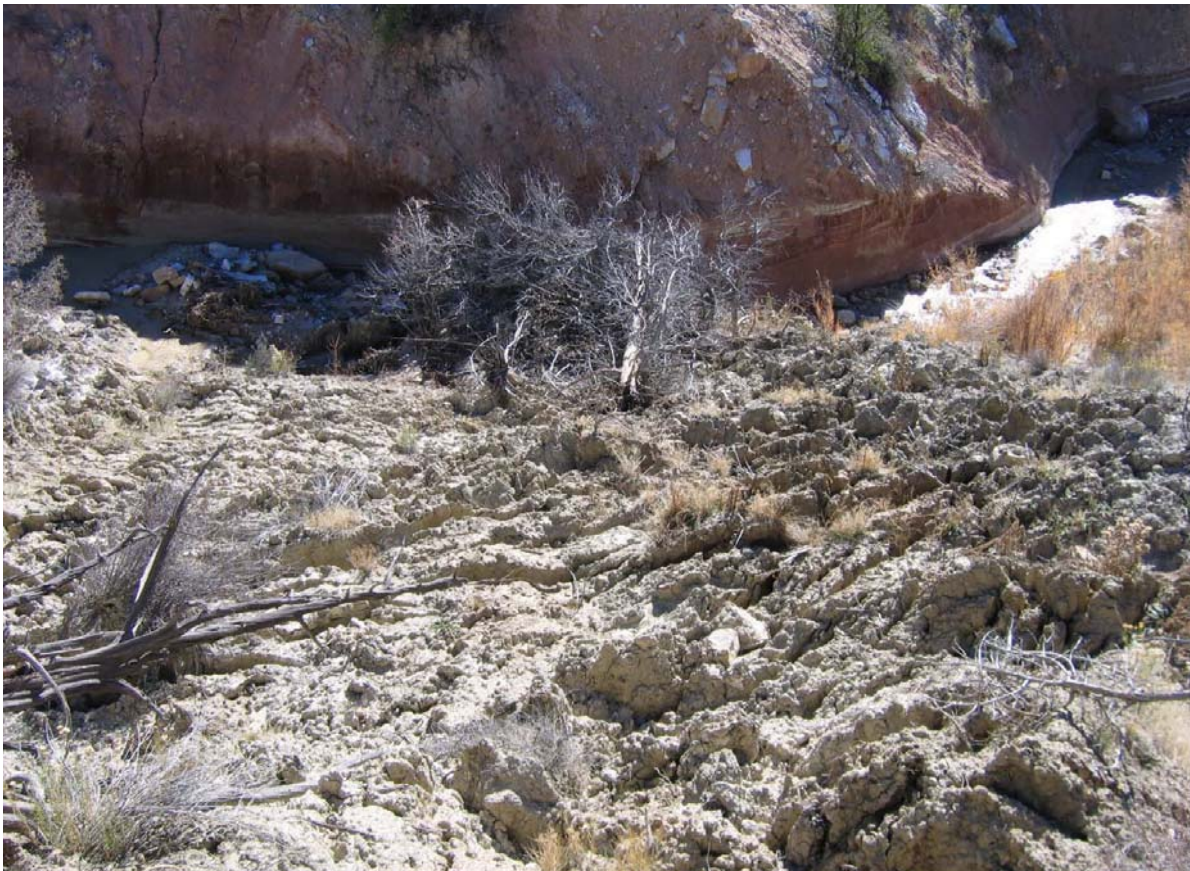
Figure 10. Local intense ground deformation in landslide 1D along Meadow Creek.

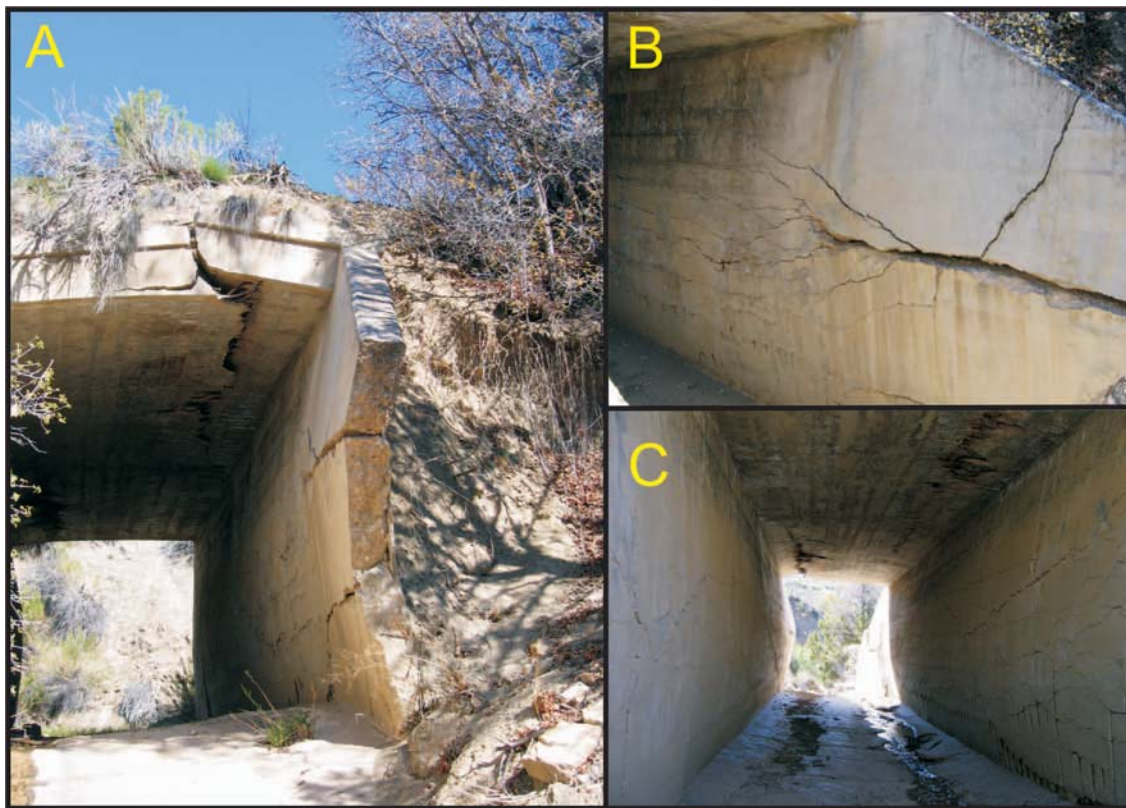
Figure 11. Damage to box culvert at abandoned SR-15 crossing of Little Meadow Creek. Damage suggests historical movement downslope of landslide 2. A) View upstream showing damage to northeast wall of box culvert and upper deck. B) Damage to northeast wall of box culvert. C) View downstream of interior of culvert showing hourglass distortion of originally rectangular box culvert.

of the southwestern part of the Meadow Creek landslide (the western part of the “creep zone”) or an as-yet unmapped slide that includes landslide 2. If the latter is true, this suggests that landslide 2 is a partial reactivation of a larger pre-existing slide that extends downslope to Little Meadow Creek.

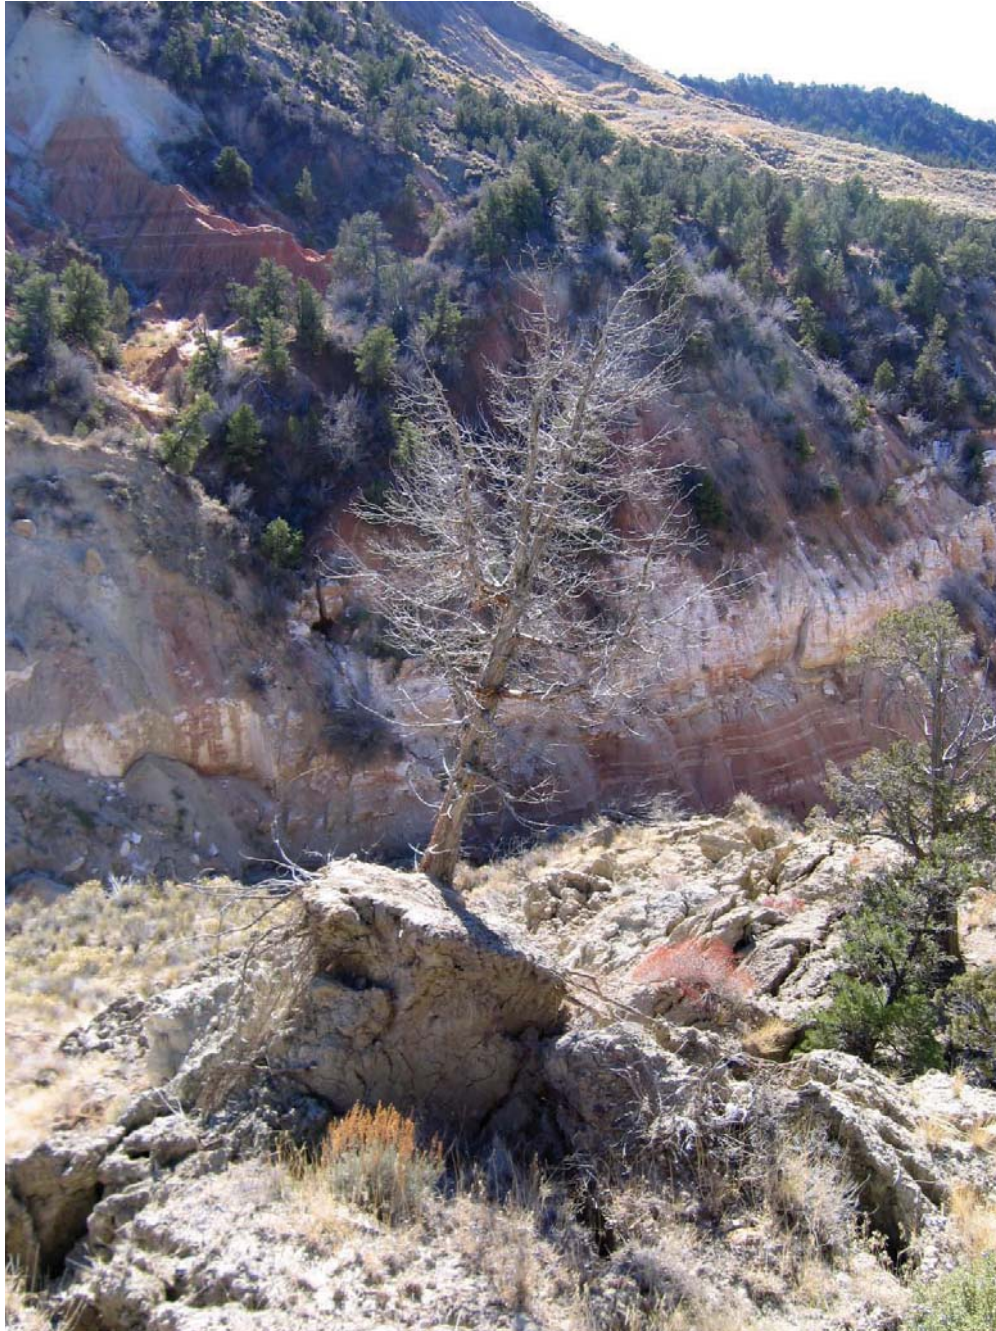
Figure 12. Local ground deformation caused by movement of landslide 3.

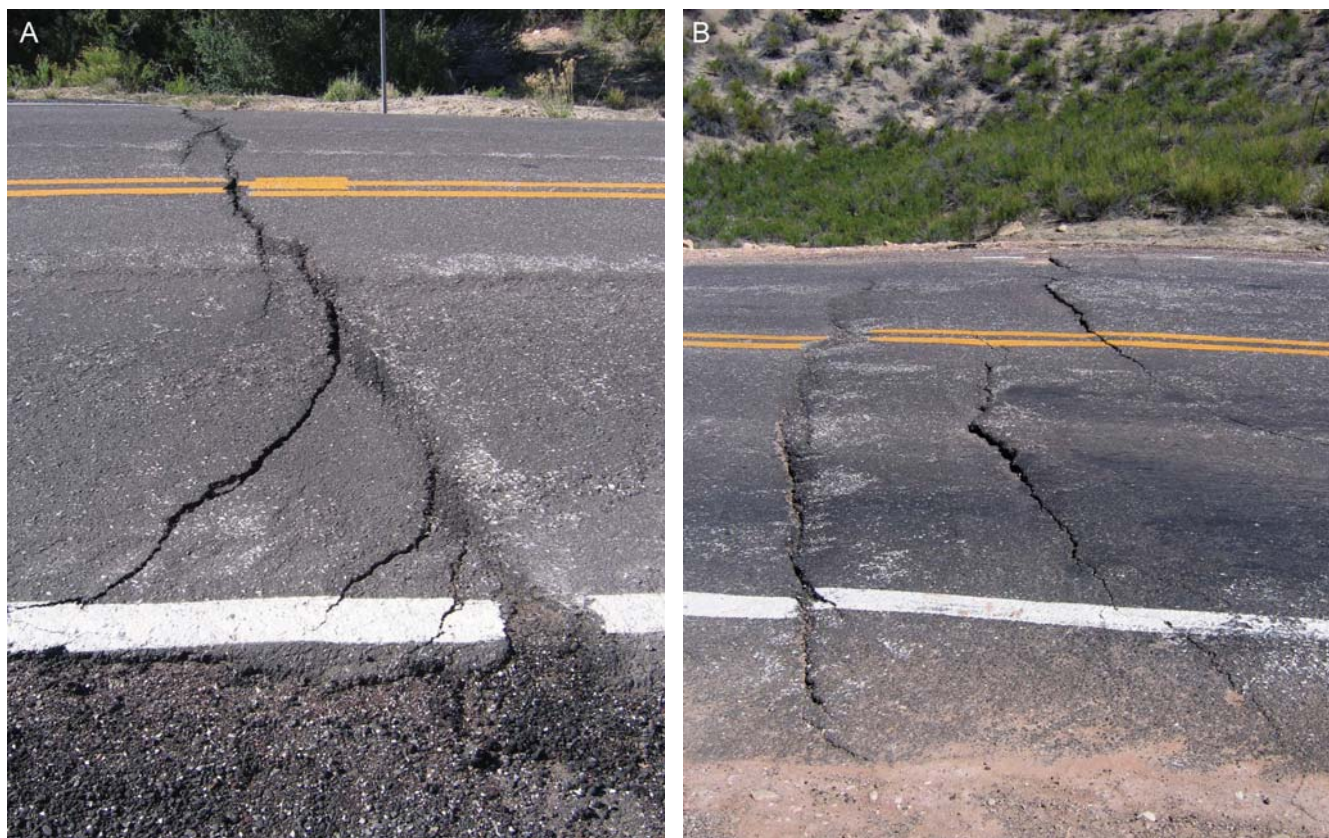
During our investigation, SR-9 was repeatedly repaired only to be recurrently damaged by persistent landslide movement between October 2005 and October 2008. The most severe damage to the highway occurred along longitudinal lateral shear zones that either bound or are internal to landslide 1 (figure 18). These structures accommodate differential rates of movement up to a factor of five. Damage to SR-9 along the west-flank shear zone of landslide 1 results from mostly ground-parallel right-lateral shear that forms left-stepping road cracks and discontinuous, zone-parallel, through-going shear fractures (figure 18A). Most of the damage between the west-flank shear zone and a major internal right-lateral shear zone results from similar ground-parallel right-lateral and locally left-lateral shear on discrete structures. Damage along the east-flank shear zone results from a combination of left-lateral shear and vertical movement (figure 18B).

Figure 18. Examples of damage to State Route 9 localized to shear zones that bound landslide 1. A) Left-stepping (diagonal cracks) merging into a nearly continuous right-lateral shear fracture along the west-flank shear zone. B) View upslope of parallel road cracks along the east-flank shear zone. Vertical offset accompanies left-lateral movement. Both photographs taken in May 2007.
