Special Investigation Report on the Safety of Parachute Jump Operations

NTSB/SIR-08/01
PB2009-917001

**National
Transportation
Safety Board**

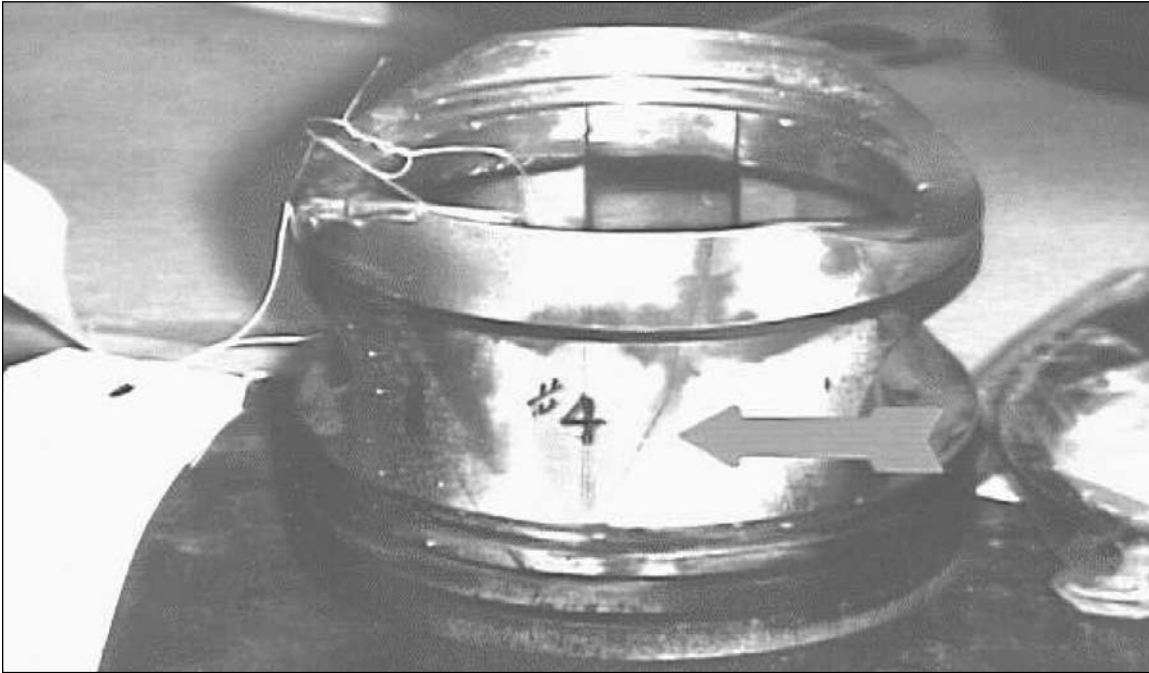
Two of these airplanes crashed following a loss of engine power. On August 14, 1993, a Cessna 182A lost engine power during takeoff and crashed in East Moriches, New York. The investigation found that inadequate piston manufacturing (all were of the same design and part number and were not manufactured by the original engine manufacturer⁵) resulted in fatigue cracking in the skirts of all six pistons. (See figure 1 on page 8.)

Although TCM SIL98-9A notes that "TCM cannot provide a TBO for engines that have been assembled with non-TCM-approved parts," it is possible that, had an overhaul been performed within the TCM-recommended TBO or sooner, the inadequately manufactured pistons and/or cracking could have been detected and corrected before engine failure occurred. Similarly, although the Sullivan, Missouri, accident airplane's right engine (which lost power) sustained damage that precluded determination of the

Figure 1. Cracking (visibility enhanced during examination with a liquid penetrant) on the No. 4 piston skirt from the East Moriches, New York, accident airplane.

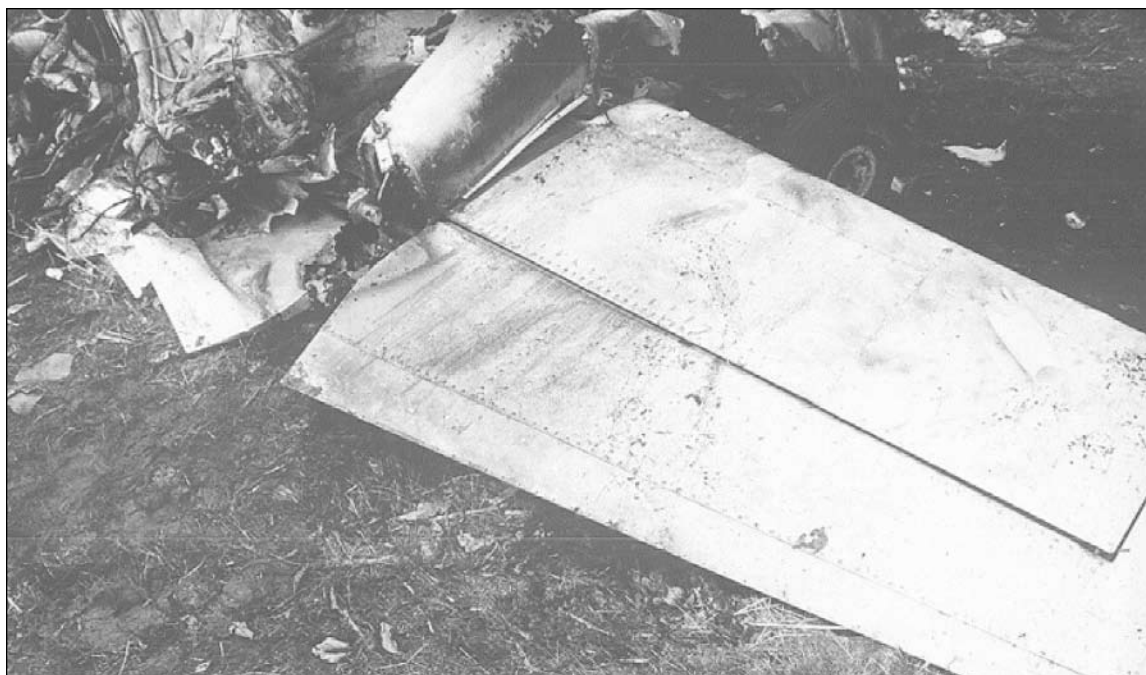
Figure 2. Engine oil coating the underside of the horizontal stabilizer on the Grain Valley, Missouri, accident airplane.

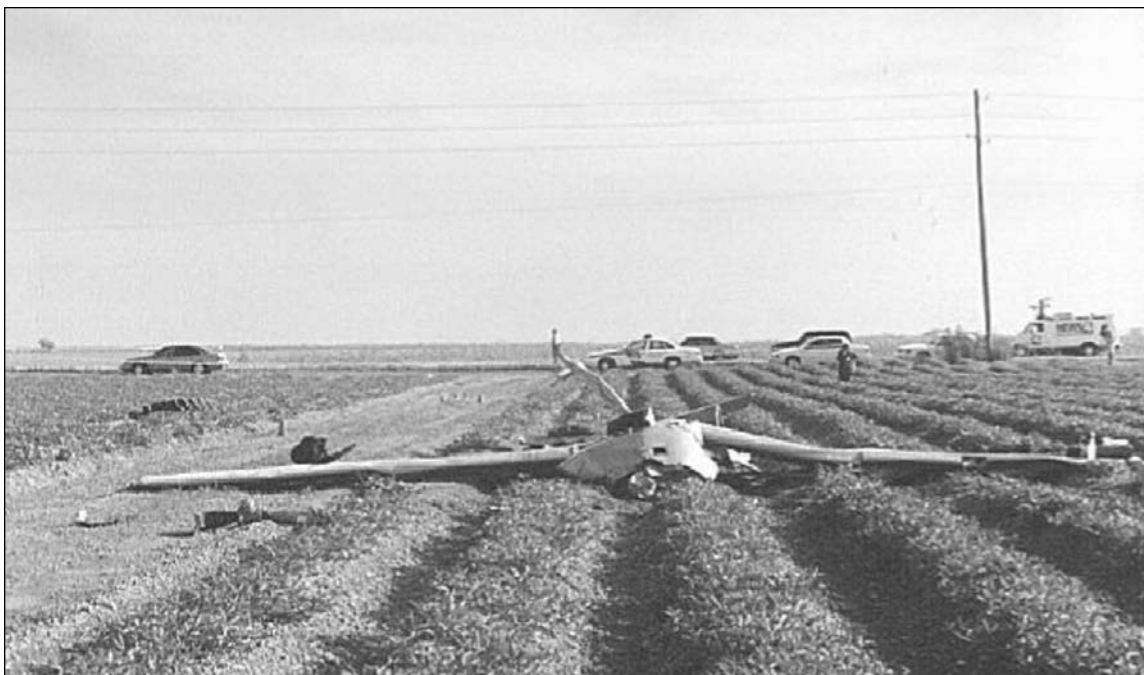
The pilot of the Cessna 205 that crashed May 25, 1997, in Homestead, Florida, had leveled the airplane at 3,500 feet and slowed it with the intent of allowing one parachutist to jump from the airplane before transporting the other parachutists on board to higher altitudes. As the first parachutist prepared to jump from the airplane, the airplane's left wing and nose dropped, and it entered a spin to the left. The airplane descended to the ground, and the pilot and five parachutists were killed; the parachutist who egressed at 3,500 feet survived. The investigation found that the commercial pilot failed to maintain airspeed as he slowed the airplane for the first parachutist's jump and that he failed to apply spin recovery emergency procedures. (See figure 3 below.)

Figure 3. Wreckage of the Homestead, Florida, accident airplane.

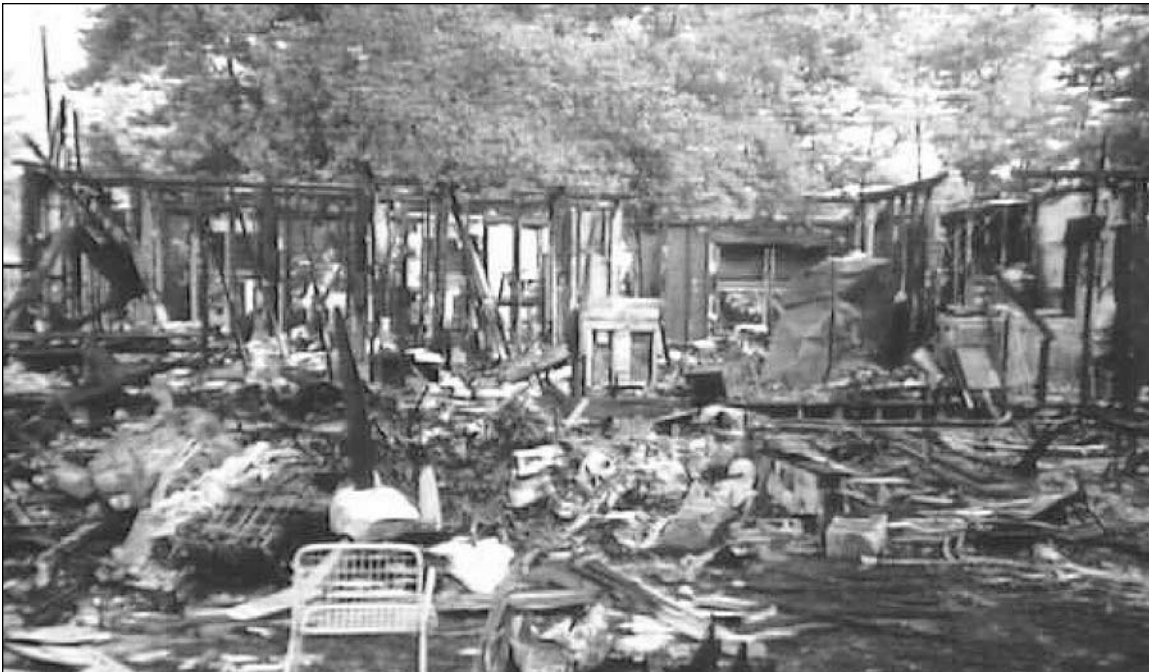
The investigation of the September 10, 1995, accident in West Point, Virginia, involving a Beech 65 that crashed following a loss of power in one engine on takeoff for undetermined reasons,¹⁵ killing the pilot, 10 parachutists, and 1 person in a house (see figure 4 below), revealed that the airplane's cabin seats had been removed, but maintenance records did not indicate when. Further, the maintenance records did not contain recalculated weight and balance information to correspond with other modifications (the accident airplane was loaded over its maximum gross weight and beyond its aft cg limit at the time that it crashed).

Figure 4. Remains of the house impacted by the West Point, Virginia, accident airplane.
