Subject: **Docket No. 50-361**
Confirmatory Action Letter - Actions to Address Steam Generator Tube Degradation
San Onofre Nuclear Generating Station, Unit 2

SONGS Unit 2 Return to Service Report

SONGS 2C17 Steam Generator Condition Monitoring Report

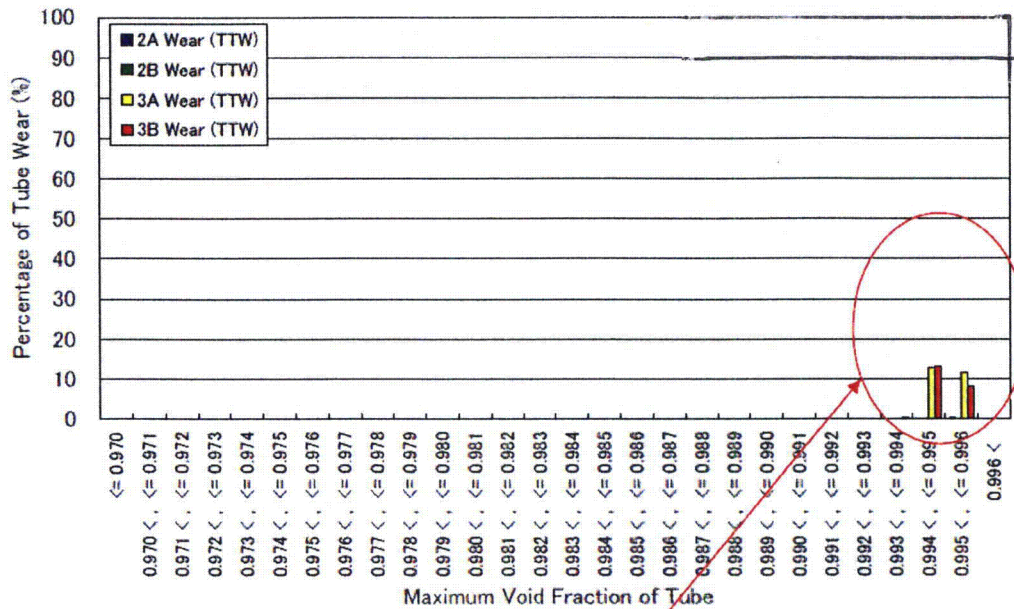
Figure 8-2: Maximum Void Fraction versus Power Level and Ratio of Tube Wear versus Maximum Void Fraction

Void fractions at the locations of tubes with TTW in the RSGs are shown in Figure 8-2. The figure demonstrates that the occurrence of TTW was limited to tubes operating with maximum void fractions of greater than 0.993.

Wear indication on tubes which are located in the region where max void fraction exceeds 0.993

By limiting power to 70% as presented in Table 8-2, void fractions are reduced to levels well below those associated with the TTW experienced at 100% power in the SONGS RSGs.

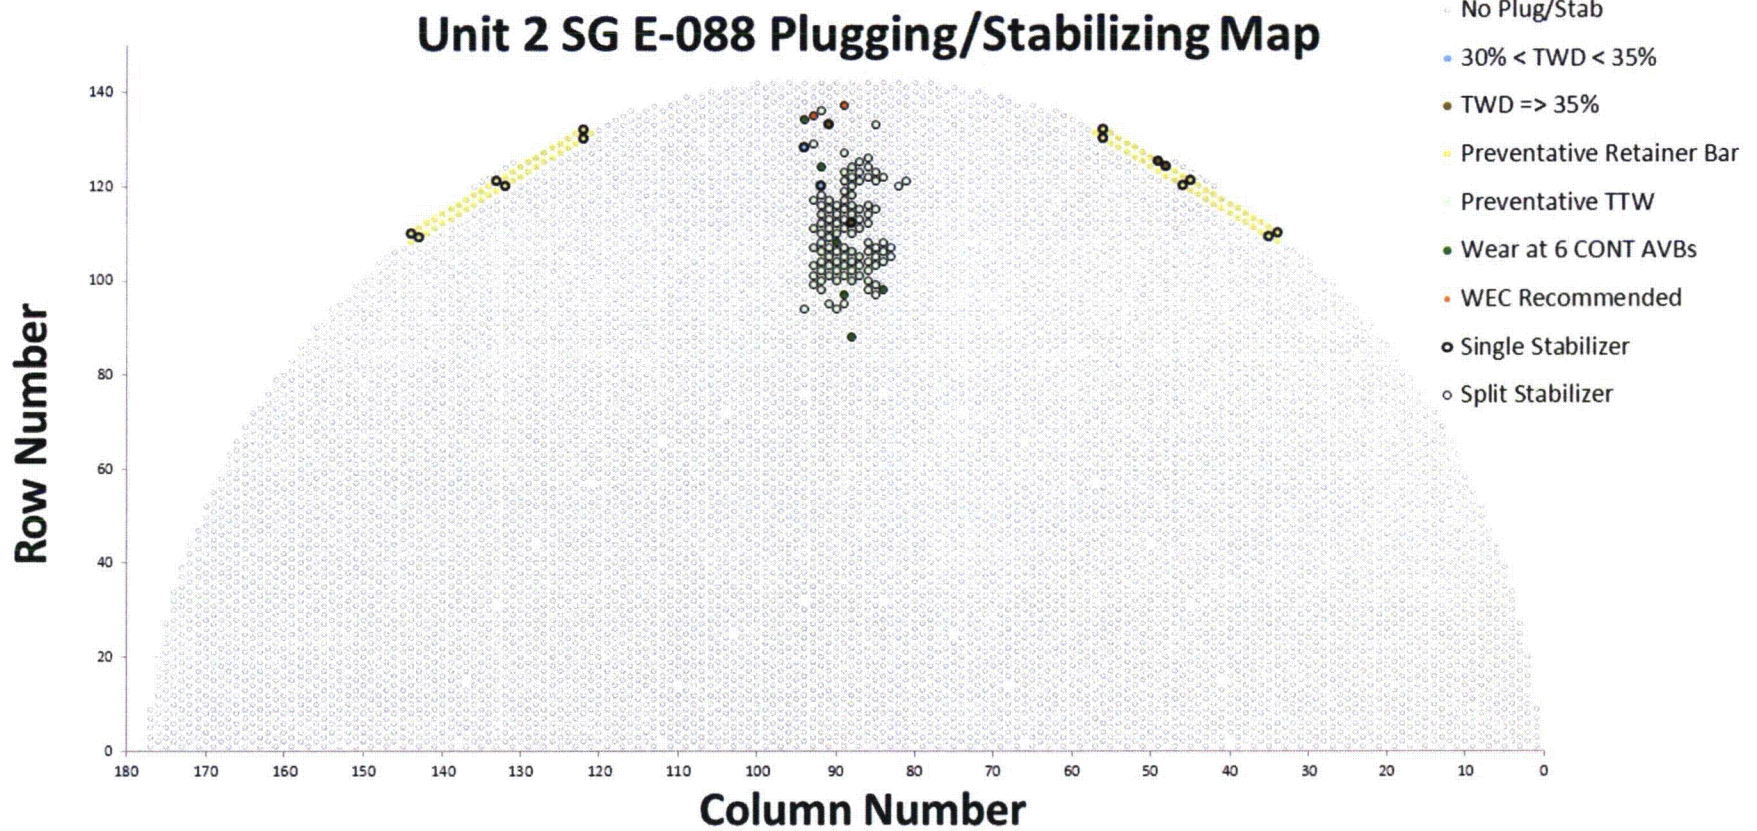
Figure 8-6: 2E-088 Plugging and Stabilizing Map

Steam Generator	TWD \geq 35% at AVB	TWD 30-35% at AVB	Wear at RB	TTW	Preventive Retainer Bar	TTW Preventive			Total Tubes Selected
						MHI Screening Criteria	Wear at 6 Consecutive AVBs	WEC Screening Additions	
2E-088	2	2	2	0	92	101	6	2	207
2E-089	0	0	4	2	90	203	6	3	308

2. SCE plugged the two tubes with TTW in Unit 2. As a preventive measure, additional tubes were plugged in the Unit 2 SGs. Tubes were selected for preventive plugging using correlations between wear characteristics in Unit 3 tubes and actual wear patterns found in Unit 2 tubes. Removing these tubes from service will prevent any further wear of these tubes from challenging tube integrity.
