**AREVA Document 51-9180143-001
SONGS Unit 3 February 2012 Leaker Outage
Steam Generator Condition Monitoring Report**

Document No.: 51 - 9180143 - 001

SONGS Unit 3 February 2012 Leaker Outage - Steam Generator Condition Monitoring Report

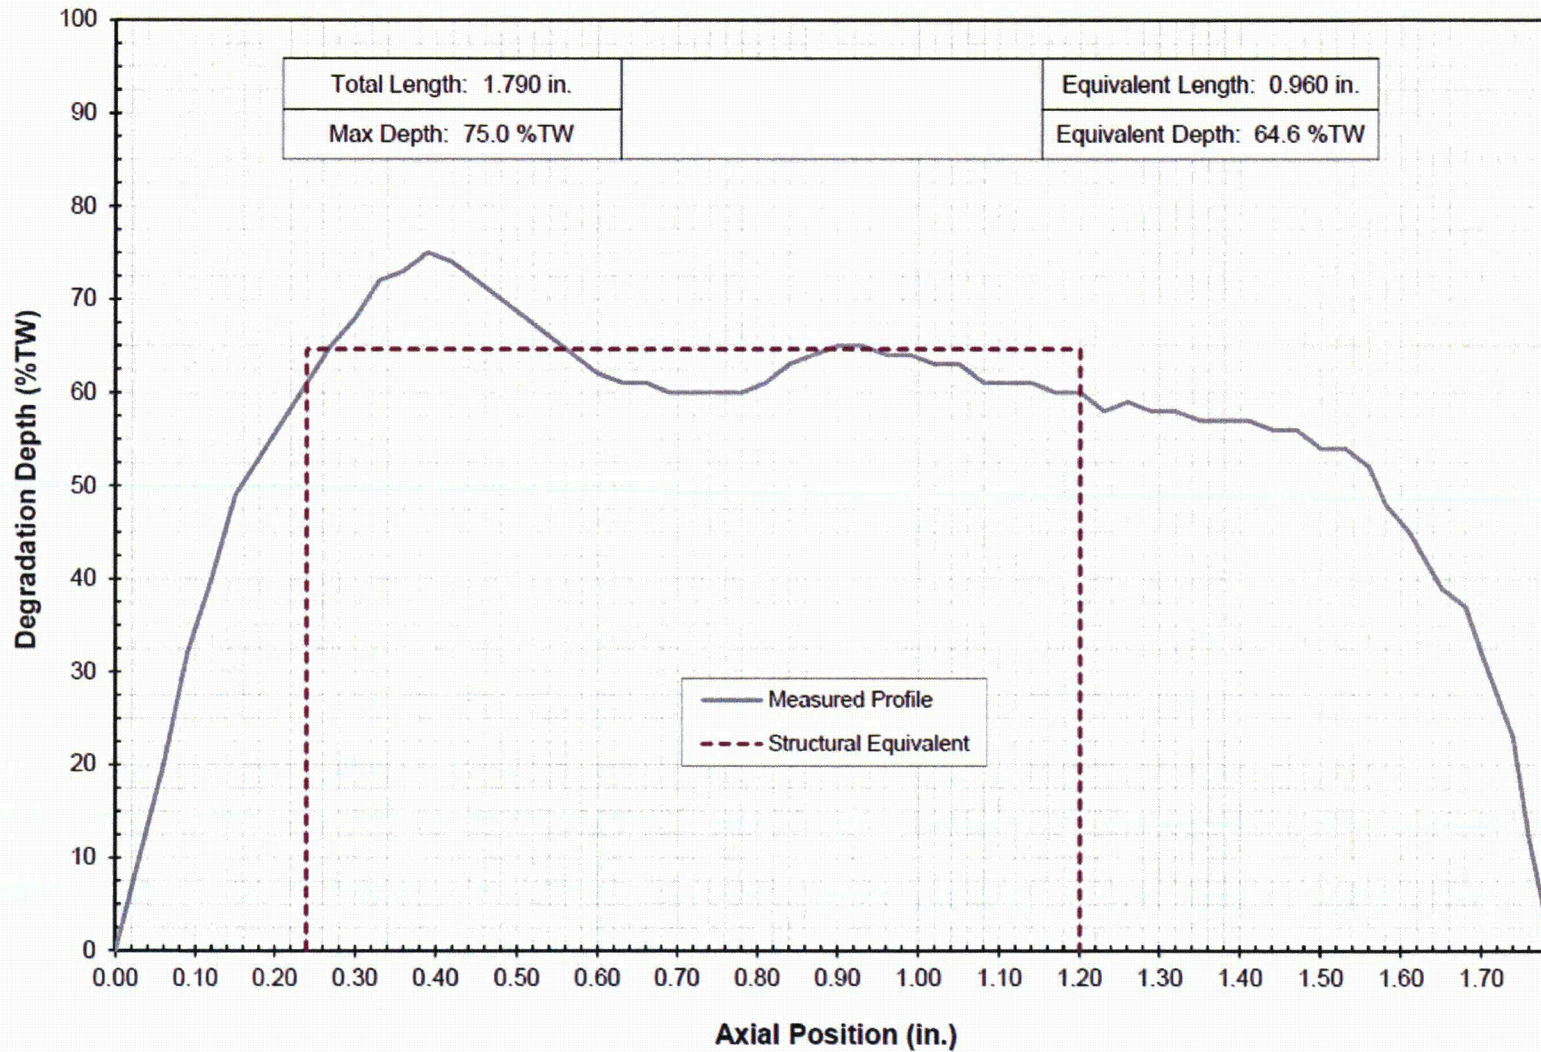
Figure 8-7: Axial Depth Profile – SG 3E-088 R106 C78 07H-1

After cooling to Mode 5 and draining the primary coolant system to midloop, the leaking SG tube (SG 3E-088 R106 C78) was located by filling the secondary side of the SG and pressurizing to 80 psig with nitrogen. The leak location was confirmed by eddy current testing to be within the U-bend portion of the tube bundle, in the tube freespan. The tube degradation which resulted in the leak was tube-to-tube wear (TTW) caused by tube movement caused by fluid-elastic instability (FEI).
