Highway–Railroad Grade Crossing Collision
US Highway 95
Miriam, Nevada
June 24, 2011

Accident Report

NTSB/HAR-12/03
PB2013-103891

Highway Accident Report

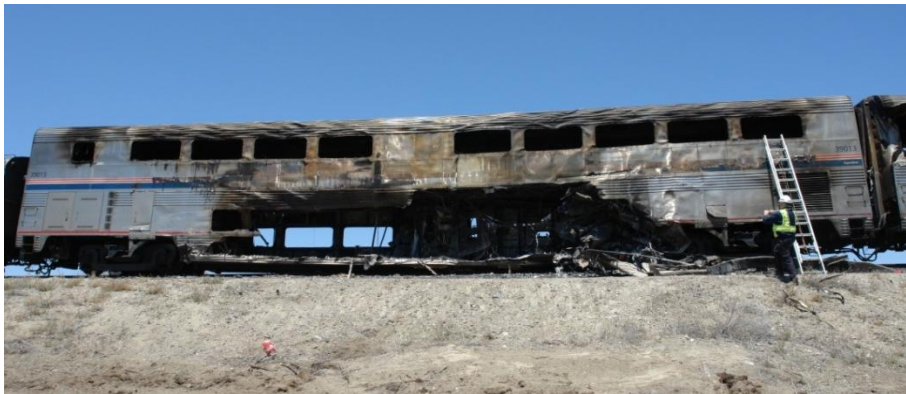
1.5.1.1 Crew Sleeper Railcar 39013. During the accident sequence, the left front of the truck-tractor struck the bilevel crew sleeper railcar near the midpoint of its forward wheel assembly. (See figure 5.) Postrecovery examination showed that the railcar roof had a wavy appearance consistent with distortion due to high temperatures. All the railcar windows had melted. The outer surfaces of the stainless-steel side panels had pronounced thermal discoloration, as evidenced by blue- and straw-colored hues. On the forward end of the railcar, the rubber diaphragm that surrounded the car-to-car door opening was intact. On the aft end of the railcar, the fire had consumed the rubber diaphragm on the car-to-car door leading to the trailing coach railcar. The interior compartment of the lower level was destroyed, rendering it substantially a continuous open space. The fire consumed all combustible materials in the lower level and destroyed the upper level of the railcar.

Figure 5. Photograph of crew sleeper railcar 39013, with front of railcar at left, showing where accident truck-tractor penetrated lower level and ensuing fire engulfed railcar.

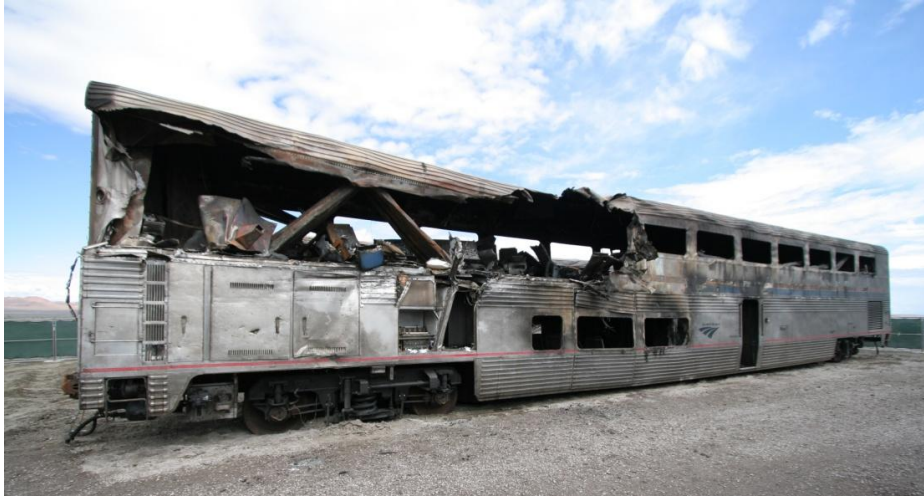
1.5.1.2 First Coach Railcar 34033. The coach railcar behind the crew sleeper railcar also sustained impact and subsequent fire damage, as shown in figures 6 and 7. This bilevel railcar had passenger seating on the upper level, and lavatories and a smaller passenger compartment on the lower level. During the accident sequence, the first trailer of the accident truck penetrated the upper level sidewall panel of the railcar, and the impact damage continued longitudinally toward the aft end. This damage resulted in an opening in the left sidewall panel, extending horizontally from the forward corner-post of the upper level passenger compartment and progressing aft about 33 feet (which is about 40 percent of the length of the railcar). The seating area at the forward end of the upper level passenger compartment also showed signs of impact damage.

Figure 6. Photograph of first coach railcar 34033 at impound lot, with front of railcar at left, showing extent of damage caused by collision with first side-dump trailer and fire damage throughout railcar.

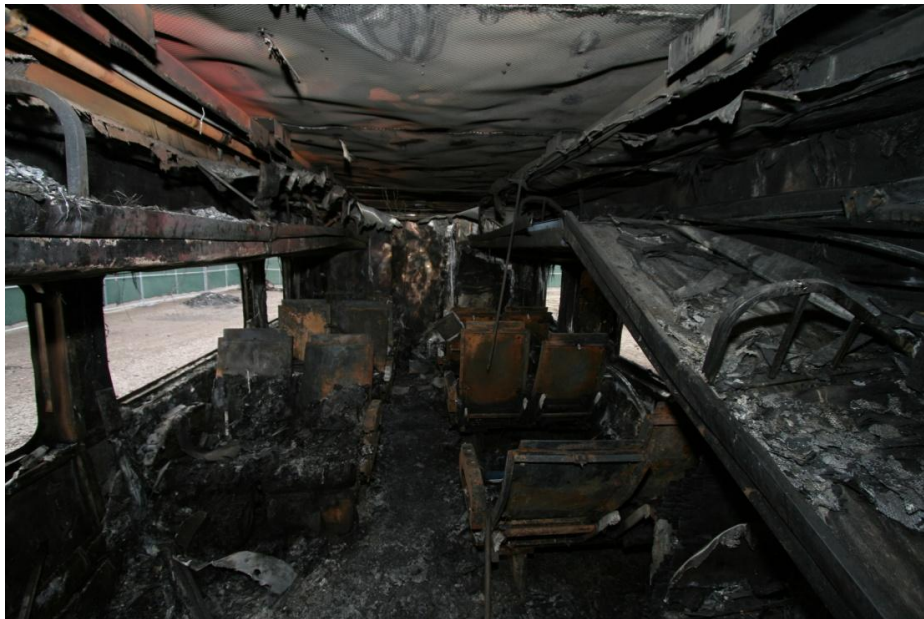
Figure 7. Photograph of interior of lower level of first coach railcar 34033, showing extensive structural and fire damage.

The fire consumed the passenger compartment on the lower level of the first coach railcar, leaving only small scraps of charred materials. The fire also consumed the passenger compartment on the upper level. All the windows of this coach railcar had melted or were missing, with the exception of two on the lower right-hand side, which were charred but remained in position. The fire had destroyed the rubber diaphragm surrounding the car-to-car door at the forward end of the railcar. The outer door mode control switch was found to be in the

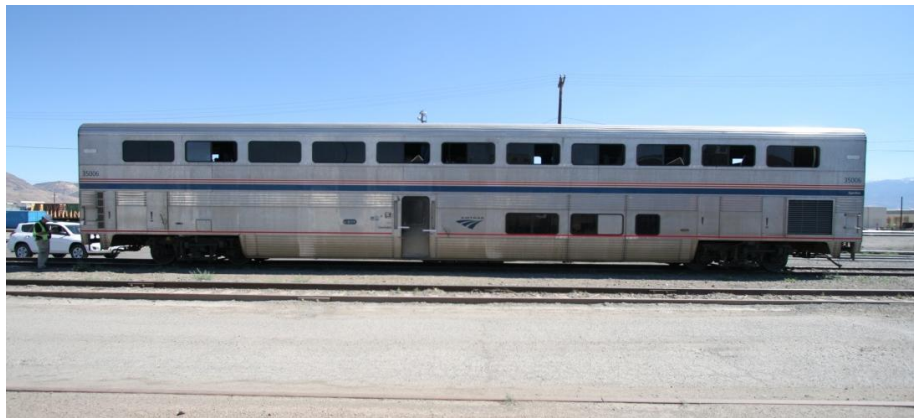
1.5.1.3 Second Coach Railcar 35006. The second coach railcar had an upper level passenger compartment, and a lower level consisting of a snack bar and lavatories. This railcar sustained only fire damage. Soot covered the exterior of the railcar. (See figure 8.) The lower level windows on the left-hand side were opaque due to degradation from thermal exposure. On the right-hand side, the lower level windows were covered with soot but had not become opaque. Thermal buckling of the roof structure was observed from the forward portion of the railcar to its middle. The fire consumed the rubber diaphragm of the forward car-to-car door, with more extensive damage on the right side than on the left. The window of the car-to-car door had melted and fallen out of position. Apart from soot, the lower level of the railcar did not sustain fire damage. The passenger compartment on the upper level was coated with soot throughout. (See figure 9.) At the forward end of the passenger compartment, the ceiling and luggage rack materials were charred. This charring extended to approximately the seventh row of seats from the front.

Figure 8. Photograph of second coach railcar 35006 at impound lot, with front of railcar at left.

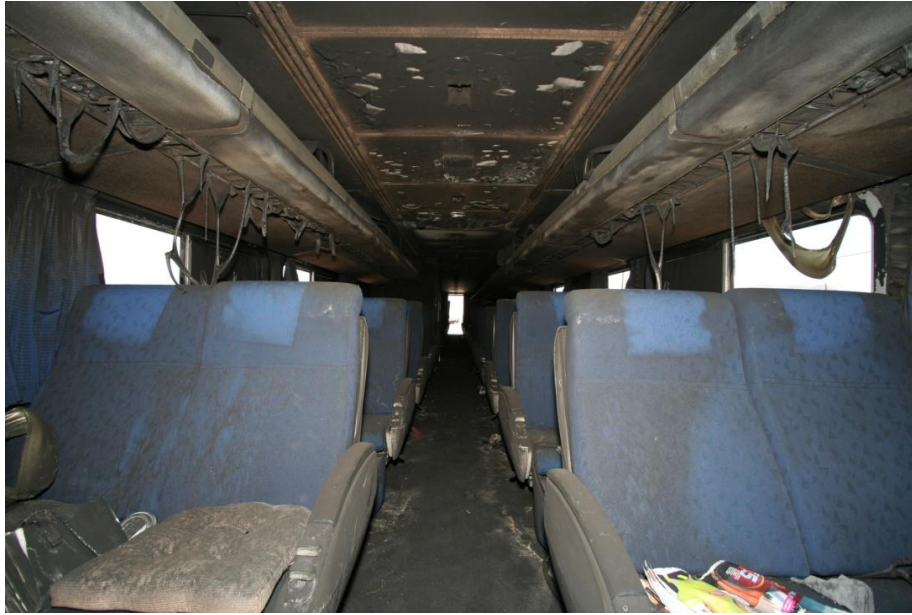
Figure 9. Photograph of interior of second coach railcar 35006, showing damage from heat and soot throughout.

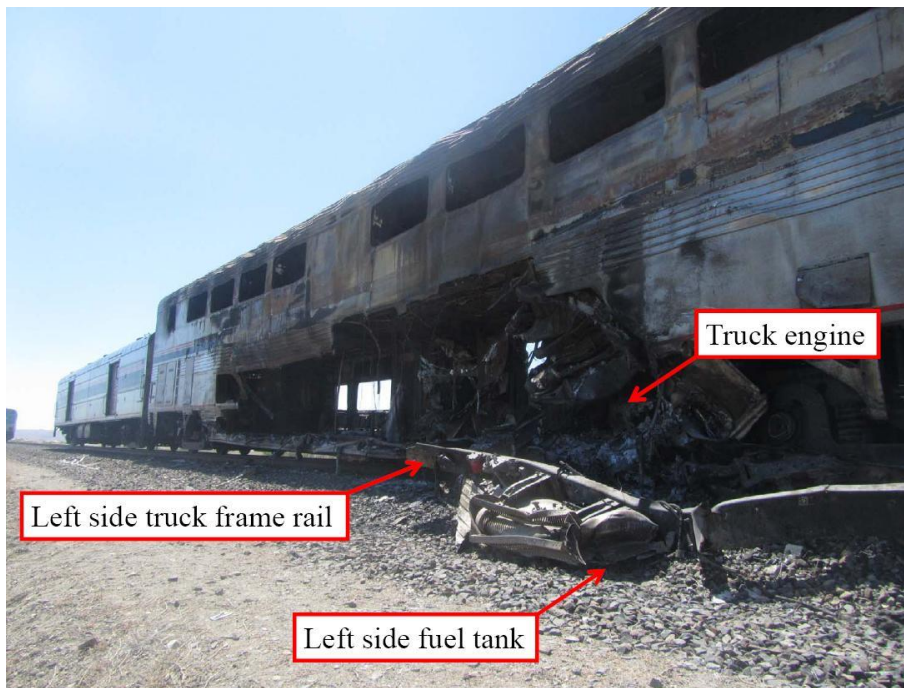
Figure 12. Photograph of portion of damaged train, showing frame-rail elements and engine of accident truck embedded within and extending from side of crew sleeper railcar.

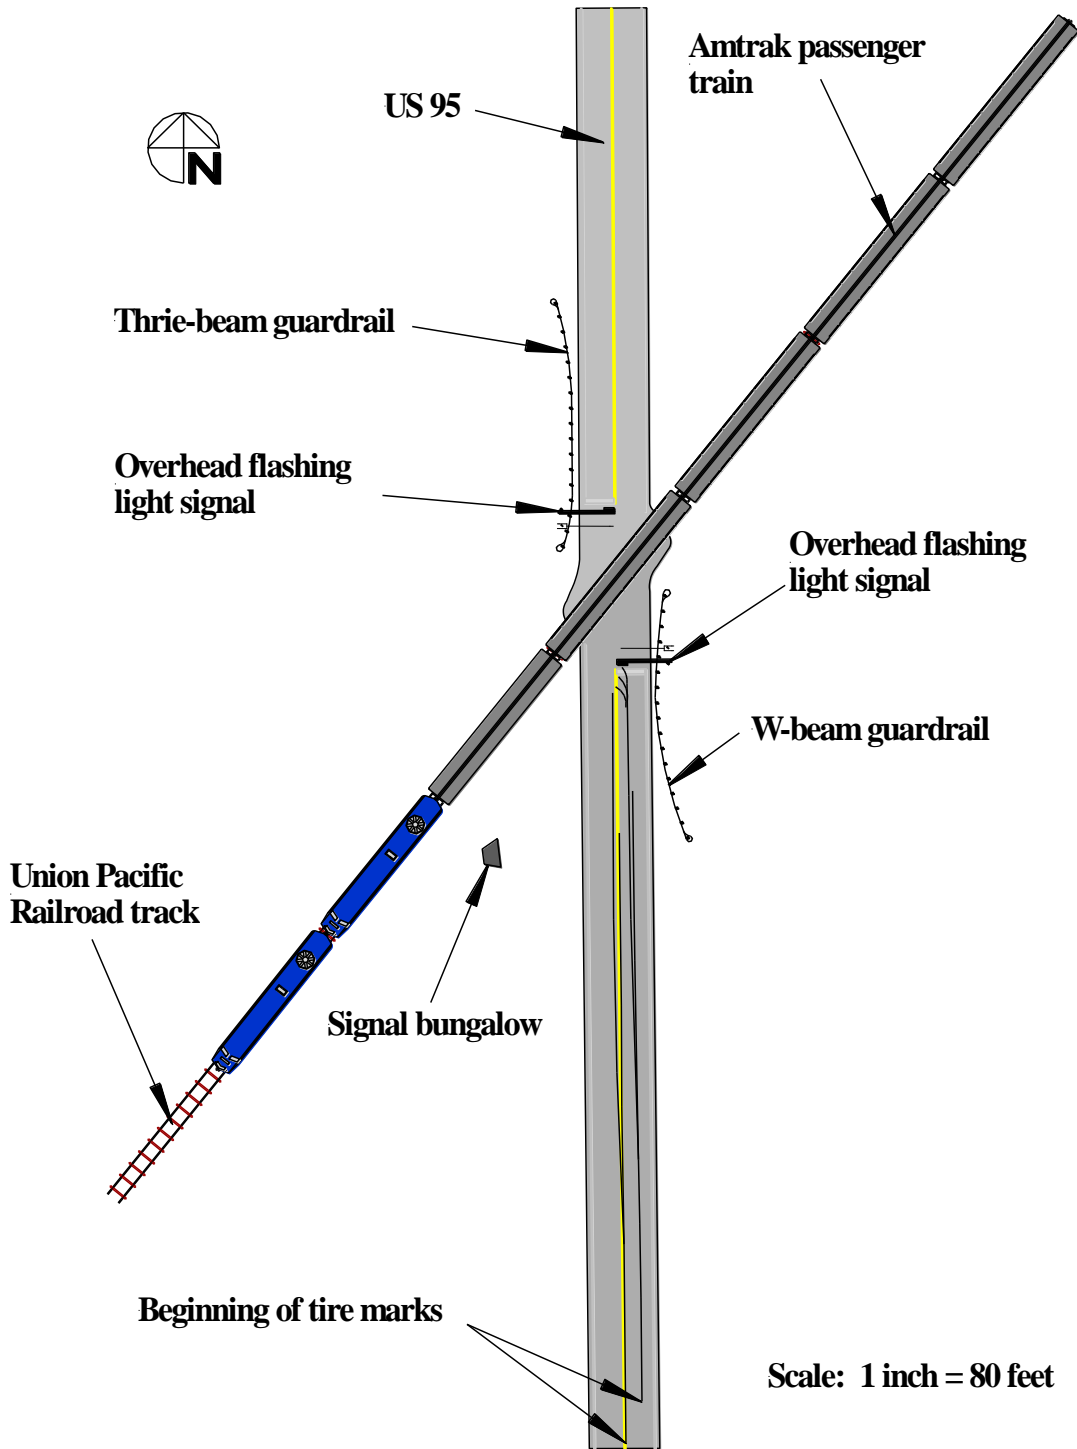
Figure 22. Diagram depicting tire marks left by accident truck in northbound lane of US 95.
