National Transportation Safety Board

Marine Accident Brief

Accident No.	DCA-12-LM-008 ¹
Accident Type	Collision
Vessels	Uninspected towing vessel <i>Natures Way Commander</i> pushing loaded barge <i>ACBL 3111</i> Two moored U.S. Army Corps of Engineers deck barges
Location	Gulf Intracoastal Waterway, Morgan City–Port Allen Alternate Route, near Port Allen Lock, Louisiana 30°26.195' N, 91°13.118' W
Date	February 1, 2012
Time	1630 central standard time ²
Injuries	None
Environmental damage	None
Weather³	Winds 34 mph west-southwest, gusts to about 40 mph Air temperature 63° F
Waterway characteristics	Canal was 324 feet wide in accident area, with available clear width reduced by barges (per U.S. Coast Guard)

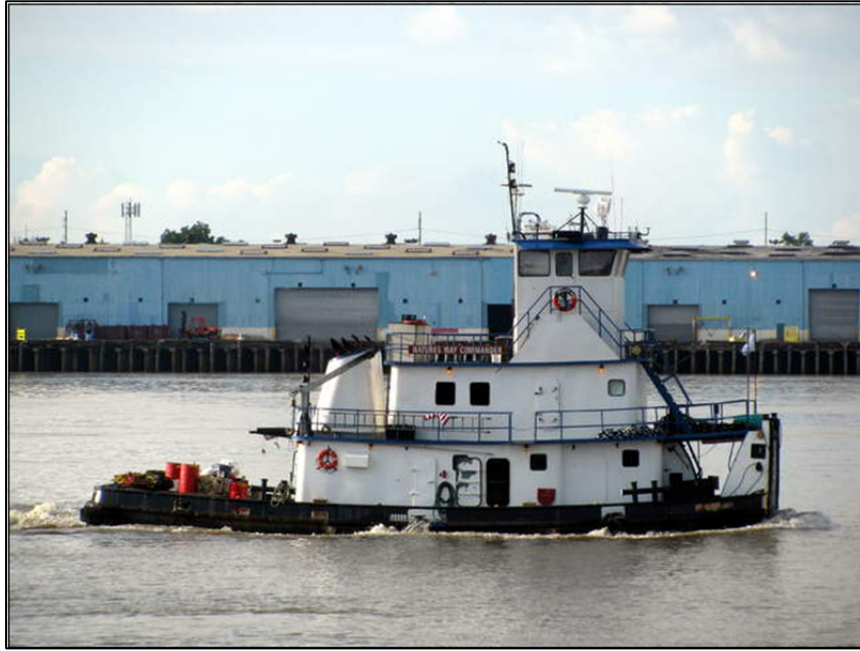
Figure 1. The uninspected towing vessel *Natures Way Commander*.
