**National Transportation Safety Board**  
Washington, D.C. 20594

**Railroad Accident Brief**

**Accident No.:** DCA-11-FR-004  
**Location:** Mineral Springs, North Carolina  
**Date:** May 24, 2011  
**Time:** 3:35 a.m. eastern daylight time  
**Railroad:** CSX Transportation  
**Property Damage:** \$1.6 million  
**Injuries:** 2  
**Fatalities:** 2  
**Type of Accident:** Rear-end collision

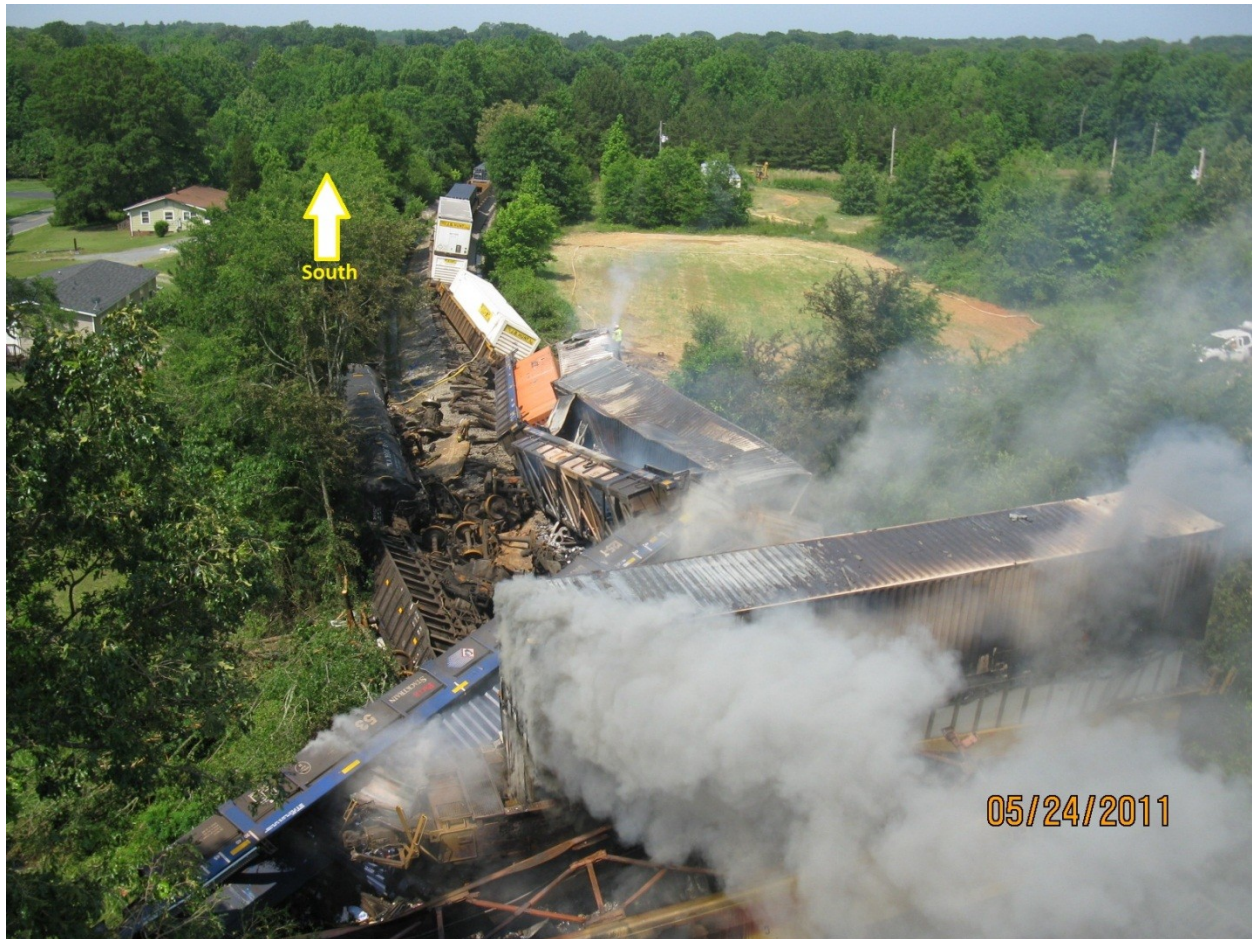
In the accident, two locomotives and the first nine cars of the striking train and the last four cars of the struck train derailed. (See figure 1.) The two crewmembers of the striking train were fatally injured; the two crewmembers of the struck train were treated for minor injuries. Property damage was estimated to be \$1.6 million.

**Figure 1.** View of accident site showing derailed cars from the striking train.

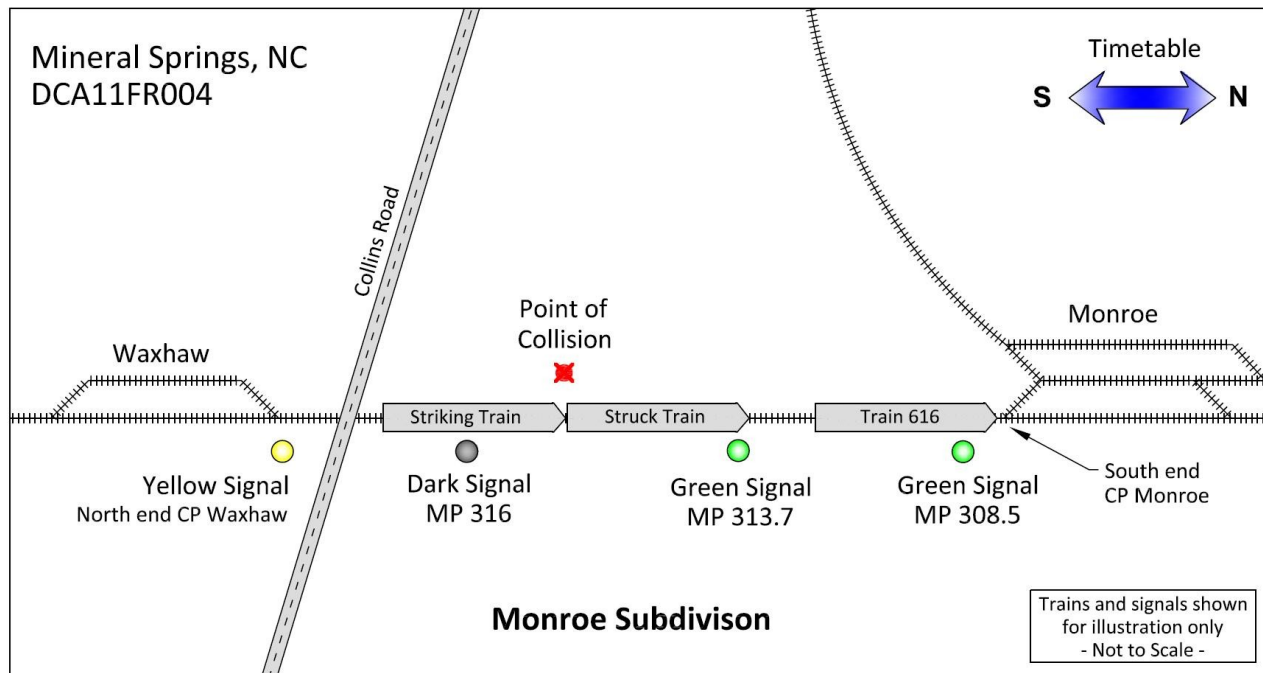
After stopping at the signal for about 10 minutes, train 616 began to move northward after receiving a green signal. Then the crew of the struck train received a green signal to proceed, and their train was struck by the striking train. (See figure 2.)

**Figure 2.** Diagram of accident area.

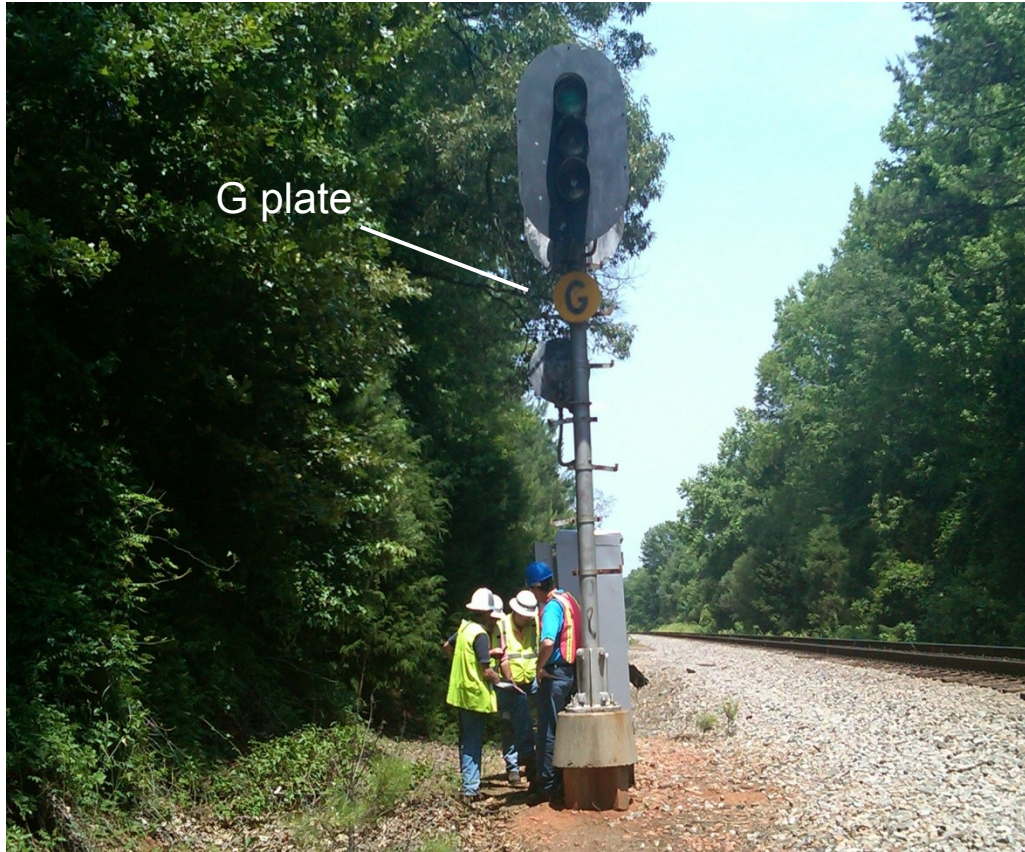
**Figure 3.** NTSB signal investigators inspecting signal at MP 316 with attached G plate.

Testing of the signal at MP 316 revealed that the red aspect<sup>6</sup> of the signal was not illuminated. Further testing found that the signal lamp for the red aspect was burned out.

In this case, both the red signal at MP 313.7 and the dark signal at MP 316 were reported in the same ticket. The ticket was closed once the red signal at MP 313.7 was resolved.

than 15 mph). Therefore, the failure of the CSX to repair the reported dark signal, although it was a fault within the incident reporting system, was not a factor in this accident.

During the on-scene investigation, CSX representatives recognized a fault in the CSX signal incident reporting procedures. The CSX implemented a corrective change, and reporting procedures now allow only one signal incident to be reported on each trouble ticket. To close a ticket, signal personnel must enter a specific remedy for the reported incident.
