NINEWA PROVINCIAL POLICE  
HEADQUARTERS  
MOSUL, IRAQ

**SIGIR PA 06-072**  
**OCTOBER 10, 2006**

SUBJECT: Report on Project Assessment of the Ninewa Provincial Police Headquarters,  
Mosul, Iraq (Report Number SIGIR-PA-06-072)

## Ninewa Provincial Police Headquarters, Mosul, Iraq

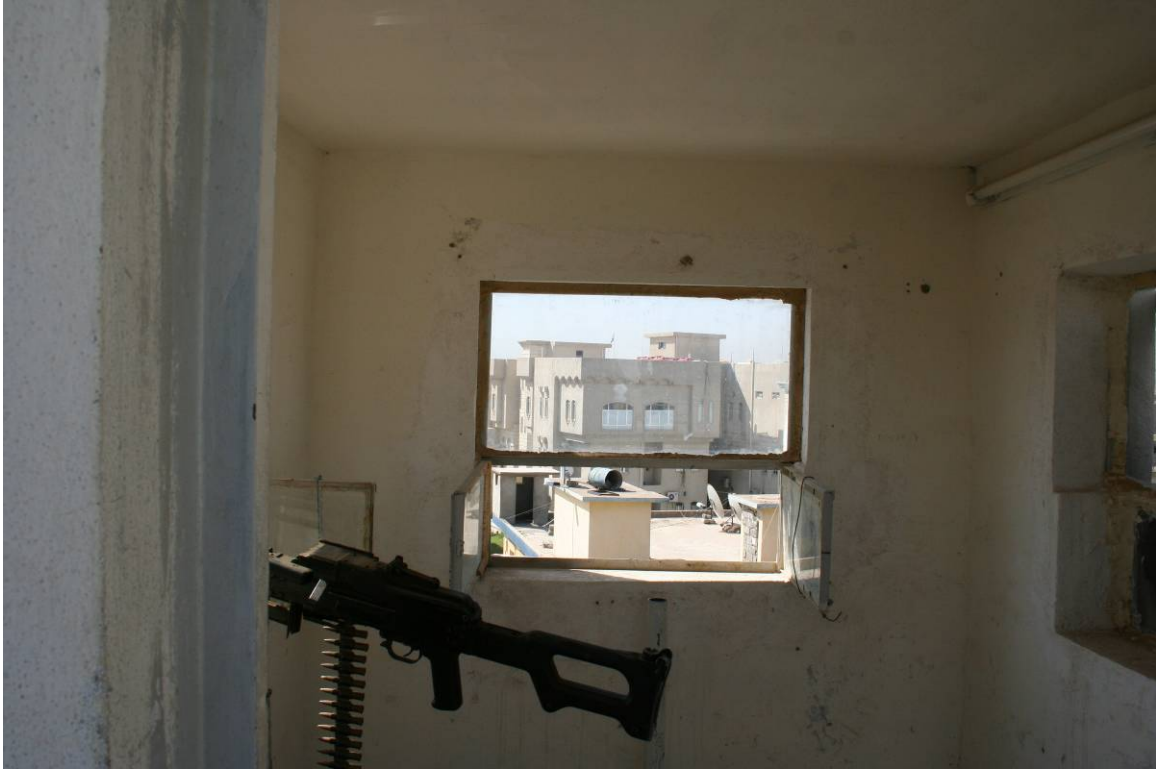
The guardhouses on the commander building did not include a fan as required and were constructed with an extra window. As a result, exposure of the guards was increased. There was no evidence that roof repairs were completed in accordance with contract terms. The contractor did not install 81 of the 134 air conditioner units specified in the BOQ. The contractor neither renovated the existing water supply system nor provided new water supply and distribution systems components when required. Old and corroded galvanized water tanks and pipes were not replaced. Throughout the facility, wall and bathroom construction and refurbishment were very substandard. Walls and enclosures were crudely constructed. Wall repainting was not complete. Multiple bathroom defects were the result of the contractor's failure to comply with numerous design and specification requirements. For example, showers were not tiled from floor to ceiling, existing wall tiles and surfaces were improperly painted, defective toilet fixtures were not replaced, and defective plumbing hardware was sometimes by-passed or painted to avoid replacement with new hardware. While a new bathroom addition was completed, it was not constructed to specifications. The generator supplied by the contractor was placed at the wrong location without a hookup. Although required, the main septic tank was not replaced with the required tank with three times the capacity of the original. Debris, rubble, and waste materials

**Site Photo 1. Contrary to contract requirements, four guardhouses were built without a fan, but with an extra window which increases the exposure of the guards.**

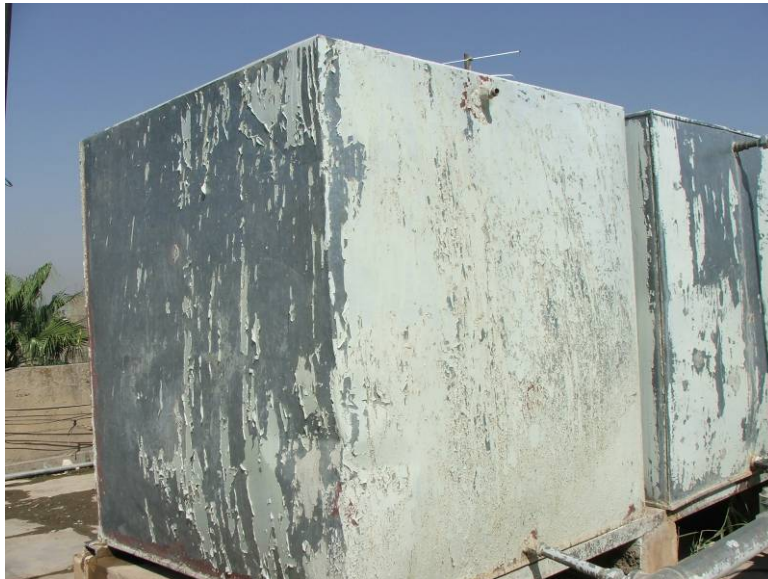
**Site Photo 3. Existing water tanks left in place versus installing new units as required.**

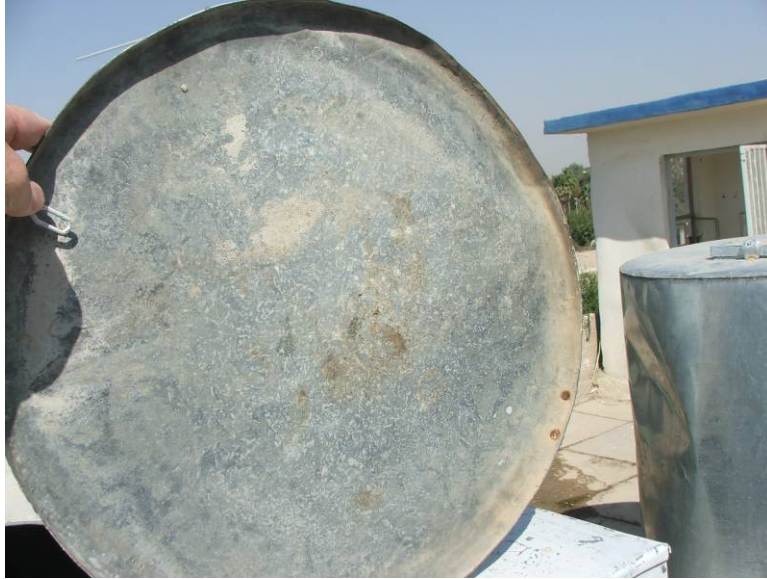
**Site Photo 4. Lid from existing galvanized tank showed substantial corrosion.**

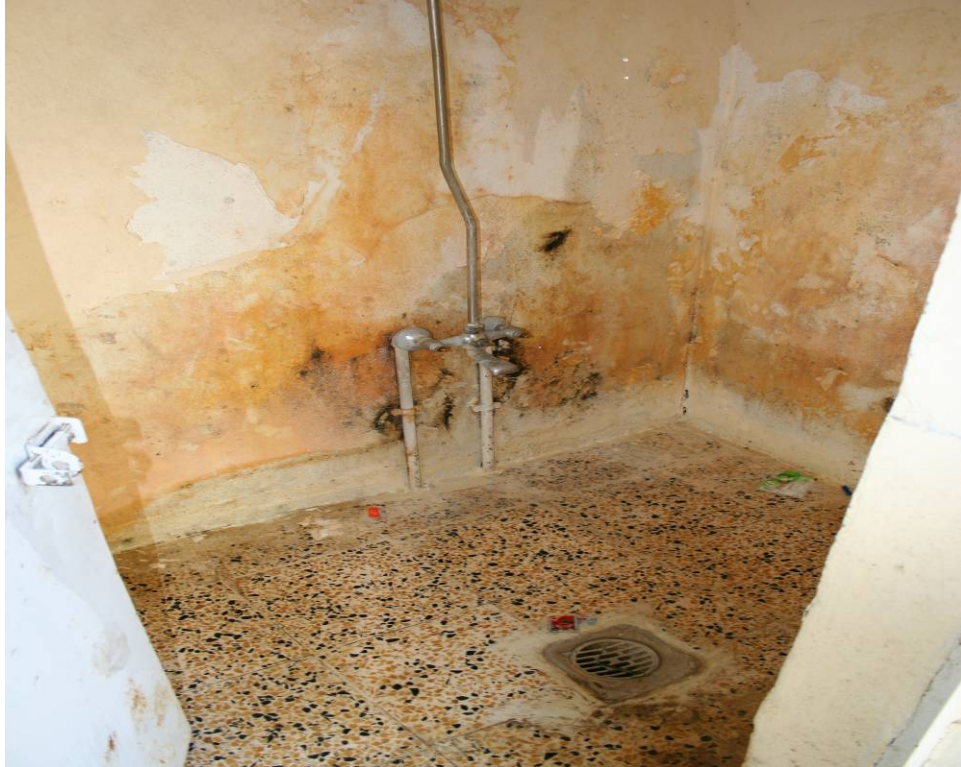
**Site Photo 7. The shower wall was painted with plaster versus being grouted with tile from floor to ceiling as required.**

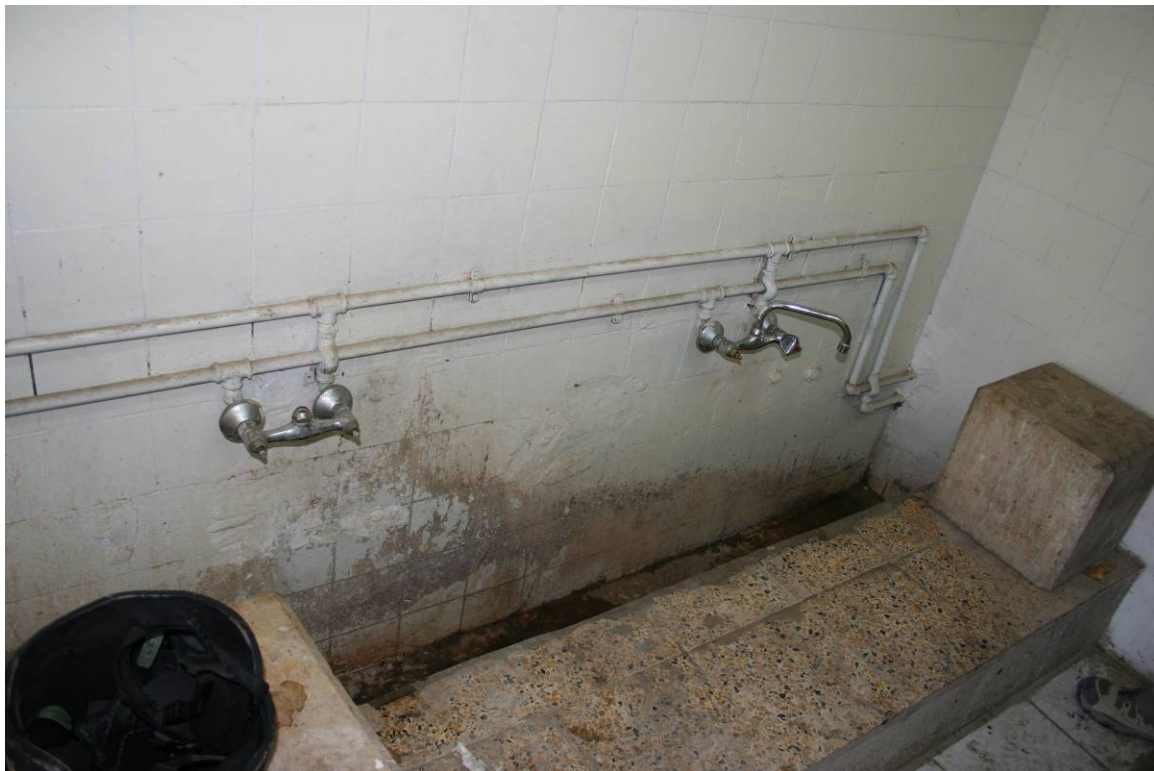
**Site Photo 8. Existing wall tile was painted and existing leaking faucets were not replaced. Left faucet was capped/disabled instead of being replaced.**

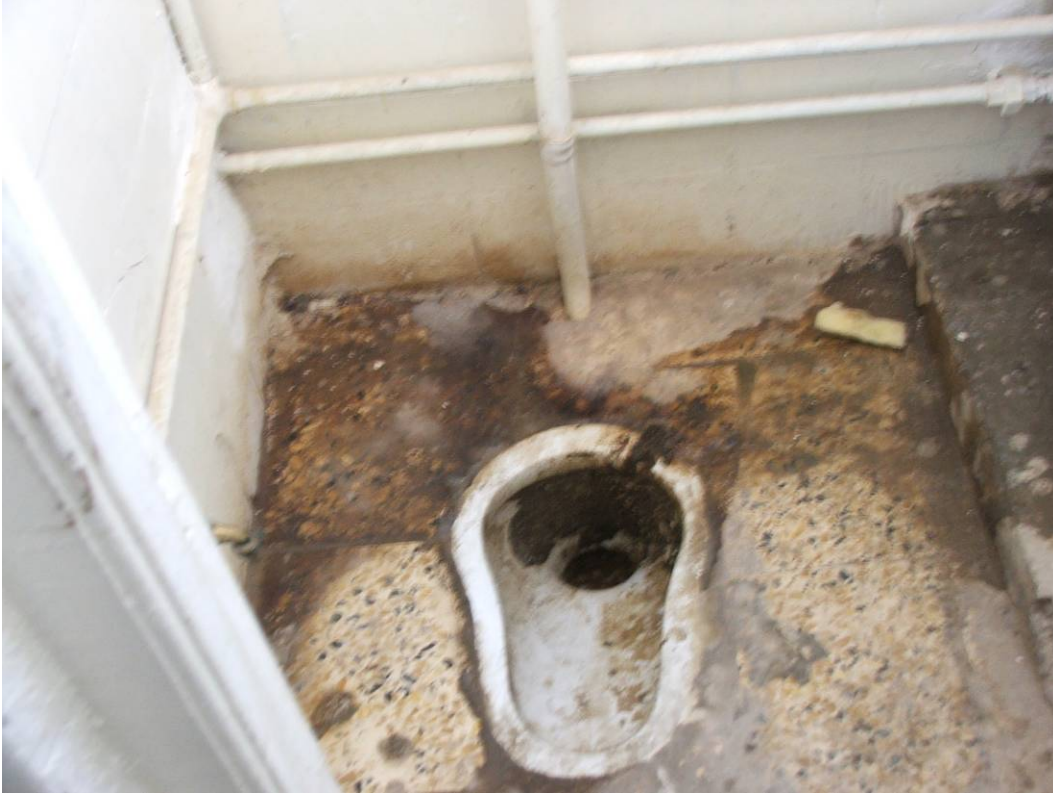
**Site Photo 9. Original water closet toilet fixture should have been replaced. The wall should have been tiled and grouted from floor to ceiling and not painted.**

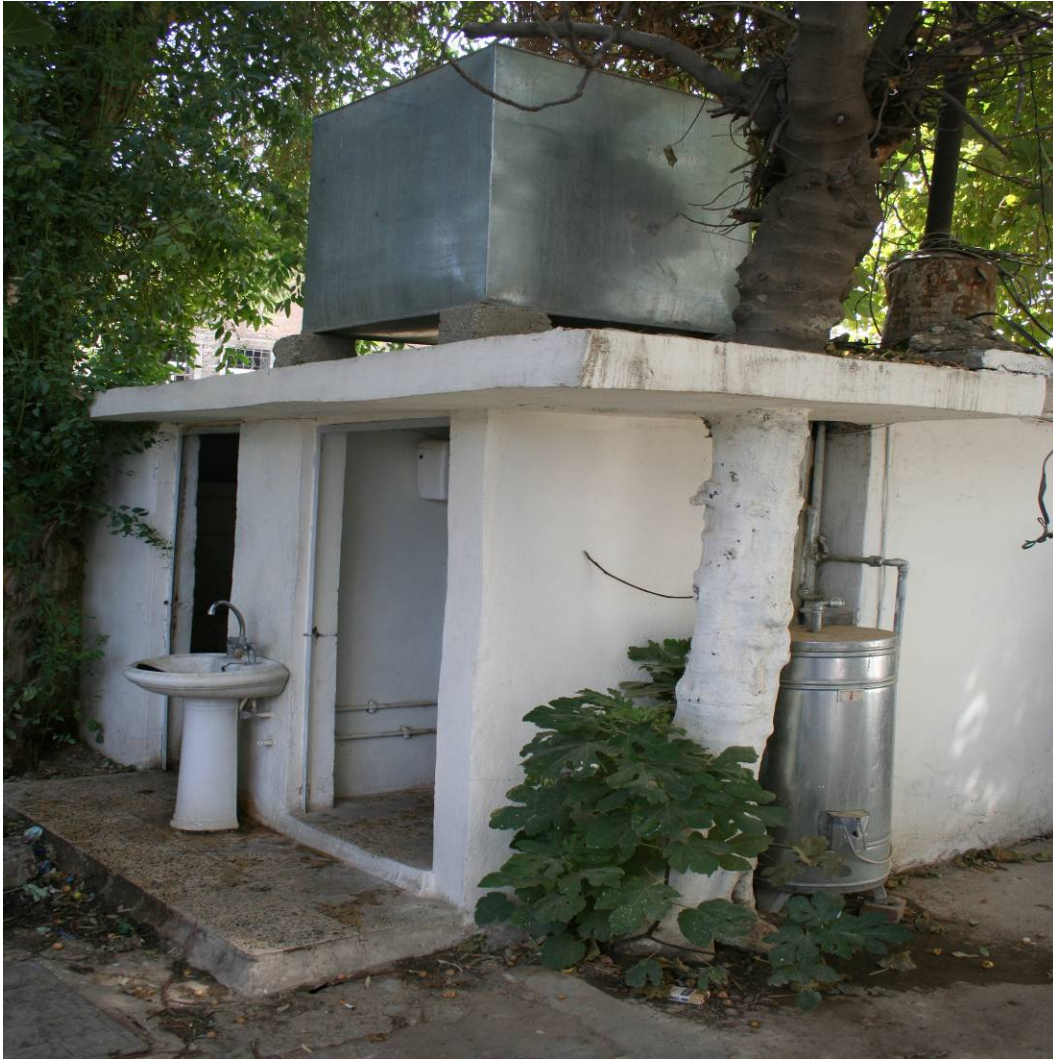
**Site Photo 10. “Shady Construction” trees were not removed when the new latrine was built.**

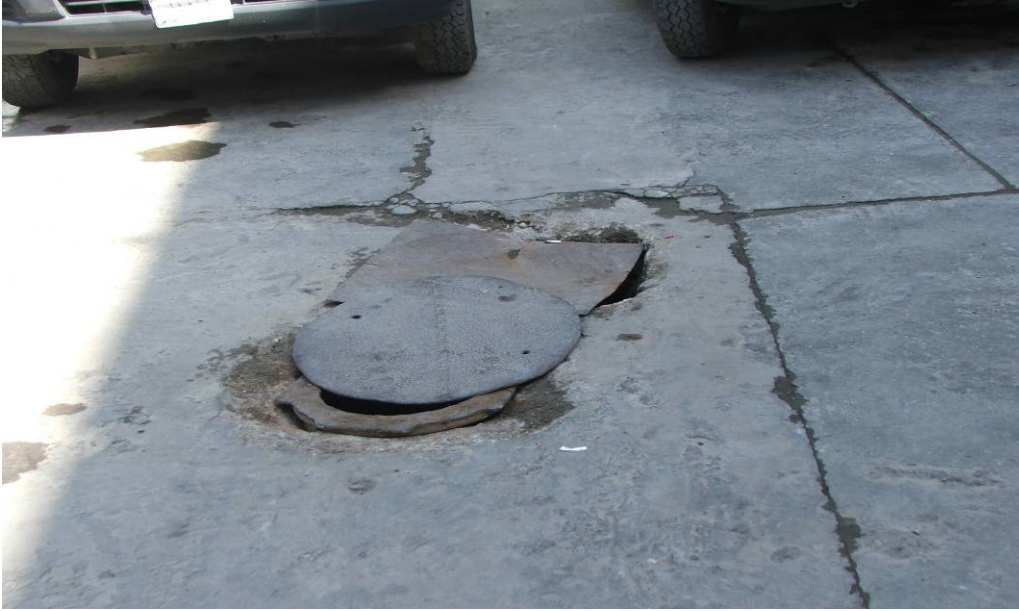
The contractor did not replace the main septic tank with a new tank three times the volume as required in the contract. Rather, the contractor added additional tanks of an unspecified and unverified size to the system. Such a course of action was outside of the design requirements. Concrete work to cover connecting pipe trenches was poor and manhole covers were generally nothing more than make-shift pieces of metal or wood. In addition, there was no evidence to support whether the underground sewer lines and system were inspected, repaired, and pressure tested as required by the contract.

**Site Photo 11. Main septic tank was not replaced with one three times the capacity.**

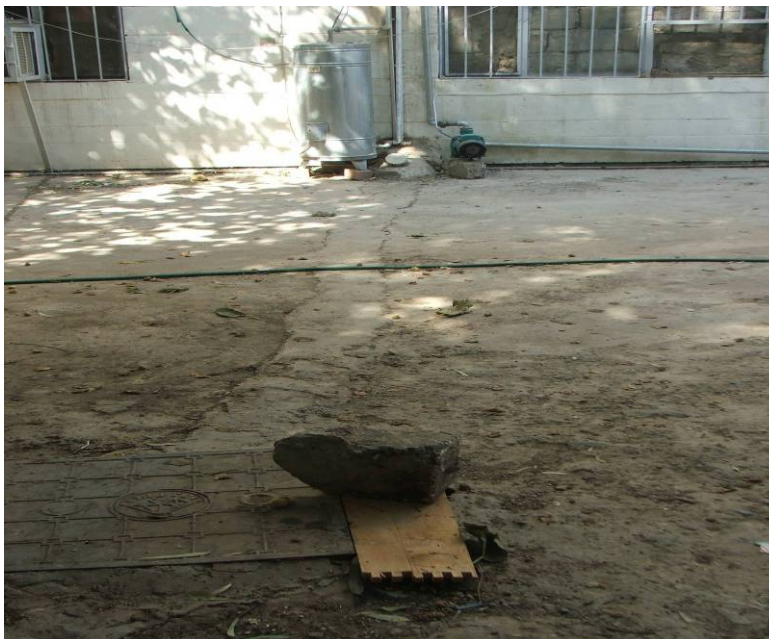
**Site Photo 12. Manhole cover made of tin/wood and concrete work over the trench which was substandard.**

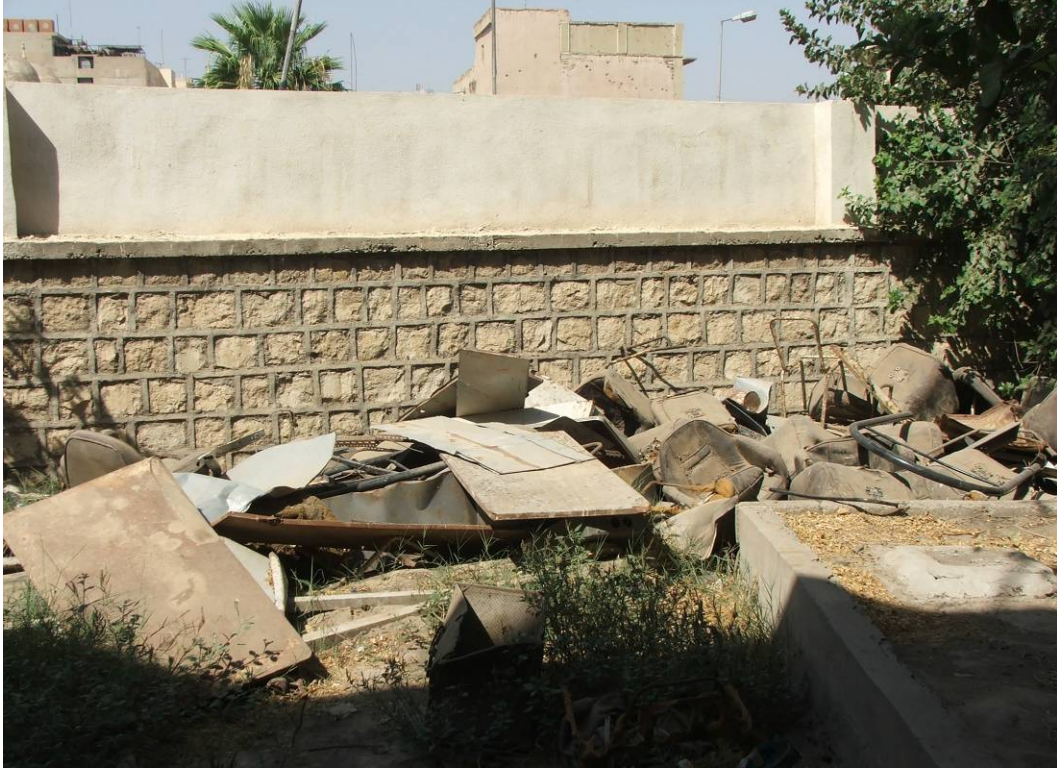
The contract required the contractor to clear and remove all existing debris and rubble at the site location defined as each building's interior, exterior, roof, and perimeter. In addition to soil and waste material, the contract specified that unused hangers, wires, cable trays, conduit, plumbing, damaged ductwork, and all inserts from ceilings and walls were to be removed. Lastly, the contractor was required to provide a final cleanup of all buildings. At the time of our site visit, there was a substantial amount of debris lying about the facility and it appeared that a final cleanup was never conducted (Site Photos 13 & 14).

**Site Photo 13. Substantial amount of debris on the Police HQ grounds was not removed.**

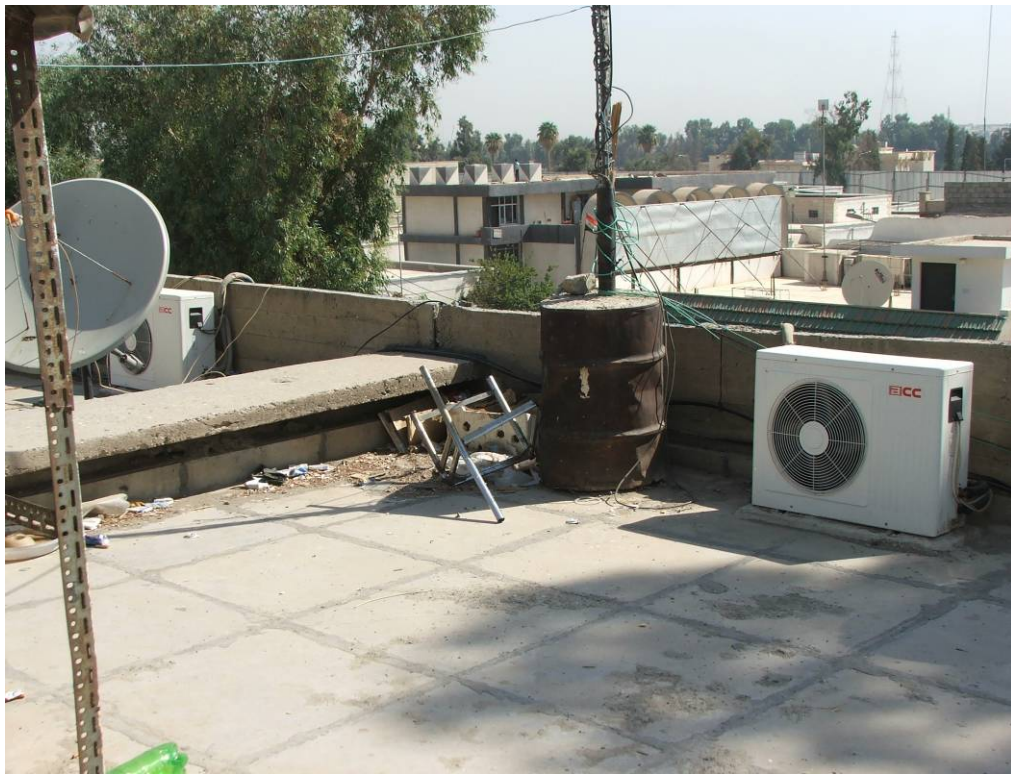
**Site Photo 14. All debris was not removed from rooftop.**

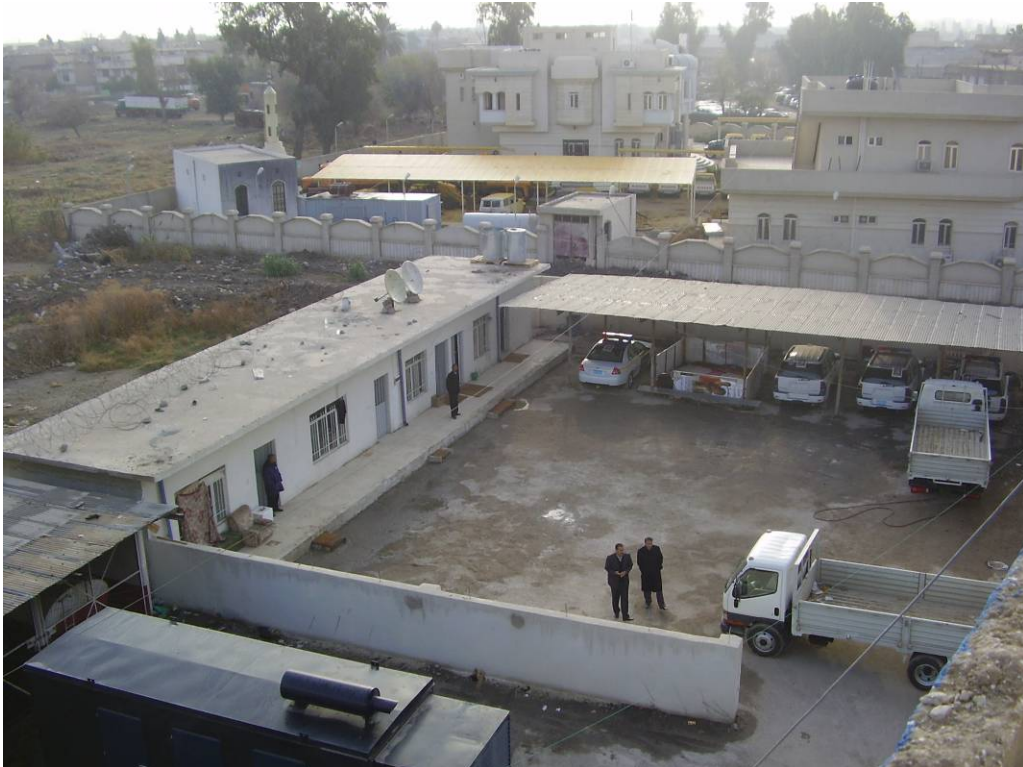
**Site Photo 17. Generator was delivered (bottom left), but never connected and load tested by the contractor.**

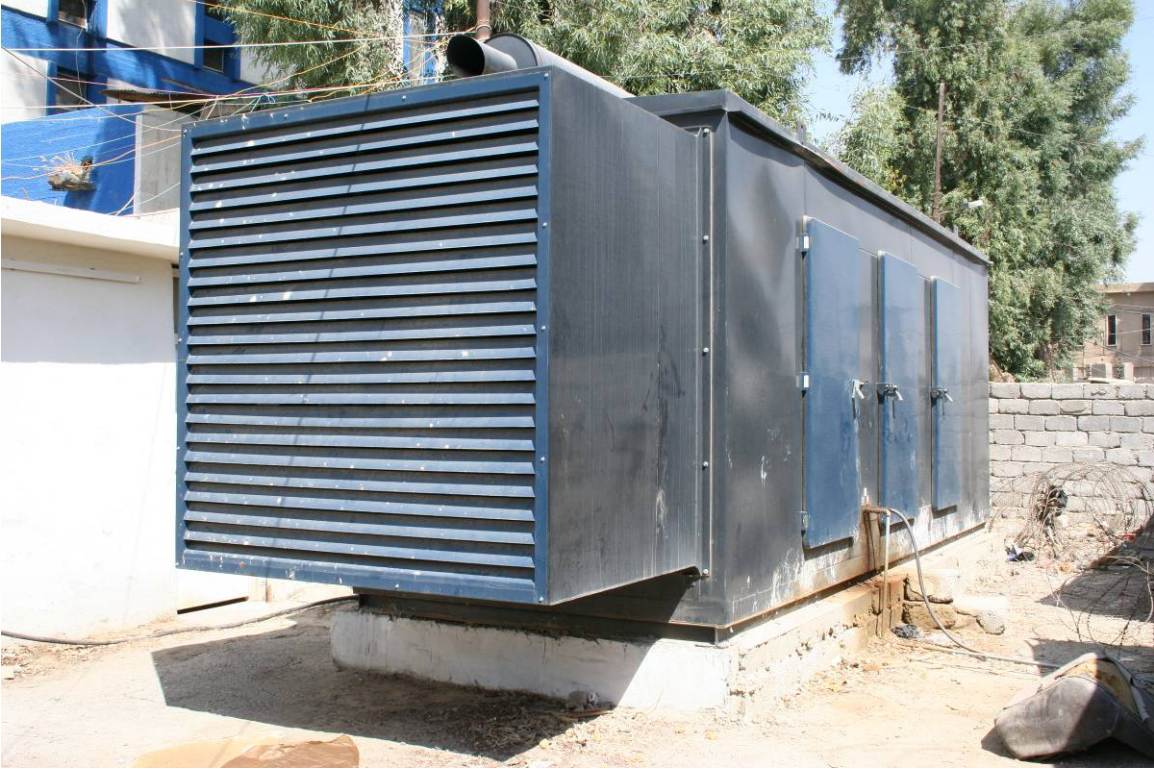
**Site Photo 18. Final site, where the generator was placed by Iraqi Police (IP).**
