BAB SHAMS POLICE STATION  
MOSUL, IRAQ

SUSTAINMENT ASSESSMENT

**SIGIR PA-06-091**  
**APRIL 25, 2007**

## Bab Shams Police Station Renovation Mosul, Iraq

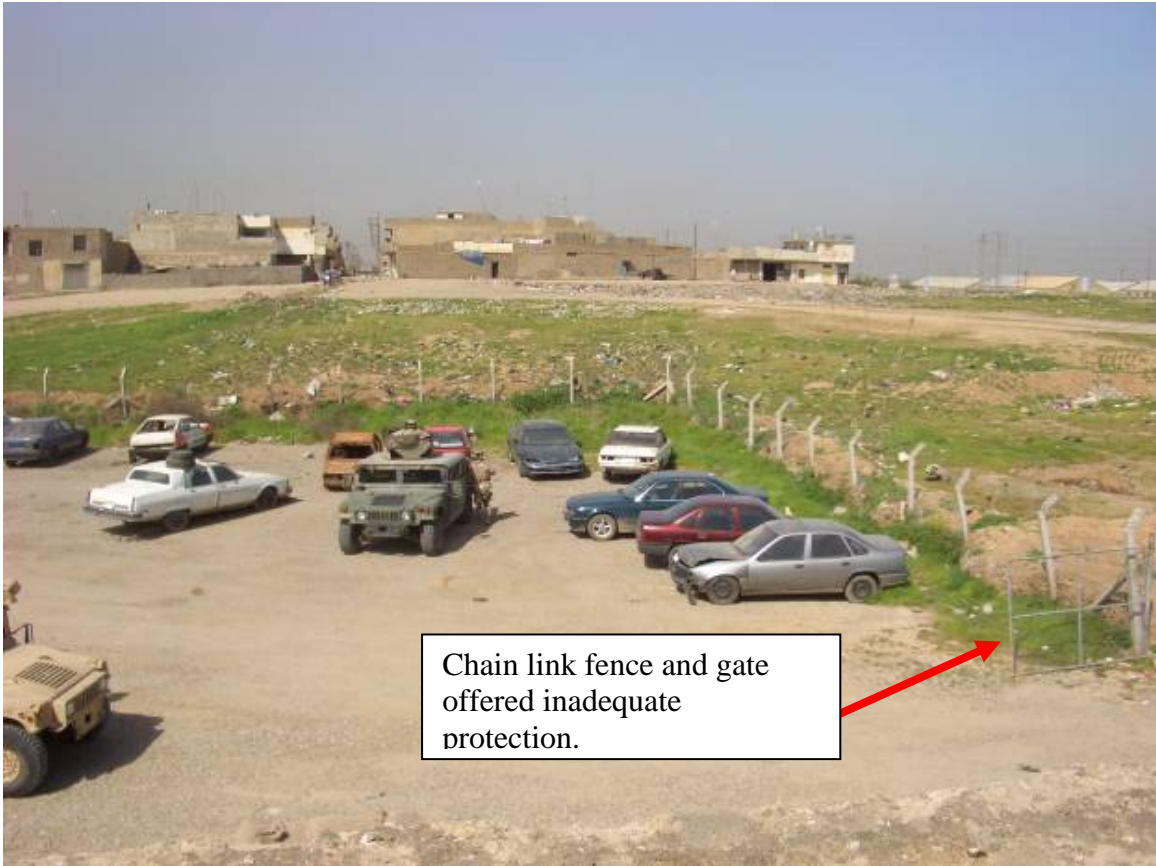
**USACE Pre-Construction Photo 3. Without a solid block wall, police station was vulnerable to direct fire and tactical observation from nearby buildings and open fields.**

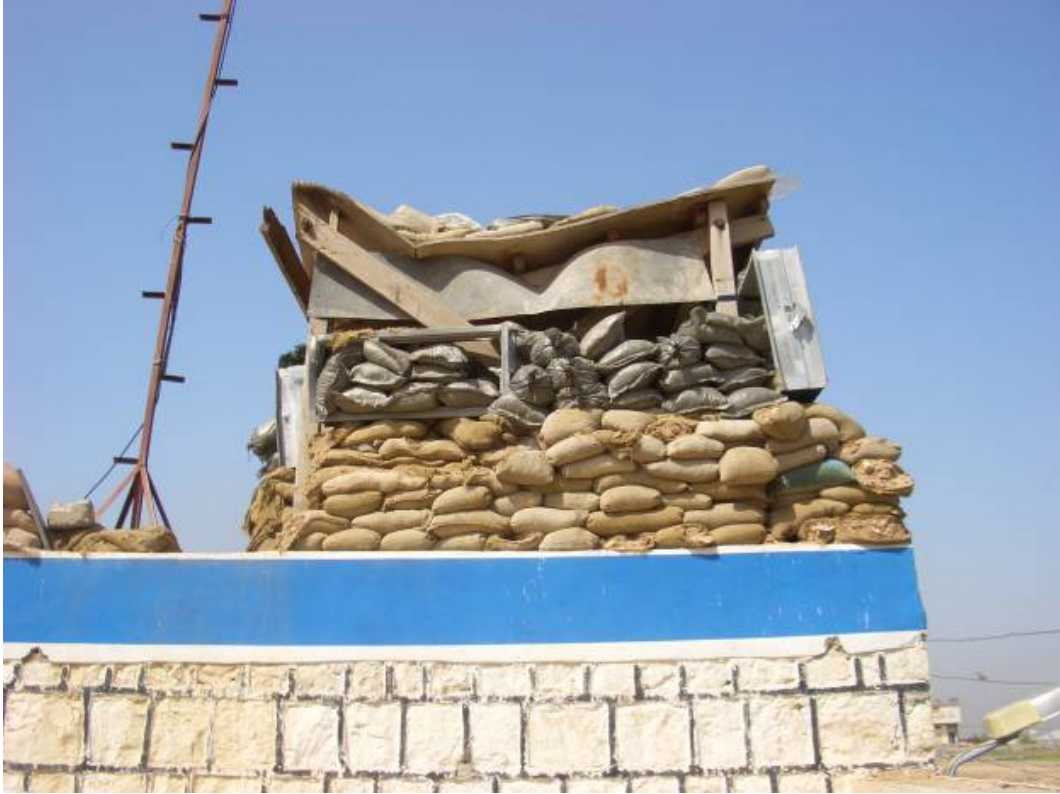
**USACE Pre-Construction Photo 5. Rooftop fighting positions/guard houses before renovation.**

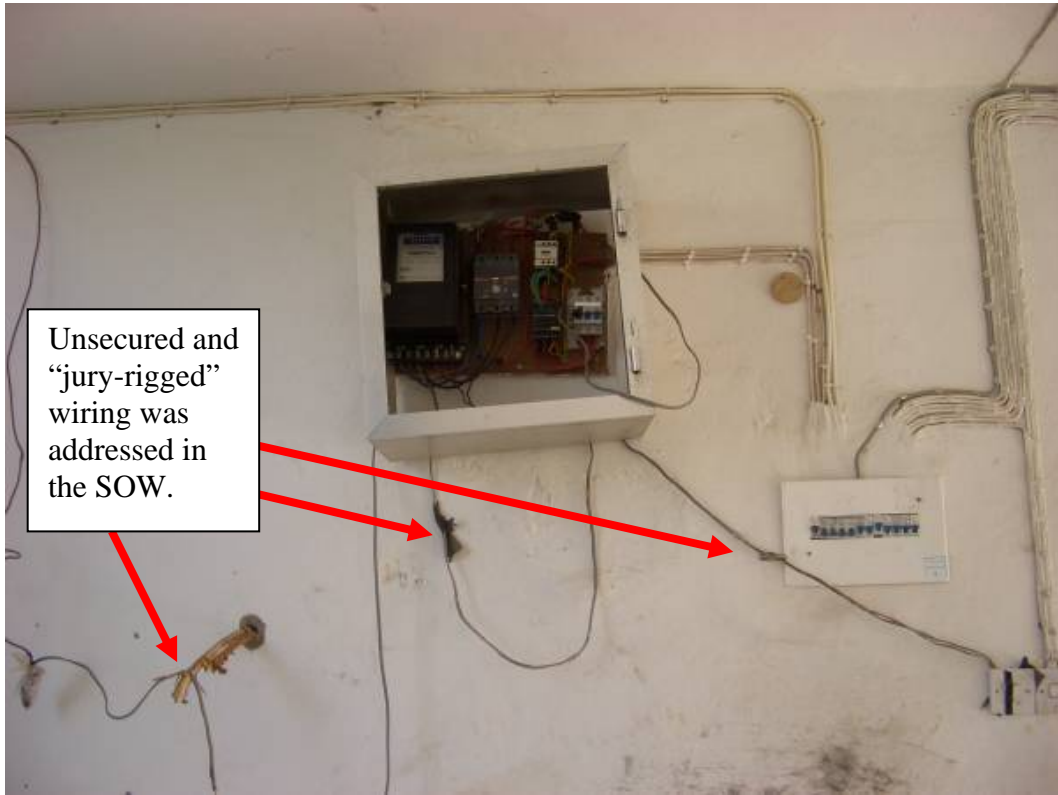
**USACE Pre-Construction Photo 6.**

The SOW specified that the pre-existing electrical system needed to be significantly upgraded during renovation. The contractor was required to repair exposed wiring, add wiring/circuits, switches, plug-ins, fluorescent lighting ballasts, building perimeter lighting, and other electrical upgrades. In addition, the SOW included a requirement to securely attach all wiring to walls. An example of the pre-existing condition of the electrical system is shown in USACE Pre-Construction Photo 6. The photo shows “jury-rigged” and unsecured wiring.

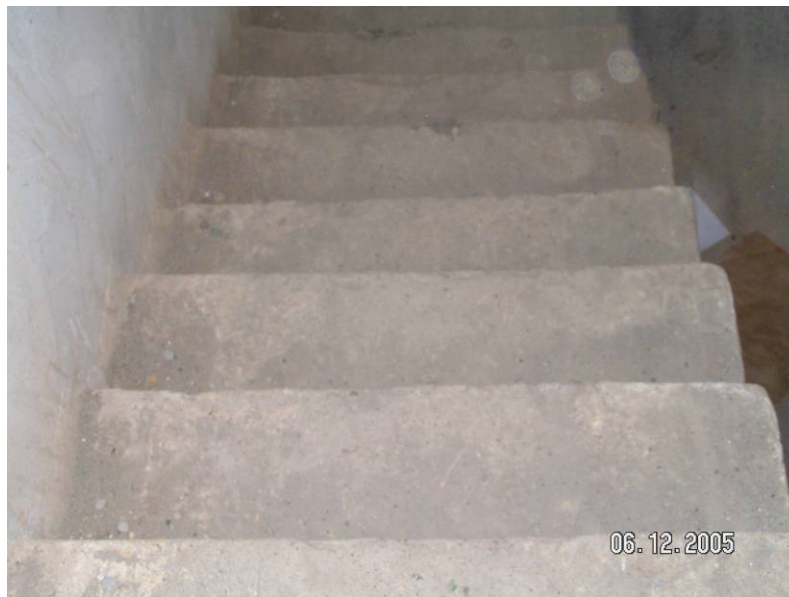
**USACE Pre-Construction Photo 8. Before renovation, steps were bare, unsealed concrete.**

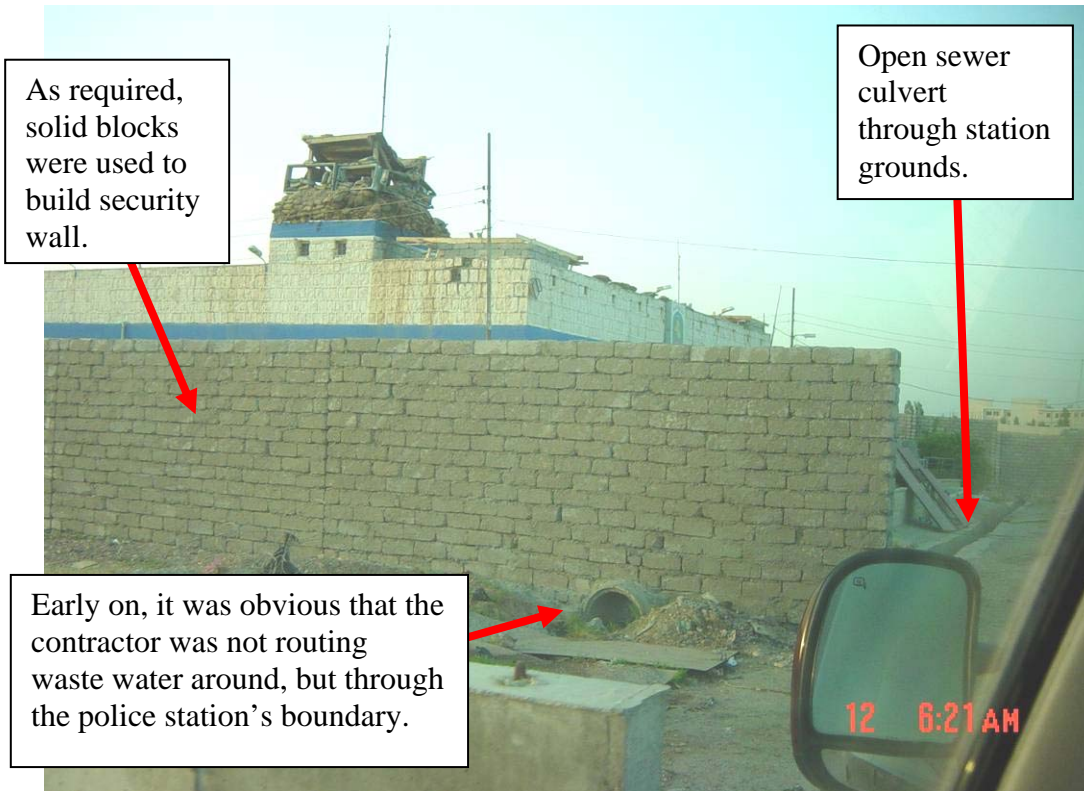
USACE Construction Photo 2 (12 Jun 05)

Contrary to SOW requirements, USACE Construction Photos 2 and 3 show that sewer water was not being routed around the perimeter of the police station, but through the station's boundaries. Issues related to the location of the sewer water conveyance system are addressed in the Site Assessment section of this report.

As required, solid blocks were used to build security wall.

Open sewer culvert through station grounds.

Early on, it was obvious that the contractor was not routing waste water around, but through the police station's boundary.

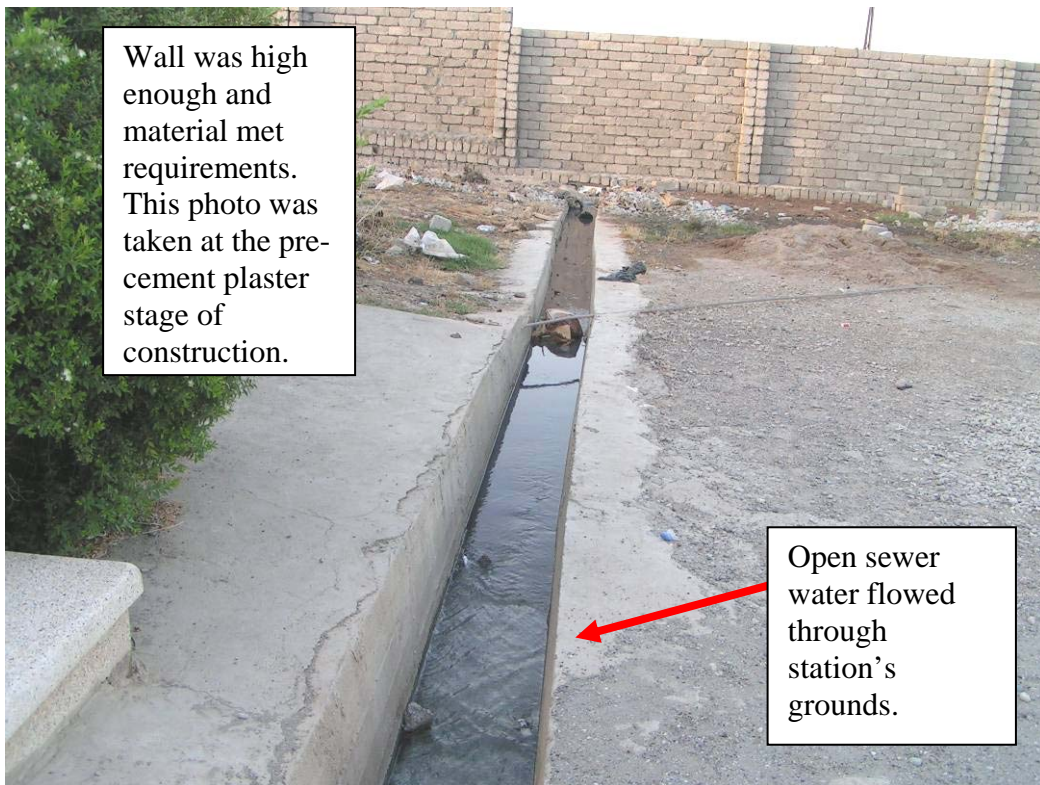
USACE Construction Photo 3 (12 Jun 05)

Wall was high enough and material met requirements. This photo was taken at the pre-cement plaster stage of construction.

Open sewer water flowed through station's grounds.

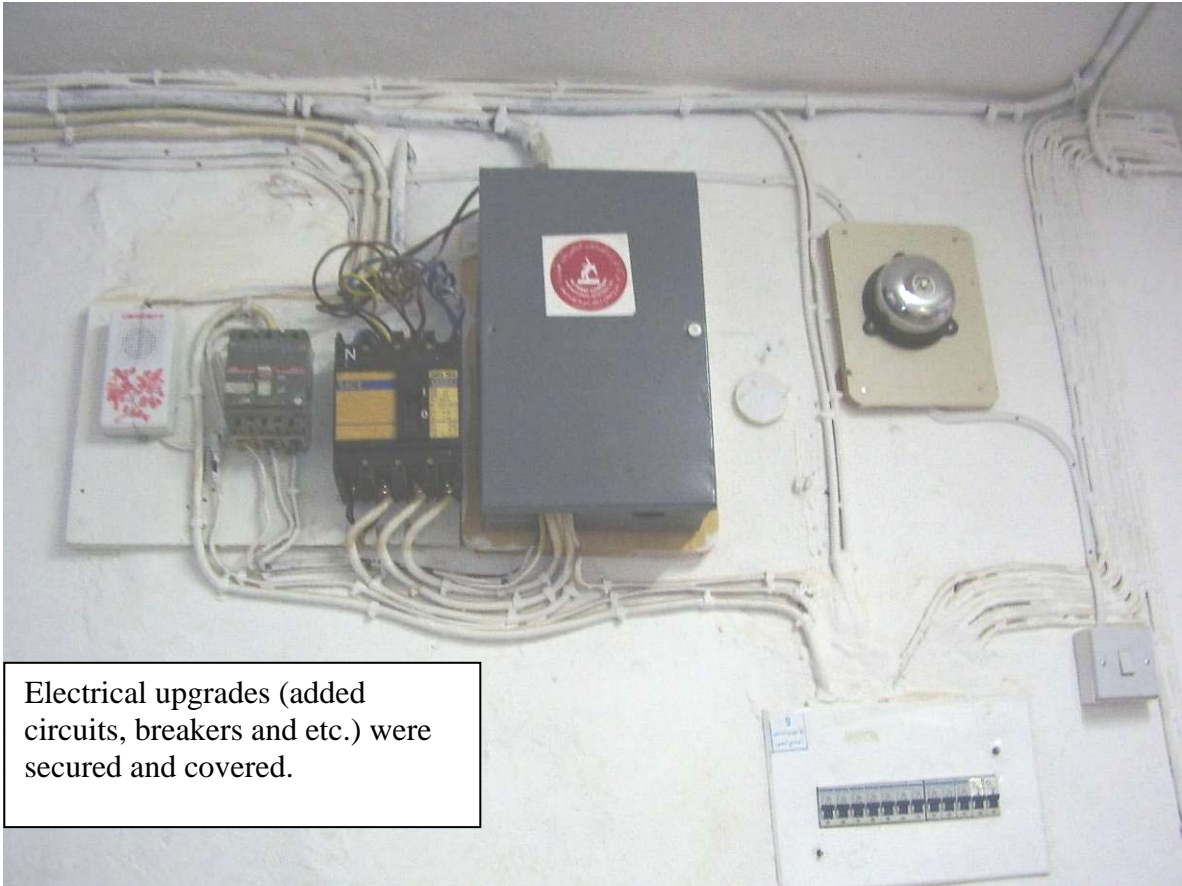
USACE Construction Photo 5 (23 Sep 05)

While USACE Pre-Construction Photo 6 documented that damaged, exposed, and unsecured wiring was present before renovation, USACE Construction Photo 5 shows that the pre-construction conditions were corrected by the contractor during the renovation project. In short, USACE Pre-Construction Photo 5 and USACE Construction Photo 6 document a "before and after" comparison of an electrical box and wiring at the same location within the building. USACE Construction Photo 6 shows a circuit breaker box that was properly covered and free of tampering following renovation. Other photos taken during construction by USACE personnel show examples of work properly completed by the contractor. For example, USACE Construction Photo 7 shows that switches and plug-ins were installed, USACE Construction Photo 8 confirmed that wiring and electrical system components were securely fastened to walls, and USACE Construction Photo 9 shows where exterior lighting was installed on the building's perimeter. All of the aforementioned examples appeared to meet contract requirements.

Electrical upgrades (added circuits, breakers and etc.) were secured and covered.

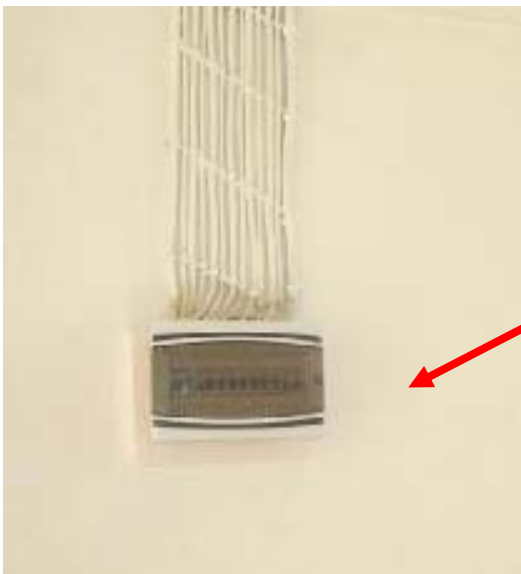
USACE Construction Photo 6 (15 Aug 05)

Breaker boxes were covered and free off tampering.

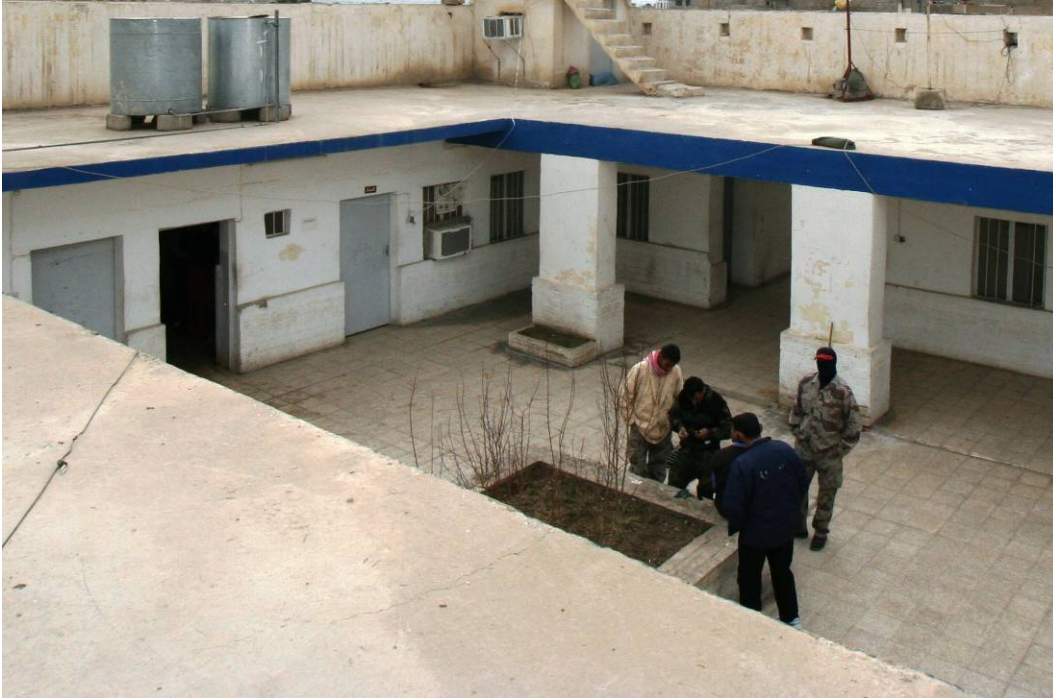
Most elements of the renovation project appeared to meet SOW requirements and the facility appeared to be able to operate at full capacity<sup>4</sup> when observed. Site Photo 1 confirmed that the same area shown in USACE Construction Photo 13 appeared to be or remained functional on 28 January 2007. Several toilets were flushed and several sinks were partially filled and drained to verify operability. In addition, the inspectors observed several sewer line traps and confirmed that they were open and that sewage generated within the police station building was able to flow. Site Photo 2 shows the specific traps observed by the inspectors. The area around the traps was dry and did not show evidence of routine plugging or backed-up sewage.

**Site Photo 1. Observed condition of the same general area shown in USACE Construction Photo 13 appeared functional.**

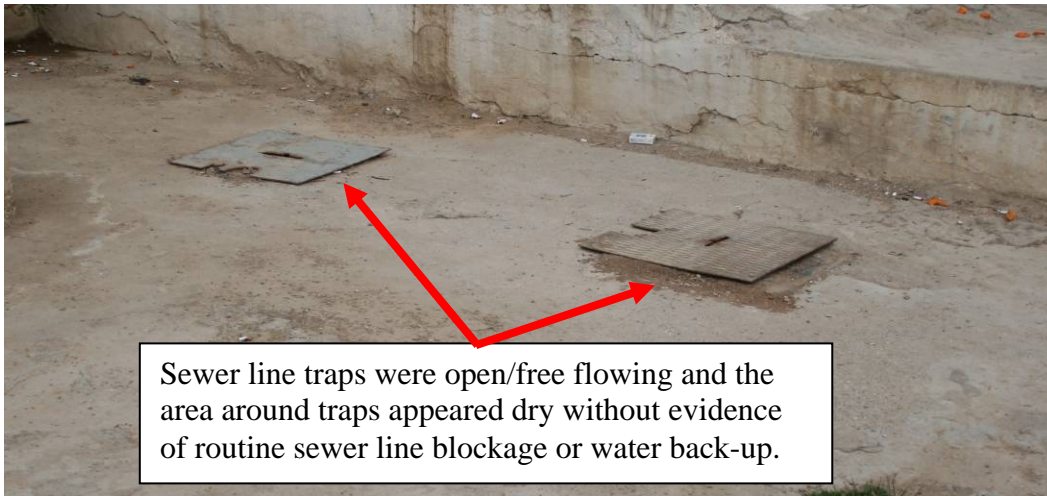
**Site Photo 2.**

Sewer line traps were open/free flowing and the area around traps appeared dry without evidence of routine sewer line blockage or water back-up.

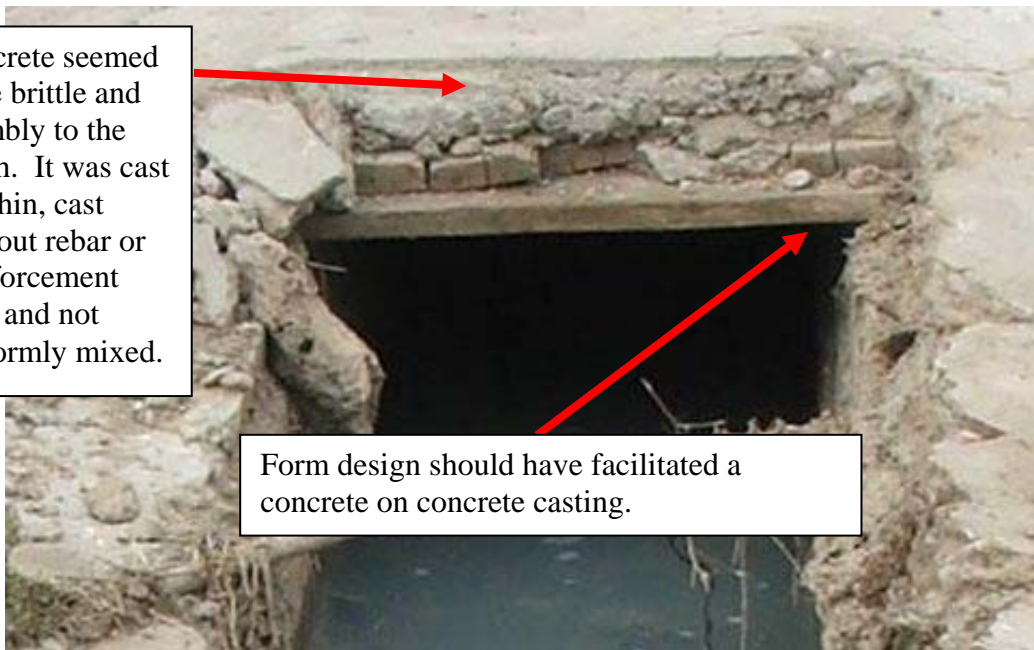
Site Photo 4.

In addition, forms should have been constructed in such a manner that the new concrete material would have been placed to touch the culvert's concrete side wall, which is concrete on concrete without wood between the new casting and the existing sidewall. The technique used by the contractor only increased the likelihood of concrete failure. As the wood rots, more stress is placed on the casting as it settles towards a concrete on concrete position.

Concrete seemed to be brittle and crumbly to the touch. It was cast too thin, cast without rebar or reinforcement wire and not uniformly mixed.

Form design should have facilitated a concrete on concrete casting.

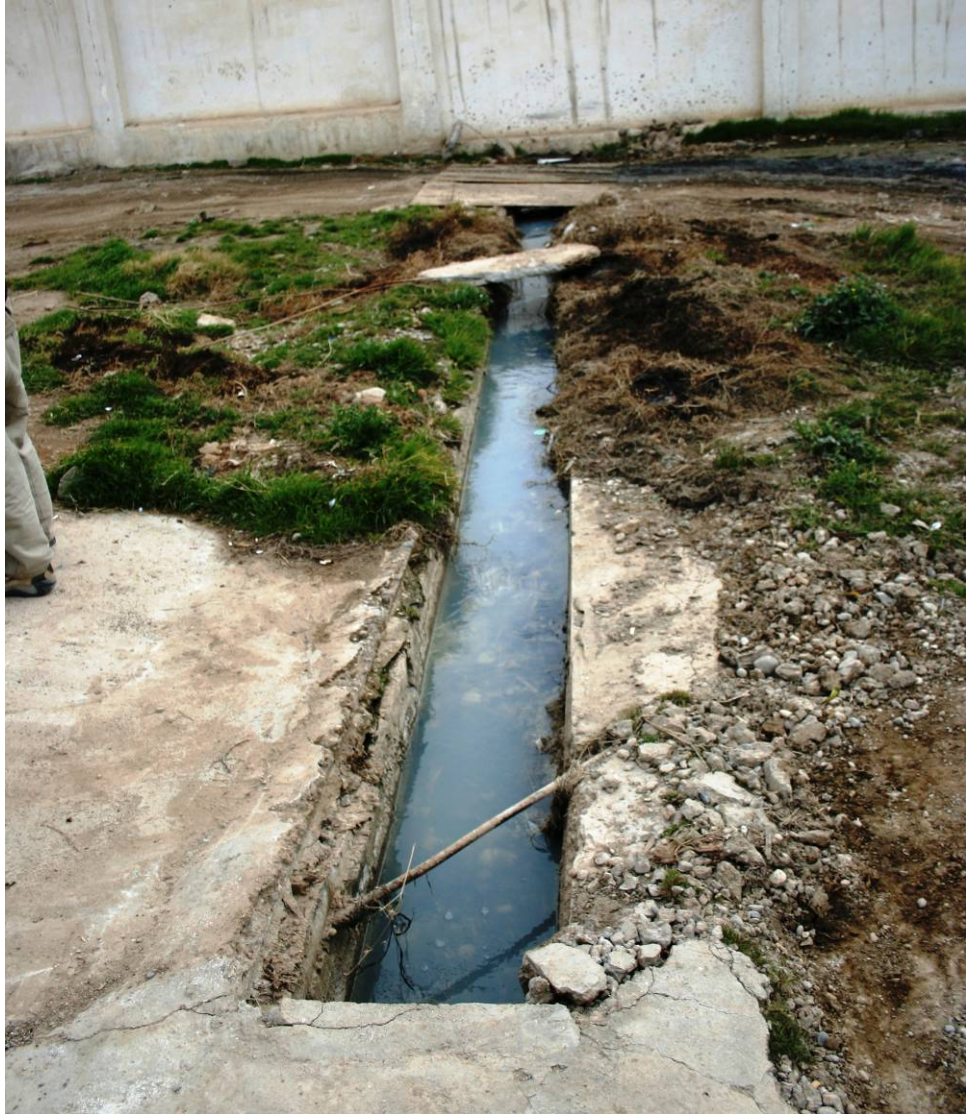
**Site Photo 5.**

Before renovation, the chain linked fence (USACE Pre-Construction Photo 3) that surrounded the IP station did not impede runoff water. Conversely, the new solid block security wall (USACE Construction Photo 3 and Site Photo 5) on the low<sup>5</sup> side of the compound could block or impede the flow of rain water runoff and sewage water flow (Site Photo 6). The runoff from within the compound, combined with the regular sewer water flow and rain water runoff channeled into the station from outside the compound, could lead to standing water conditions within the compound.

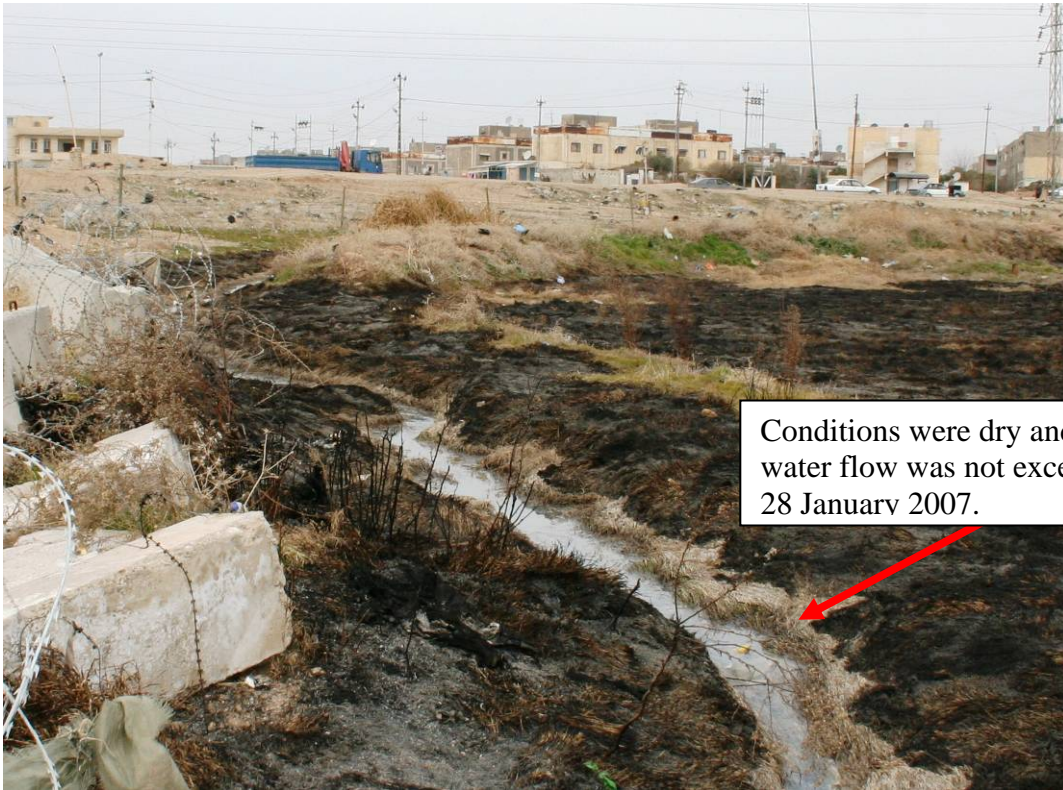
**Site Photo 6.** Outside the entrance, there was a sizeable area with sufficient slope to generate substantial runoff to IP station boundaries.

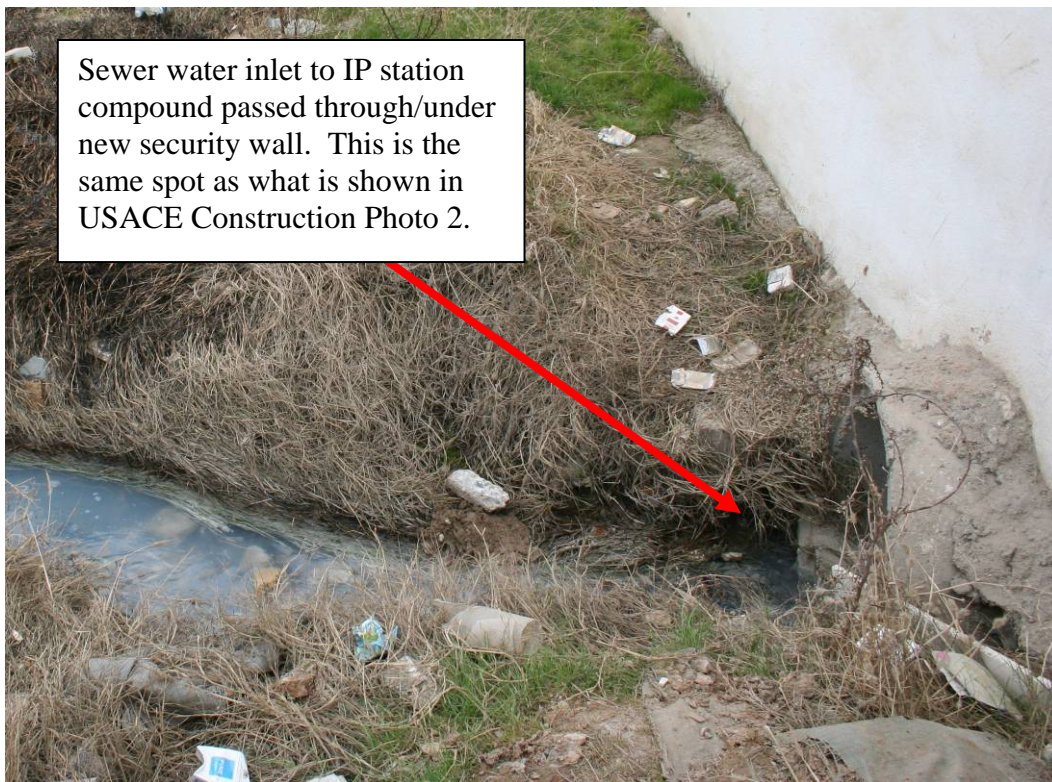
**Site Photo 7.**

At the time of the site inspection, the conditions were dry and not impacted by recent rains. Nevertheless, Site Photo 7 shows that the open culvert on the high side or half of the compound was running free and able to handle the waste water volume entering the compound that day. However, Site Photo 8 taken at the exit and the open culvert's lowest spot within the confines of the compound shows the open culvert nearly full. It would not take much rain water runoff to create a flooded condition within parts of the IP compound area.

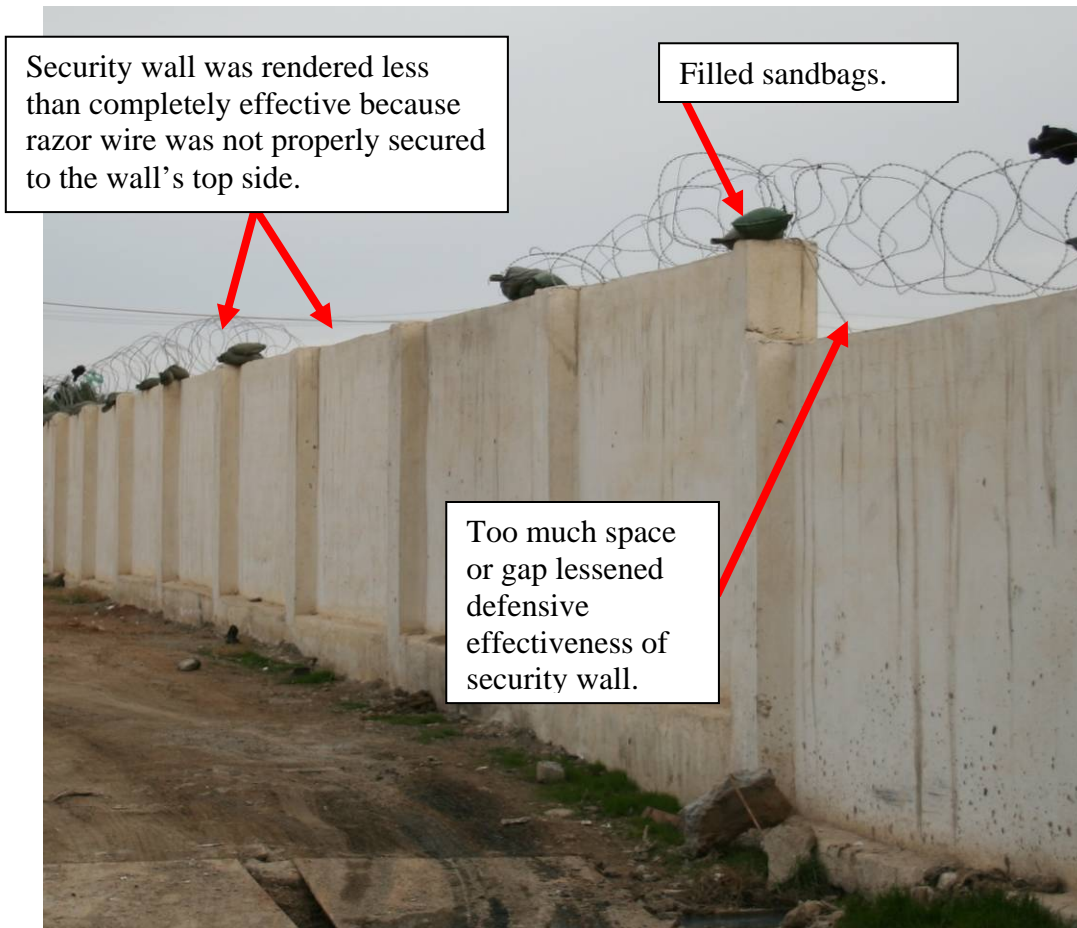
Site Photo 9.

All requirements related to the construction of the security wall were met with the exception of the barbwire which was not adequately secured and placed on the top side of the wall. Site Photo 9 shows that the wire was merely held in place by sand bags that could be pushed or pulled off by personnel wanting to scale the wall. Without the sand bags in place, the wire does not stay in place atop the wall. In addition, the wire was stretched in such a manner that spaces or gaps between the wire and wall developed. SIGIR inspectors observed several places where the wire was not attached or placed in a manner that enhanced the defensive effectiveness of the security wall.

A review of the USACE final inspection report dated 23 September 2005, disclosed that the wire for the top of the perimeter wall was not installed and was “still piled up on the ground where it was unloaded from the delivery truck”. USACE officials were aware of

the problem; however, it appeared that issues related to the wire were not adequately addressed before final payment to the contractor was approved by the USACE RE.

USACE/IRMO should survey the site’s current condition and develop cost effective plans to (1) route waste water around the perimeter of the police station and (2) securely attach wire to the security perimeter wall.

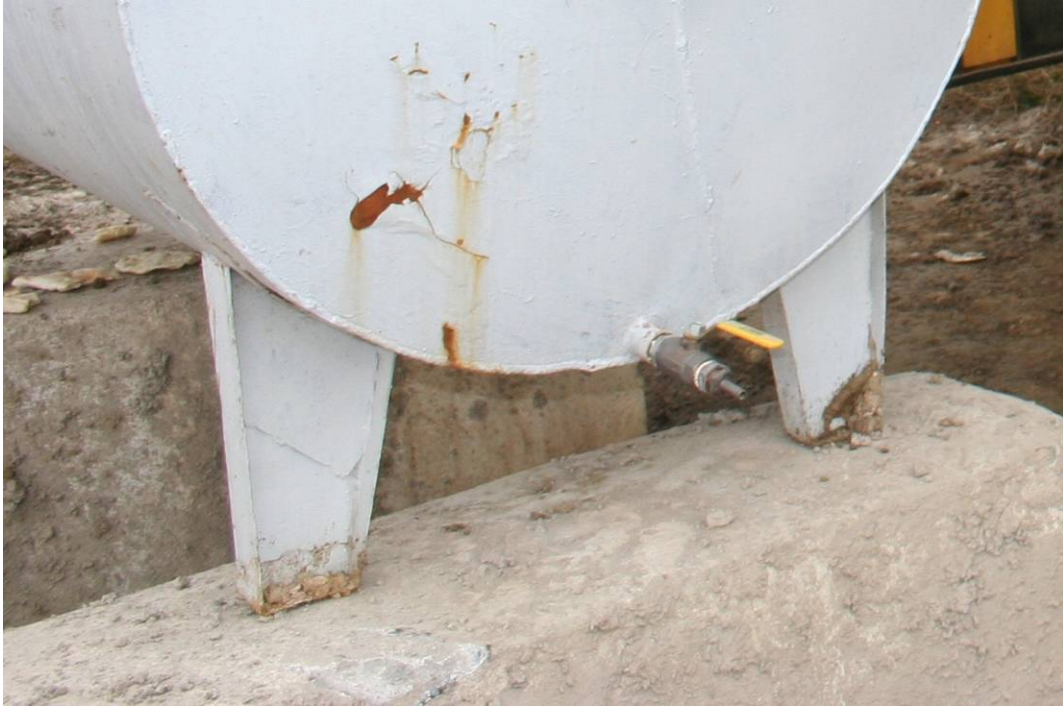
It appeared that the contractor installed, in accordance with SOW requirements, a new working generator with a fuel tank and automatic controls to start and switch to generator power in the event of disruption or loss of power from the municipal power grid. However, the generator system was inoperable when observed by SIGIR inspectors on 28 January 2007. IP personnel told SIGIR inspectors that various electrical control components “*did not work*” and no one knew how to operate or fix the generator. At the time of the site visit, the relay control panel door on the generator system was wide open and switch and control components were exposed to the elements. In addition, the inspectors checked and verified that the generator’s oil level was low (at the add mark when cold). While the oil was dirty and gritty to the touch, there was no visible evidence of metal shavings to suggest excessive engine wear. Lastly, the fuel line between the fuel tank and engine had been removed (Site Photo 10).

**Site Photo 10. Fuel line between the tank and the generator engine had been removed.**

- Make the generator operational.
- Reinstall lighting, switches, and other electrical components that have been removed or damaged.
- Implement an effective equipment and facility operations and maintenance program staffed with trained personnel.

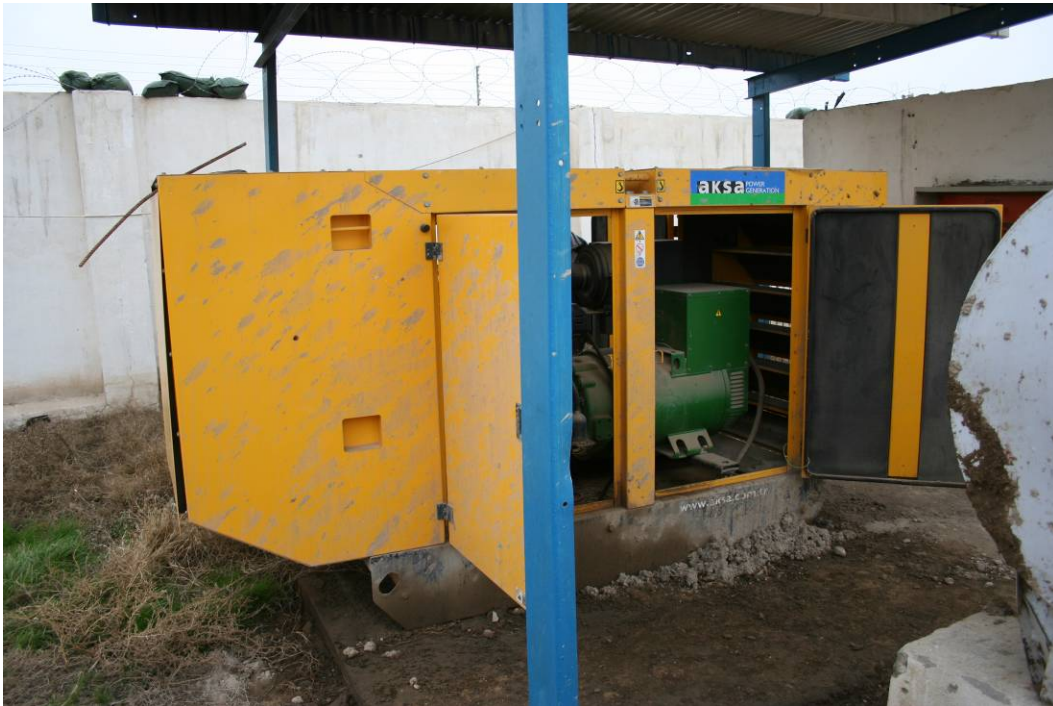
The new generator, which cost \$79,000, appeared to have been abandoned (Site Photo 11). Issues related to automatic transfer switch and controls will be addressed in the next section of this report.

**Site Photo 11. Without a fuel line and working controls, the new generator appeared abandoned.**

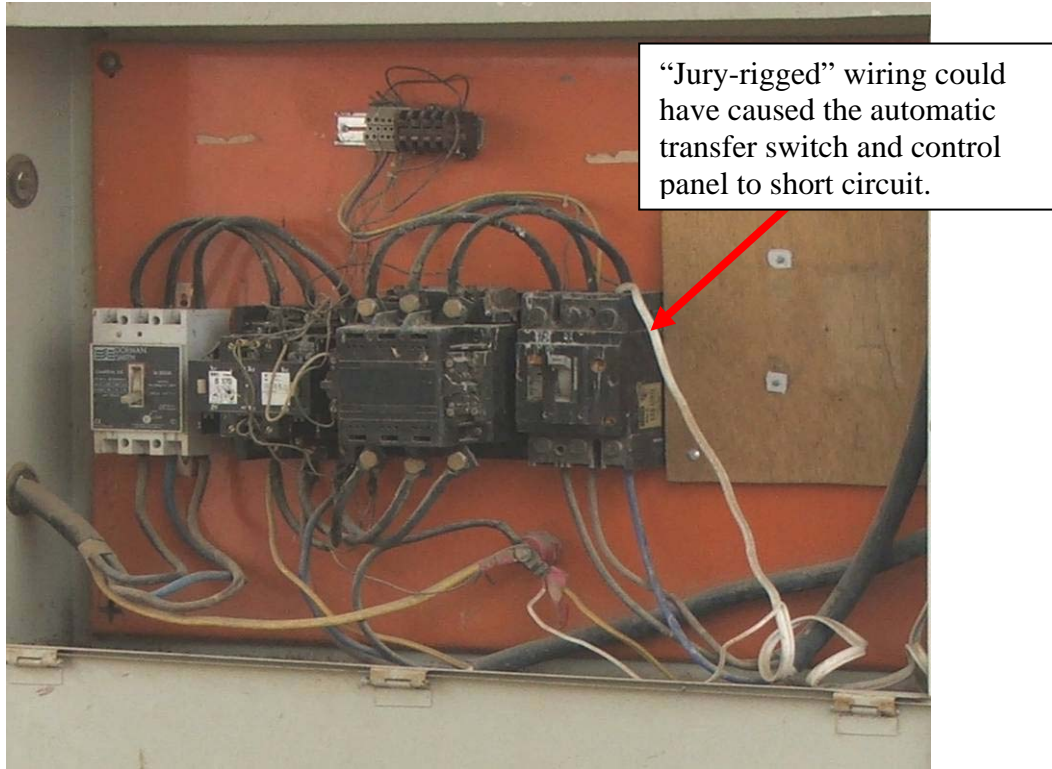
**Site Photo 12.**

SIGIR inspectors observed that the automatic transfer switch and control panel had been tampered with and that the door on the automatic transfer switch and controls panel was wide open and the expensive switching components were exposed. While the inspectors were told by IP personnel that the transfer switches were broken, we could not determine when or by whom the “jury-rigged” wiring was added to the circuitry (SIGIR Site Photo 12). In any case, “jury-rigged” wiring likely could have caused the automatic transfer switch and control panel components to short circuit and break down.

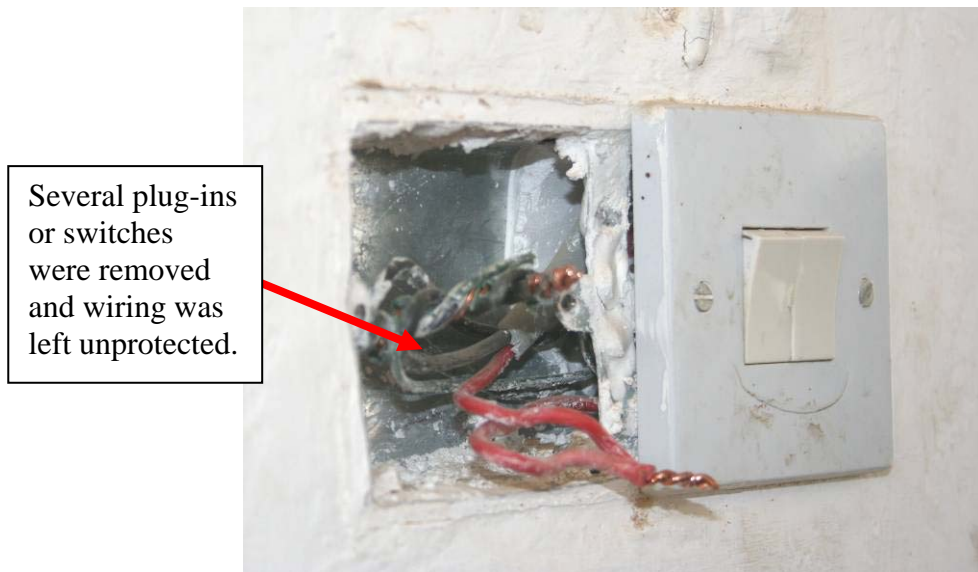
**Site Photo 13.**

Throughout the facility, SIGIR inspectors observed that numerous switches or plug-ins had been removed. In every case of a missing switch or plug-in, the wiring was crudely twisted together in order to keep the circuit closed as a means to allow power to flow to draw points (lights, switches, plug-ins, etc.) farther down the circuit. SIGIR Site Photo 13 is an example of one of several places where a switch or plug-in was removed.

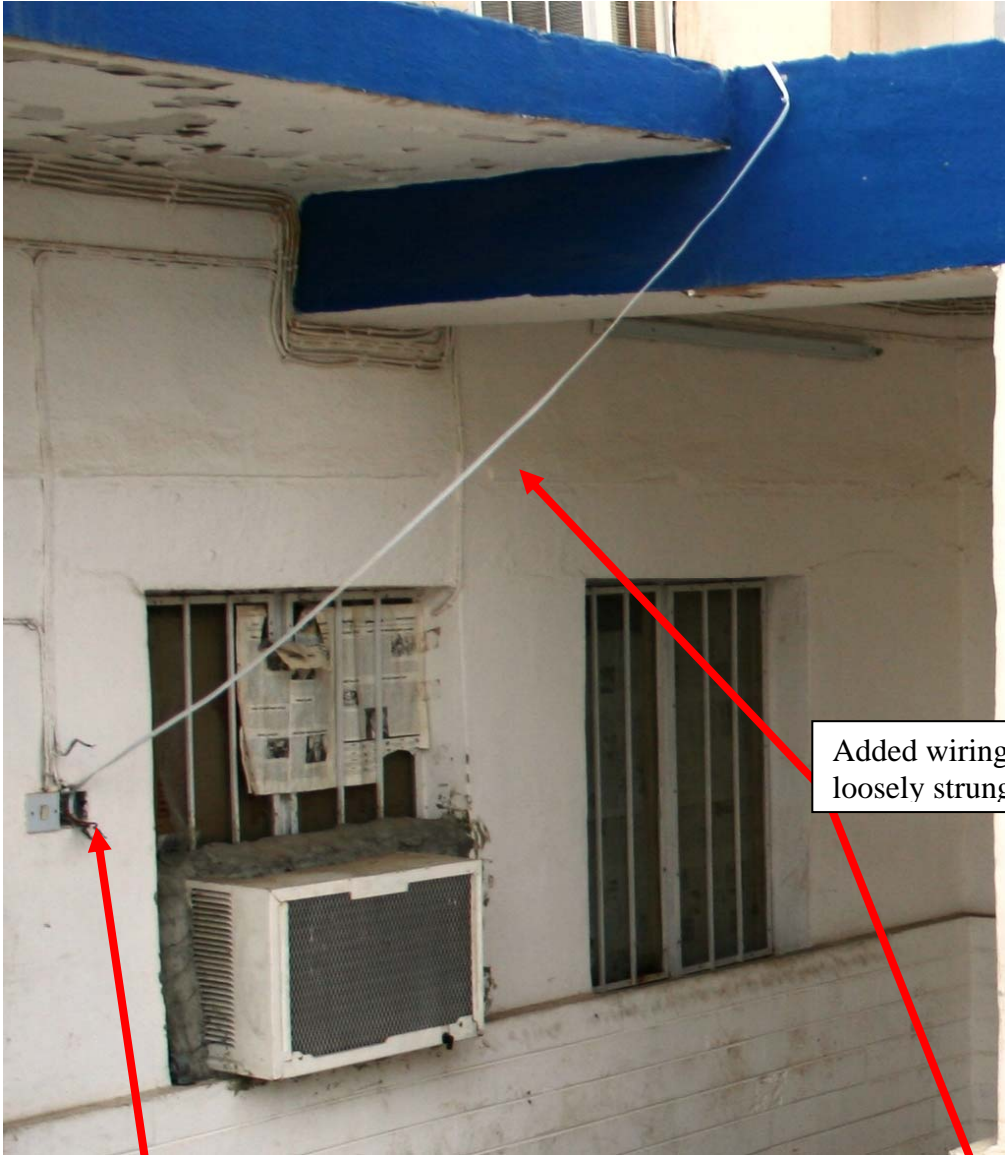
Site Photo 14.

In Site Photos 14 and 15 a typical form of tampering observed by SIGIR inspectors is shown. Site Photo 14 shows how added wiring was loosely strung. Site Photo 15 is a close up and it shows the technique used to “tap into” an existing circuit. Specifically, the existing circuit and load requirement was maintained by twisting the wiring together in order to close the existing circuit. However, the “jury-rigged” wiring that fed a draw point only added to the circuit’s potential load or draw.

Added wiring was loosely strung.

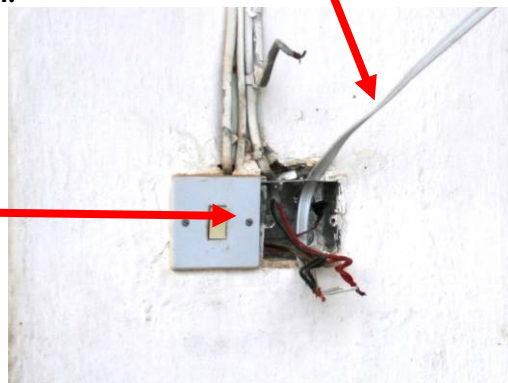
Site Photo 15.

Switch or plug-in was removed and added wiring "tapped into" the circuitry.
