GAUGLI-ASHUR POLICE STATION  
MOSUL, IRAQ

SUSTAINMENT ASSESSMENT

**SIGIR PA-06-092**  
**APRIL 26, 2007**

SUBJECT: Report on Project Assessment of the Gaugli-Ashur Police Station  
Renovation, Mosul, Iraq (Report Number SIGIR-PA-06-092)

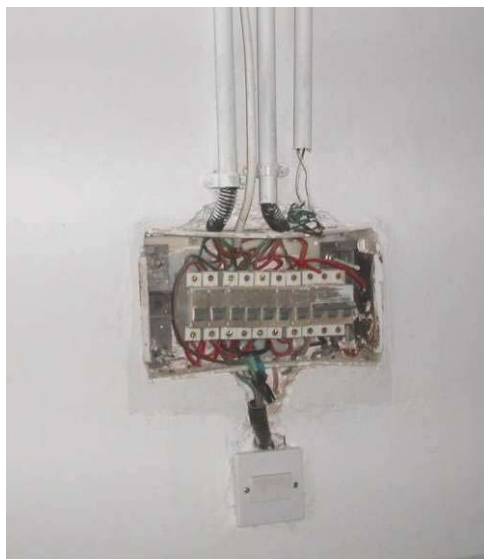
The contract's SOW described various requirements related to the overall electrical system. Exposed or damaged wiring needed to be replaced (rewired) and all wiring needed to be securely fastened to walls. As needed, switches, plug-ins, and fluorescent lighting ballasts needed to be installed. Lastly, electric system upgrades included the installation of a new generator with all necessary connections and controls to facilitate automatic conversion to generator power when needed.

**USACE Pre-Construction Photo 1. USACE referred to what a "typical" electrical system need was.**

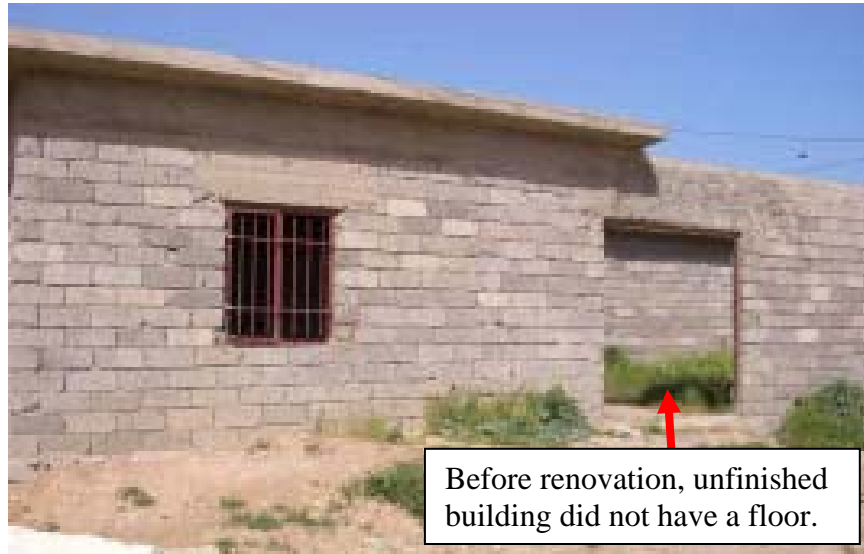
**USACE Pre-Construction Photo 2.**

The previously started but not finished detention center needed to be completed. Renovation work included installing a floor, detention cell, and steel bars over windows.

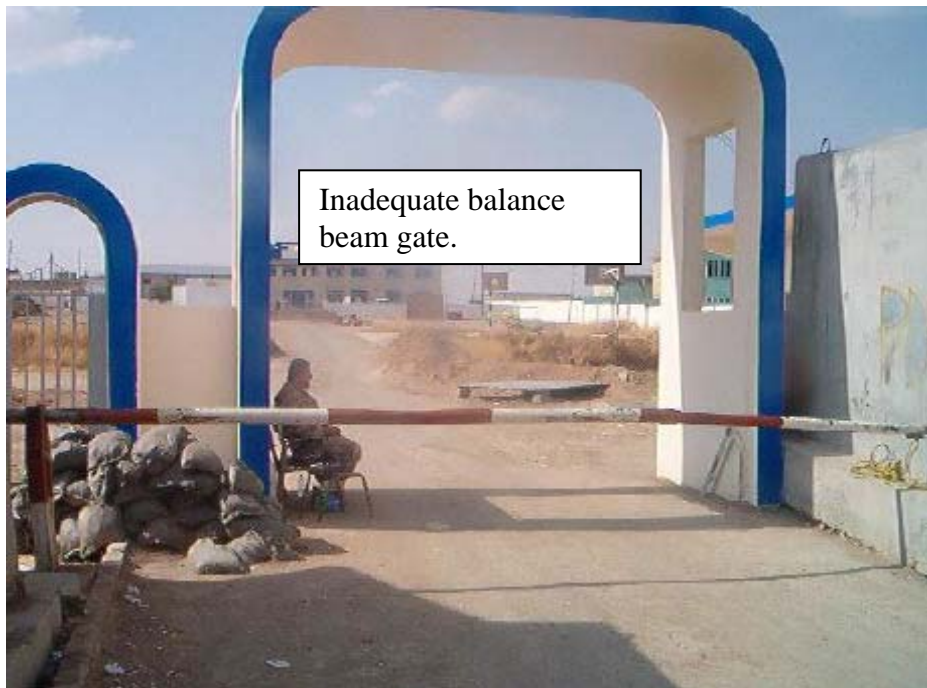
**USACE Pre-Construction Photo 3.**

Force protection was an important aspect of the renovation project. Accordingly, the SOW included requirements to install a heavy metal gate to prevent unauthorized access to the facility and construct rooftop guard houses. Before renovation, the balance beam gate shown below did not provide adequate security.

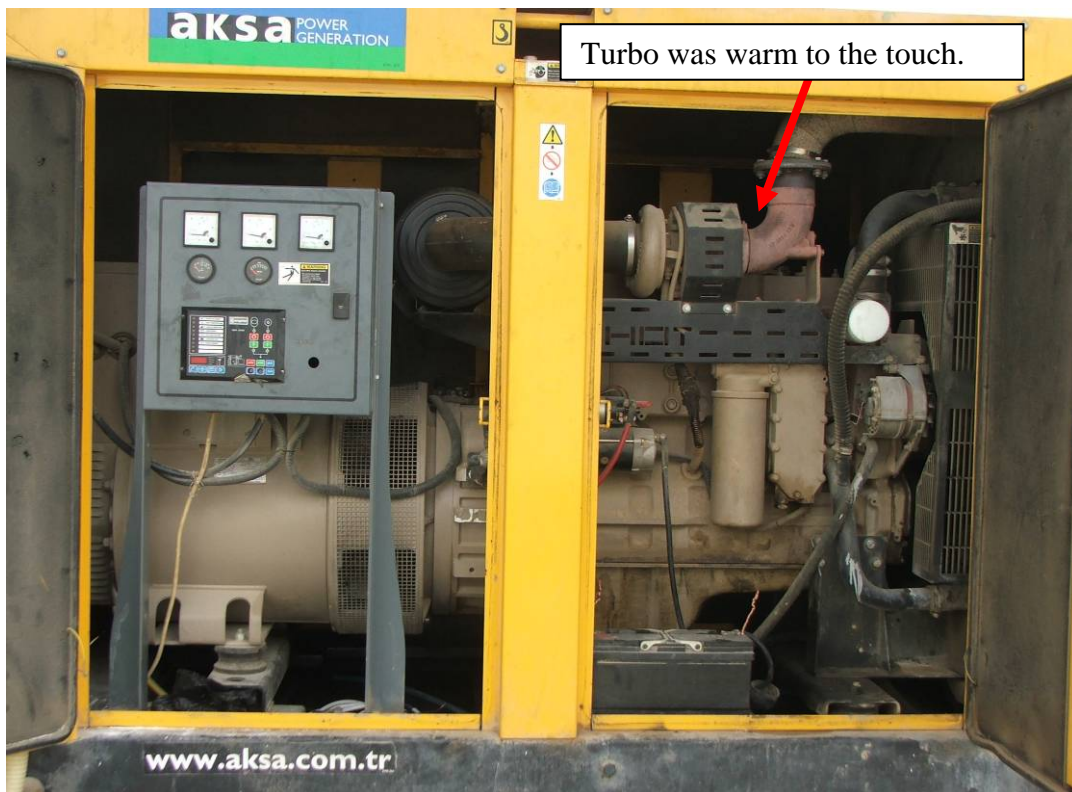
IP personnel stated that the generator and transfer switch system were operational and often used at night. SIGIR verified that the generator's oil level was full and the engine's turbocharger was warm to the touch (Site Photo 1). Accordingly, it was very likely that the generator system had been running the previous night.

**Site Photo 1. The generator installed per requirements appeared completely operational without any signs of neglect. When checked, the oil level was full and did not feel gritty. Belts and hoses appeared serviceable.**

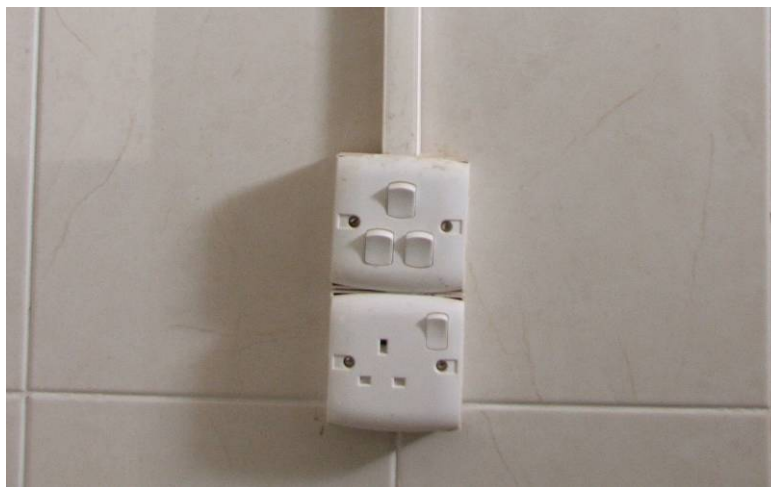
While on site, SIGIR did not observe any instances of potentially harmful electrical system tampering. Wiring improvements appeared compliant with SOW requirements (Site Photo 2). In addition, several showers, sinks, and toilets were tested to verify that they were fully operational. Interior and exterior plumbing improvements included new and upgrade showers, toilets, water heaters, piping, and sink installations appeared proper (Site Photo 3). Also, it appeared that numerous water supply tanks had been installed throughout the facility (Site Photo 4). SIGIR did not observe any evidence of chronic septic tank overflow and there was no sewer water standing<sup>2</sup> in the area. Interior and exterior painting appeared complete and compliant with SOW requirement in terms of paint type, color, and placement scheme. Rooftop guard houses were placed in such a manner that fields of fire and observation were maximized in order to improve the station's defensive position if

**Site Photo 2. Throughout the facility wiring, switches, and plug-ins were securely fastened to walls as required by the SOW.**

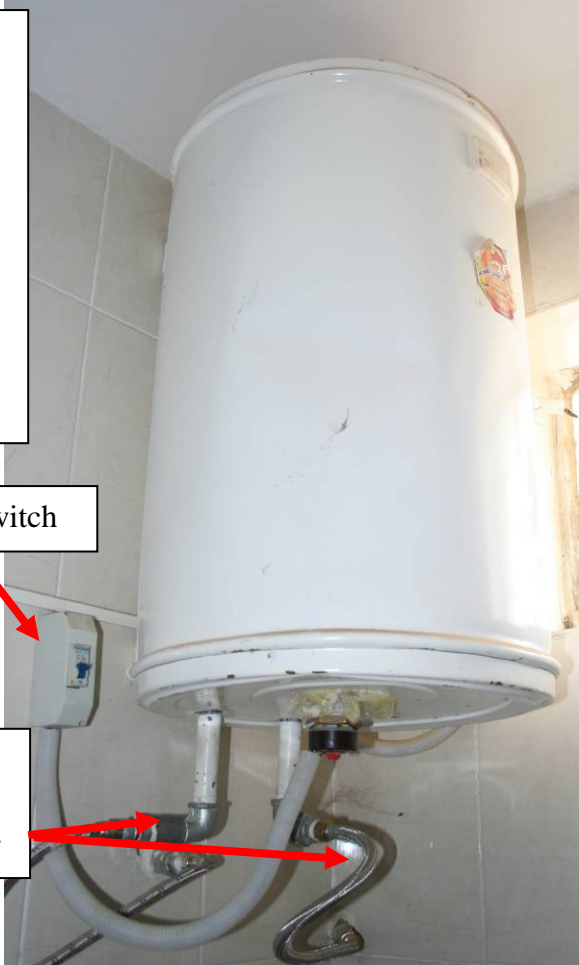
Per SOW requirements, improvements included several different water heater installations observed by SIGIR. In all cases, the water heater appeared properly secured, the plumbing and fittings did not leak, and the electric power feed was controlled by a circuit breaker/switch.

Breaker/switch

Metal piping and fittings made for a water tight installation.

Site Photo 3. Water heater.

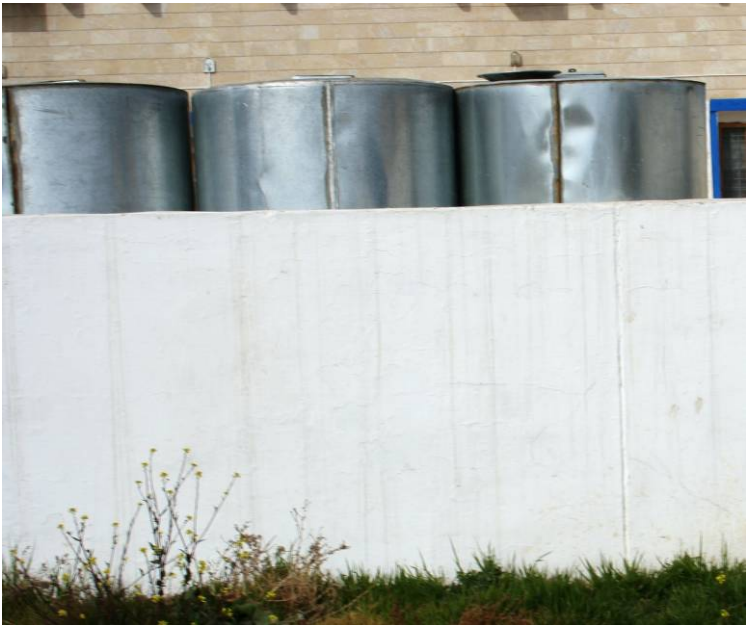
Site Photo 4. Throughout the facility, SIGIR observed new water storage tanks to meet SOW requirements to provide adequate supply.

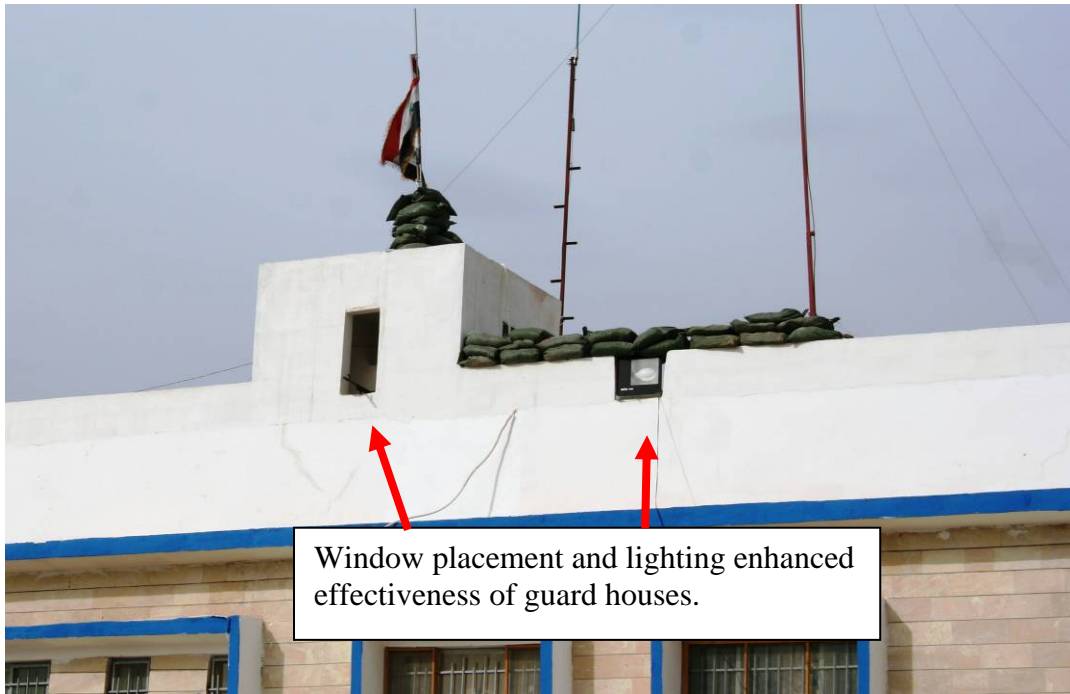
**Site Photo 5. As required, new rooftop guard houses and lighting upgrades improved force protection capability.**

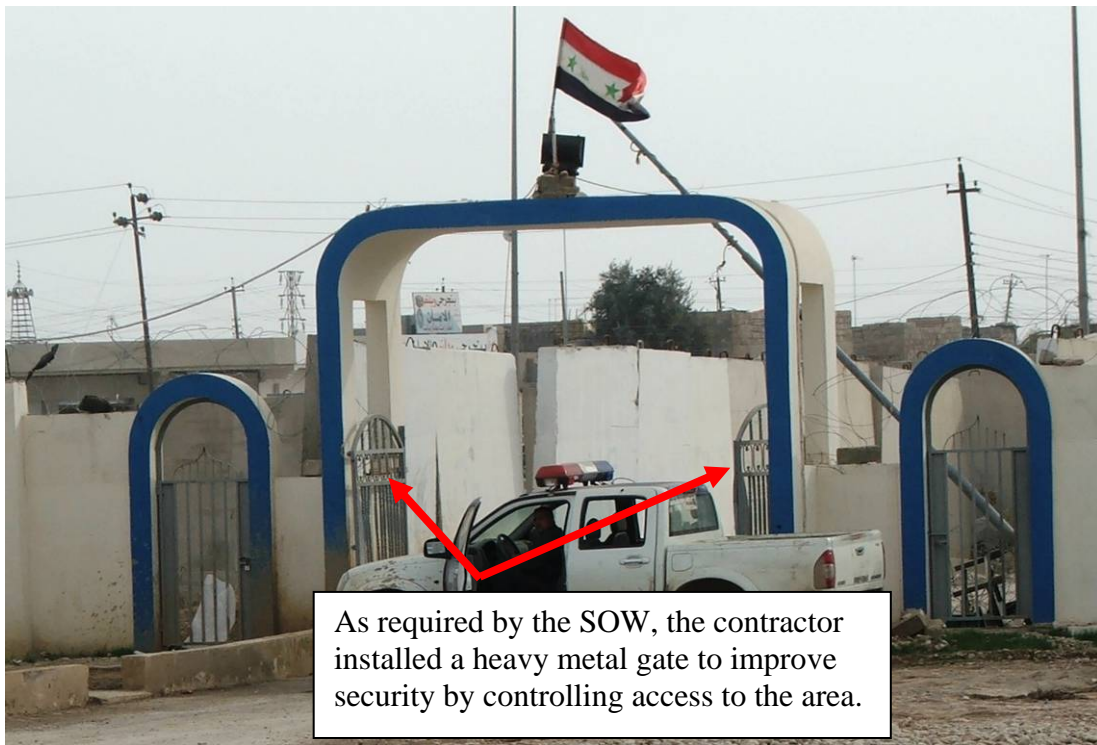
attacked (Site Photo 5) and a heavy gate to control access to the area was installed by the contractor to meet SOW requirements (Site Photo 6). Lastly, SIGIR observed the detention center was functional and in use (Site Photo 7).

**Site Photo 6. Heavy metal gate.**
