RELIEF AND RECONSTRUCTION
FUNDED WORK AT MOSUL DAM
MOSUL, IRAQ

SIGIR PA-07-105
OCTOBER 29, 2007

SUBJECT: Report on Relief and Reconstruction Funded Work at Mosul Dam, Iraq
(Report Number SIGIR PA-07-105)

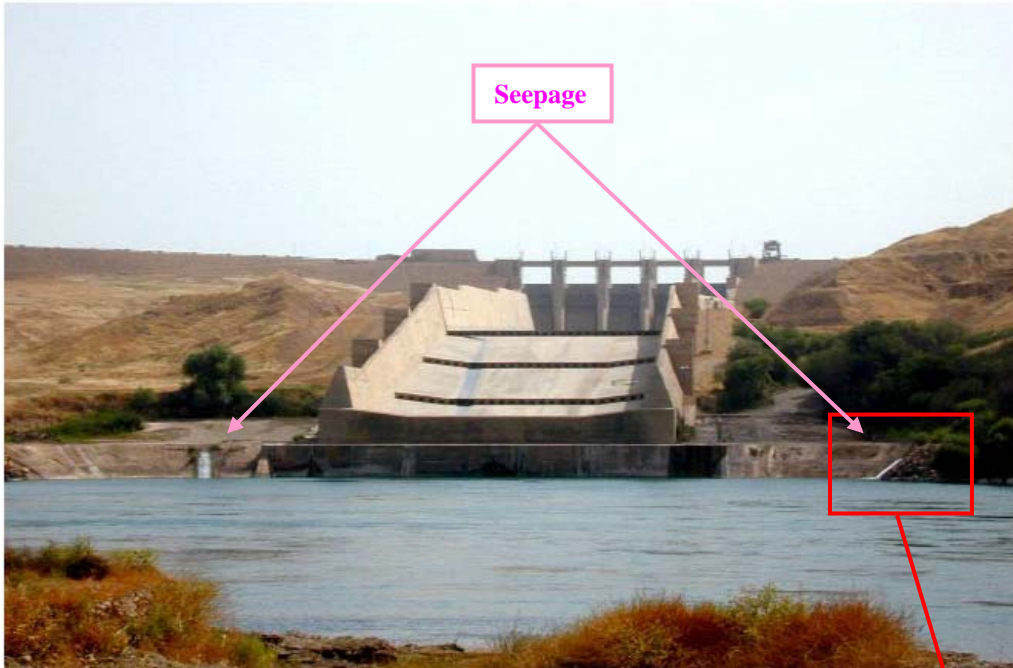
**Site Photo 6. Example of seepage at the Mosul Dam
(Photo courtesy of USACE)**

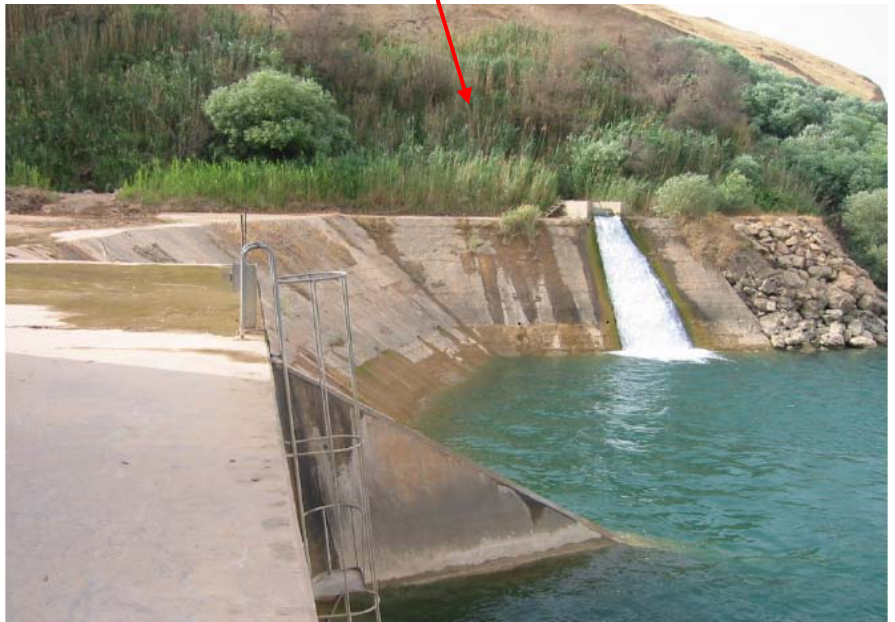
**Site Photo 7. Close-up view of seepage at the Mosul Dam
(Photo courtesy of USACE)**

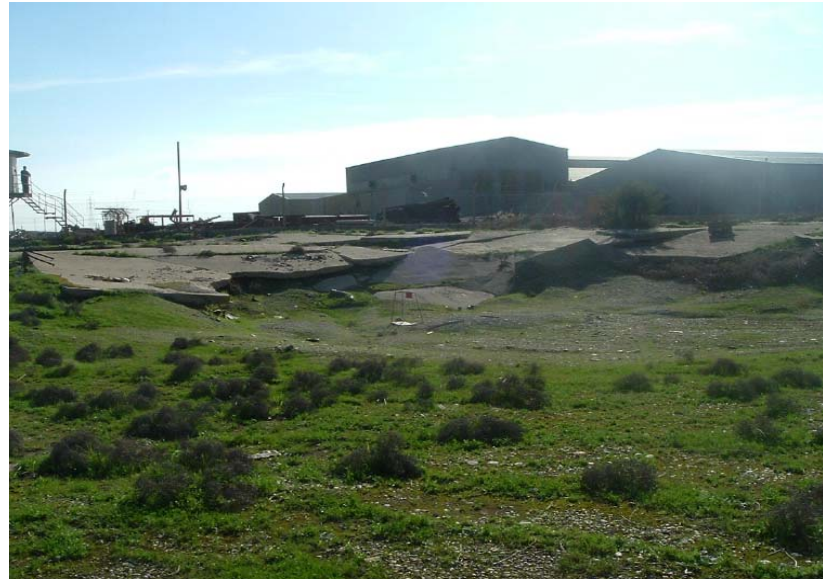
**Site Photo 9. Sinkhole beneath a concrete-paved area
(Photo courtesy of the USACE)**

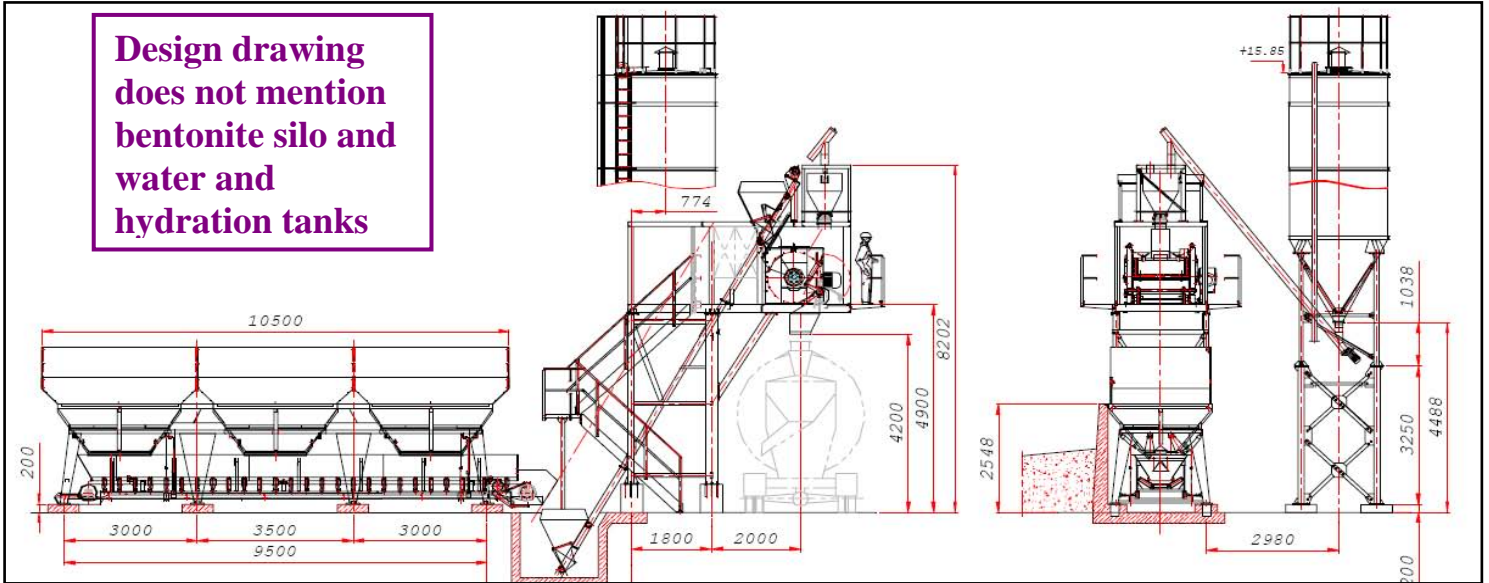
GRD provided the contractor's design submittals for the two sizes of grout-mixing plants (i.e., 30-m³/hour and 100-m³/hour), which we reviewed. For the 30-m³/hour grout-mixing plants, our review of the design drawings concluded that the contractor was clearly offering concrete-mixing plants, not grout-mixing plants (Figures 12 and 13). Grout mixing plants require a bentonite silo and water and hydration tanks, associated weighing and measuring devices, additional pumps and motors, which were not included in the design drawings.

Figure 12. Contractor's design drawing for 30-m³/hour concrete-mixing plant

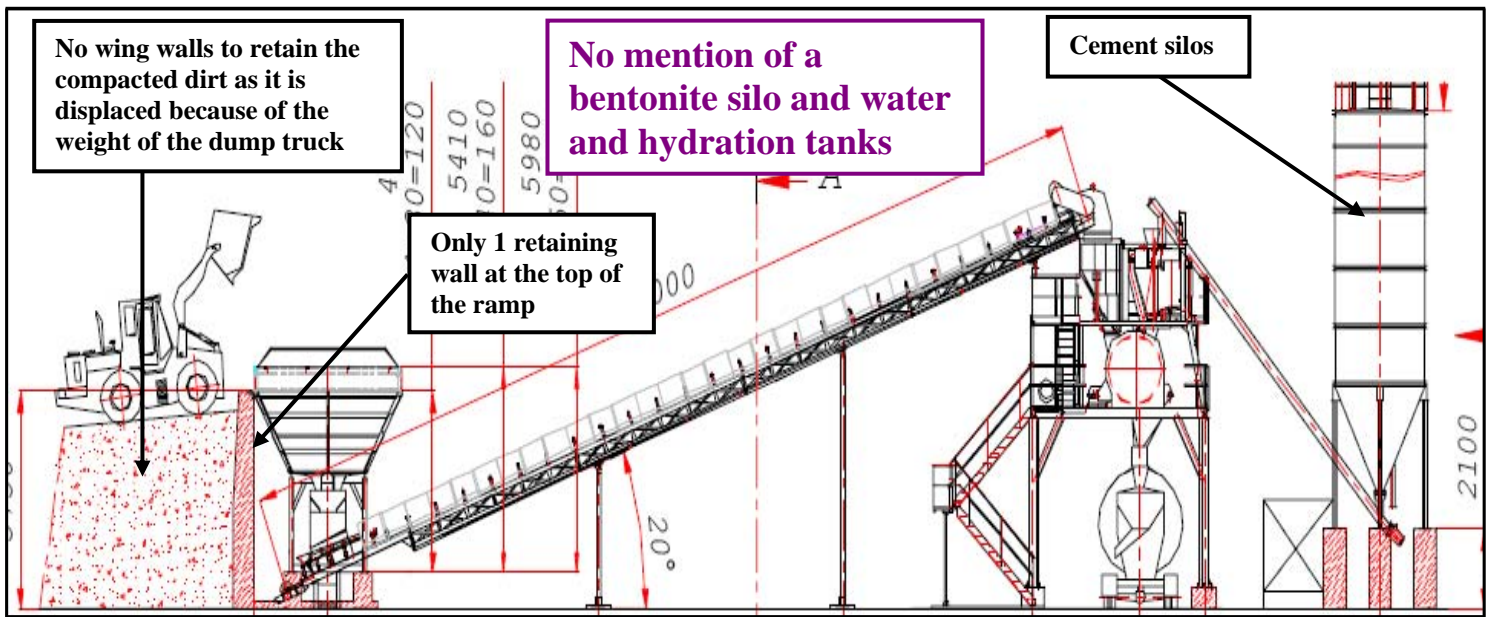
Figure 13. Contractor's design drawing for 100-m³/hour concrete-mixing plant

In our opinion, the 100-m³/hour mixing plant design submittal also clearly indicated the contractor was offering a concrete-mixing plant, not a grout-mixing plant (Figure 15). The design submittal lacked a bentonite silo, water and hydration tanks, associated weighing and measuring devices, and additional pumps and motors, which are essential for a grout-mixing plant (Figure 13).

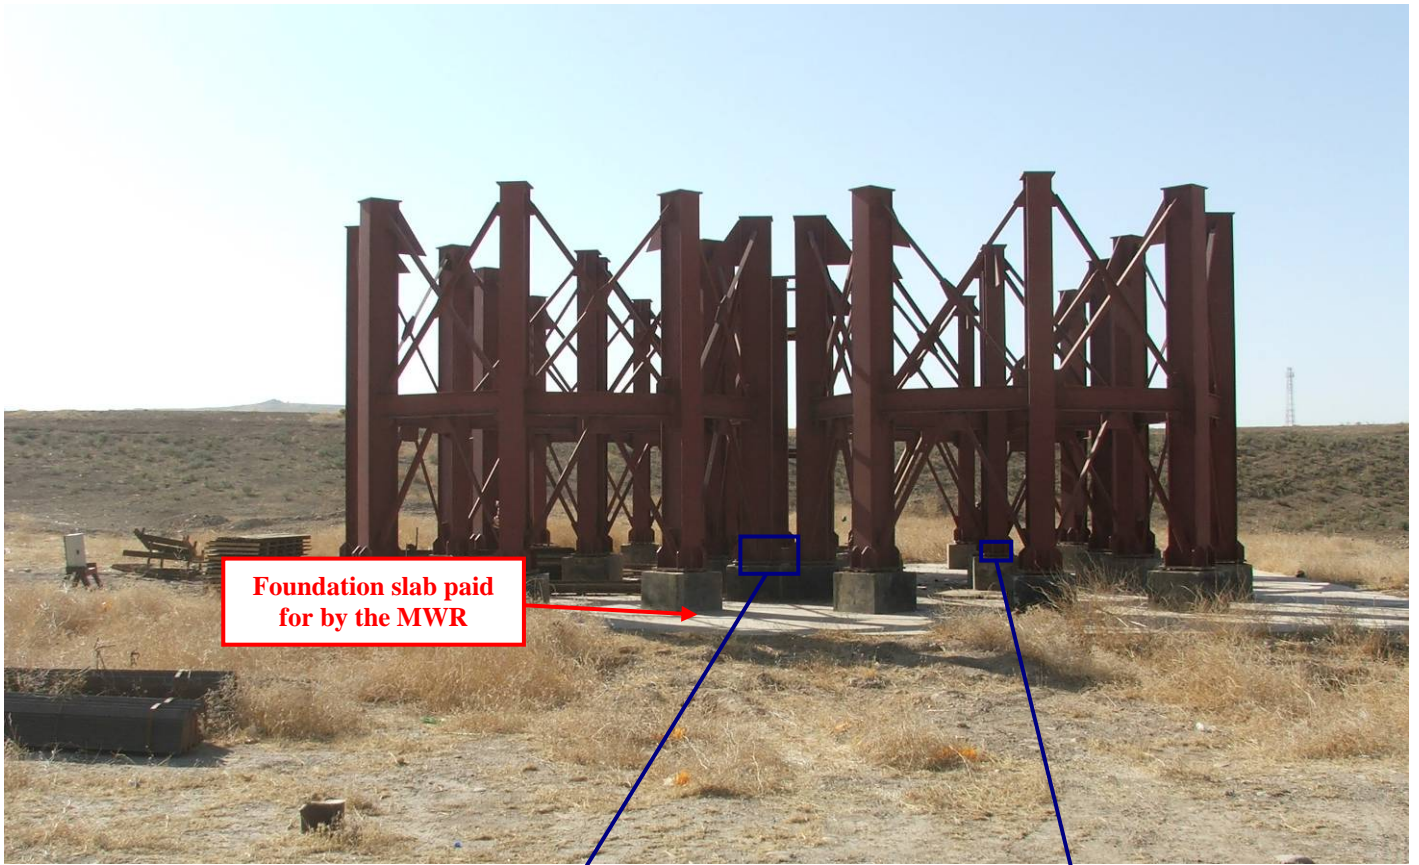
Foundation bolts are essential for the stability of the structure. The contractor erected steel columns, bracings, and beams by welding structural steel elements together. We observed foundation bolts cast within concrete columns so deficient that there was insufficient thread available to properly fasten the nuts on. (Site Photos 18 and 19). A foundation bolt is essential to secure the steel columns. Inadequately installed foundation bolts increase the probability of the structure's failure. We identified 43 of 144 (30%) foundation bolts inadequately installed. The installation of the foundation bolts also contradicts the contractor's own design construction techniques, which required bolt threads to extend higher than the nut (Figure 28 and Site Photo 20). In some instances, the contractor extended the foundation bolt well beyond the nut and continued to use poor installation practices, such as the use of too many washers (Site Photo 21). Considering that the stationary silos are to hold approximately 6,000 tons of cement, along with the weight of the steel superstructure with columns, we believe that inadequate installation of the foundation bolts leaves this structure in a potentially dangerous condition.

Site Photo 17. View of the partially constructed stationary silos

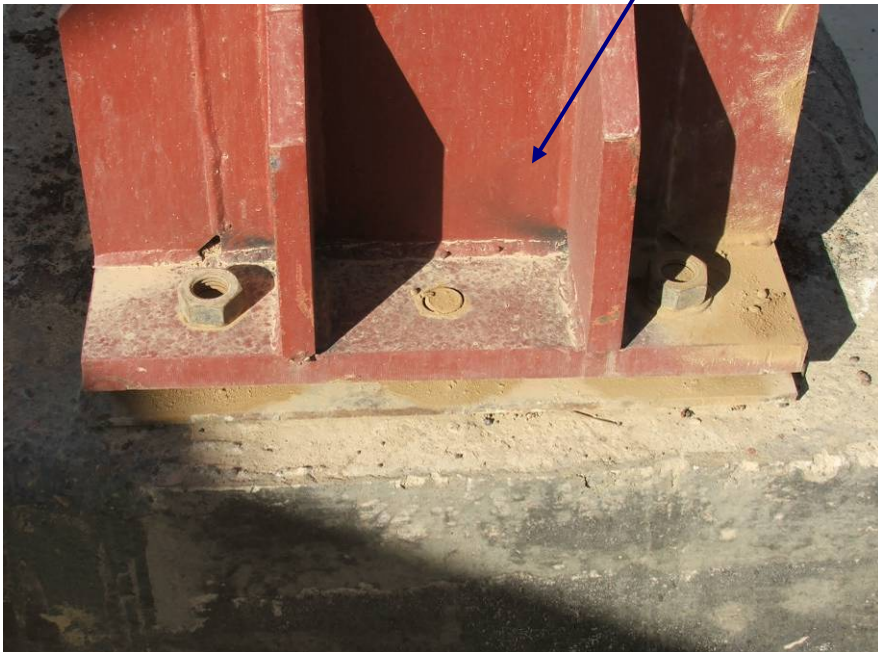
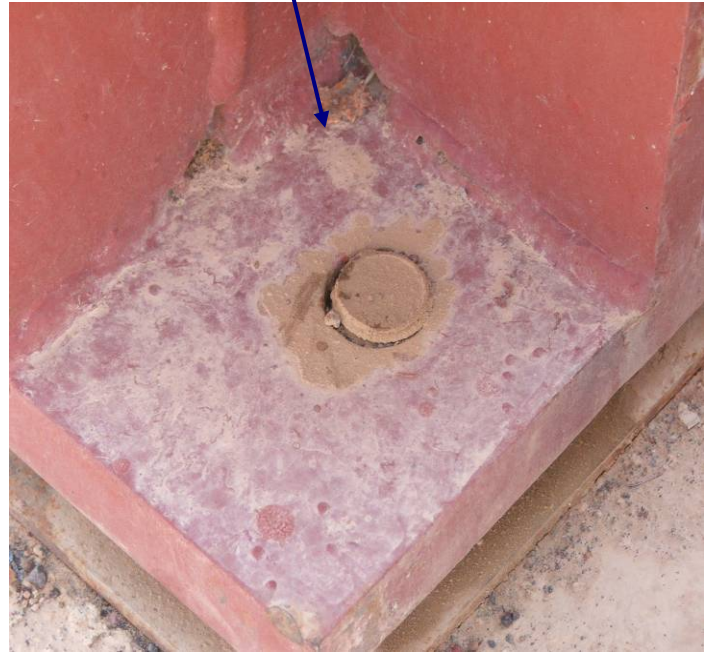
We identified an instance where construction did not appear to be adequate. The inspection team observed that some foundation bolts cast within concrete columns had insufficient thread to properly fasten the nuts. Specifically, we determined that 43 of the 144 (30%) foundation bolts were inadequately installed. Further, the installation of the foundation bolts also contradicted the contractor's own design construction techniques, which required bolt threads to extend higher than the nut. Complete design drawings are needed to determine if the remaining foundation bolts are adequately secured within the foundation or pose a serious threat of failure. Because each stationary silo will hold approximately 1,500 tons of cement, we believe that the inadequate installation of the foundation bolts leaves this structure in a potentially dangerous condition.

Site Photos 18 and 19. Close-up view of foundation bolts for the stationary silos

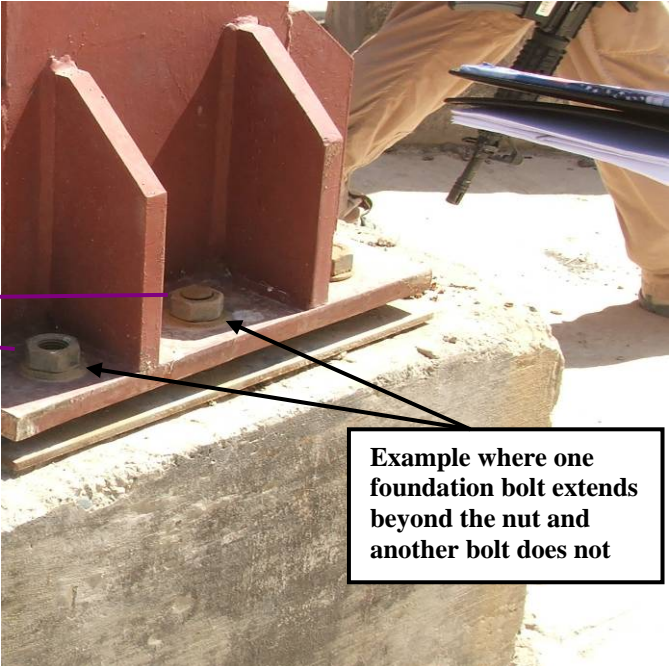
Example where one foundation bolt extends beyond the nut and another bolt does not

Site Photo 20. Examples of installation practices

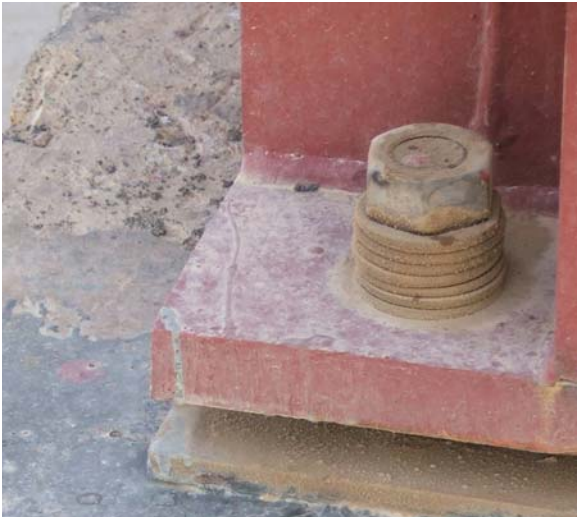
Site Photo 21. Poor installation technique (the use of 7 washers)

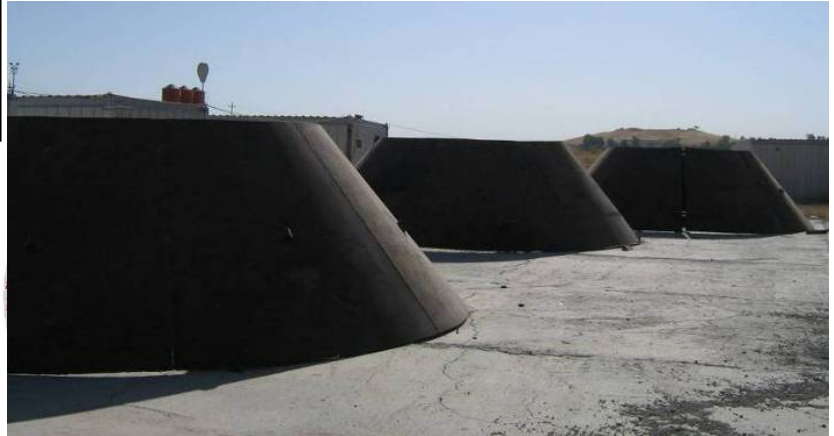
Parts of stationary silos either not delivered or unaccounted for, including significant pieces such as cylindrical holding tanks, cement loading system, control room, and funnel cones

Site Photo 22. Three partially welded funnels for the stationary silos

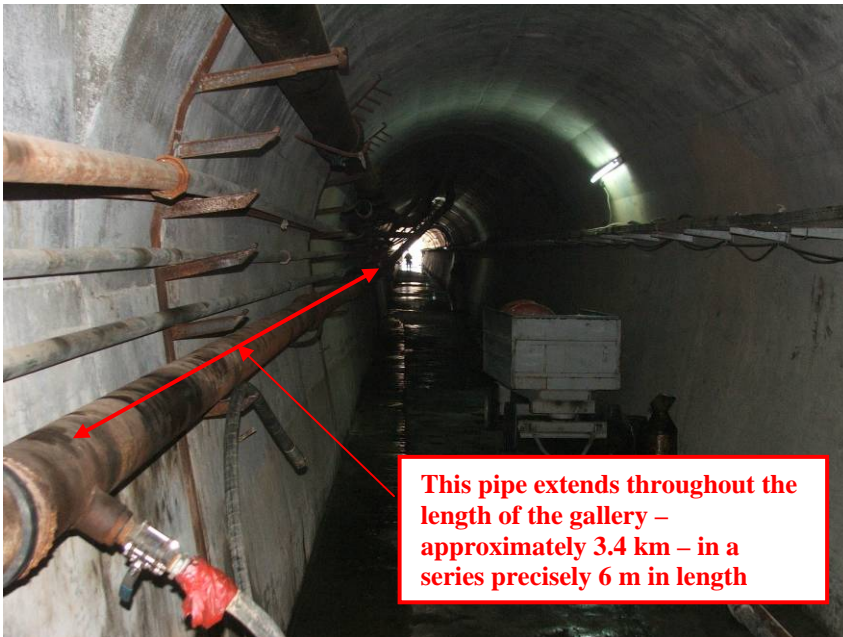
This pipe extends throughout the length of the gallery – approximately 3.4 km – in a series precisely 6 m in length

Site Photo 25. View of interior gallery pipes used to carry water outside

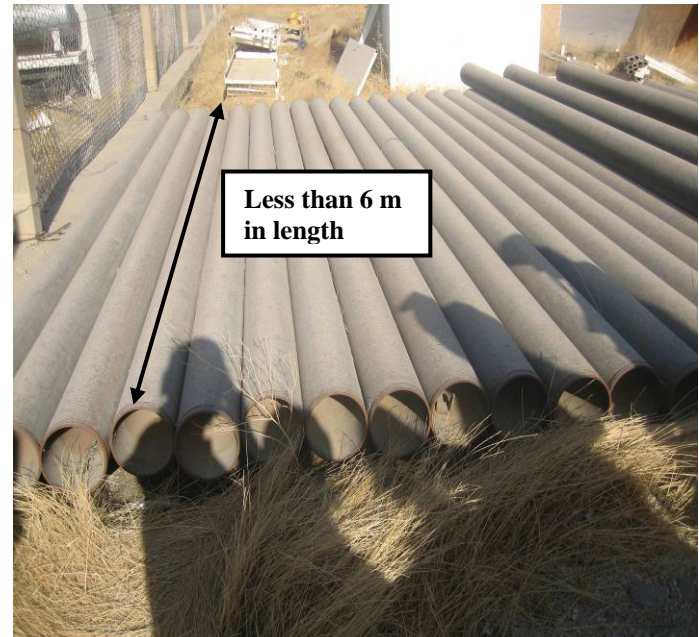
Mosul Dam personnel stated that because the pipe sizes are not accurate, workers will have to cut and weld two pieces together (which is very difficult to do) or simply not use the pieces. Currently, the pipes sit unused located outside a warehouse.

Less than 6 m in length

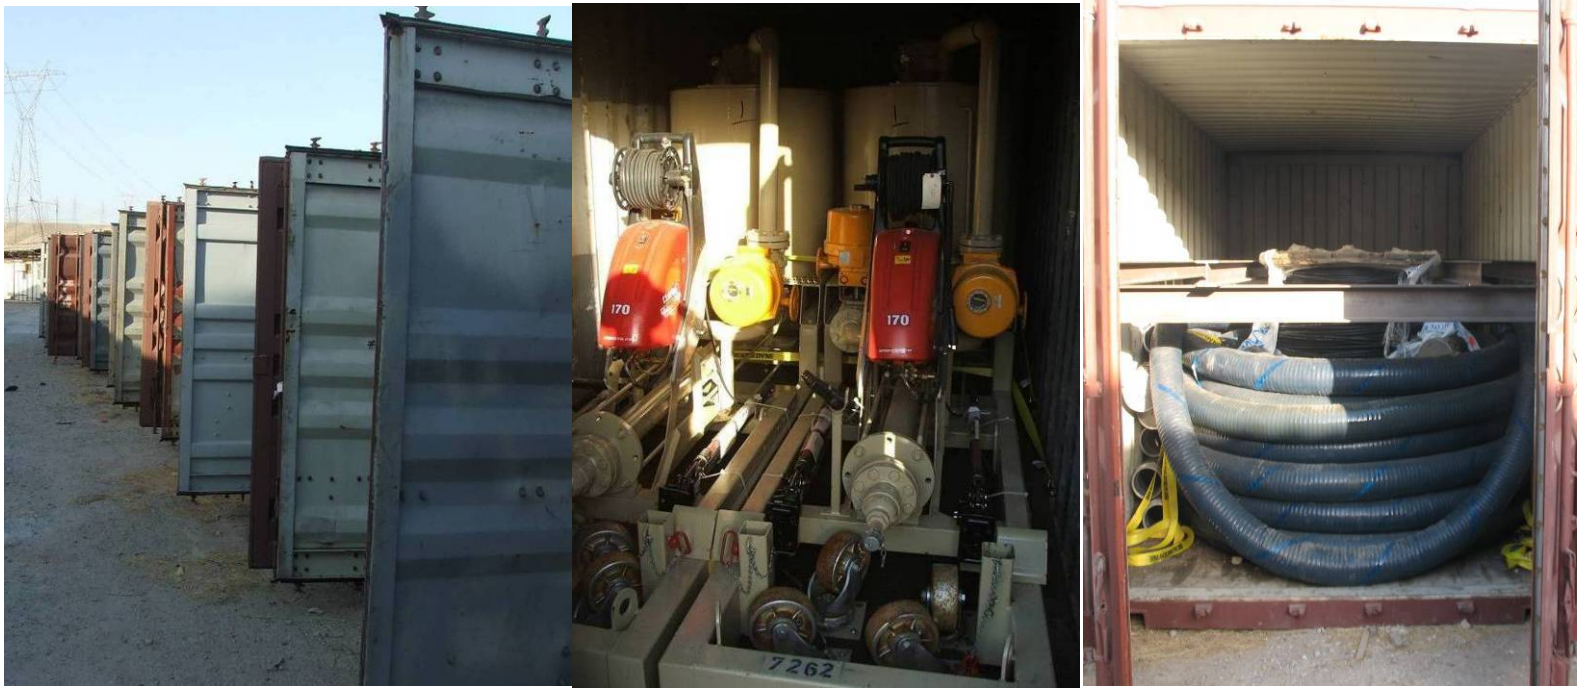
Site Photos 30, 31, and 32. Conex boxes with partially assembled enhanced grouting equipment

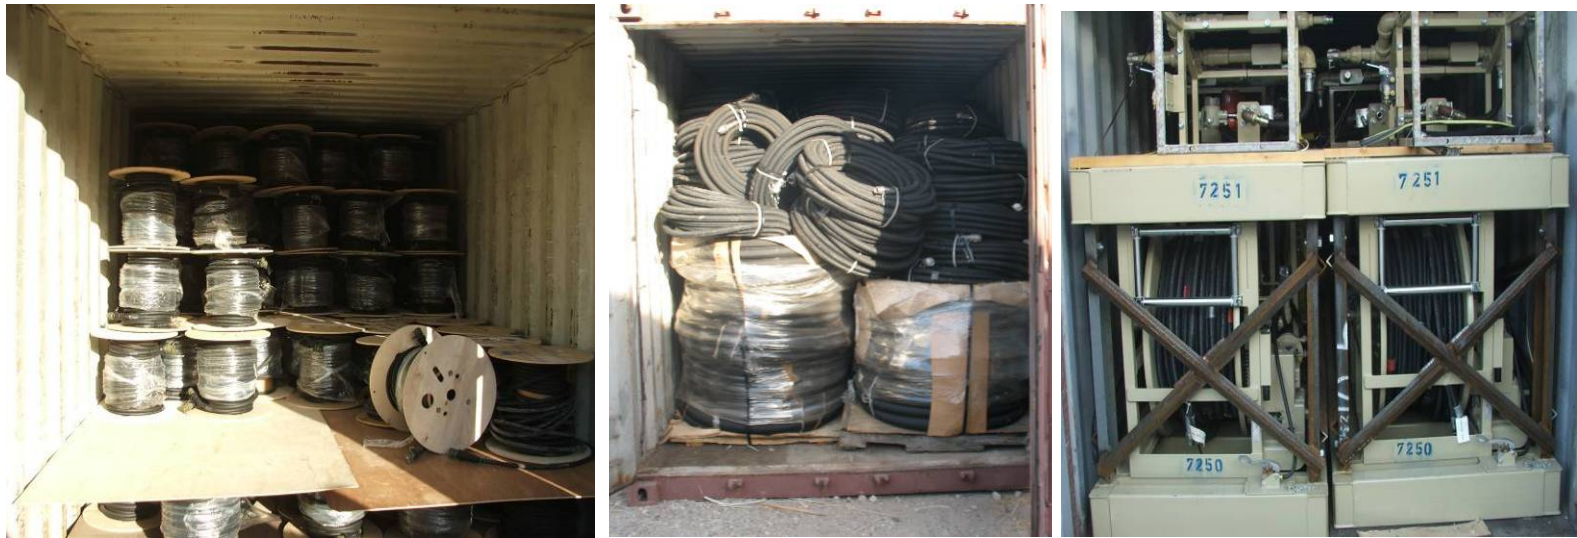
Site Photos 33, 34, and 35. Conex boxes with partially assembled enhanced grouting equipment
