BARTILLA BOOSTER PUMP STATION REPAIR
COMMANDER'S EMERGENCY RESPONSE PROGRAM
NINEWA GOVERNORATE, IRAQ

SUSTAINMENT ASSESSMENT

SIGIR PA-07-109
OCTOBER 23, 2007

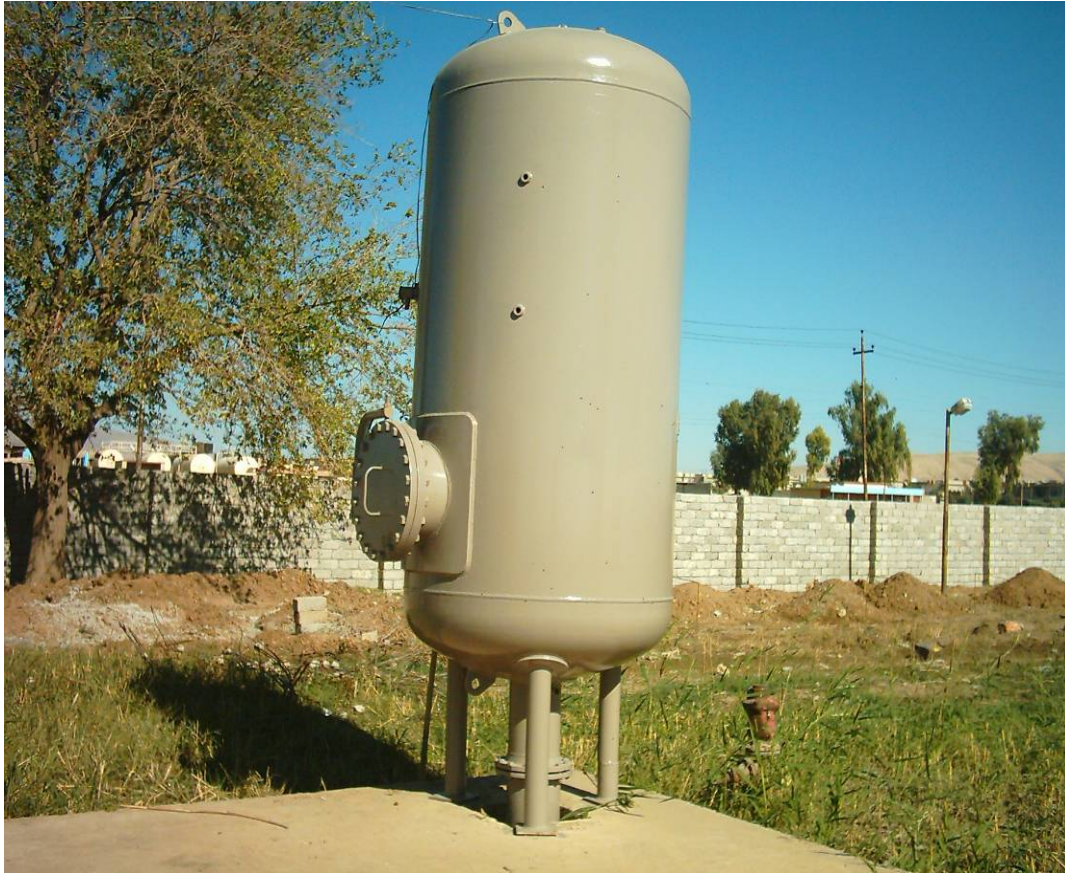
Site Photo 1 documents the anti-hummer system before any maintenance occurred, and Site Photo 2 shows the maintenance performed by the contractor on the anti-hummer system.

Site Photo 2. Anti-Hammer system after maintenance (Photo courtesy of USACE)

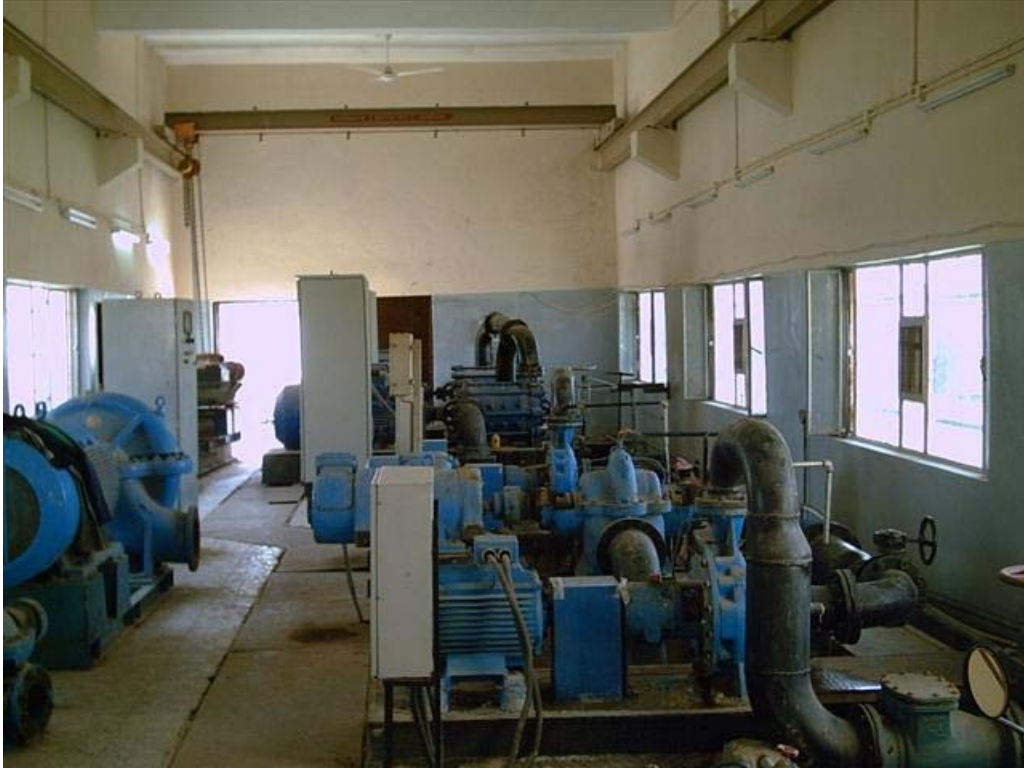
Site Photo 3 documents the general maintenance performed inside the booster pump station building and Site Photo 4 displays the general maintenance performed on the exterior of the booster pump station building, including the roof, walls, windows, doors, and exterior painting.

Site Photo 3. General maintenance performed inside the Bartilla Booster Pump Station pump room (Photo courtesy of USACE)

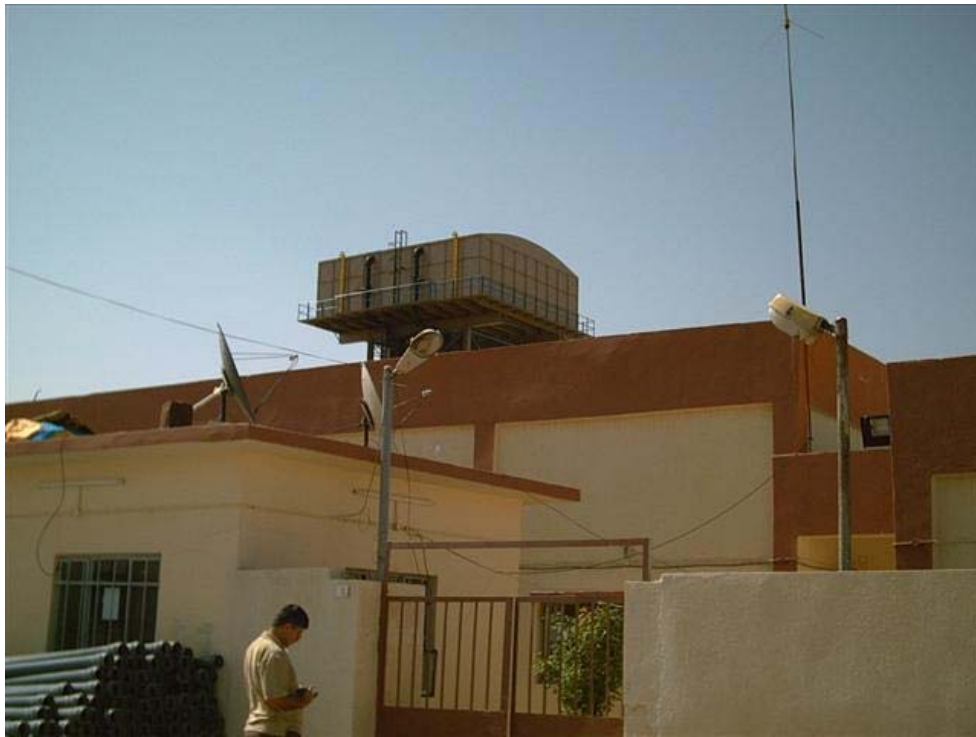
Site Photo 4. General maintenance performed on the exterior of the Bartilla Booster Pump Station (Photo courtesy of USACE)

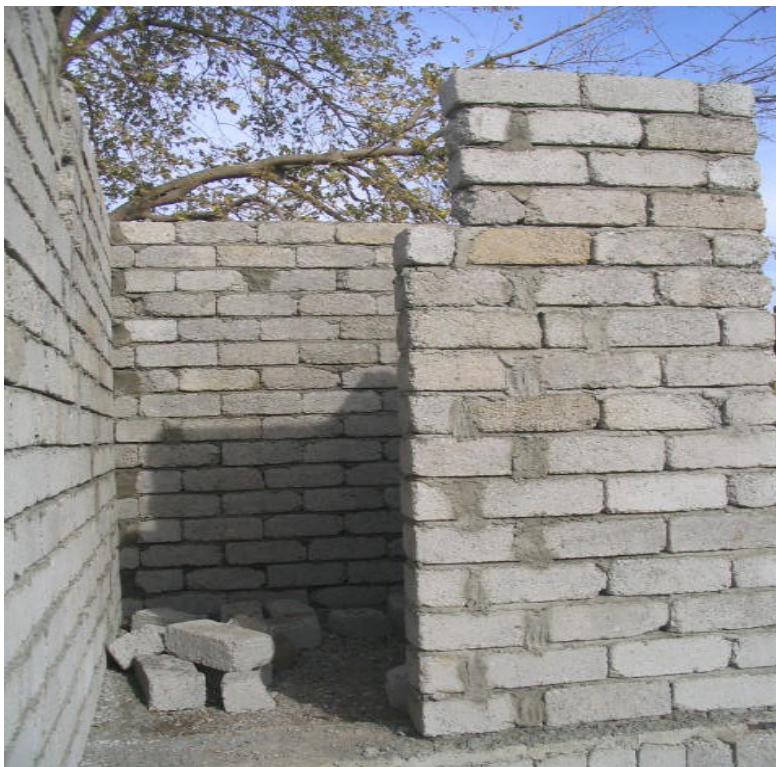
Site Photo 6 displays the new construction of a water closet at the Bartilla Booster Pump Station, and Site Photo 7 documents the completed construction of the water closet.

Site Photo 6. Construction of a water closet (Photo courtesy of USACE)

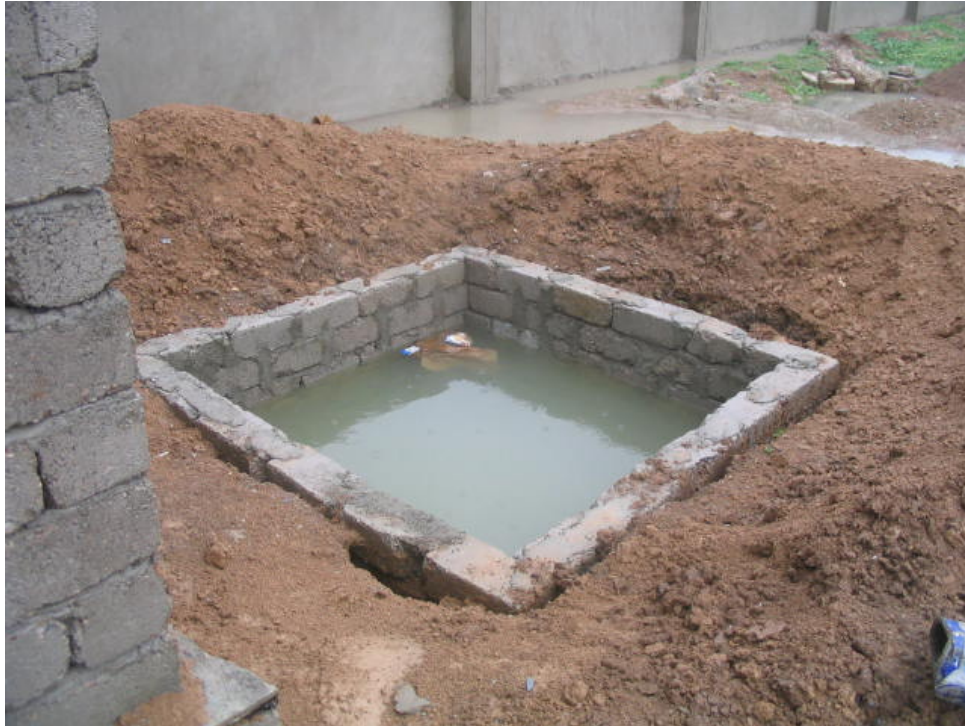
The excavation of the septic tank is shown in Site Photo 8, and Site Photo 9 documents the testing of the 2mx2mx2m septic tank.

Site Photo 9. Septic tank testing (Photo courtesy of USACE)

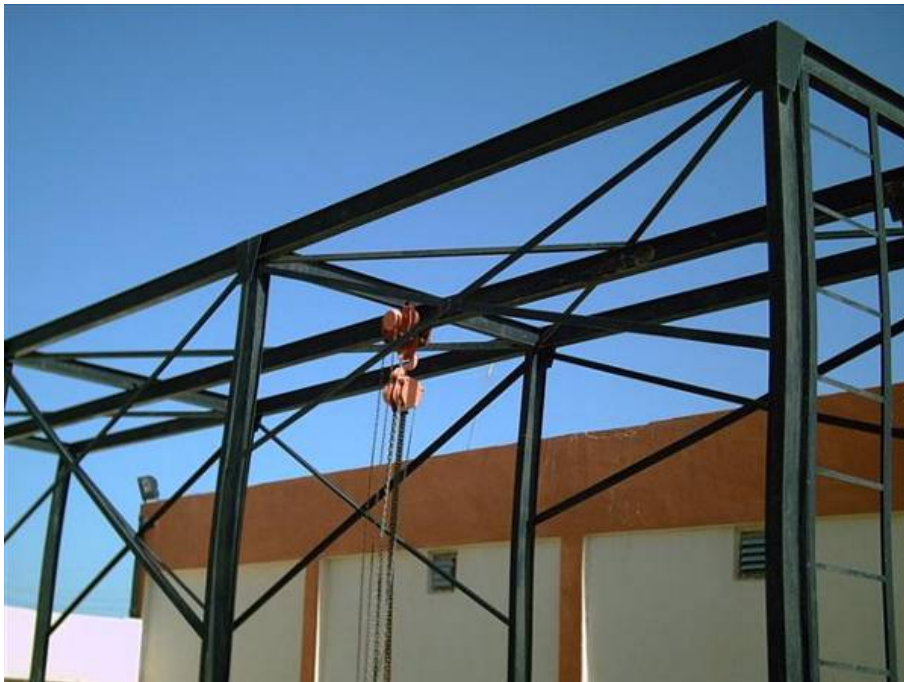
Site Photo 10 shows the installation of the hand-operated 3-ton crane for the ground storage tank.

Site Photo 10. Installation of the new 3-ton crane (Photo courtesy of USACE)

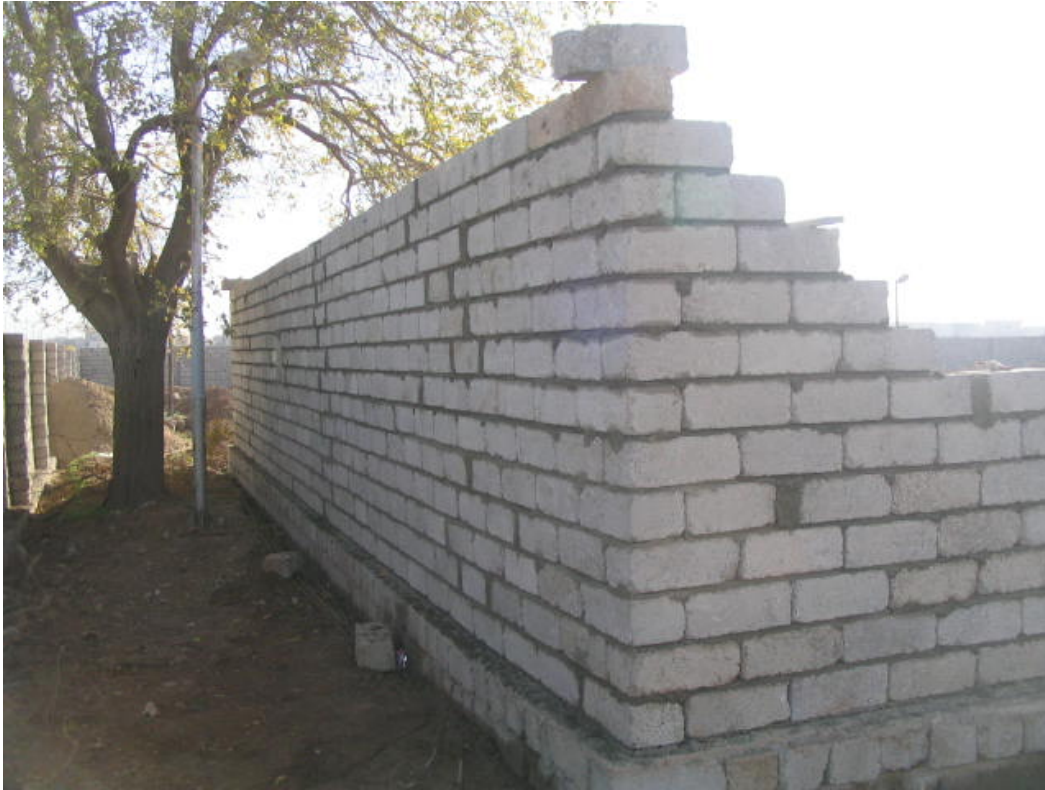
Site Photo 11 documents the construction that occurred for the manager of operations' new office.

Site Photo 11. Construction of the manager of operations' new office (Photo courtesy of USACE)

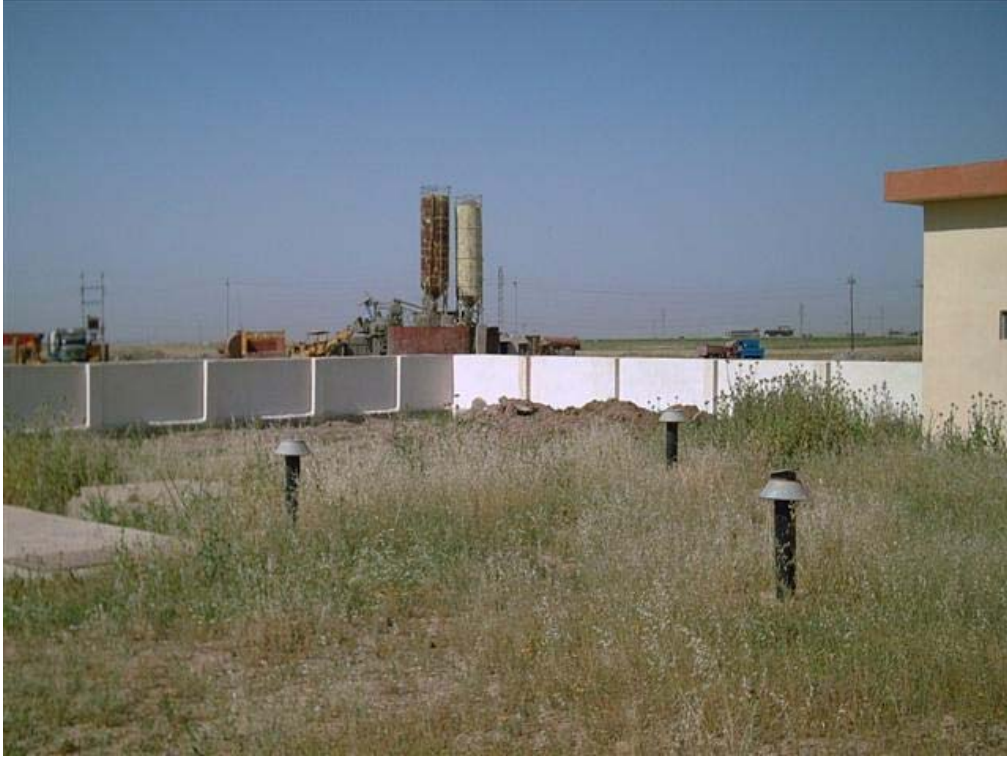
The construction of the two-meter high fence, made from concrete blocks and cement plaster, is shown in Site Photo 12. Site Photo 13 documents the completed construction of the two-meter high fence around the perimeter of the Bartilla Booster Pump Station.

Site Photo 13. Newly constructed security wall (Photo courtesy of USACE)

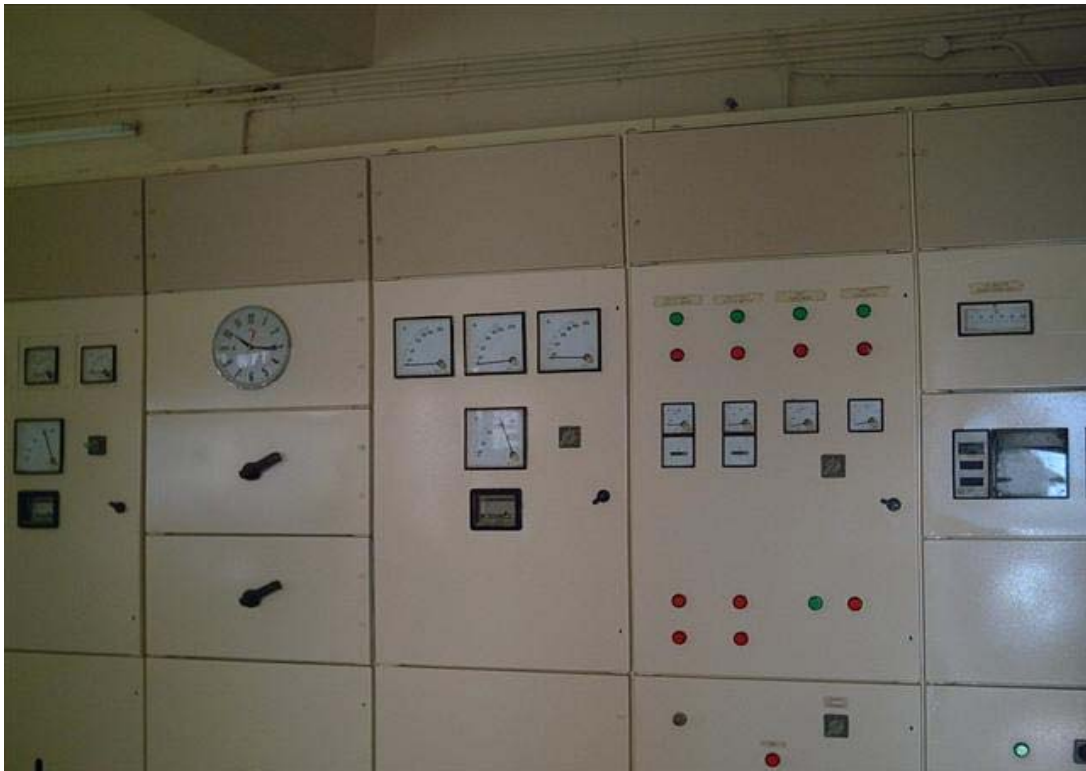
Site Photo 14 shows the pump house control panel after receiving general maintenance.

Site Photo 14. Pump house control panel after maintenance (Photo courtesy of USACE)

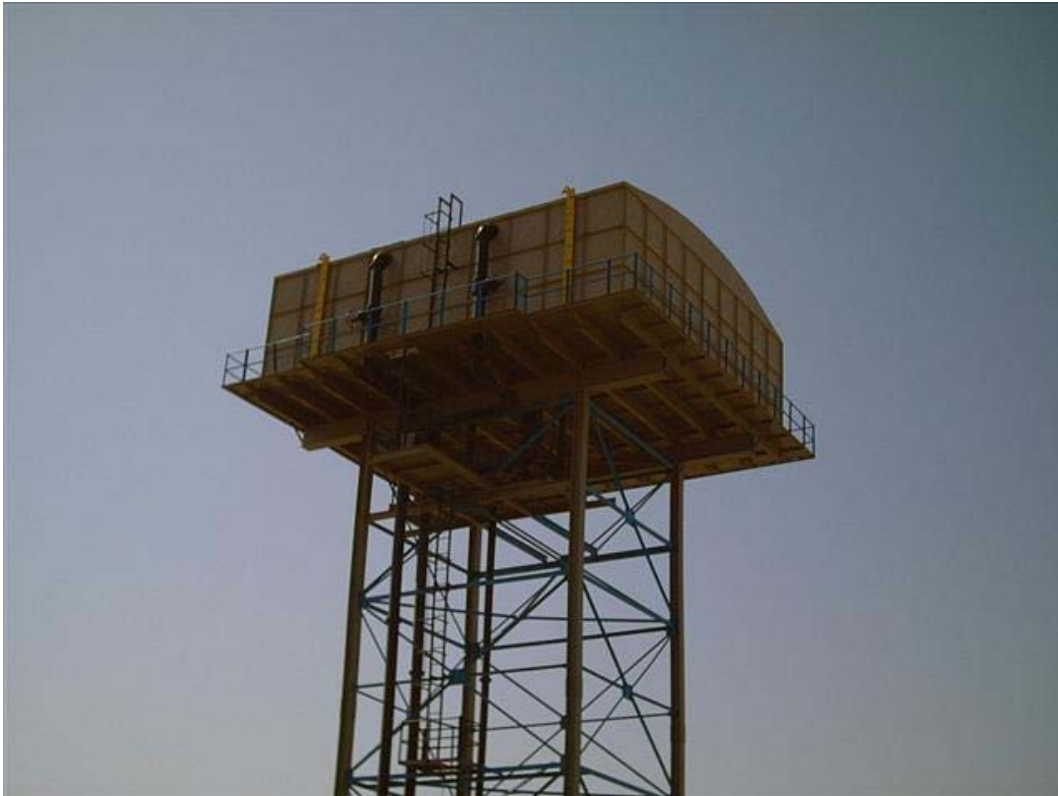
Site Photo 15 documents the elevated steel tank after receiving general maintenance.

Site Photo 15. Elevated steel water tank after maintenance (Photo courtesy of USACE)
