**HADITHA DAM PERIMETER SECURITY
HADITHA, IRAQ**

SUSTAINMENT ASSESSMENT

**SIGIR PA-09-192
APRIL 13, 2010**

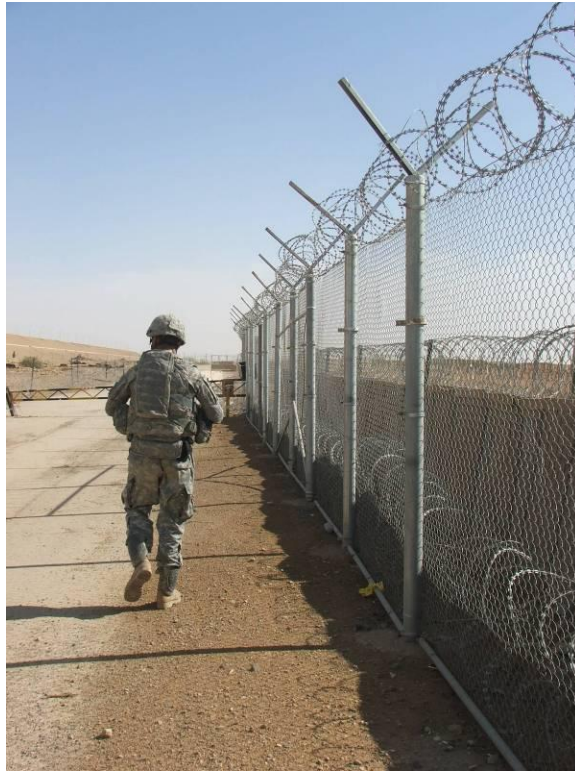
The fence consisted of 2.5 meter tall, four-inch diameter posts at 3 meter intervals connected at the base with a two-inch diameter brace rail. A tension wire ran along the top of the fence through the chain link fabric. The posts were topped with "V" brackets, which support a continuous coil of concertina wire. Two additional coils of concertina wire were placed on grade (on the ground) along the exterior of the fence (Site Photo 2).

Site Photo 2. Typical fence section

Some sections of the perimeter fence did not conform to the Uniform Facilities Guidelines Section 3231 or the USACE standard drawings for the security fence. Strands of barbed wire were not placed on the “V” shaped brackets along the top of the fence to contain the concertina wire coil. The contractor used concertina wire coil that is a single coil approximately 18 inches in diameter, instead of the contract-required interlaced double coils of 24 and 30 inch diameter.

The contractor attached the chain link fabric to the fence posts with steel bands at 32 inches on center. The attachment did not conform to the 15 inches on-center requirement of the USACE standard drawings for a security fence, and was not consistent with the 18 inches on-center indicated on the contractor’s drawings.

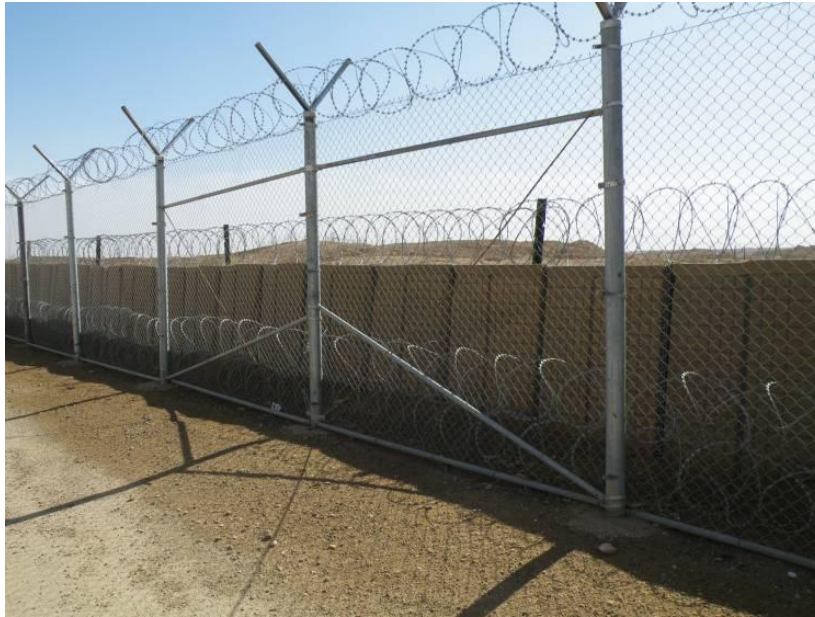
Brace panels were constructed along the fence line at approximately 100 foot intervals (Site Photo 3). The brace panels consisted of two horizontal and two diagonal brace rails, and two truss rods. The chain link fencing appeared continuous across most of the pull posts with no tension bars or bands evident, which conflicted with the approved details for the fence.

The fence brace rails were different dimensions than shown on the contractor’s drawings. The brace rails were attached to the pull post approximately 36 inches above the post base, instead of 58 inches as shown on the contractor’s drawings. The difference will affect the ability of the brace panel to resist tension from the chain link fabric.

Also, SIGIR noted that many of the brace rails were misaligned. This may not be critical to the function of the brace panels, but is indicative of poor workmanship.

Site Photo 3. Typical fence section

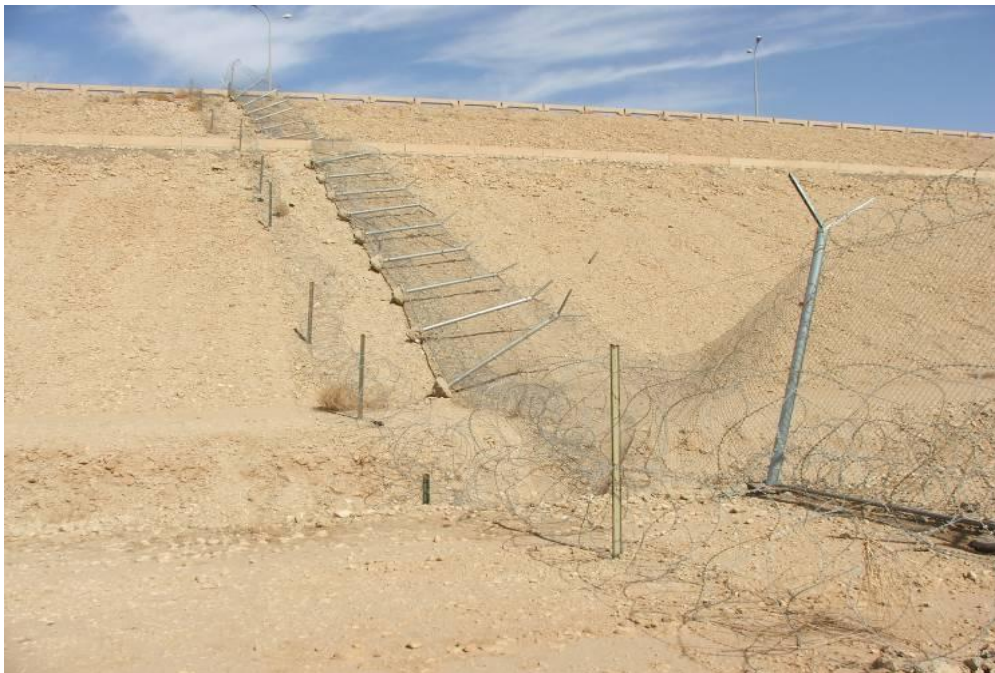
During the site assessment, SIGIR observed a fallen fence line approximately 150 feet long. The fallen fence section was located on the southern face of the dam and traversed the slope from the base of the dam to the paved road along the dam's breast⁶ (Site Photos 4 and 5).

Site Photo 4. Failed fence section

Iraqi Army representatives that were stationed at the Haditha Dam at the time of SIGIR's site inspection stated that the fence collapsed during a period of high winds. SIGIR inspected the section of collapsed fence and determined that this scenario was plausible.

After the inspection, it was determined that the fallen fence line poles were in the ground less than 0.5 meters. The Al Asad Resident Office stated that the contractor will replace and set the poles in concrete to the proper depth. In addition, approximately 10% of the remaining fence poles will be reset.

1. Replace and repair the collapsed fence line.
2. Reset the remaining fence poles that were not set to their proper depth.
3. Implement controls to ensure that the contractor provides daily quality control reports of the corrective actions taken for the deficiencies.

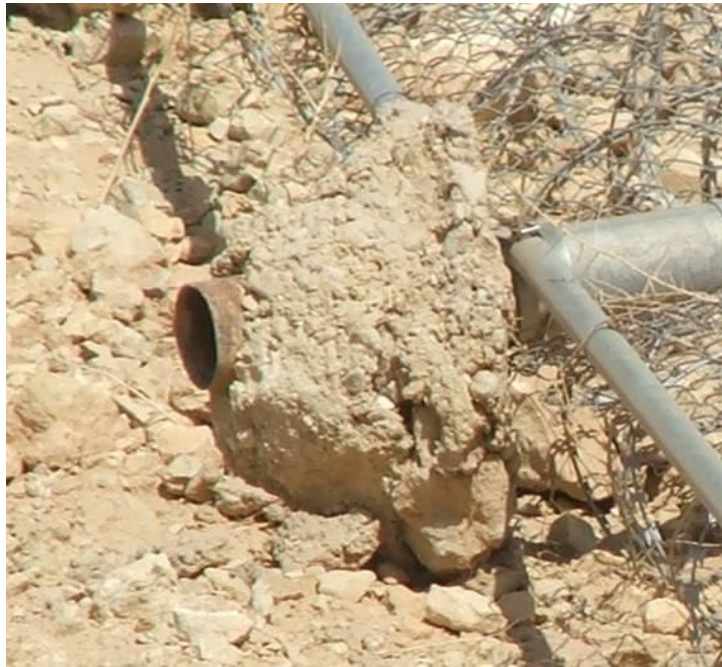
The concrete anchorage for the fence posts was approximately 8 to 12 inches deep (Site Photo 6), which was inconsistent with the contractor's design drawings that showed a 45 inch depth for a typical line post. The configuration of the concrete anchorage was not consistent with the contractor's design plans and tapered from approximately 16 inches in diameter at the top to 8 inches in diameter at the base of the post, instead of the required uniform diameter of 16 inches. In addition, the anchorage did not cover the end of the post as shown in the design drawings, which will allow for increased corrosion of the post.

Site Photo 6. Concrete anchorage at failed fence post

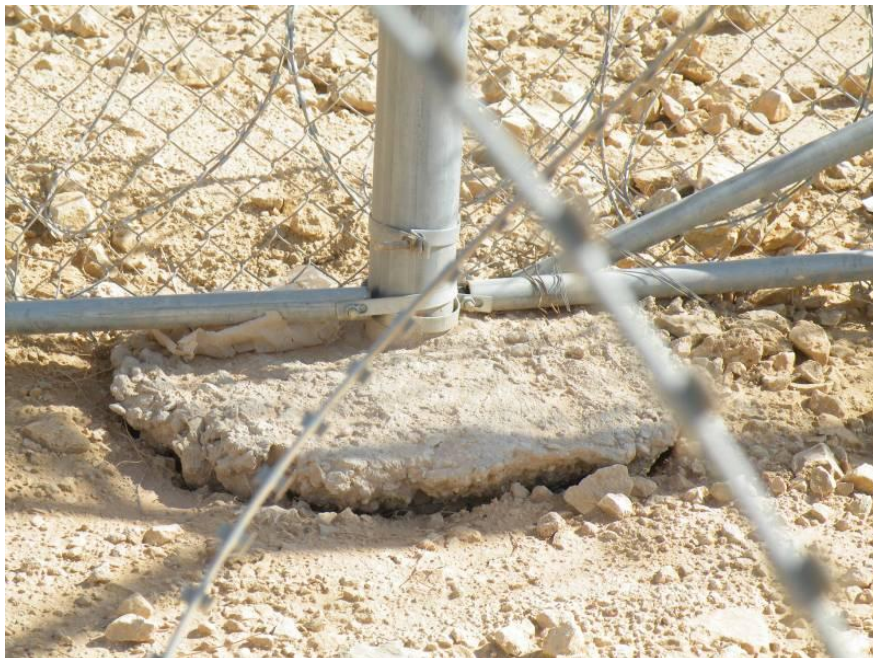
SIGIR examined the post foundations for several posts that were still in the ground. A gap existed between the concrete anchorage and the surrounding soil, indicating movement of some posts (Site Photo 7).

Site Photo 7. Concrete anchorage

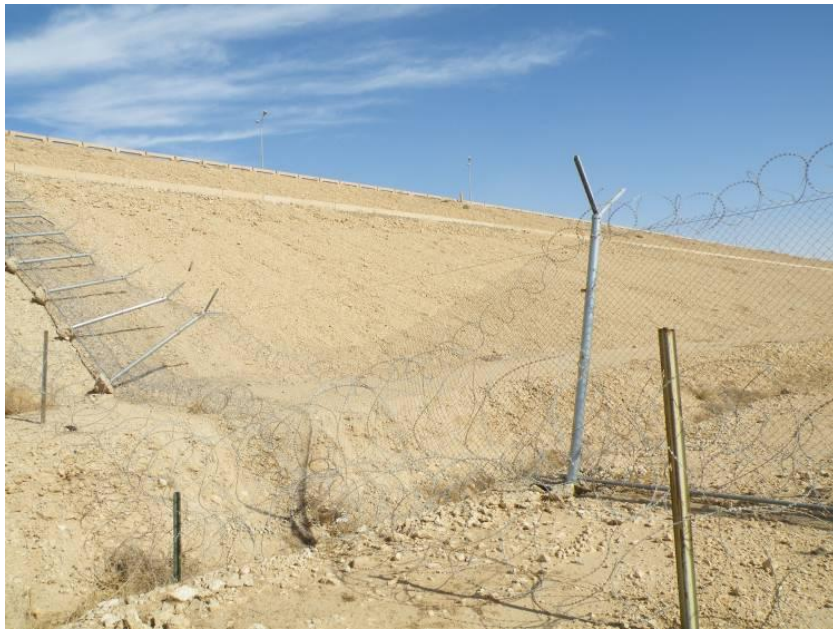
While inspecting the collapsed section of the fence, SIGIR noted a poorly constructed swale⁷ crossing (Site Photo 8). To bridge an existing swale perpendicular to the fence line, the contractor extended the spacing between posts and extended the chain link fence

across the swale. This left a gap several feet high and several feet wide beneath the chain link fence. The concertina wire placed at the base of the fence did conform to the contour of the channel and provides a less effective barrier to prevent entry to the facility.

Site Photo 8. Poorly constructed swale crossing

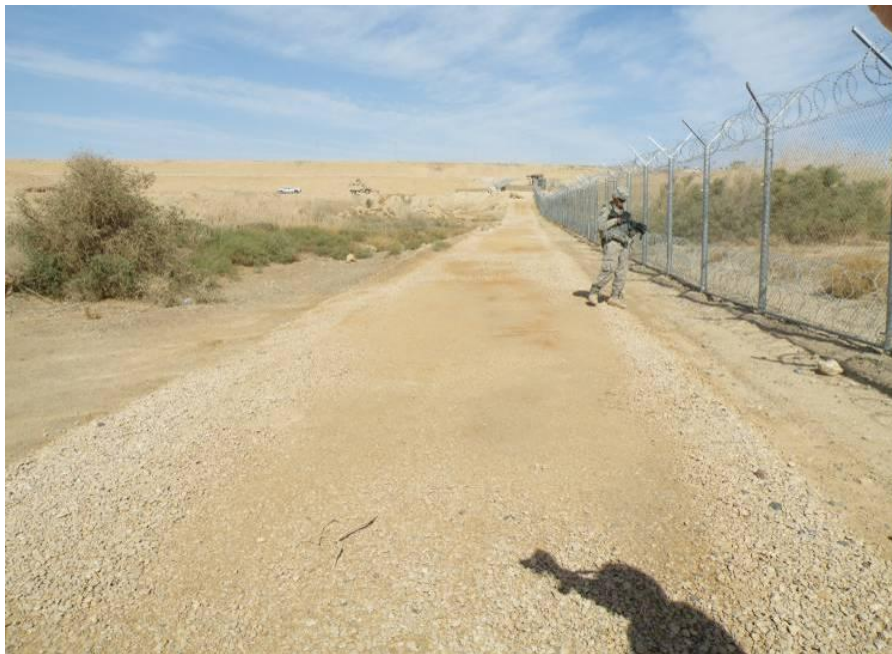
SIGIR inspected approximately 300 meters of the perimeter access road which was approximately 4 meters wide and surfaced with a coarse aggregate. The alignment of the road generally followed the perimeter fence and was straight with good visibility (Site Photo 9).

Site Photo 9. Perimeter drive

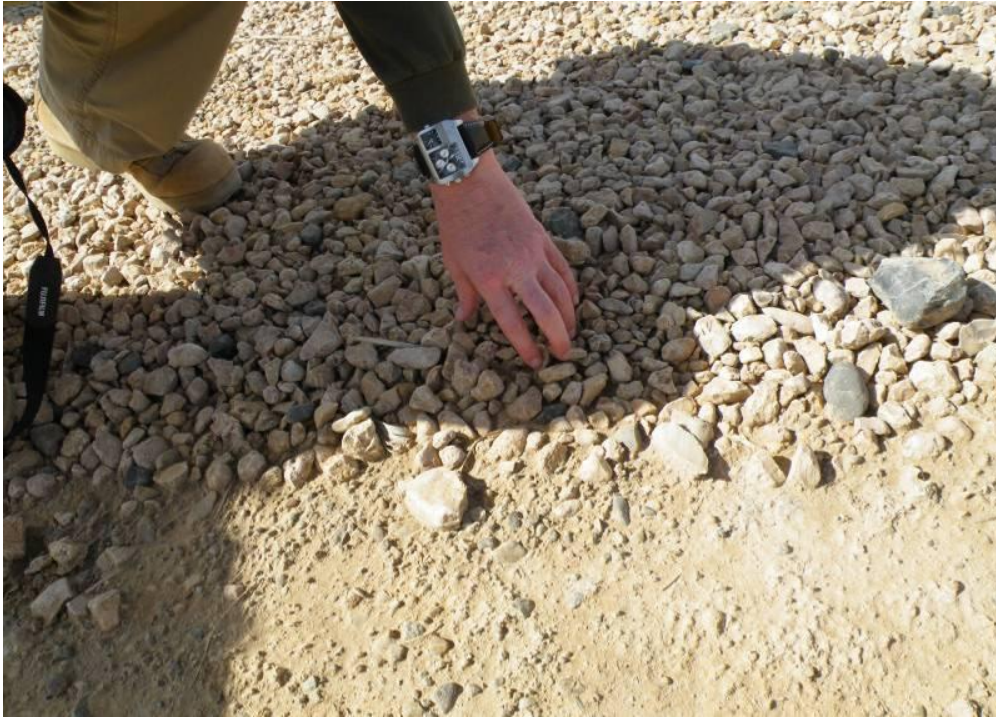
The contractor's design drawings show a 6-inch layer of compacted, coarse aggregate for surfacing. SIGIR verified the presence of a 4-6 inch layer of coarse aggregate on the roadway surface (Site Photo 10).

Site Photo 10. Roadway surface

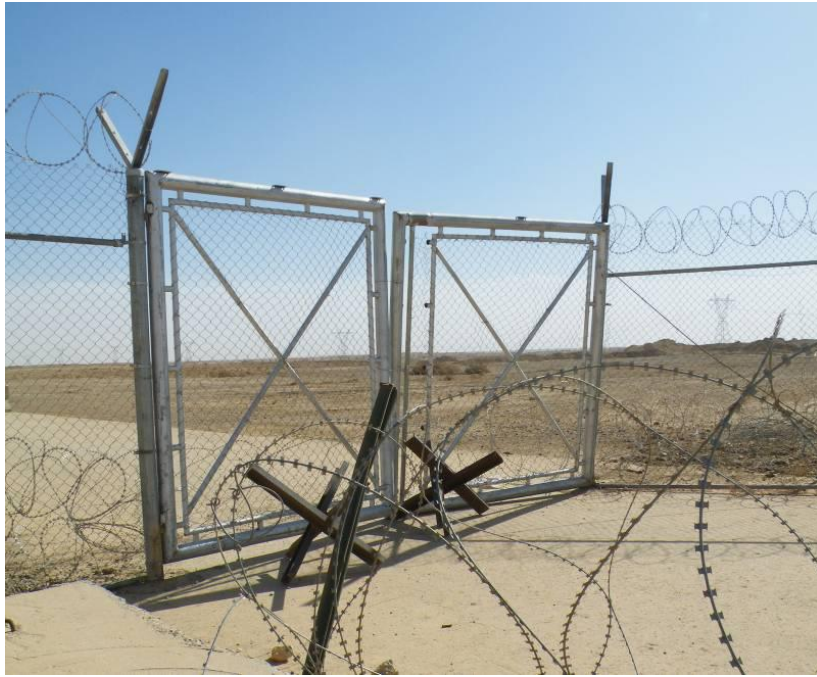
SIGIR noted that the quality of construction of the entry gate was poor. The swing panels of the gate were misaligned and the swing posts were not plumb (Site Photo 11).

Site Photo 11. Entry gate

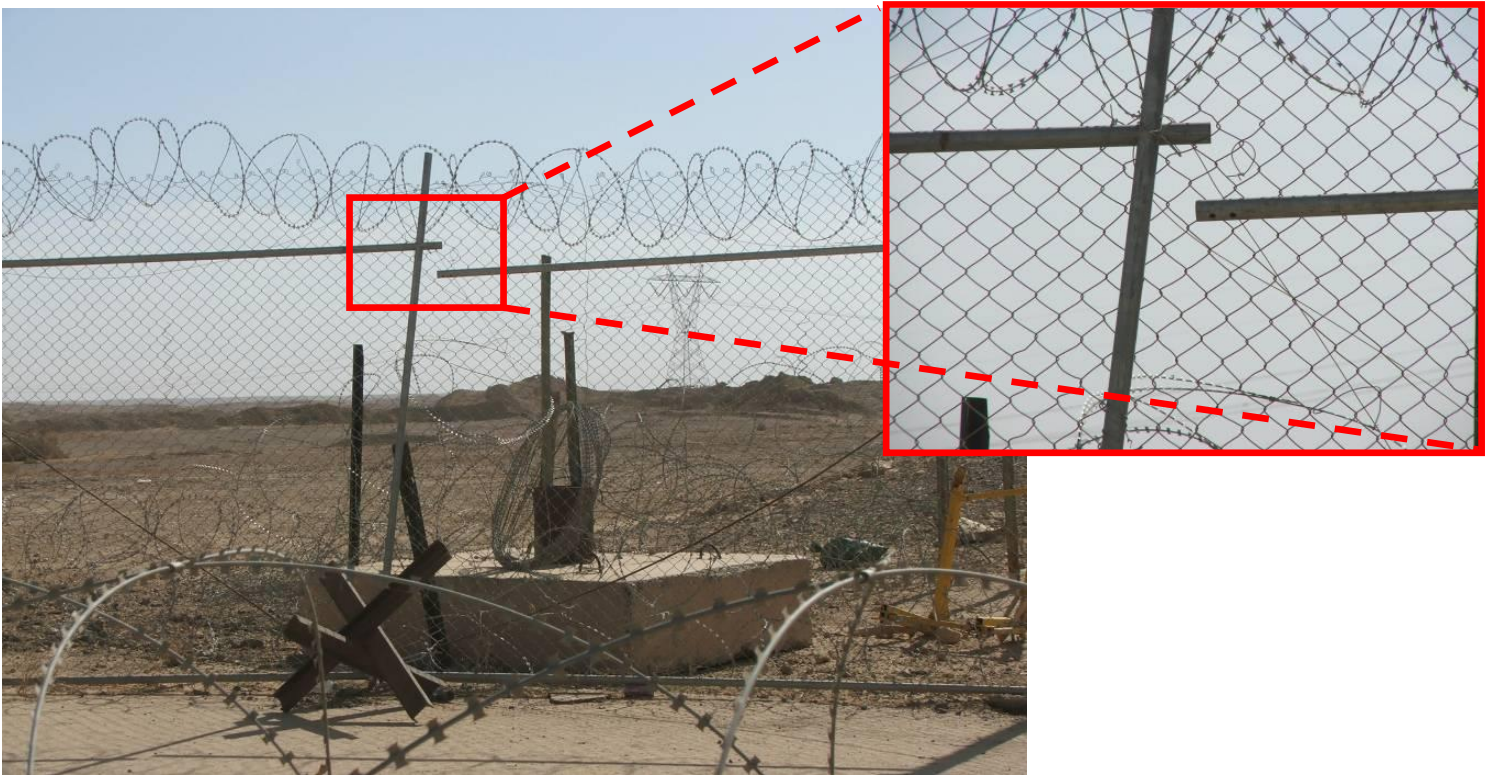
The section of fence adjacent to the gate was broken and was inadequately repaired (Site Photo 12). According to Iraqi Army representatives, the fence fell apart. Iraqi Army representatives attempted to repair the fence with materials on hand.

Site Photo 12. Broken fence near entry gate

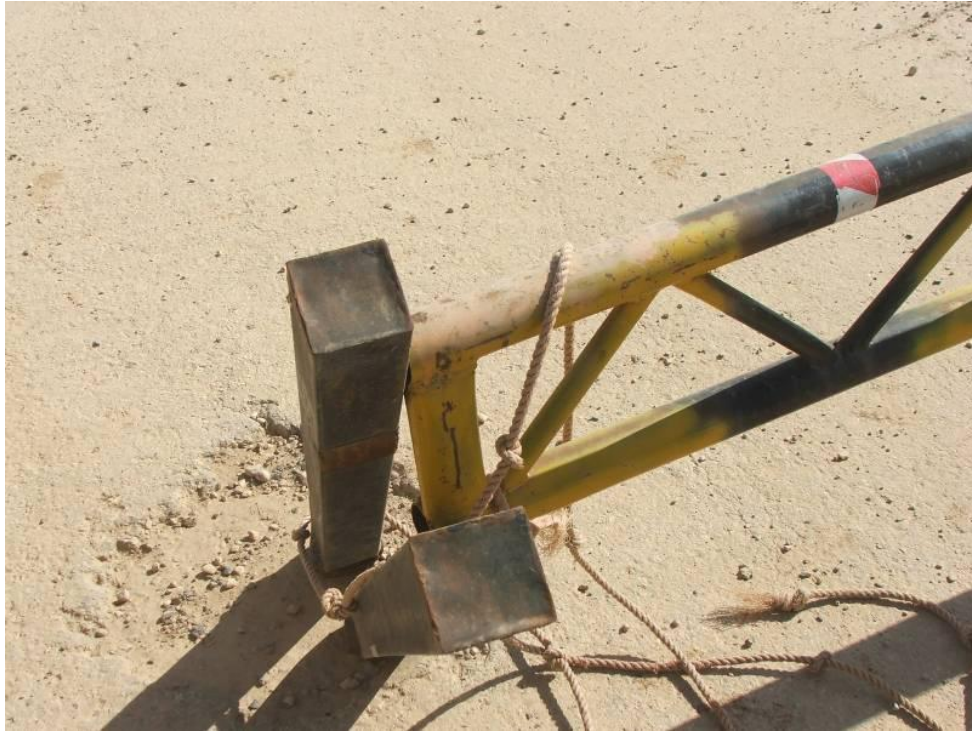
The lifting gate was misaligned and was damaged (Site Photo 13). The location of the lifting gate was poorly planned because the security fence was modified (not in accordance with the design) to accommodate the location of the lifting gate, leaving a significant gap in the chain link fabric (Site Photo 14).

Site Photo 13. Misaligned lifting gate
