**APPENDIX I**  
**SITE EVALUATION**

## 1. Dams along the Mill River, Stamford Connecticut

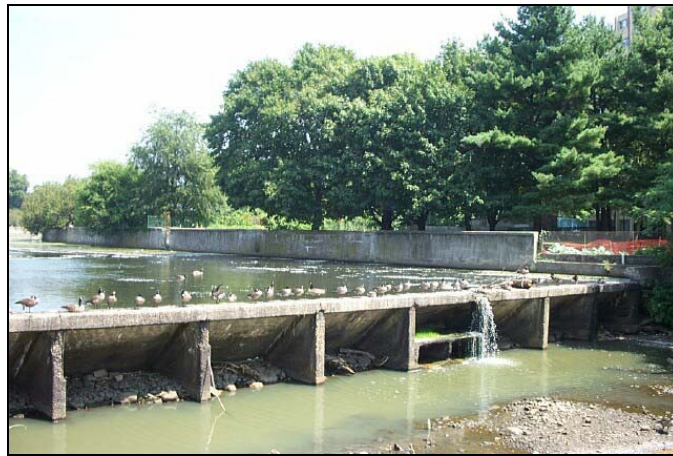
**Dam 1:** Main Street Dam, river mile 0.72. The 9.3-foot dam prevents fish passage.

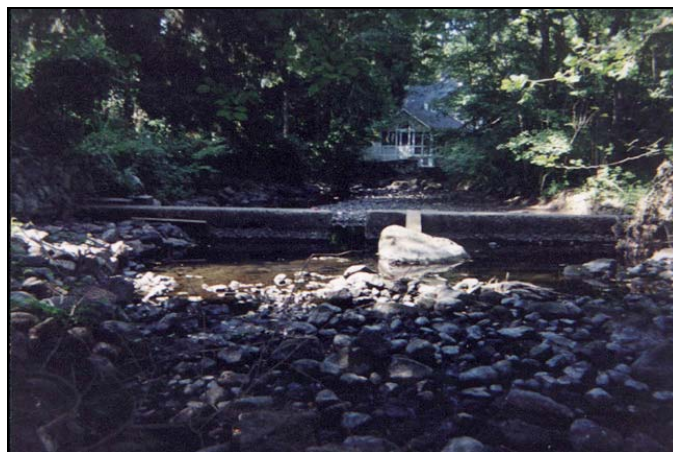
**Dam 2:** General Electric, 260 Long Ridge Road, river mile 4.88. This dam has a notch in the center allowing fish passage.

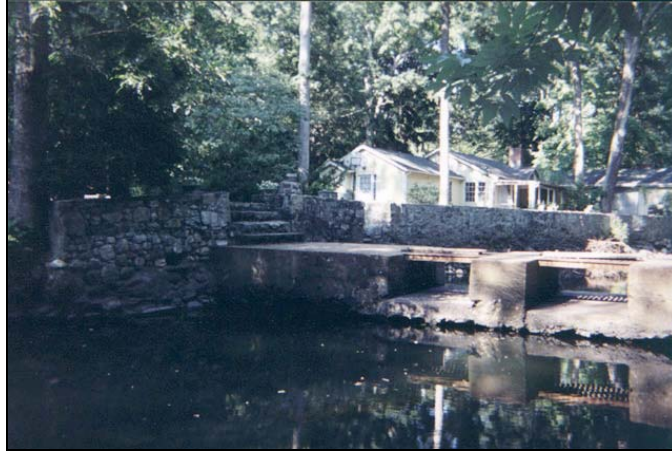
**Dam 3:** North of Arden Lane, river mile 5.22. Base of dam blocks fish passage.

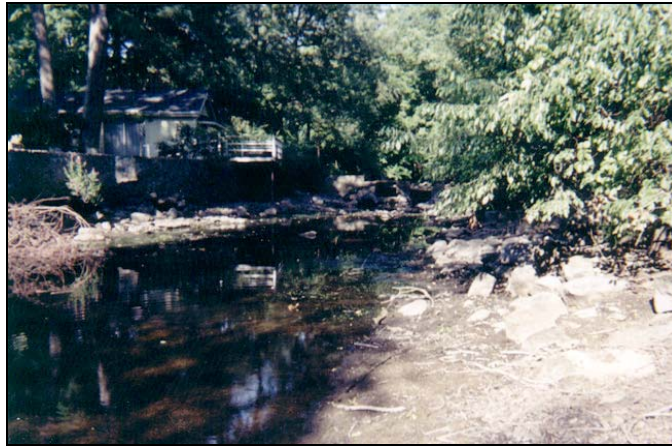
**Dam 4:** North of Arden Lane, river mile 5.25. Similar to Dam 3 in structure. Base of dam blocks fish passage.

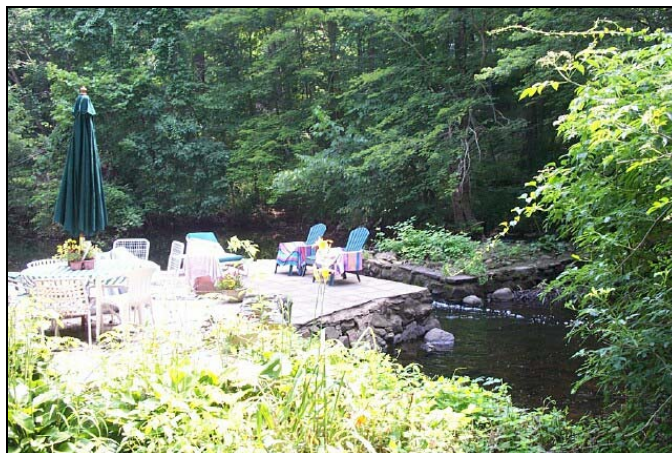
**Dam 5:** Maltbie Avenue, river mile 5.29. This dam has a side channel on the far side (east side) which allows fish passage. A weir forms a pool behind it. There is a spillway about two feet wide behind the blue deck chairs, with a drop of 2 - 3 feet.

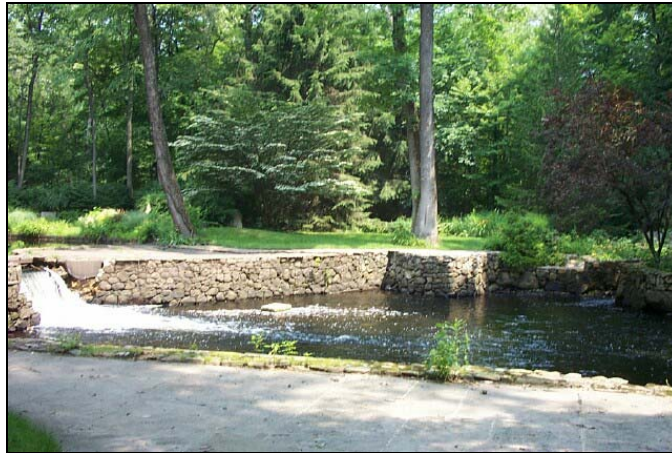
**Dam 6:** Hunting Lane, river mile 5.49. This dam is similar in structure to Dam 5, with a side channel allowing fish passage.

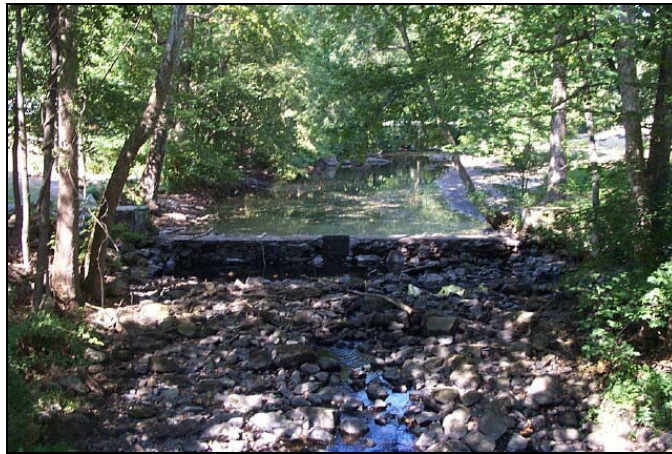
**Dam 7:** Merritt Parkway, river mile 6.05. This dam does not currently allow fish passage, but there is a gate in the center of the dam that could easily be opened to restore fish passage.

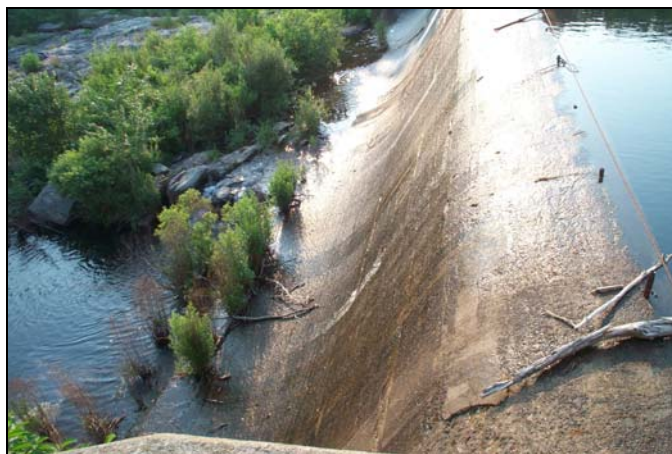
**Dam 8:** North Stamford Dam, river mile 8.13. No fish passage.
