Partial Collapse of the Willow Island Cooling Tower

PURPOSE

This case study describes the safety culture shortcomings that led directly to the partial collapse of a natural draft, hyperbolic, reinforced concrete cooling tower at Willow Island, WV, on April 27, 1978. The cooling tower was one of two towers being constructed by Research-Cottrell, Inc., for the Pleasants Power Station, a coal-fired electric power station owned by Allegheny Energy Supply Company. The resulting deaths of 51 construction workers represent one of the most costly accidents, in human terms, of any in the U.S. construction industry's history.

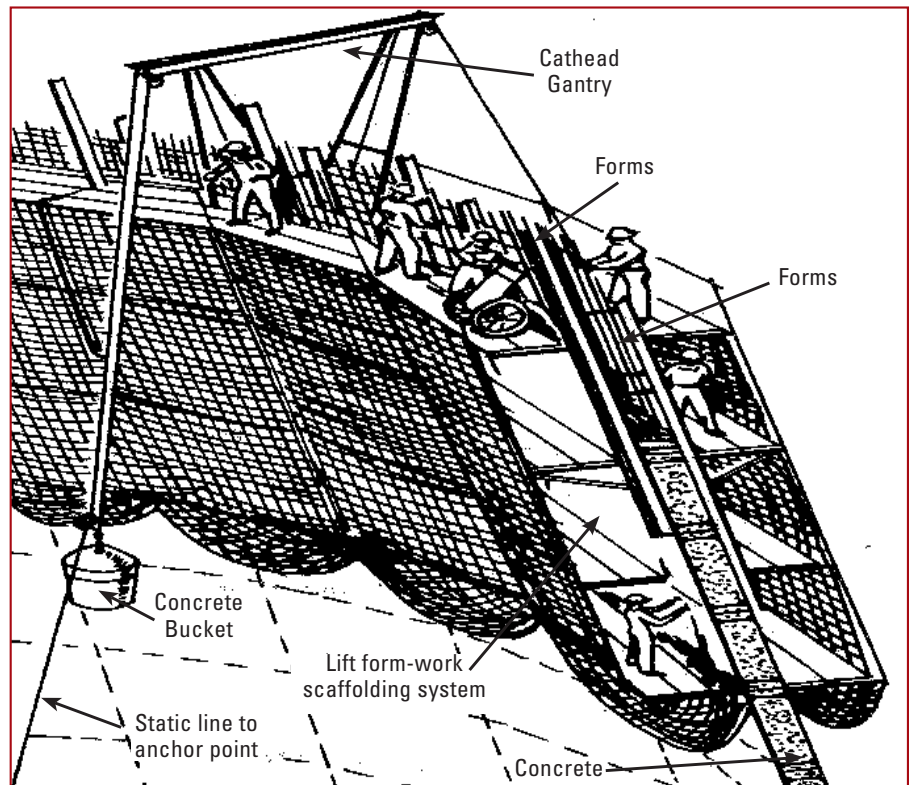
Perspective of Scaffolding System (NBS Rpt, 1979)

The shell [of the cooling tower] was constructed through the use of a patented lift form technique.² Except for the lower and upper portions of the tower, the construction procedure at Willow Island utilized a scheme to place a 5-ft (1.5-m) lift per day. At the time of failure, 28 lifts had been completed with the most recent one having been placed the previous day. The form work which supported the less than one day old concrete of lift 28 had been raised into place for lift 29. According to eyewitness accounts by workers, lift 28 began to collapse when the third bucket of concrete was being hoisted up to the working platform... According to eyewitnesses, the entire section of lift 28 collapsed into the tower [falling approximately 170 feet] within a few minutes.

- The concrete that supported the lift form-work scaffolding system was of insufficient compressive strength to support the loads to which it was being subjected. The concrete had been placed only 18 hours before being required to support the lift form-work scaffolding system and had a predicted compressive strength of 220 pounds per square inch (psi) as noted in NBSIR 80-2010.⁴ As further noted, the concrete would have started to fail at a compressive strength of 1,000 psi. In addition, the required concrete strength to support the lift form-work system should have included a factor of safety of 2 and consideration of the dynamic effects of the hoisting loads.

- **A decisionmaking process for critical safety-related process variables, based on written procedures, should be established.** In the case of the Willow Island accident, movement of the lift form-work scaffolding system should have been based on demonstration, via a concrete testing program, that the concrete had achieved minimum safety strength. Likewise, movement of the anchor point for the static line that was used by the hoisting system for lifting concrete should have been subjected to a careful decisionmaking process.
