MEMORANDUM FOR THE RECORD

SUBJECT: Status of Recovery Effort as of 14 September 1971

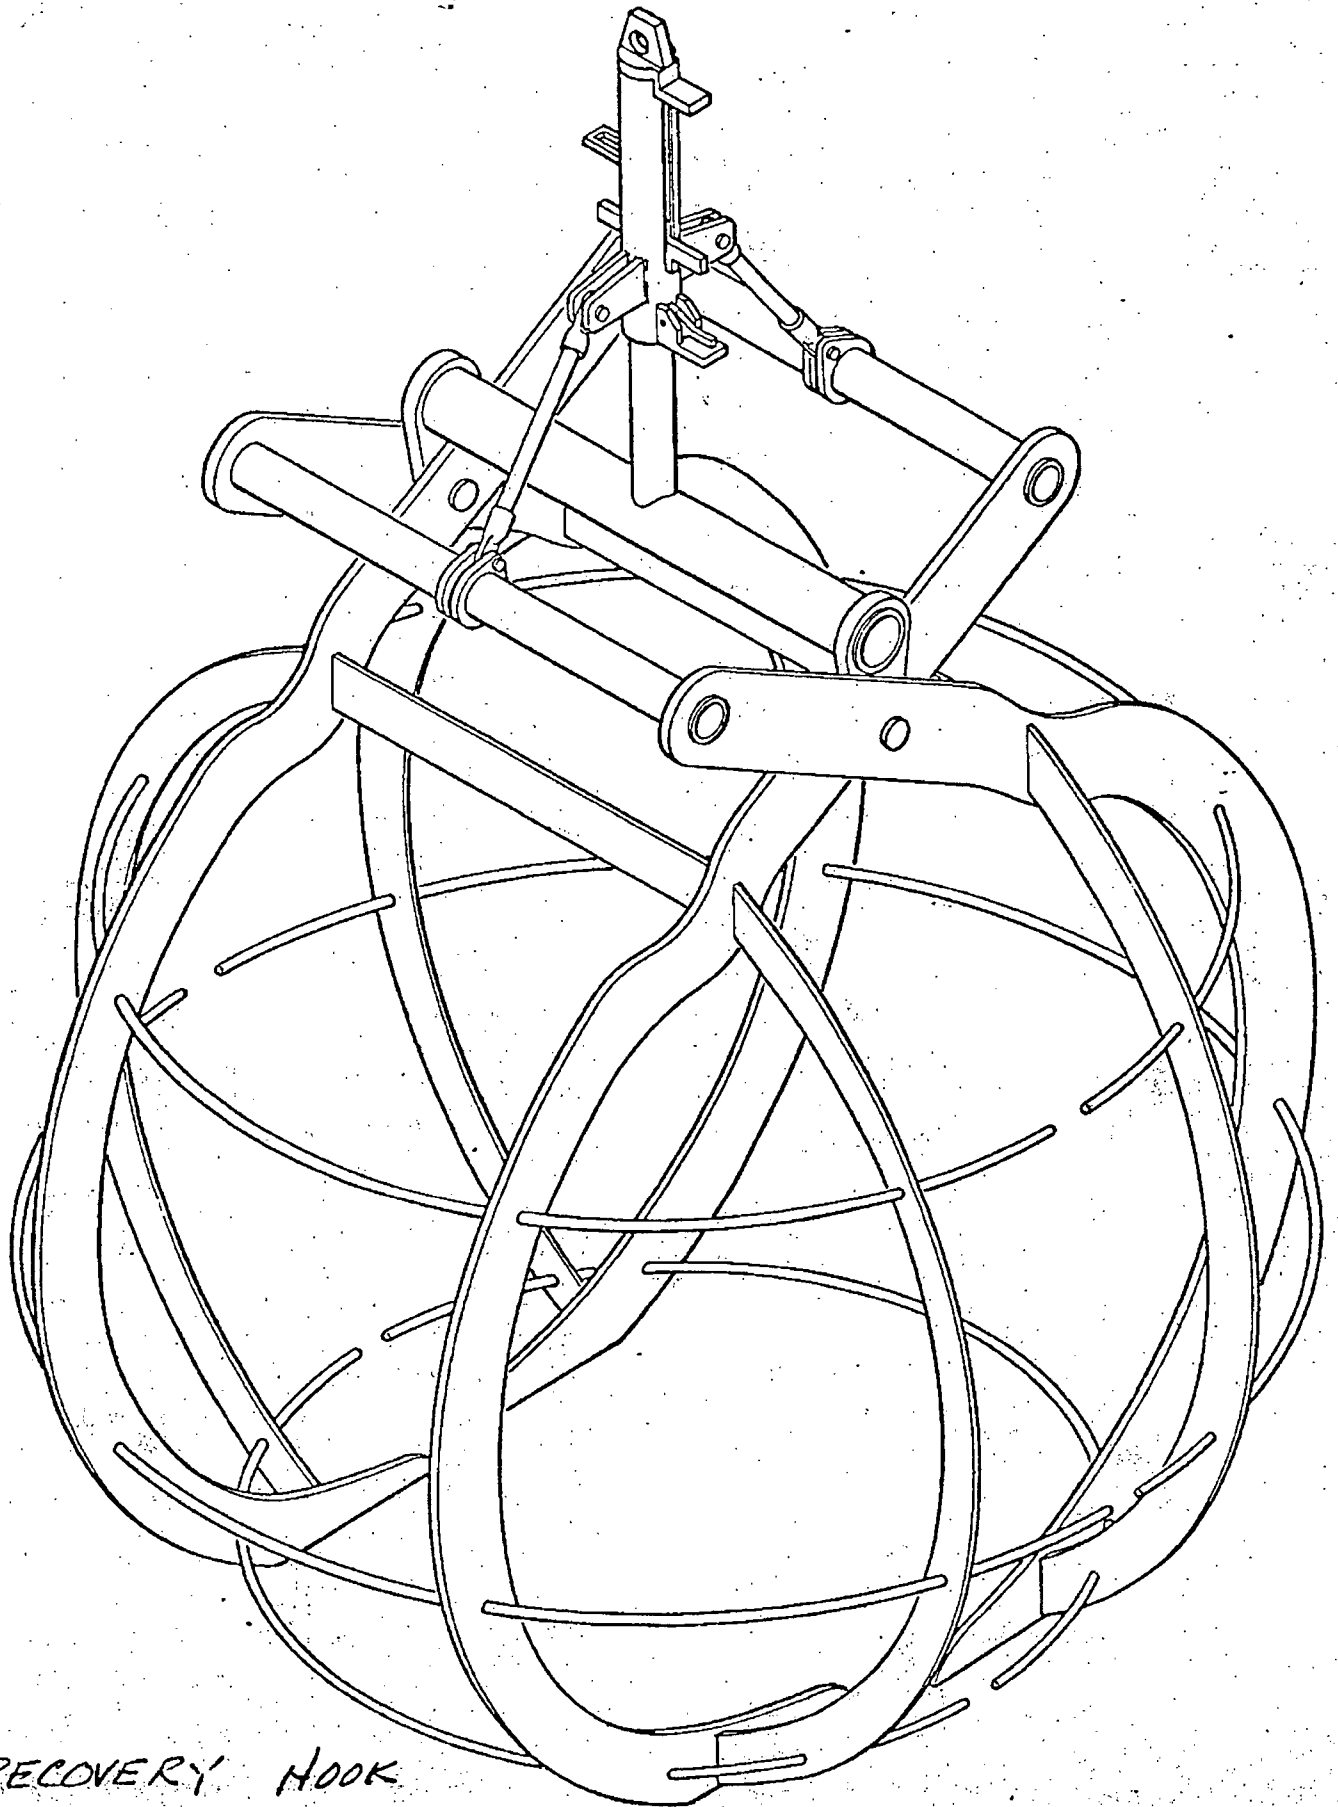
RECOVERY HOOK
FIGURE 1.

2. The first question was the amount of damage sustained by the recovery vehicle upon water impact. The impact shock was estimated at 2600 g's. A review of the problem by several structural engineers indicated that the vehicle was in one piece; however, the cannister was hydroformed around the payload and ruptured in several places. Many of the main structural elements were beryllium and were probably broken. As a result, there were no structural hard points that were available for lifting so that an enveloping type of pick-up device was needed. Figure I shows the recovery aid. Simplicity of design was a key parameter to assure functioning under adverse conditions.

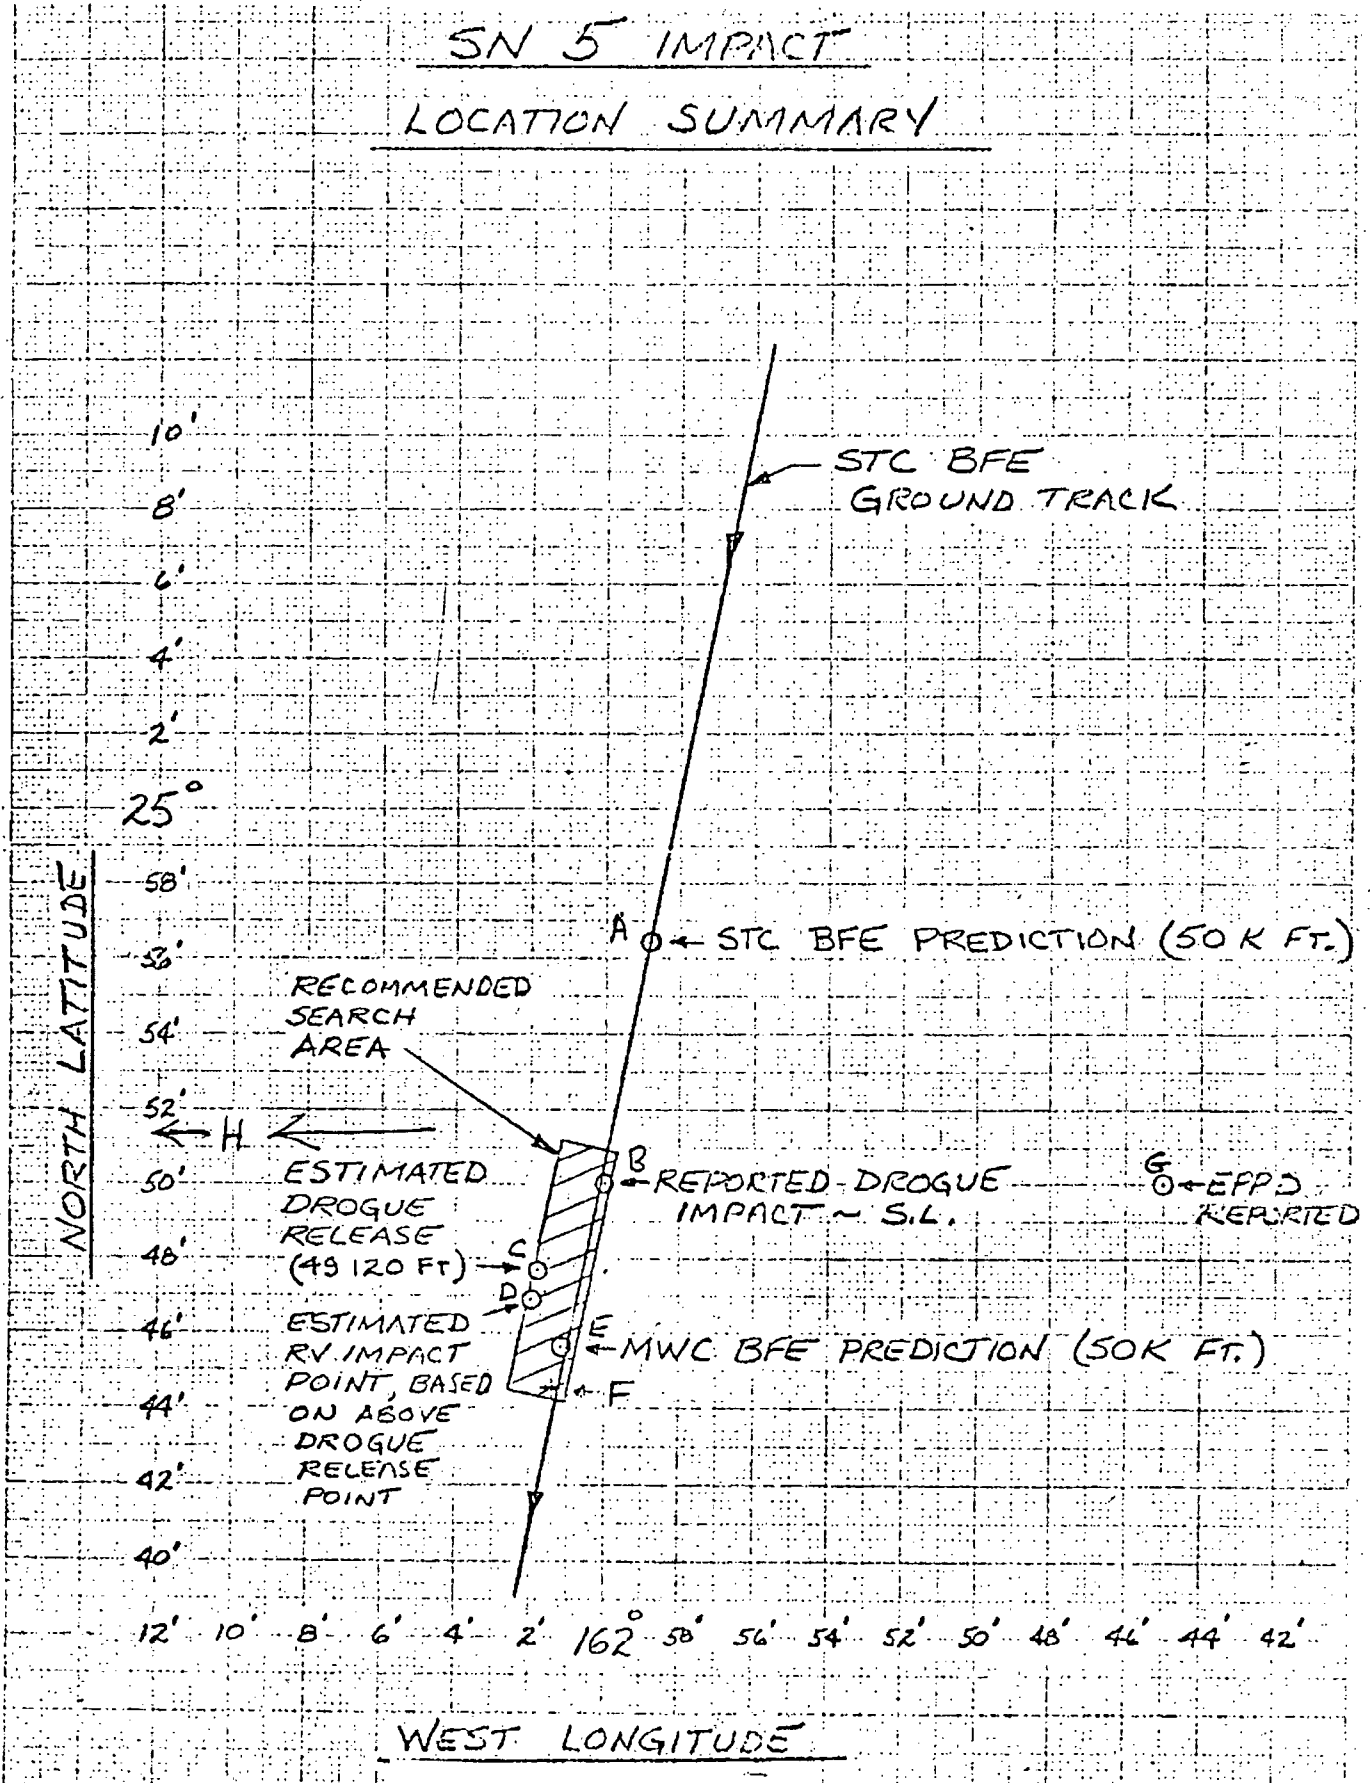
FIGURE II

3. The second problem was locating the impact point to a high degree of accuracy. Several different groups made assessments of the location with widely divergent results at first. Figure II shows the various impact points. Point A is the originally predicted impact point by the Satellite Tracking Center (STC). Point B is the final STC recommended impact point. They had originally recommended point H at 164° west longitude, but on questioning found an error in their calculations. Point B is also the reported location of the drogue chute by the aircraft using Lorán C (accuracy of 2-3 miles). Point G is the main chute deployment point (50,000 feet) reported by the aircraft. At that time, however, they were having problems with spurious responses so that point G is discounted. Point C is calculated from Point B using the wind direction aloft. Point D is calculated as a ballistic trajectory from point C. Point E is the impact point calculated by the recovery vehicle contractor using spacecraft ephemeris both before and after RV separation. Point F is our independent Government trajectory calculation. The conclusion is that the search area is as shown, an area 1.5 miles wide by 8 miles long.
