**SUBJECT: DIABLO CANYON SPECIAL INSPECTION REPORT 50-275/01-10;
50-323/01-10**

Report No.: 50-275/01-10
50-323/01-10

Facility: Diablo Canyon Nuclear Power Plant, Units 1 and 2

Dates: April 5 through May 18, 2001

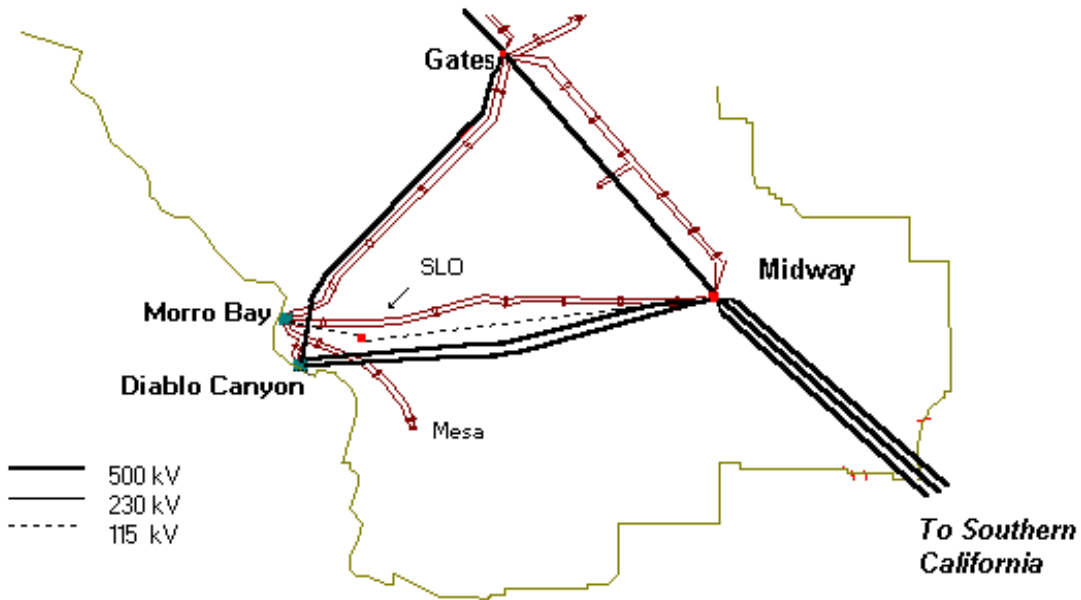
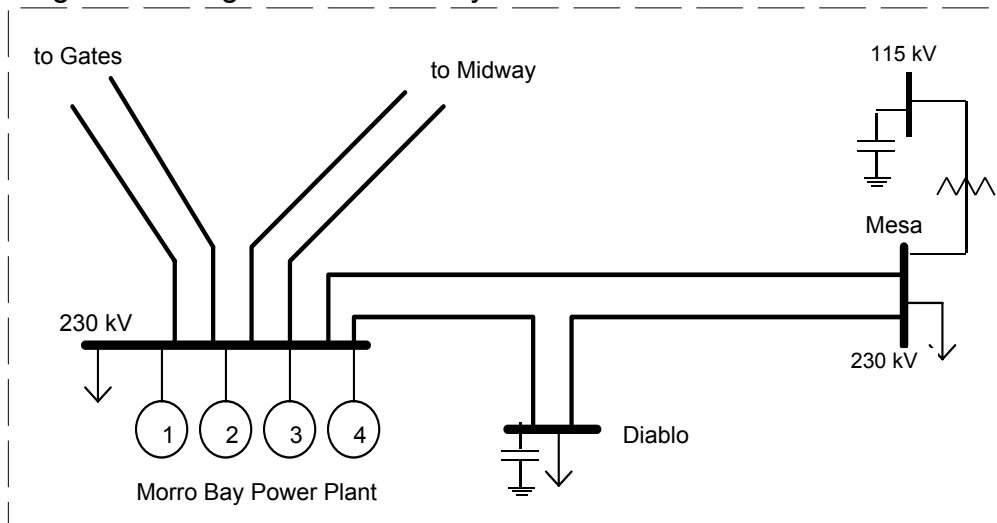
ATTACHMENT 3

The inspectors concluded that a loss of 500 kV in this event was unlikely. The fire burned away from the 500 kV offsite power lines, and the prevailing winds at the time would not have blown the fire towards the 500 kV lines. In addition, the 500 kV line within close proximity (75 yards) to the fire was the Diablo to Gates line only. Both Diablo to Midway lines remained available to carry all of the 500 kV loads, thus 500 kV offsite power would not be threatened even if the fire caused a loss of the Diablo Canyon to Gates line (Attachment 3).

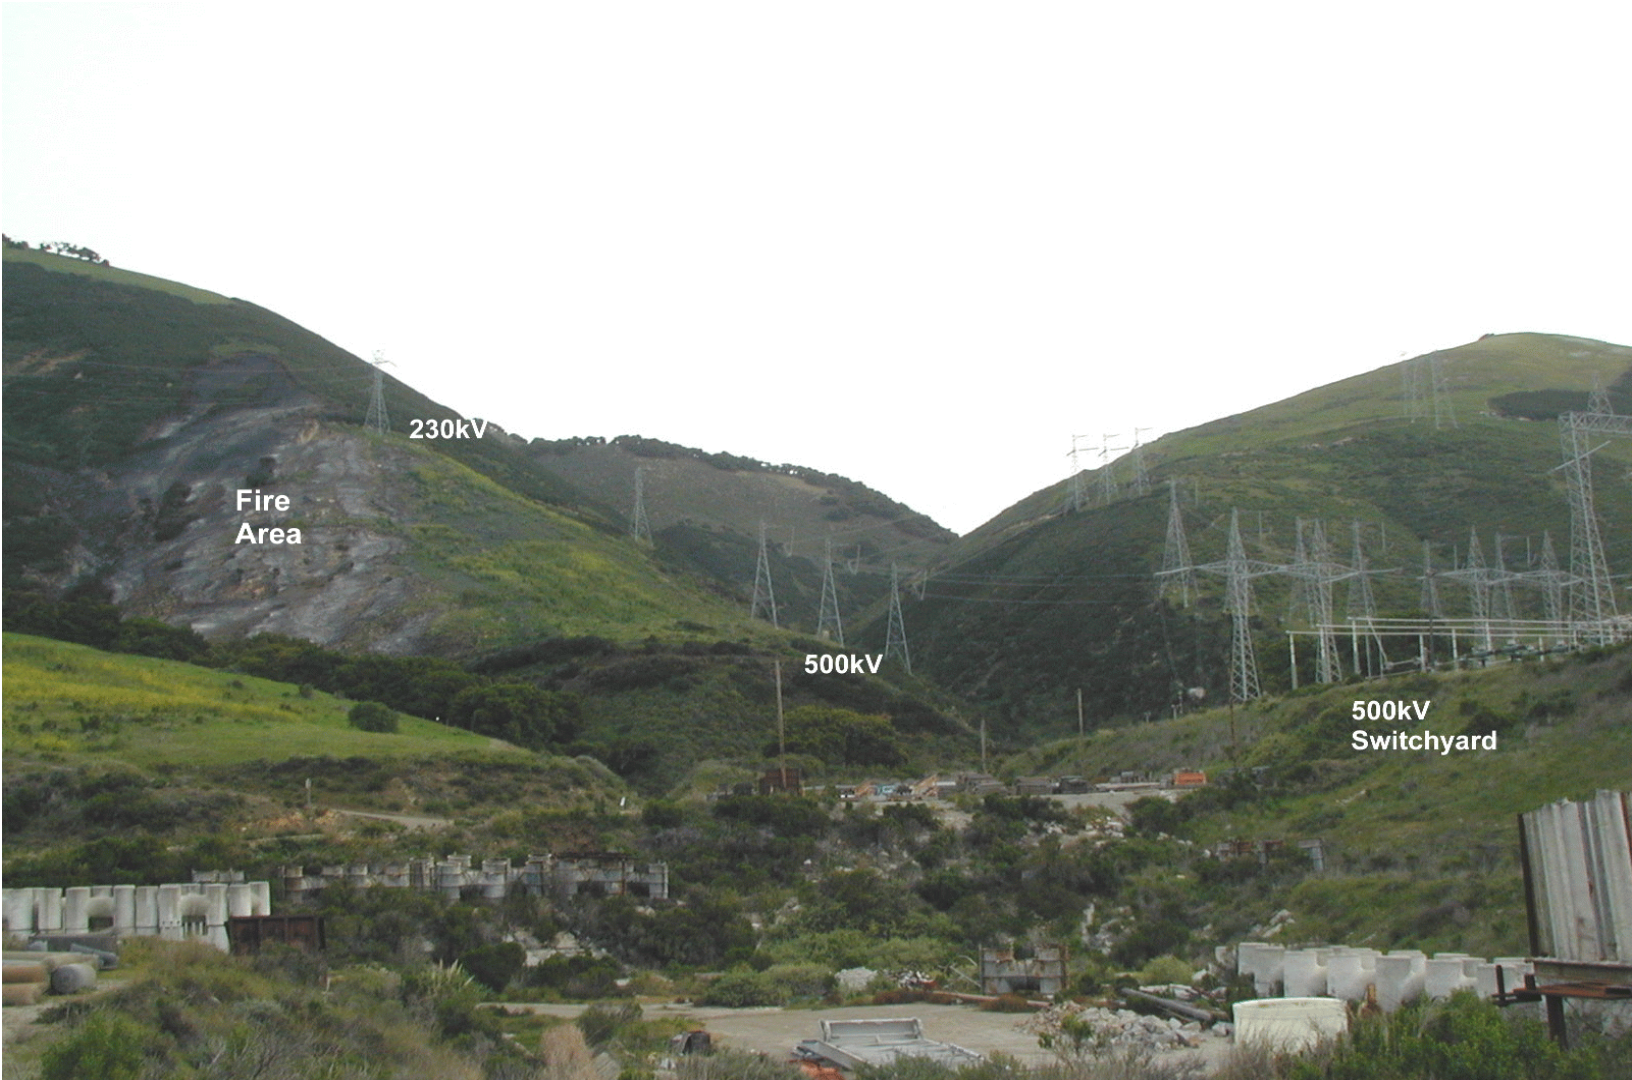
Attachment 4

could cause faulting on the offsite power lines. Licensee actions to preclude recurrence included a requirement to hand carry cut brush out of any ravines prior to performing a controlled burn so that ravines do not act as chimneys which could allow fires to jump established firebreaks during controlled burns (Attachment 4).

The loss of control of the planned burn resulted from burning brush in a ravine which acted like a chimney, drying and igniting brush above. Smoke from burning the wet grass caused the phase-to-phase fault on the 230 kV lines. The fire crews did not fully anticipate the effect of burning in the ravine and the potential that the smoke could cause faulting on the offsite power lines. Licensee actions to preclude recurrence included a requirement to hand carry cut brush out of any ravines prior to performing a controlled burn so that ravines do not act as chimneys which could allow fires to jump the fire break during controlled burns.

Inspection of the burn site indicated that the fire propagated vertically up the slope's ravine until it burned itself out on green brush some 100-200 yards uphill and away from the 230 kV tower. The inspectors concluded that the fire had very little chance of spreading in the direction of the nearest 500 kV tower (i.e., Tower 0/2A, Diablo to Gates 500 kV line, Attachment 3) because of the fire break of some 150 yards created by prior controlled burns.

The licensee stated that the fire crews did not fully anticipate the effect of burning in the ravine and the potential that the smoke could cause faulting on the offsite power lines. Discussions with the licensee indicated that corrective actions to preclude similar recurrence has been implemented. This action includes hand carrying cut brush out of any ravines prior to performing a controlled burn so that ravines do not act as chimneys which could allow fires to jump the fire break.
