February 12, 2002

SUBJECT: INDIAN POINT 2 - NRC INSPECTION REPORT 50-247/01-11

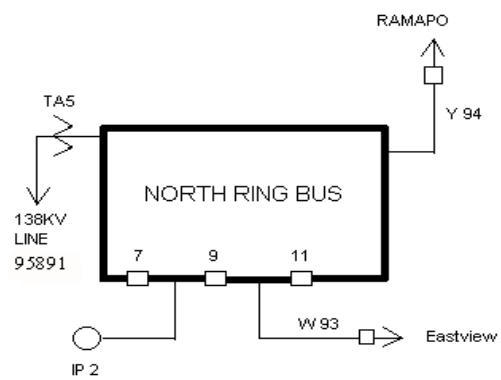
Figure 1
Buchanan 345 KV Switchyard

The transient electrical fault occurred on phase A of 345 KV line W93 (Eastview feeder) attached to the north ring bus in the Buchanan Switchyard. See Figure 1 for a simplified diagram of the switchyard connections. Protection relays in the offsite electrical system operated to isolate line W93 by opening breakers 9 and 11. Breaker 11 reclosed automatically as designed and the main generator continued to feed the ring bus through Breaker 7. However, a protective relay for the RAMAPO feeder misoperated and failed to block a protective trip on line Y94. This left the output of the IP2 main generator connected to the ring bus through Breaker 7 with only the loads on line 95891 fed from the ring bus via transformer TA5. The IP2 1000 MW generator output exceeded the loads fed from TA5, which caused the turbine/generator to overspeed. IP2 protective relays operated to trip the main turbine-generator on over-frequency at 62.5 hertz. The turbine trip caused the Indian Point 2 reactor to automatically shut down. Breaker 7 opened as designed following the reactor and turbine-generator trip. The Y94 protective relay that failed was subsequently found to have shorted internally, and was replaced.

The offsite power distribution personnel inspected line W93 and found it acceptable for continued service. The cause of the transient fault was not identified. For the fault that occurred in the 345 KV electrical system, the plant electrical response was as expected in accordance with the plant design (reference UFSAR Sections 8.2.2.2 and 8.2.3.4).
