**Anamet, inc** *Materials Engineering & Laboratory Testing*

26102 EDEN LANDING ROAD, SUITE 3 • HAYWARD, CALIFORNIA 94545 • (510) 887-8811 • FAX (510) 887-8427

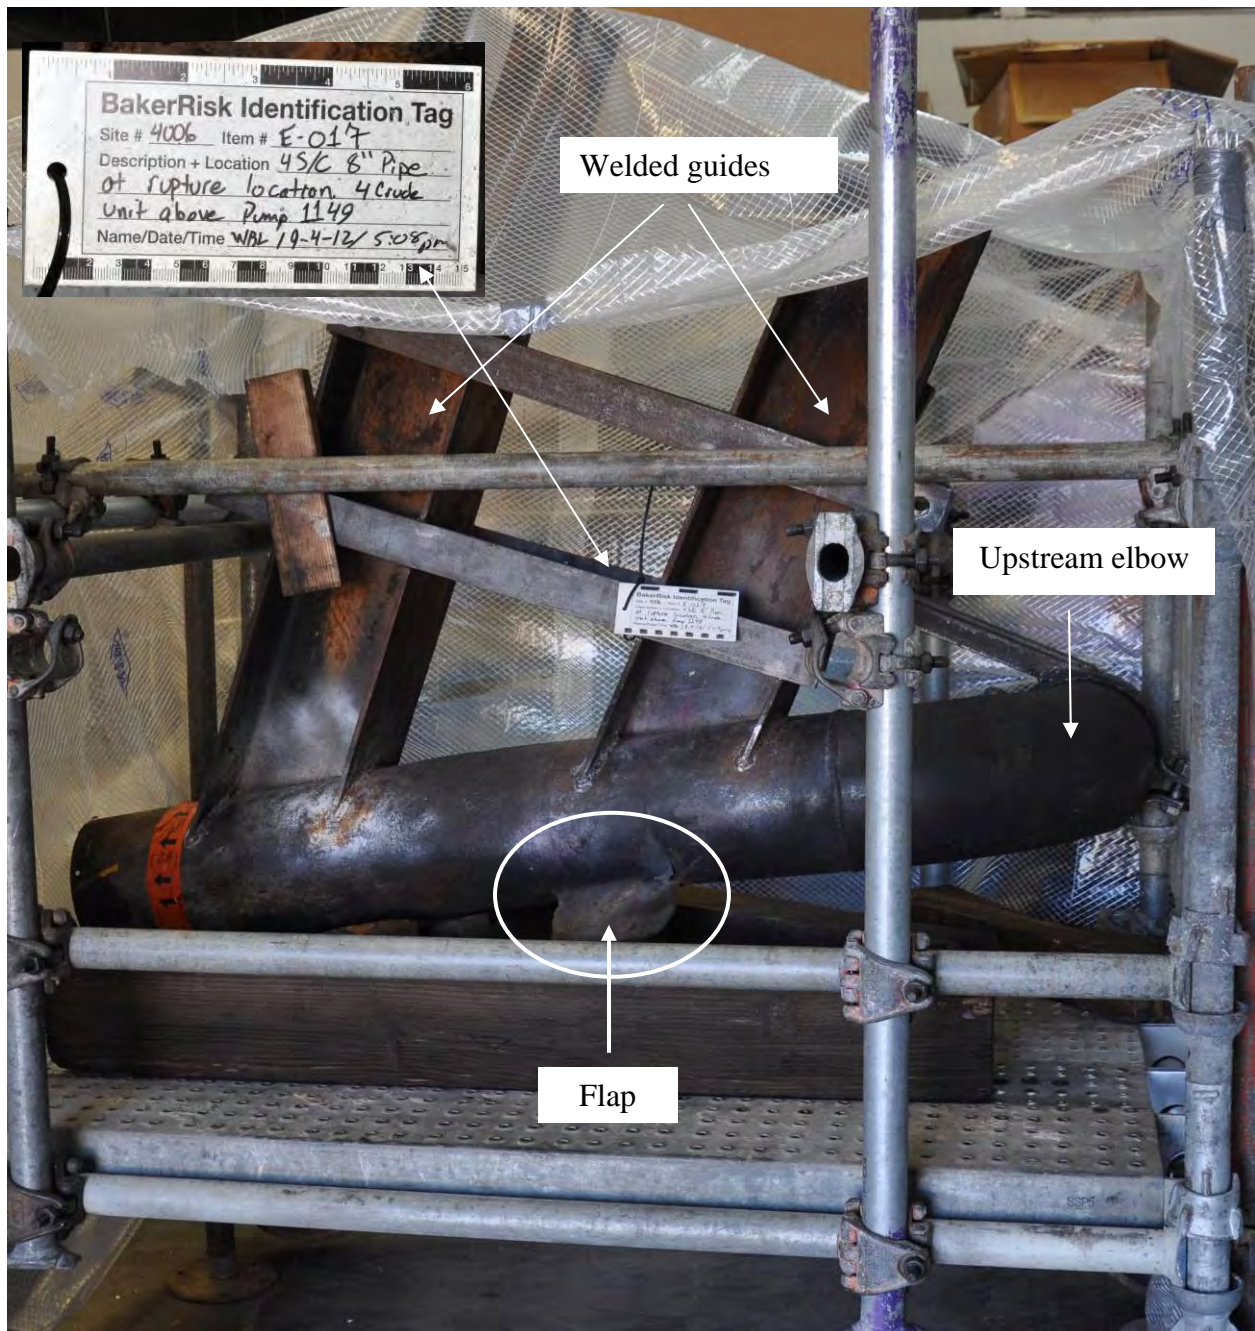
Figure 1 Photograph of the ruptured section of the 8-inch 4-sidecut sample E-017. The rupture location is circled. The flap projecting from the bottom is pipe wall forced outward at the location of the rupture. In service, the welded guides were vertical.

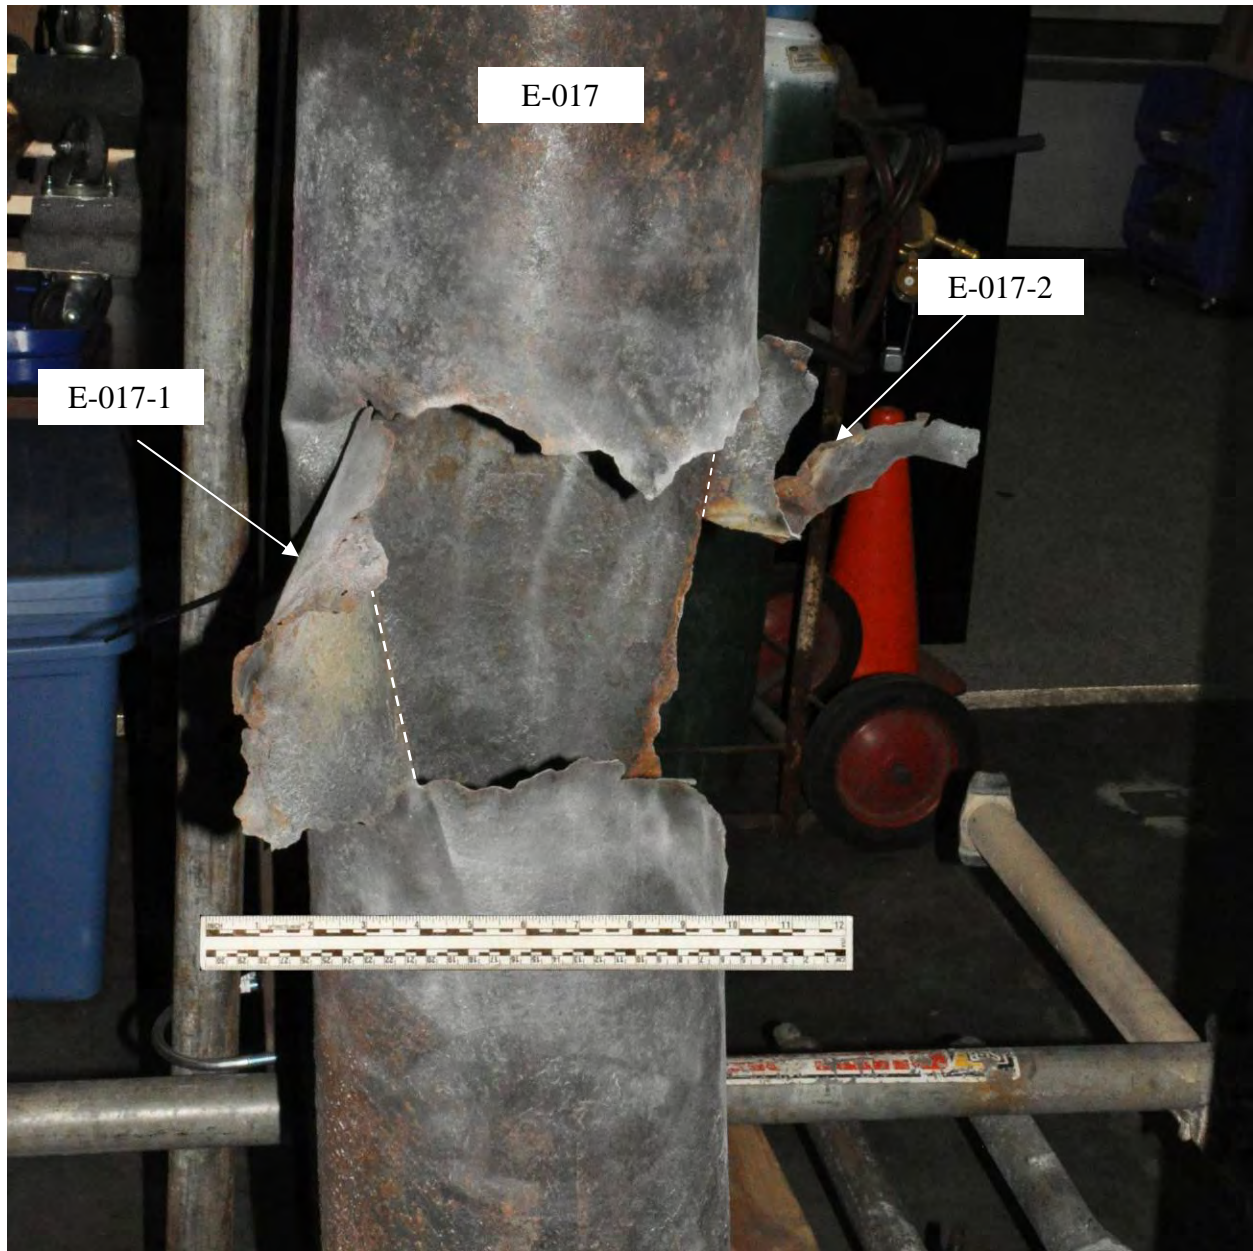
Figure 3 Photograph of the rupture. Talcum powder had been applied around the rupture to aid laser scanning used to construct a three dimensional record of the rupture geometry. The dashed lines indicate where the rupture flaps, assigned the identification numbers E-017-1 and E-017-2, were sectioned.

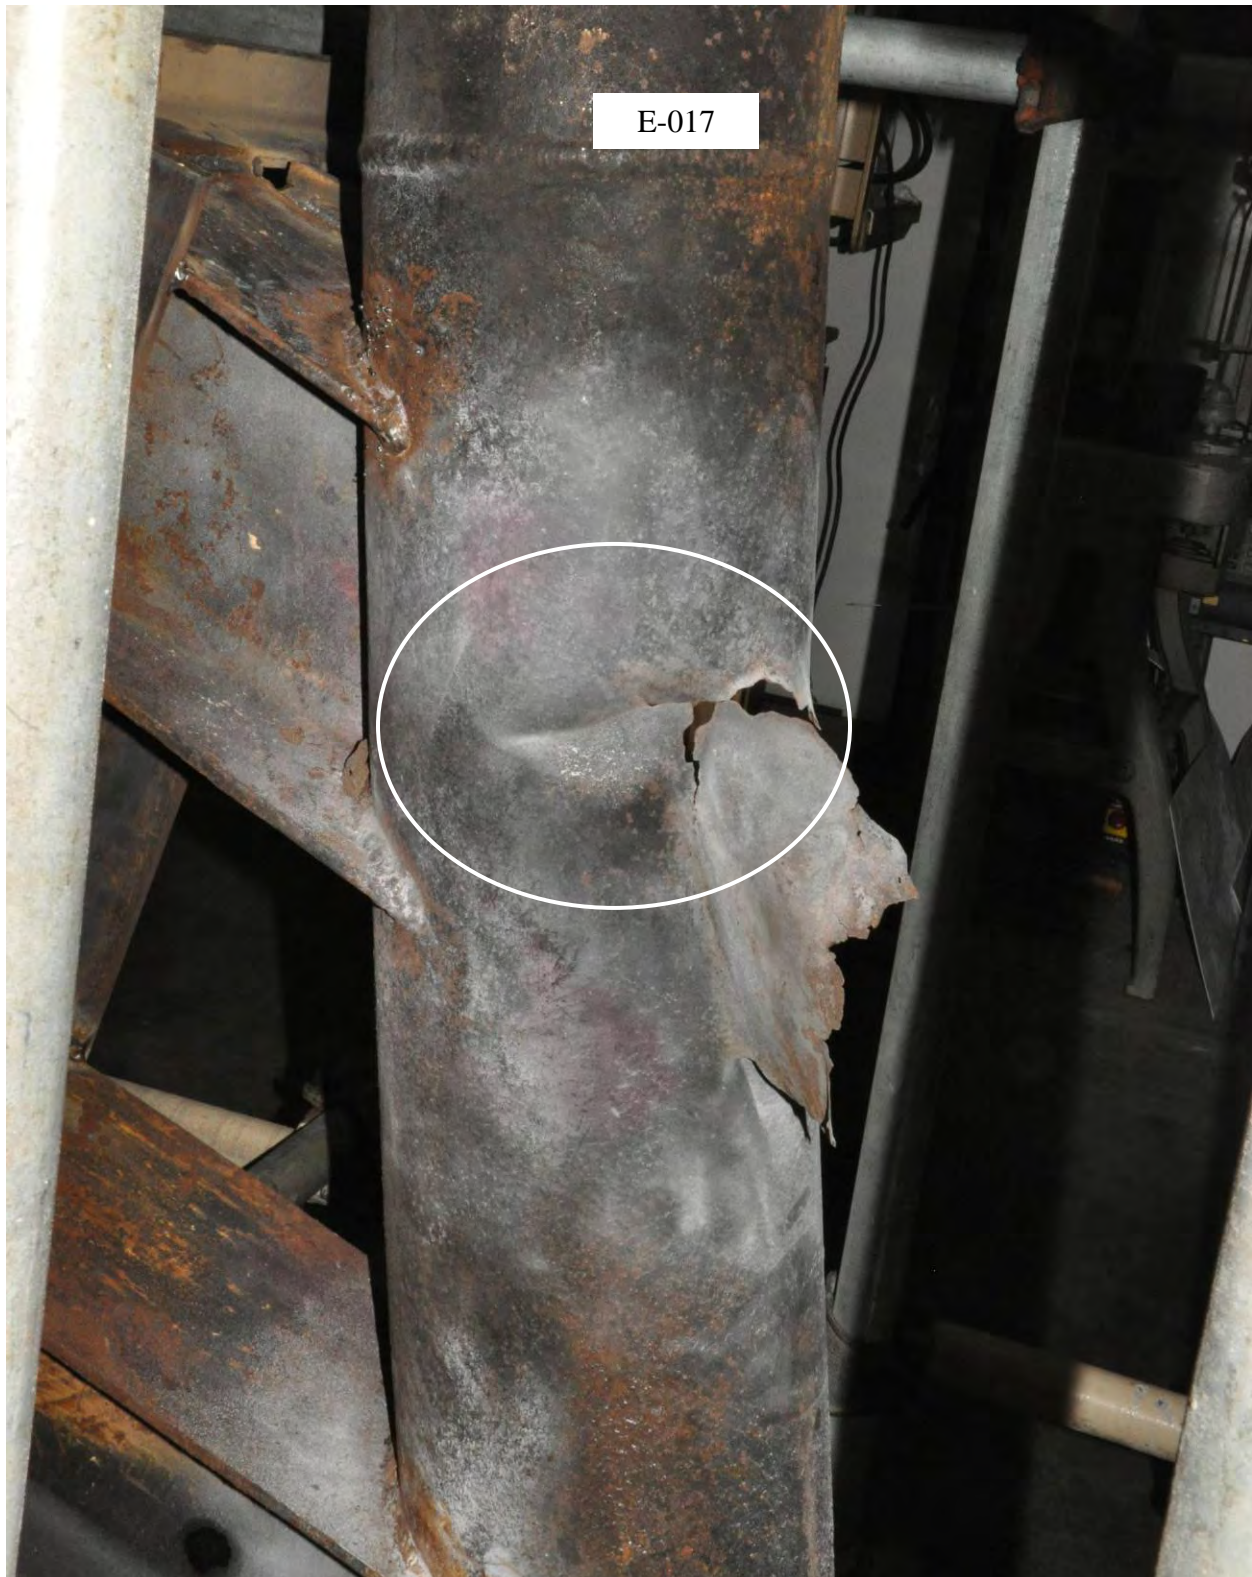
Figure 6 Photograph of the ruptured section of sample E-017. A small degree of buckling was present near the upstream welded pipe guide.

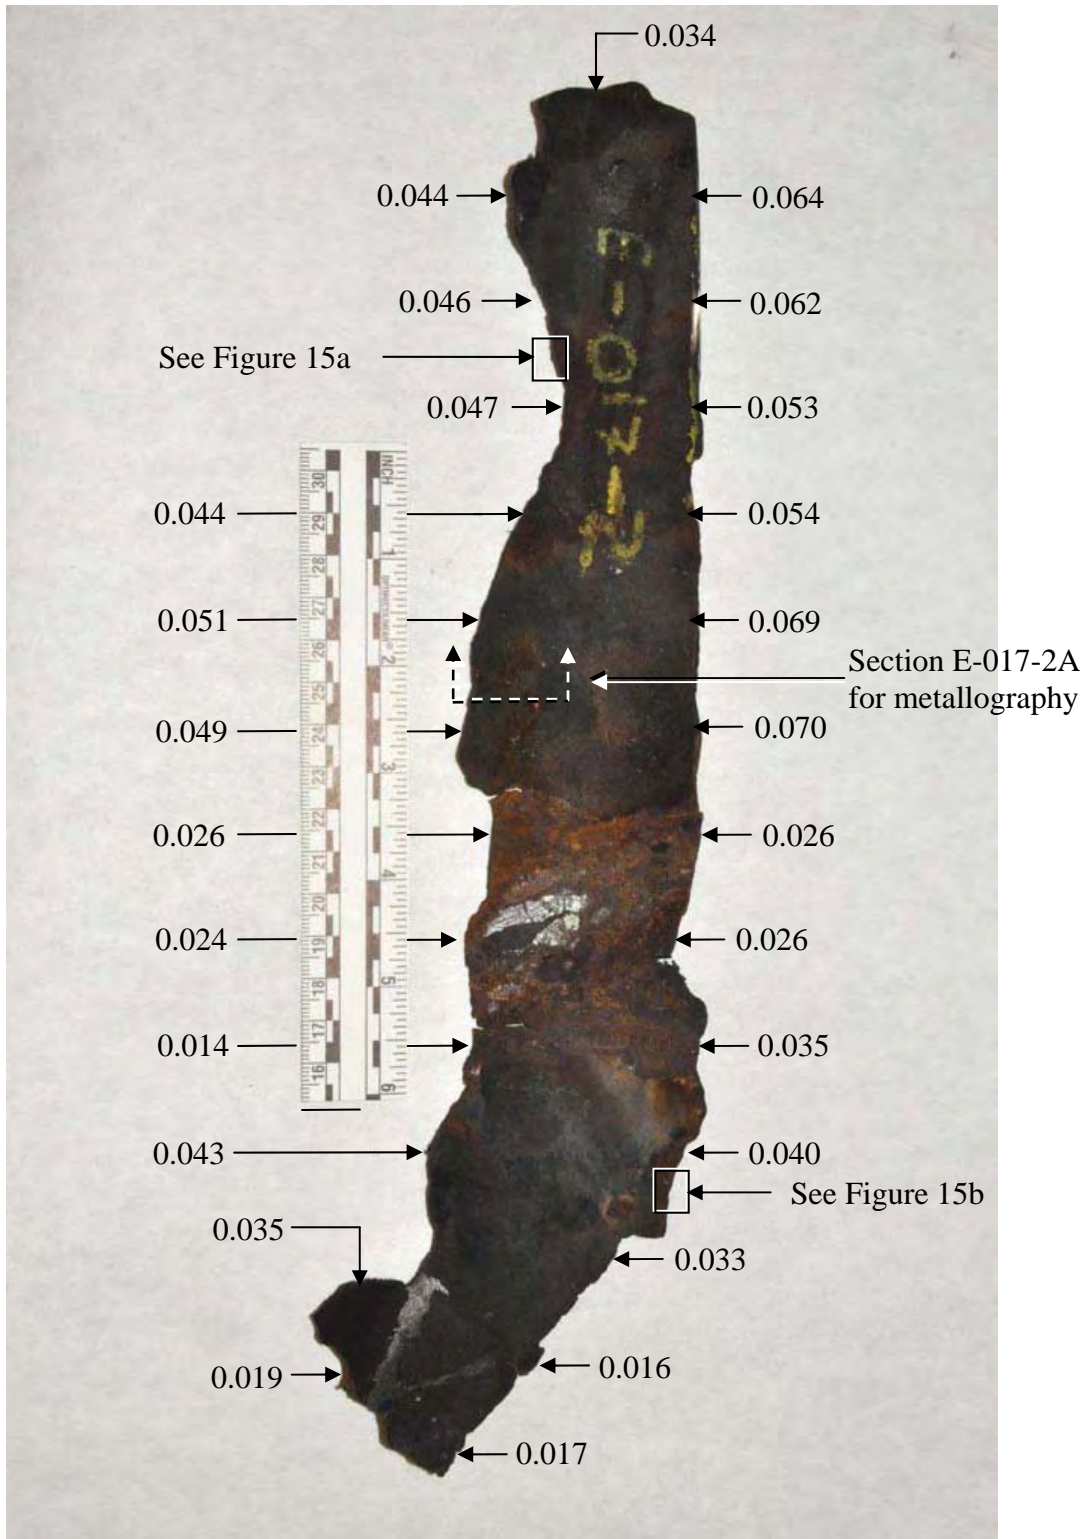
Figure 10 Section E-017-2 after flattening. Thickness measurements were made with a pointed anvil micrometer within 0.100-inch of the edge at the locations indicated before cleaning.

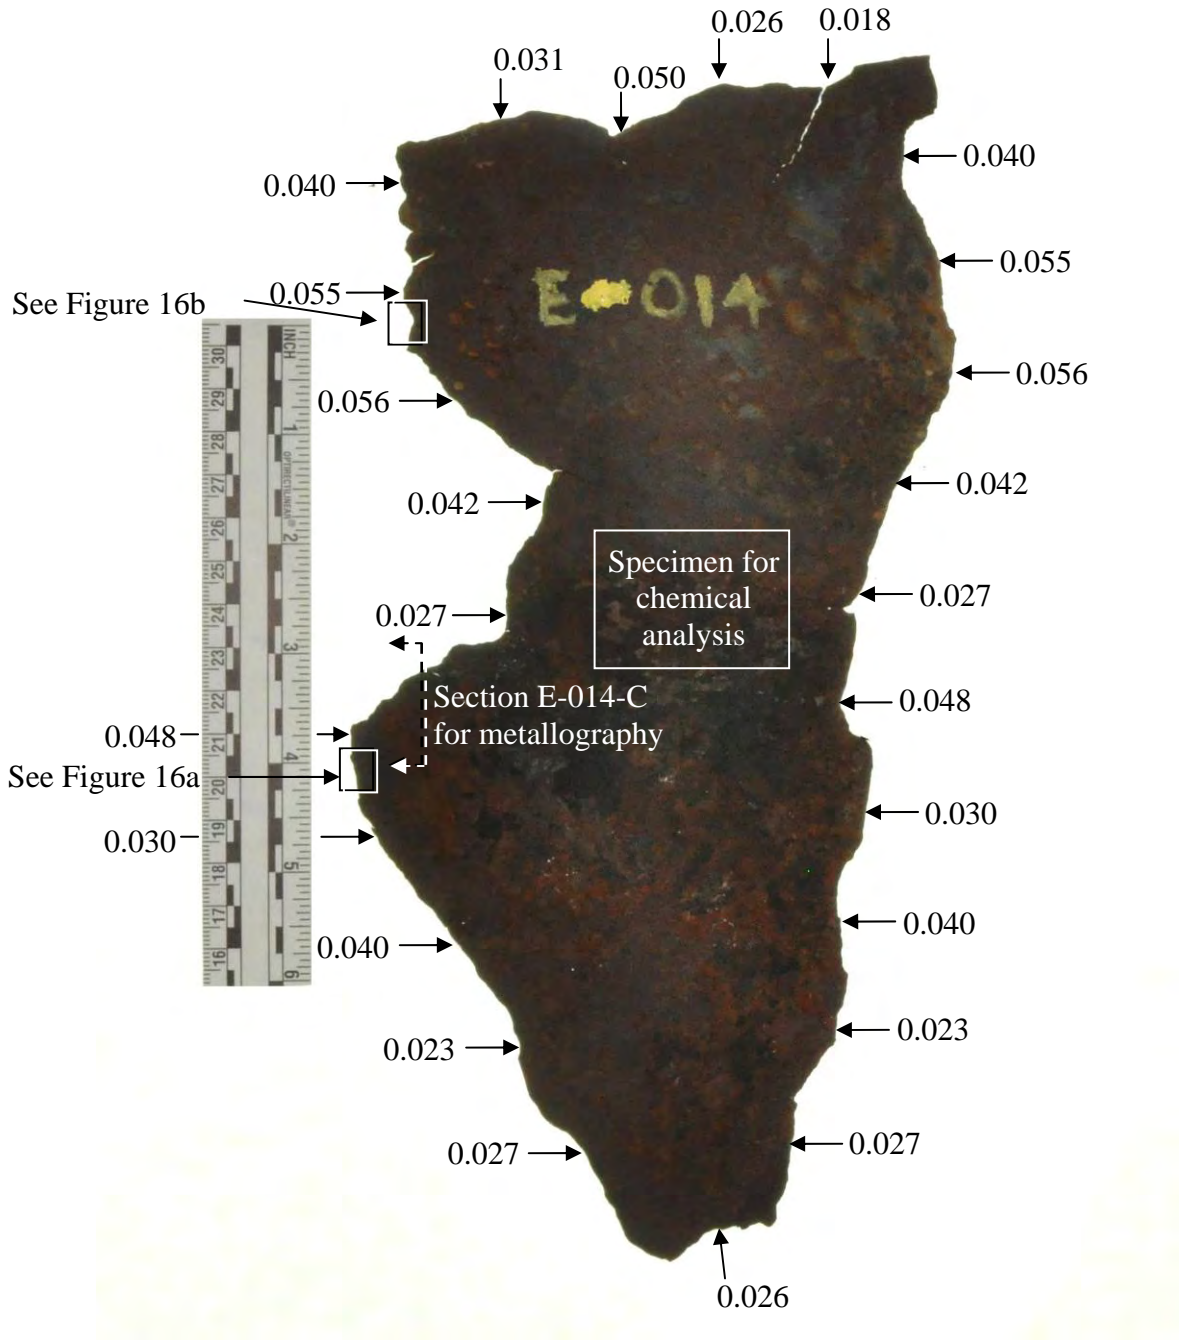
Figure 12 Fragment E-014 after unfolding and flattening. Thickness measurements were made with a pointed anvil micrometer within 0.100-inch of the edge at the locations indicated before cleaning.

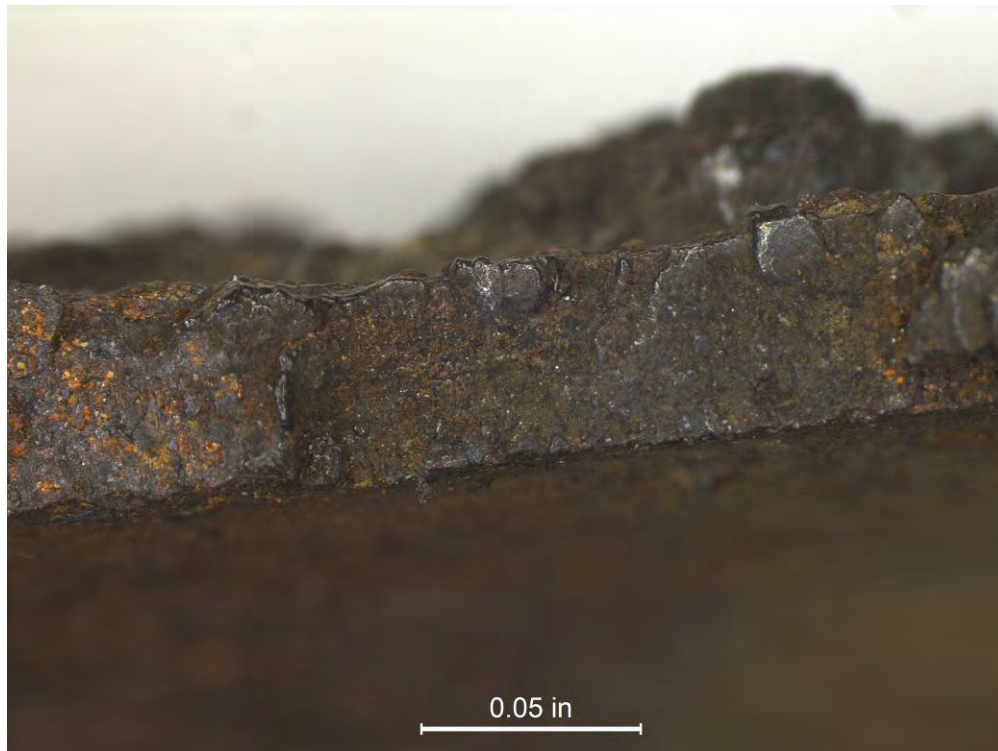
Figure 14 Representative optical macrographs of tapered edges on the rupture edge of specimen E-017-1. The locations from which these macrographs were recorded are indicated in Figure 8.

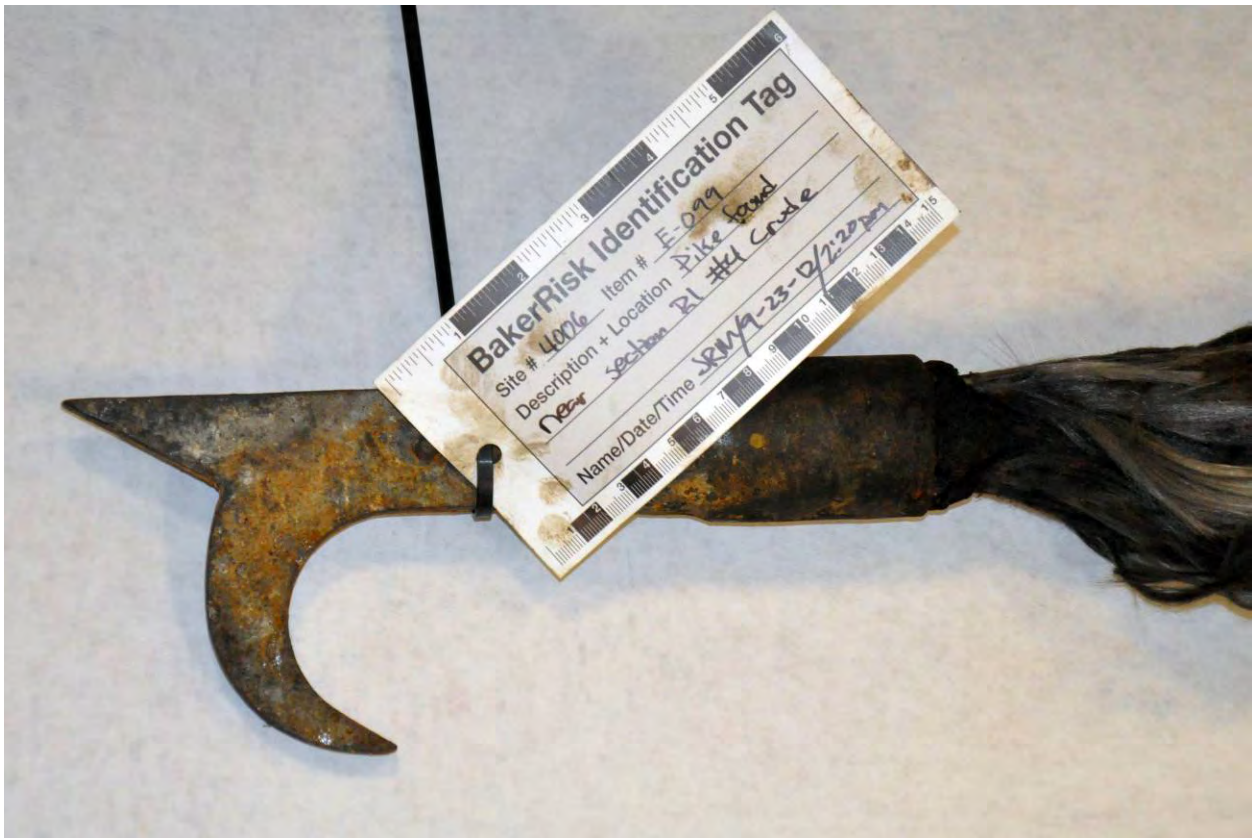
(b) Boxed area in (a)

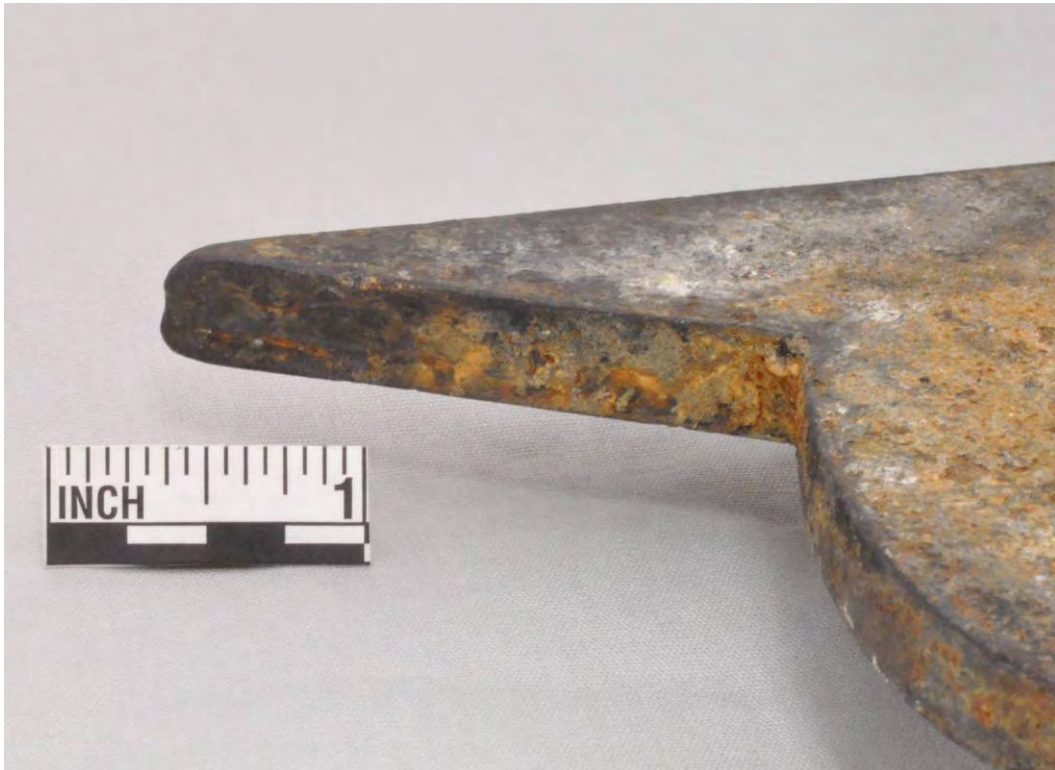
Figure 18 Photographs of pike pole sample E-099 recovered from the site of the ruptured 4-sidecut. The pole was made from glass fiber reinforced polymer, and much of the polymer was burned away in the fire. A tangle of exposed glass fibers remained.

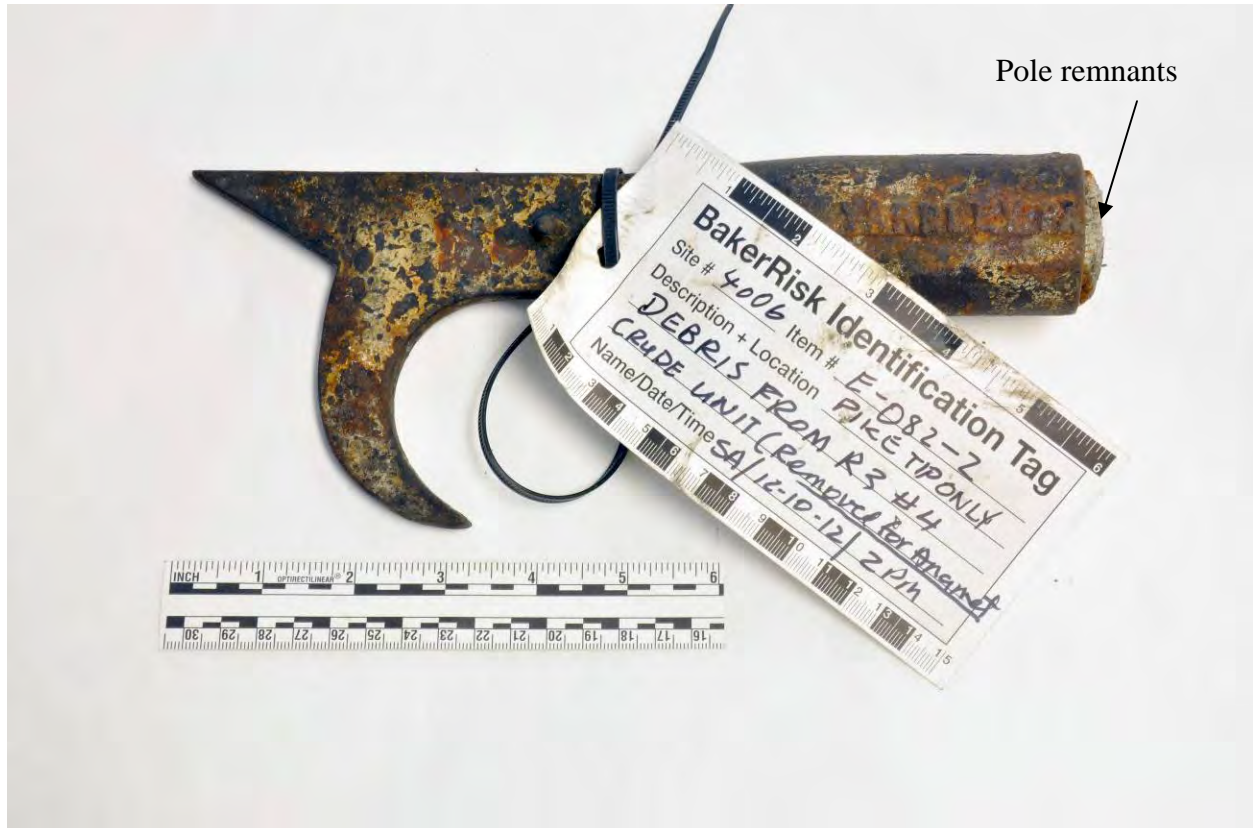
Figure 20 Photograph of pike pole head, sample E-082-2, recovered from the site of the ruptured 4-sidecut. The glass fiber reinforced polymer pole was absent except for the indicated remnants.

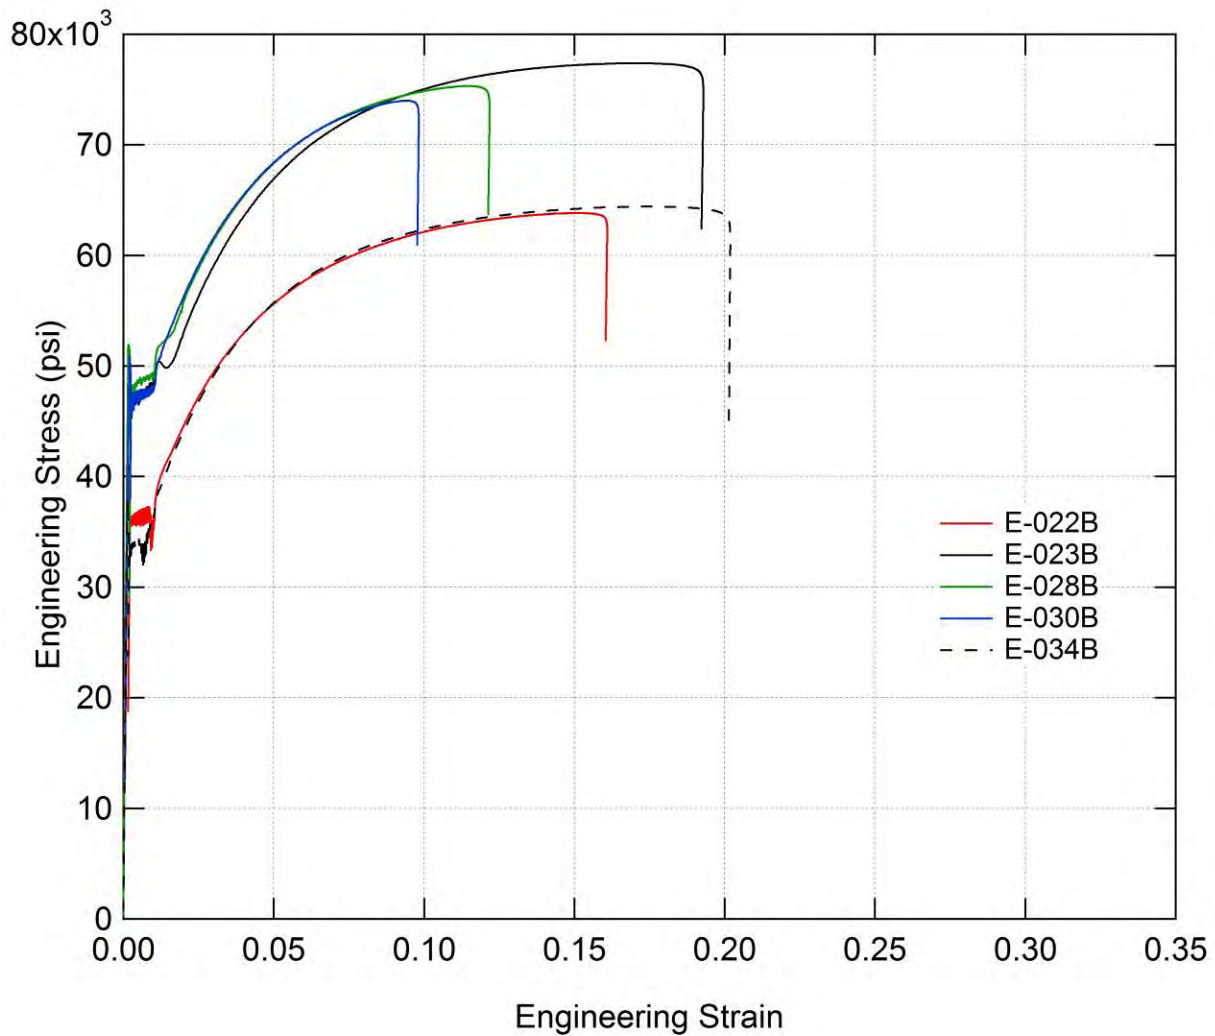
Figure 38 Stress-strain curves from tests performed on specimens machined from 8-inch pipe sections. Tabulated values of tensile strength, yield point, and total elongation are listed in Table 10.

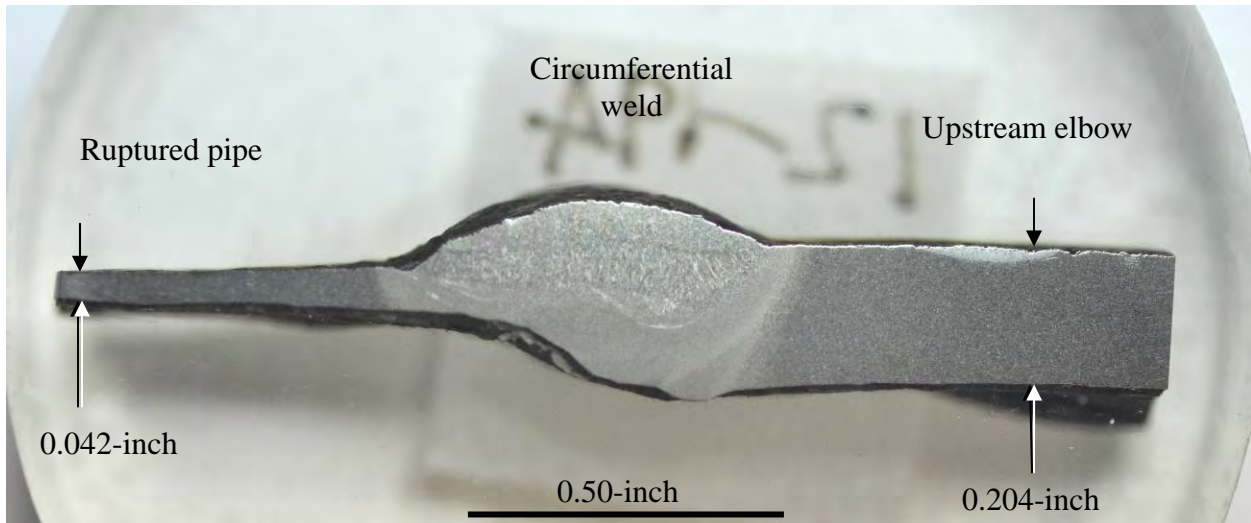
Figure 43 Photographs of the locations from which specimens of the ruptured pipe and upstream elbow were sectioned from sample E-017 for metallography.

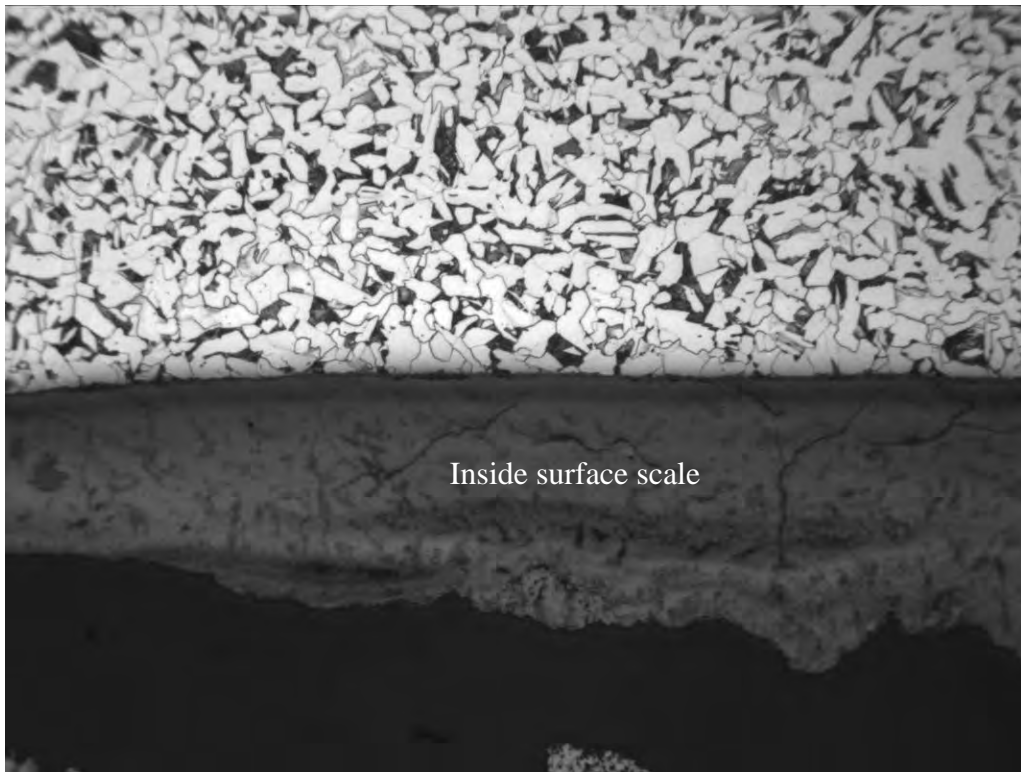
(a) Ruptured pipe, location labeled  $\alpha$  in Figure 44b 100X

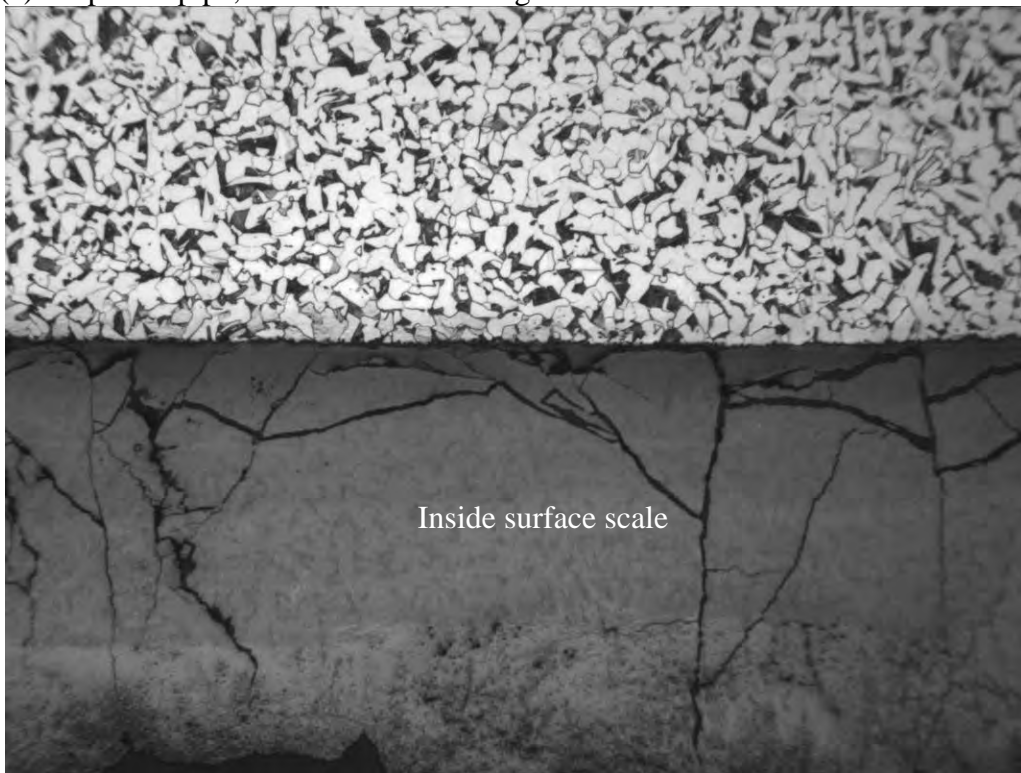
(b) Upstream elbow, location labeled  $\beta$  in Figure 44b 100X

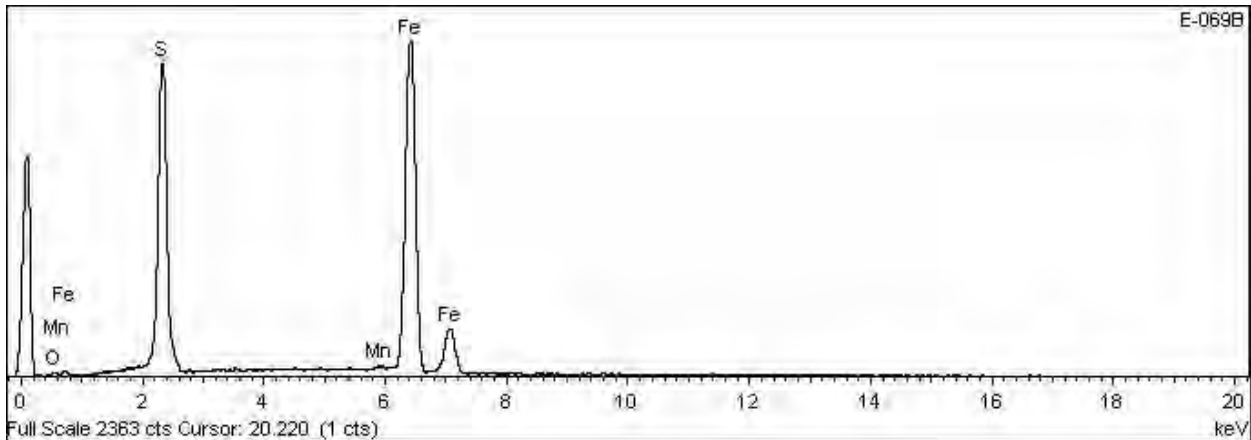
(a) Spectrum from specimen E-069B

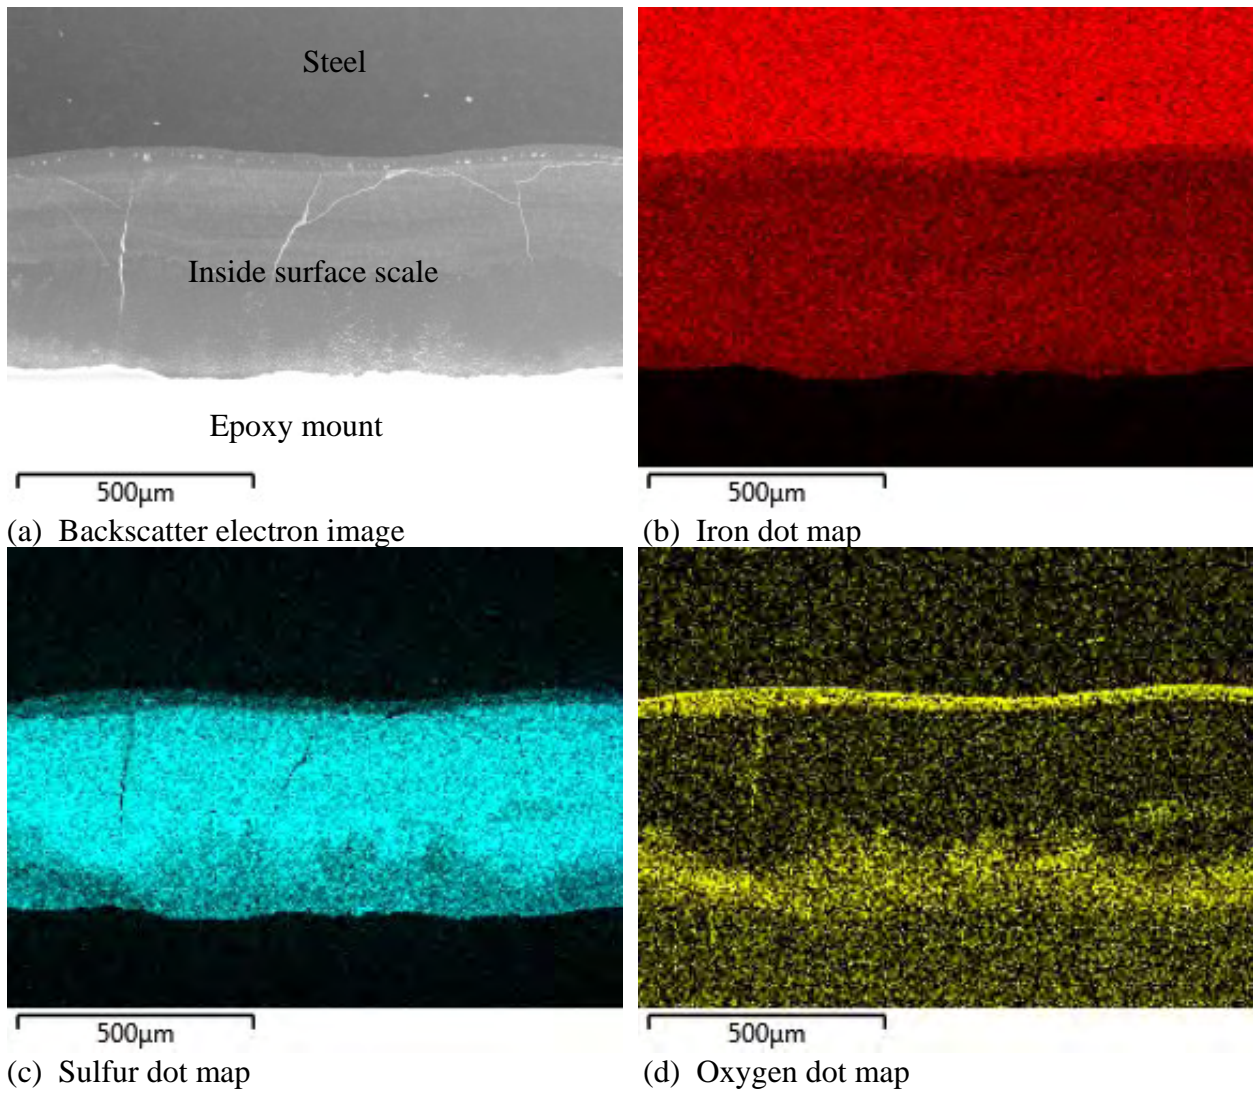
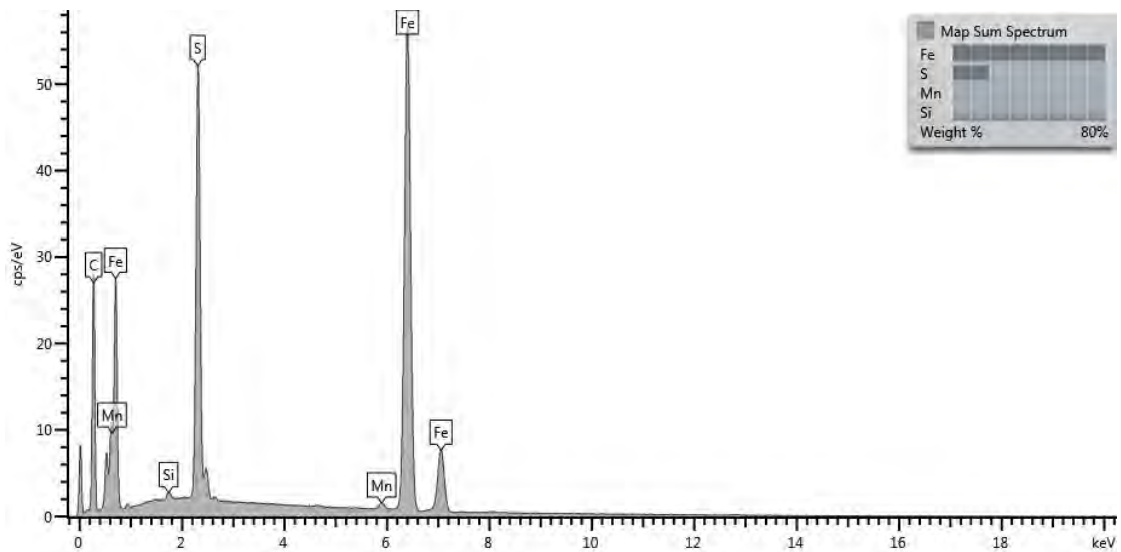
(e) Figure 57 EDS dot maps and total map spectrum from polished specimen E-023B.

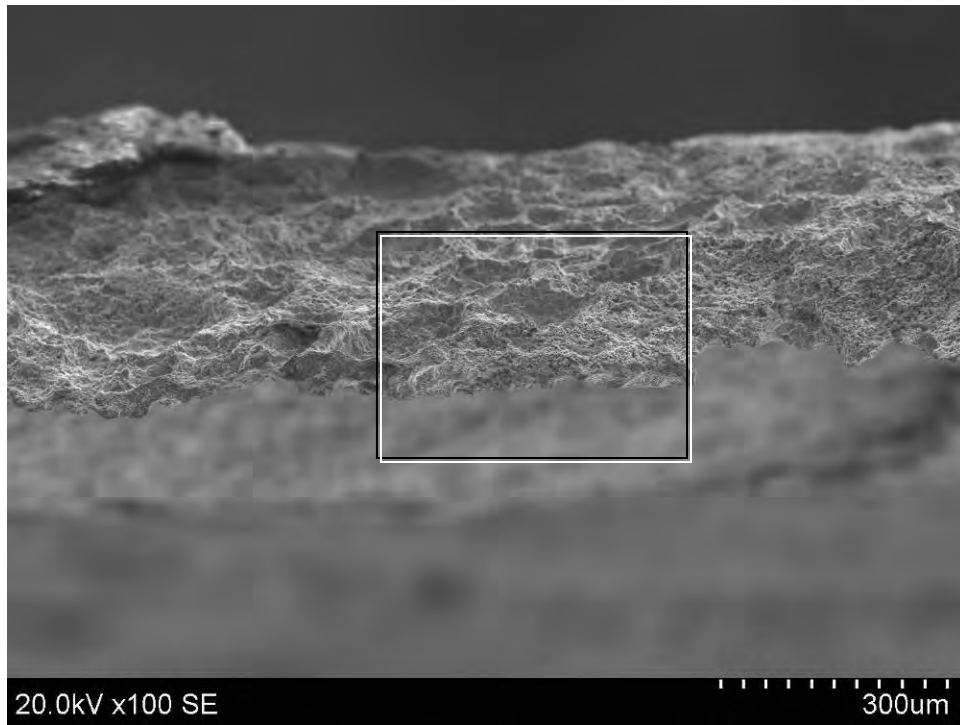
Figure 58 SEM micrographs of the rupture edge of sample E-017-1 after cleaning in Micro90™ with ultrasonic agitation.

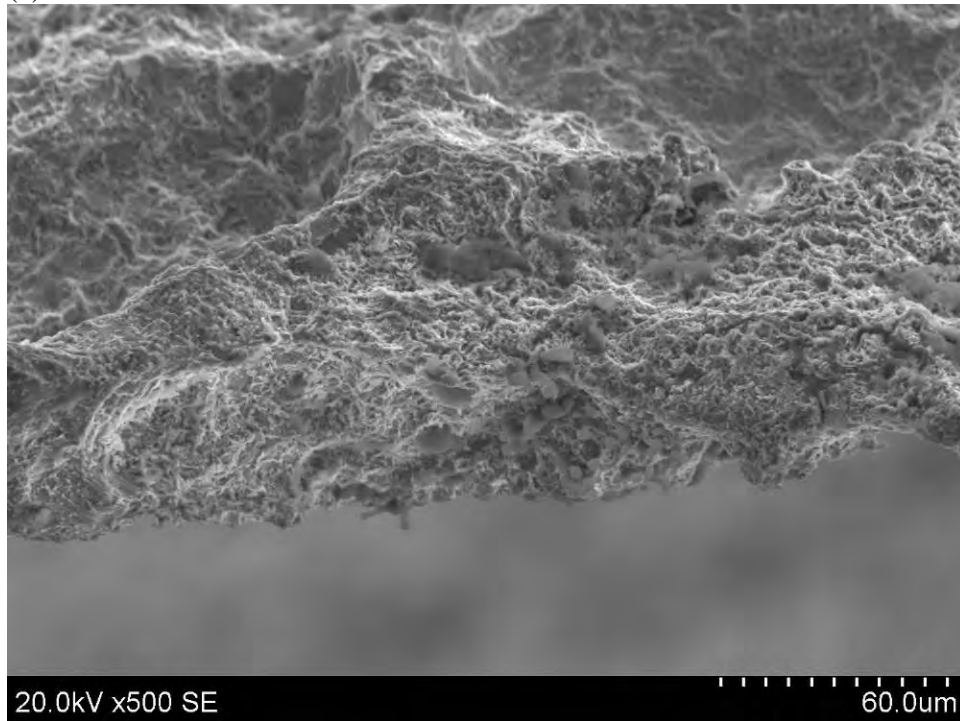
(b) Boxed area in (a)

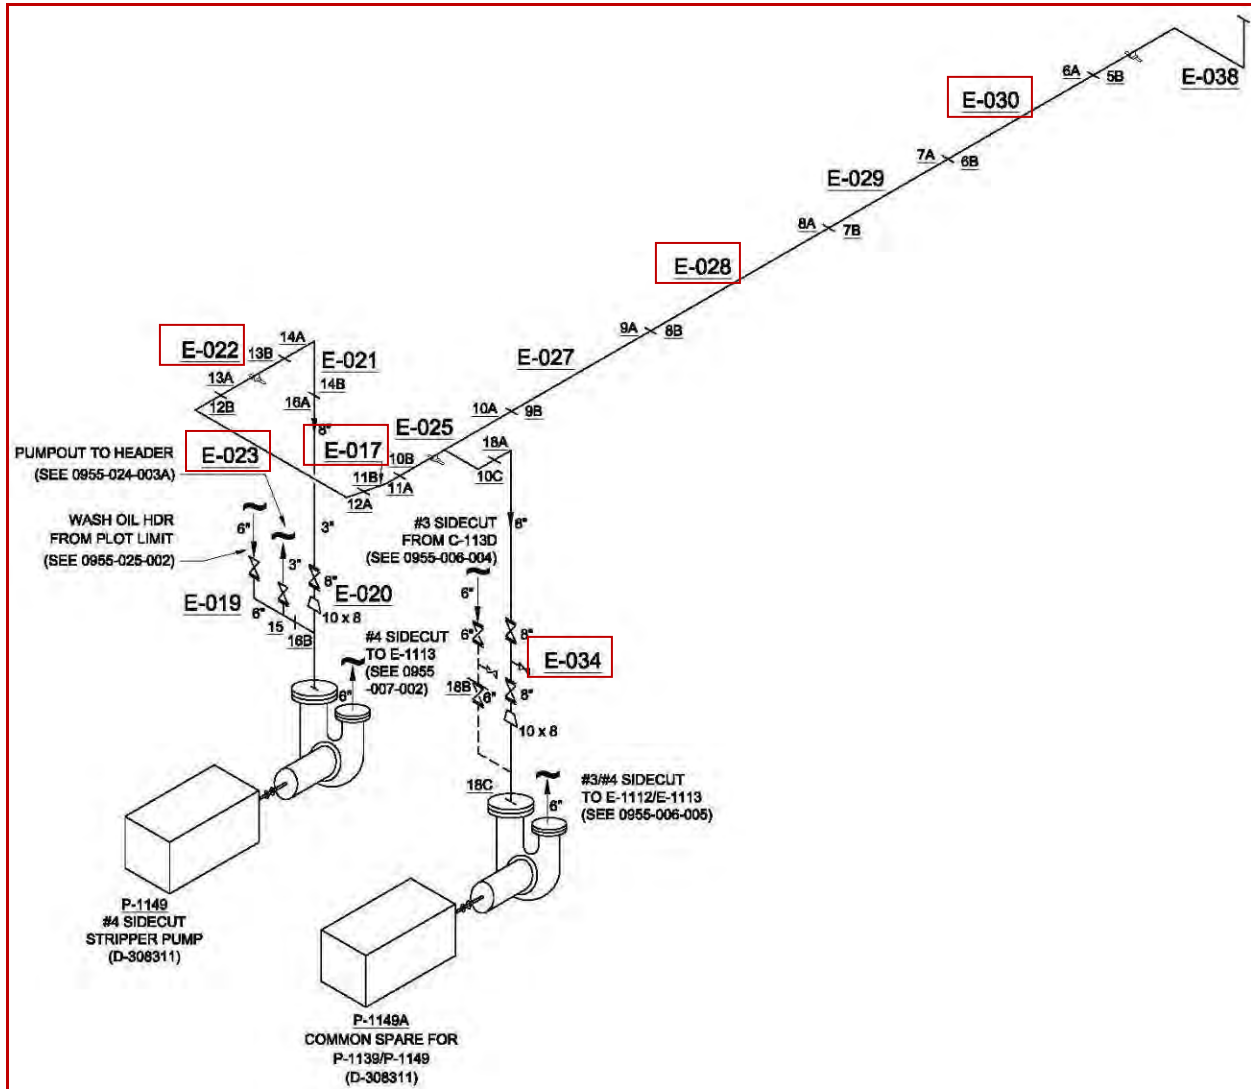
8-inch Pipe Measured Wall Thickness <sup>A</sup>  
(Nominal wall thickness of 8-inch Schedule 40 is 0.322-inch.)

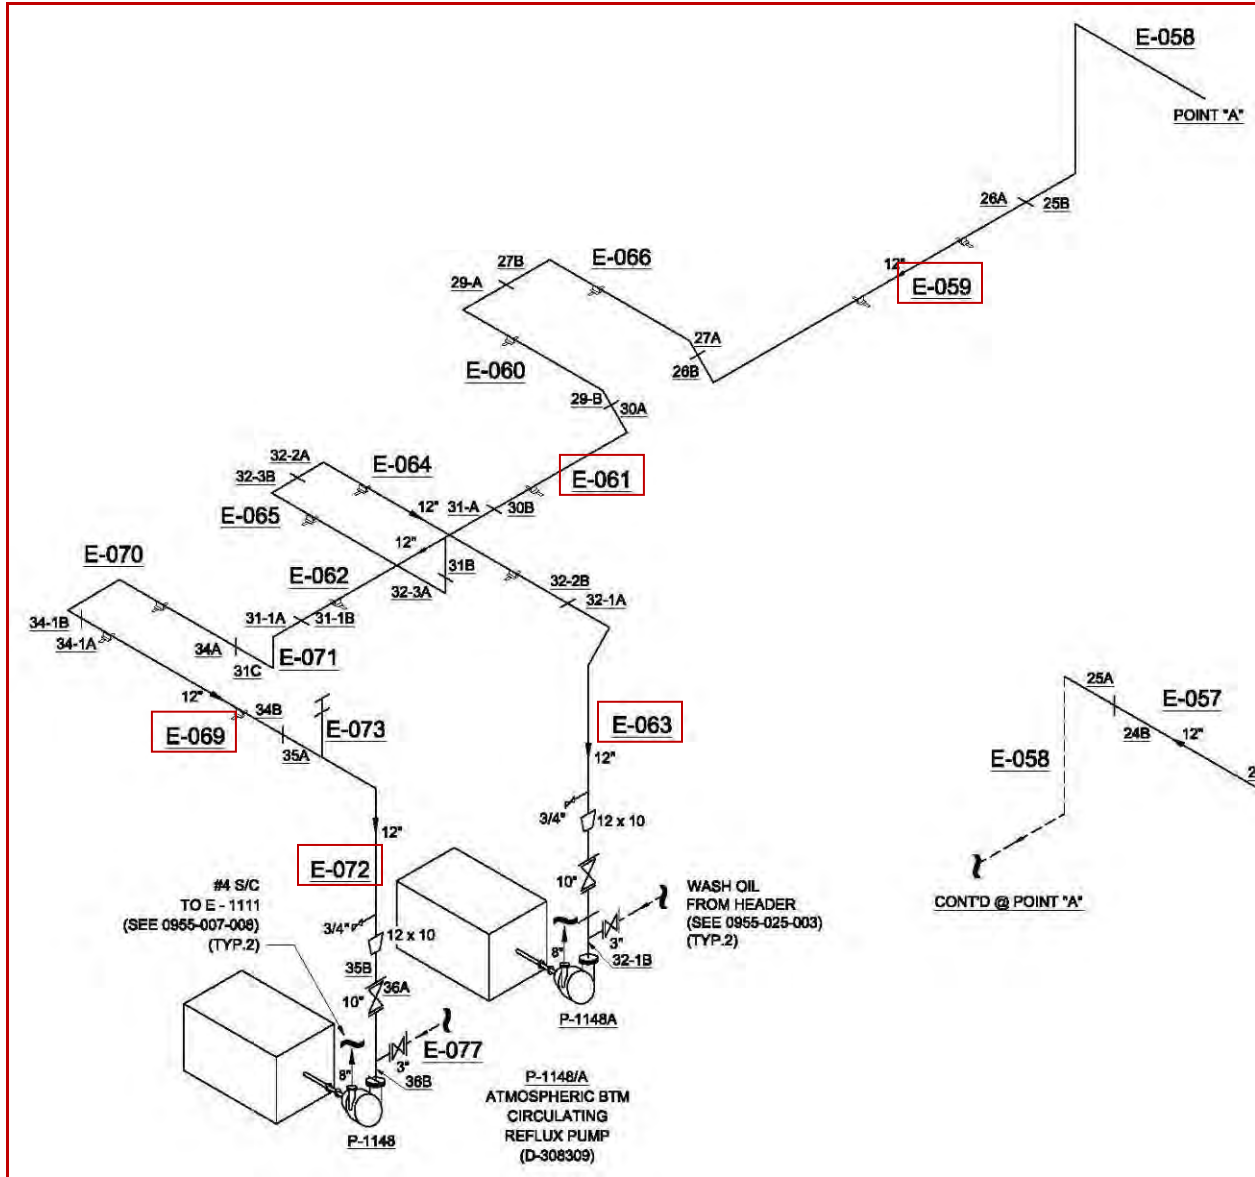
12-inch Pipe Measured Wall Thickness <sup>A</sup>  
 (Nominal wall thickness of 12-inch Schedule 40 is 0.406-inch.)
