**Anamet, inc** *Materials Engineering & Laboratory Testing*

26102 EDEN LANDING ROAD, SUITE 3 • HAYWARD, CALIFORNIA 94545 • (510) 887-8811 • FAX (510) 887-8427

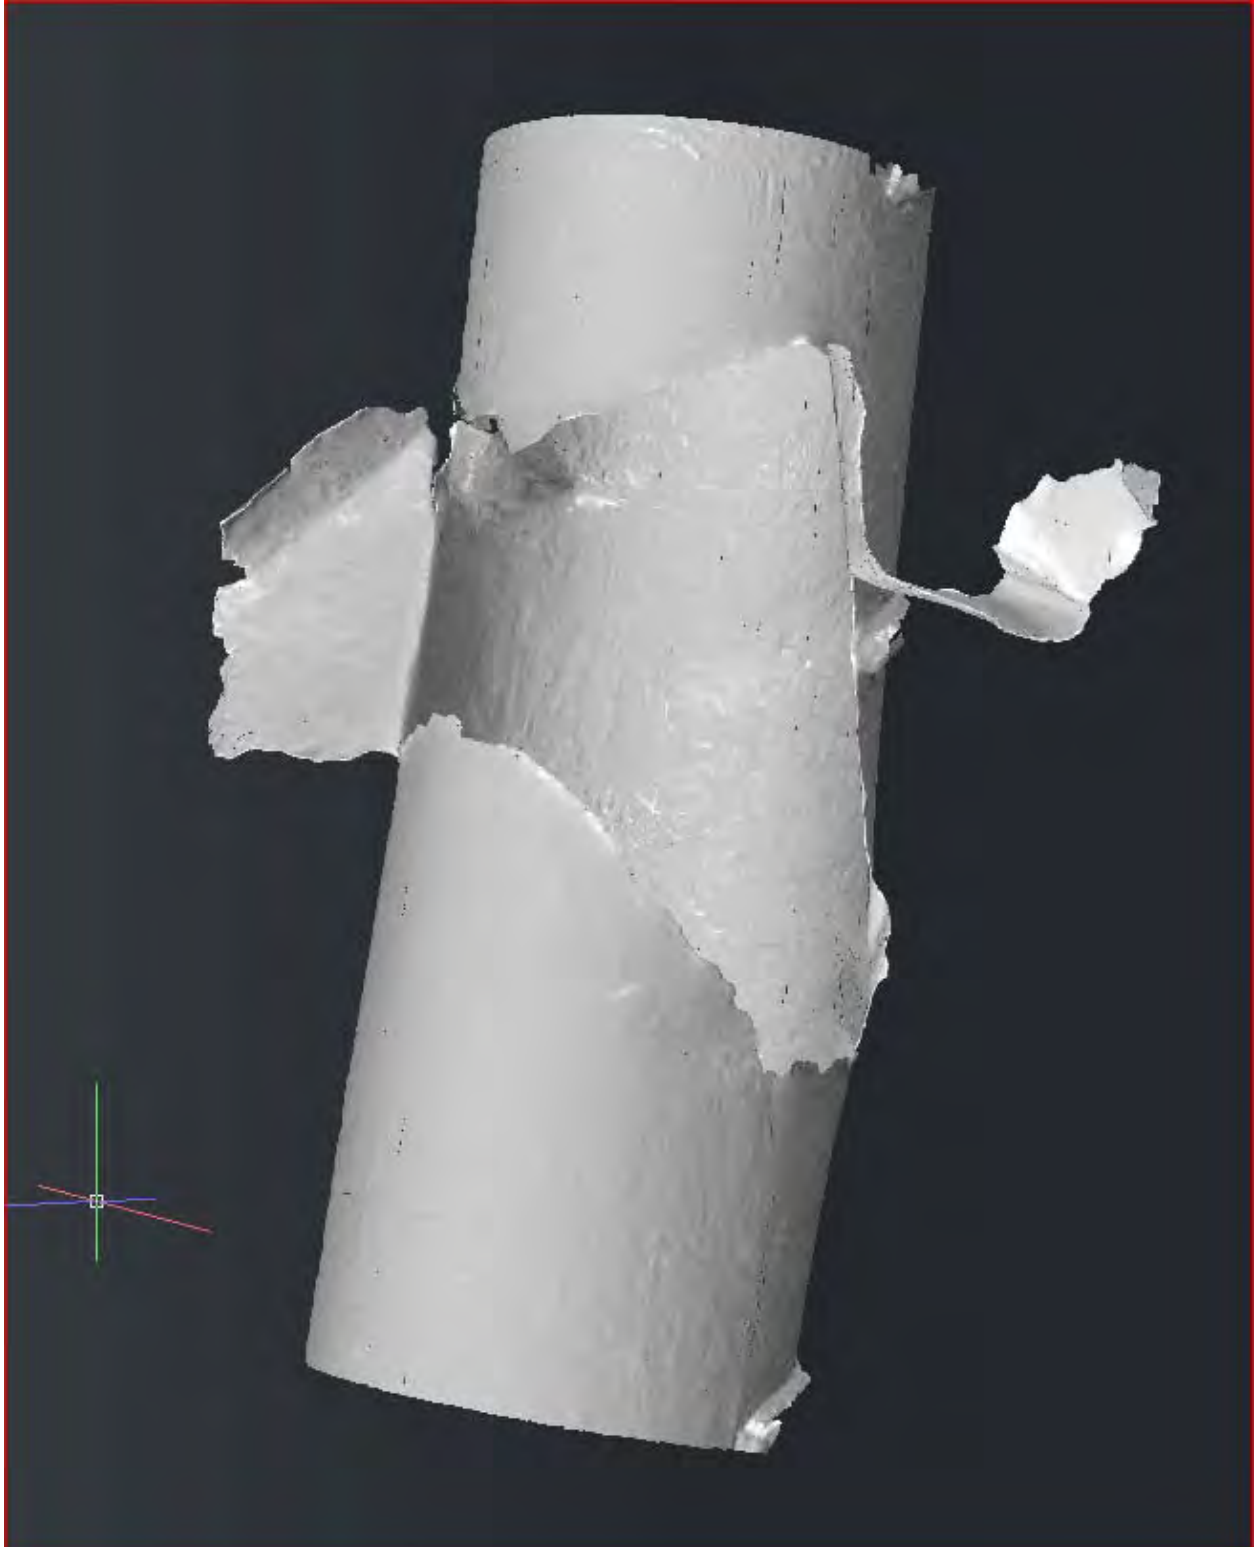
Appendix D  
XRD results 8-inch and 12-inch side –cut samples
