ANALYSIS OF NAPTF TRAFFIC TEST DATA
FOR THE FIRST-YEAR RIGID PAVEMENT TEST ITEMS

PRESENTED FOR THE 2002 FEDERAL AVIATION ADMINISTRATION AIRPORT
TECHNOLOGY TRANSFER CONFERENCE

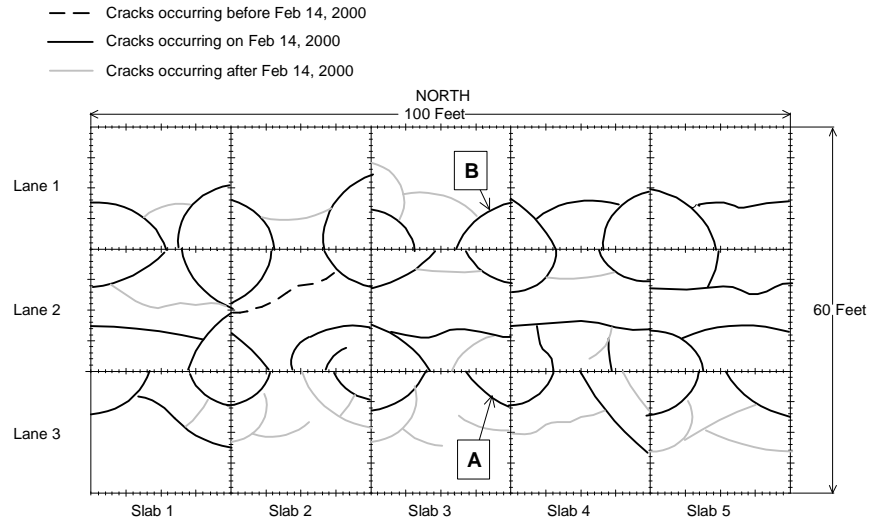
(a) Test Item HRS (after 236 passes)

Twenty-eight passes of the test vehicle were applied on February 14, 2000. After completion of the initial twenty-eight passes, corner cracks were observed in test items MRS and HRS. No corner cracks were found in LRS after the first 28 passes. However, longitudinal cracks were observed in all slabs in lane 2 of LRS (except for slab 5, where the longitudinal crack was not observed until the following morning, on February 15, 2000). In March 2000, traffic tests were resumed and continued until all the slabs cracked. Ultimately, several slabs were cracked into five and even six pieces as shown in Figure 4. Corner cracks appeared in LRS during the resumed phase of testing (Figure 4c).

Figure 4. Pattern of Cracks Observed in Rigid Test Items

Figure 7 gives evidence of when and how the corner crack, indicated by “A” in Figure 4(a), developed.

Gages CSG – 173 (top) and CSG – 192 (bottom) displayed unusually high strain readings attributed to cracking through the strain gage location. The high strain values for pass 1 are consistent with large displacements associated with slab cracking. For example, the peak strain value recorded for pass 1 is 0.22×10^{-3} (Figure 7b). This is a tensile strain measured near the top of the slab at the transverse joint location. For comparison, if the modulus of elasticity of the concrete is estimated as 6,000,000 psi (41,370 MPa), and the actual concrete flexural strength is estimated conservatively as 1000 psi (6.89 MPa), then the tensile strain at the gage depth needed to cause rupture of the concrete is

or about half of the actual recorded strain at the gage. The factor $(3/4.5)$ in the above calculation is needed to adjust for the difference between the 1/2 in. (3.8 cm) embedded depth of the sensor and the extreme fiber (top surface) of the slab. Based on the above analysis, it was verified that crack A in Figure 4(a) initiated near the longitudinal joint and extended through the slab to the transverse joint during the first pass of the vehicle. Similar analyses showed that the majority of corner cracks identified in HRS lane 3 also developed during the first vehicle pass.

Figure 9 shows selected strain time histories for a strain gage (CSG-50) located along the north longitudinal joint in test item HRS. This sensor is located near crack B as shown in Figure 4(a). Four curves are presented: two for traffic in the west-to-east direction (Figure 9a) and two for traffic in the east-to-west direction (Figure 9b). All four curves are based on the same gear lateral position, with one line of tires in the six-wheel carriage tracking closely along the longitudinal joint (see Figure 3). Taken together, the four curves suggest that corner crack B developed after pass 6 but before pass 24. The strain histories for passes 24 and 25 are highly degraded in comparison with the corresponding strain histories for passes 5 and 6, which is consistent with the probable cracked condition of the slab during the later passes. That cracking did not occur at this location prior to or during pass 5 is clear because pass 6 essentially duplicated (in reverse) the strain history associated with pass 5, indicating that the slab still had structural integrity.

As shown in Figure 4(a), corner crack C extends from the longitudinal joint to the transverse joint in lane 1. Figure 10 presents selected strain records for the strain gage (CSG-12) at the approximate location where crack C intersects the transverse joint. Strain records are shown for four consecutive passes of the vehicle, passes 9 through 12. Based on analysis of these strain records, it is believed that crack B initiated at the transverse joint during pass 10 (maximum strain developed in Figure 10) and was extended continuously during subsequent passes 11 and 12. It is believed that the crack progressed from the transverse joint toward the longitudinal joint during this loading phase. Similar analyses of other strain records in lane 1 of test item HRS (six-wheel load) indicate that all cracks in that area started after pass 9.

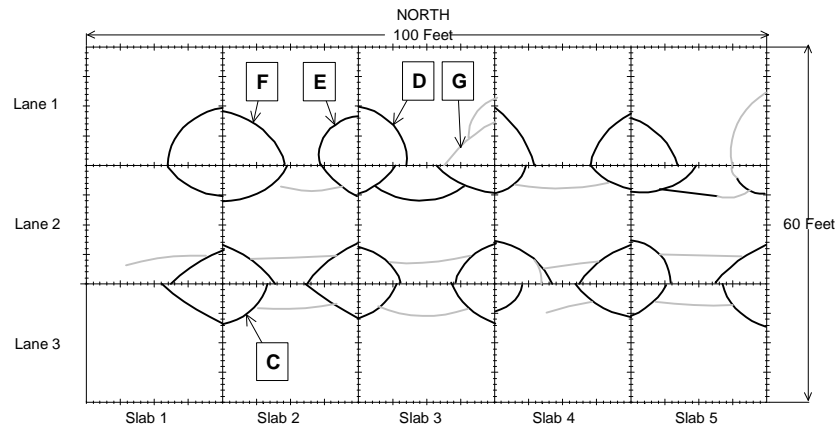
(b) Test Item MRS (after 646 passes)

Figure 8 compares strain measurements in test item MRS for a pair of strain gages (CSG – 473, bottom, and CSG – 474, top) located at a point along the south longitudinal joint as indicated in Figure 2. The corner crack at location C in Figure 4(b) occurred during pass 1, as indicated by the sharp change in the shape of the tensile strain response at 4.2 s of pass 1 (Figure 8a). Similar analyses of the other strain gages in MRS confirm that, as with HRS, the majority of corner cracks developed during the first or second pass of the vehicle. It is instructive to compare the strain readings in Figure 8 with the LRS strain curves in Figure 6, also recorded during passes 1 and 5. It was observed that for Figure 6 (LRS), the strains for pass 5 were higher than those for pass 1 due to the positive contribution of the interior line of tires. By contrast, in Figure 8 (MRS) the response for pass 5 is much smaller than that for pass 1. In the latter case, the contribution of the two interior wheels did not increase the response, simply because corner crack C had already formed prior to pass 5.

A somewhat different situation was observed in lane 1 of test item MRS. On February 14, 2001, after the initial 28 vehicle passes, all slab corners in MRS along both longitudinal joints were observed to be cracked except for one corner (identified by G in Figure 4b). The corner crack (D) that appeared in the southwest corner of slab 3 crossed through strain gage CSG-156 (Figure 2), so it is reasonable to expect that the strains recorded by CSG-156 provide useful information about the cracking history of this slab. Figure 11 shows three strain records for CSG-156. The very large disparity in the magnitudes of the strains between passes 5 and 24 suggests that it was between those two passes that cracking initially occurred. It is interesting to note that the magnitudes of the peak strains recorded for passes 24 and 25 are far beyond the elastic range. Nevertheless, even in the postcracking environment the shapes of the strain curves are intelligible, and the peaks corresponding to the passage of each of the three tires can be identified readily.

Since no strain gage exists on slab 3` at the location where crack D intersects the transverse joint, it is impossible to determine from the available information whether this crack initiated at the transverse or at the longitudinal joint. Crack D might have initiated from the longitudinal joint side during pass 6, or alternatively, from the transverse joint during either pass 9 or pass 10. Either possibility is consistent with the data in Figure 11 and other strain records.

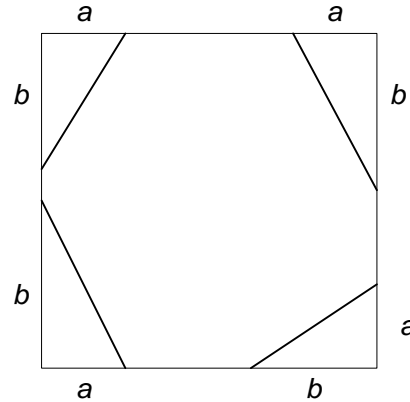
Figure 5 shows a typical corner cracked slab and defines the dimensions used in reporting crack size. The lengths a and b of the two sides of the cracked corners were measured and the average values are listed in Table 1. Measurements showed that the HRS slabs exhibited the largest, and the LRS slabs exhibited the smallest, corner cracks. Furthermore, it was found that

Figure 5. Definition of Corner Crack Dimensions in Table 1

all pavement slabs were curled up at the corners, with the HRS slabs exhibiting the greatest amount of curling and the LRS slabs exhibiting the least amount of curling. The larger cracked corner areas observed on the HRS slabs are consistent with greater separation of the PCC slab corners from the econocrete base.

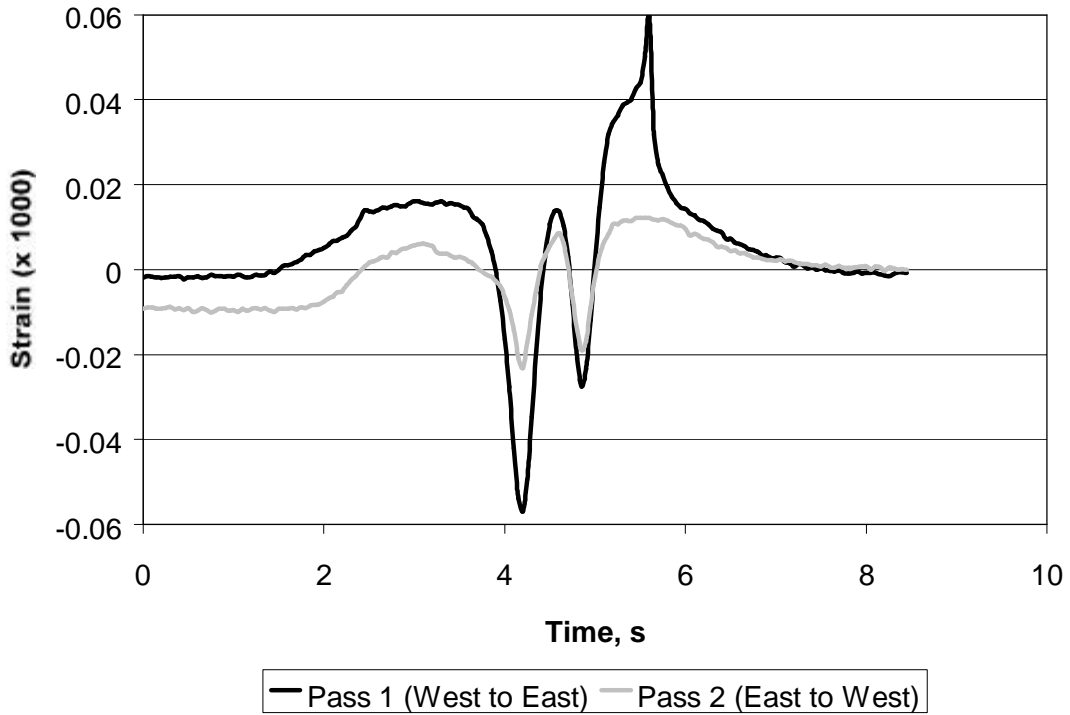
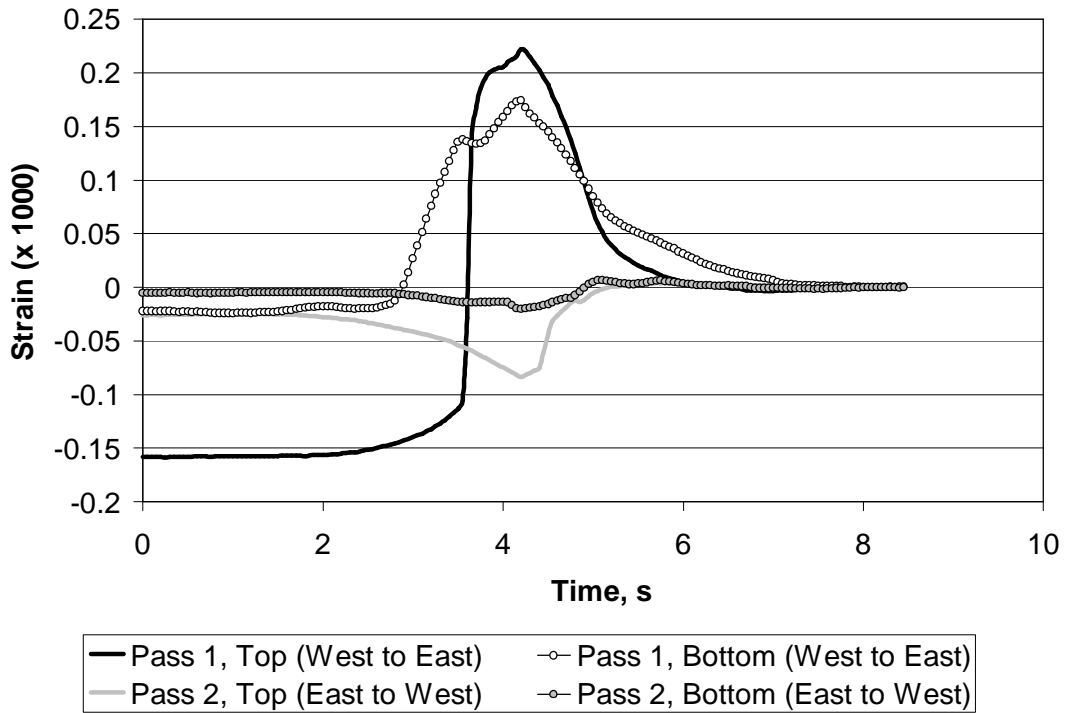
Figure 7. Strain Responses in Test Item HRS, Lane 3 (Four-tire Load). Strain responses show evidence of crack formation at the slab corner identified by “A” in Figure 4(a)

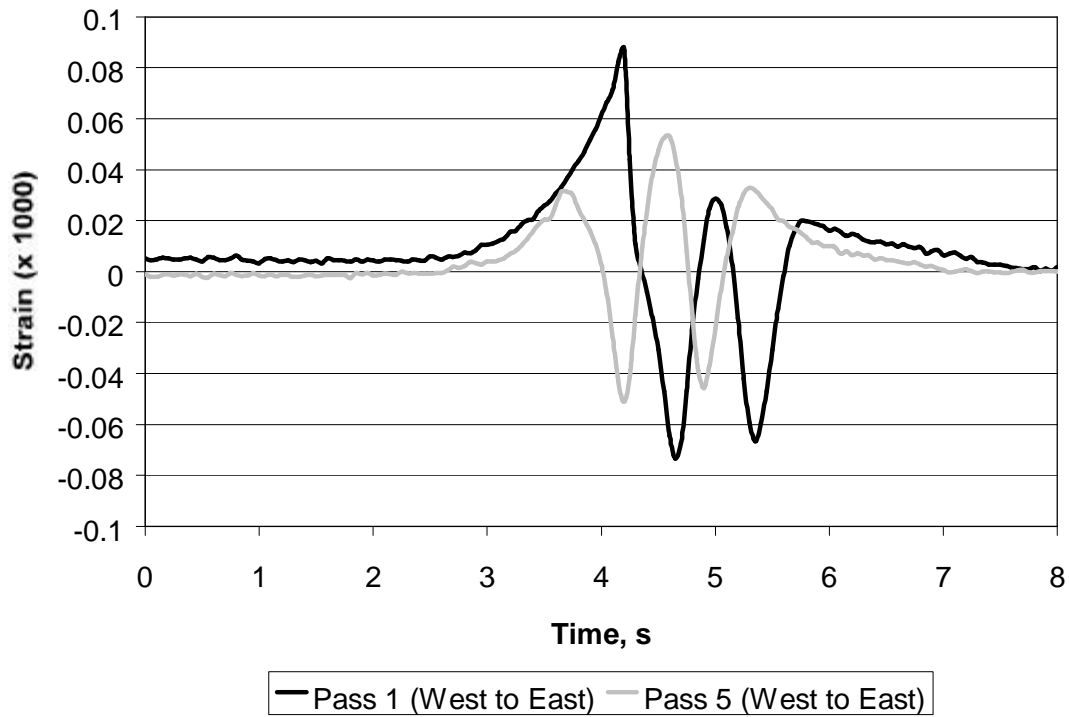
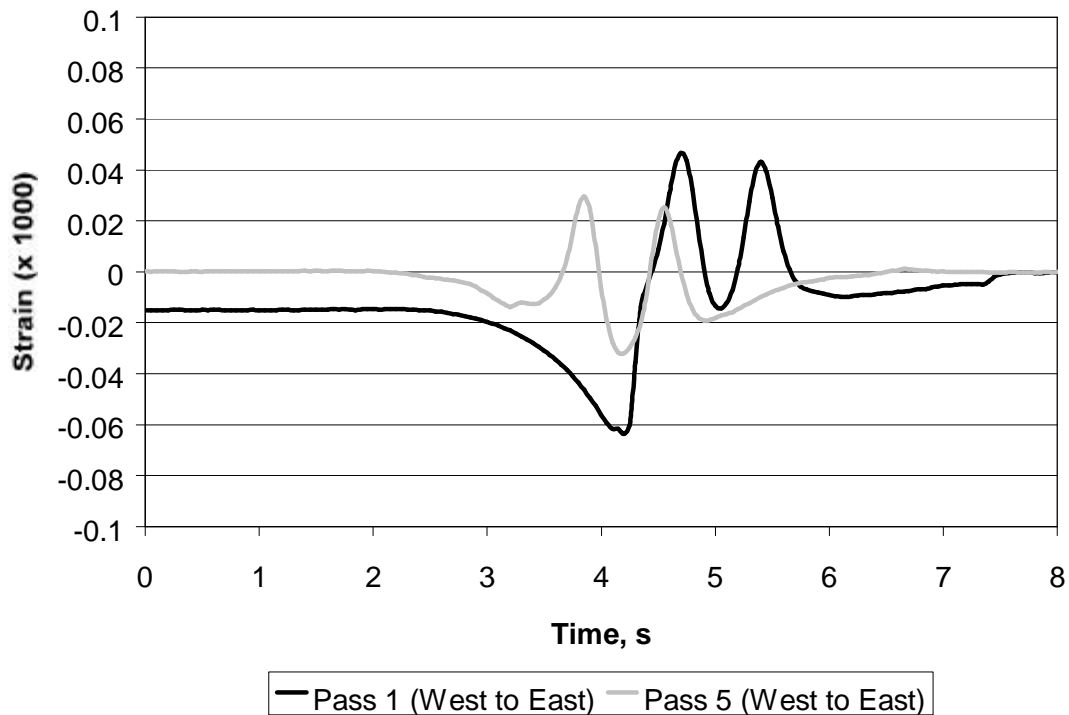
Figure 8. Strain Responses in Test Item MRS, Lane 3 (Four-tire Load). Strain responses show evidence of crack formation at the slab corner identified by “C” in Figure 4(b)

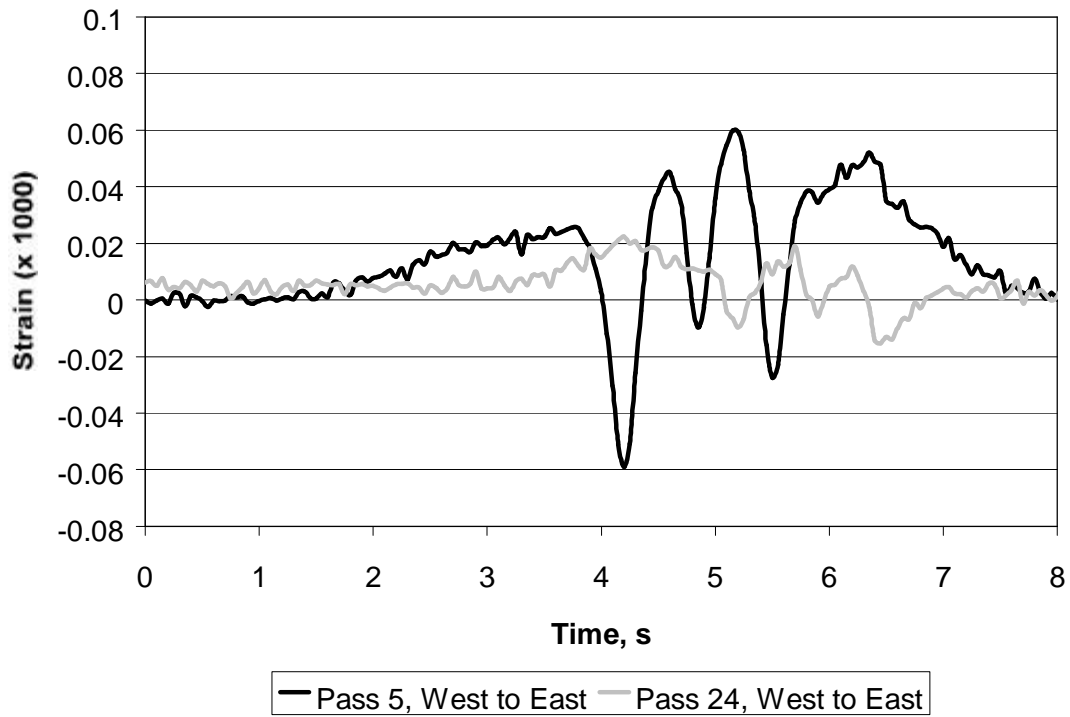
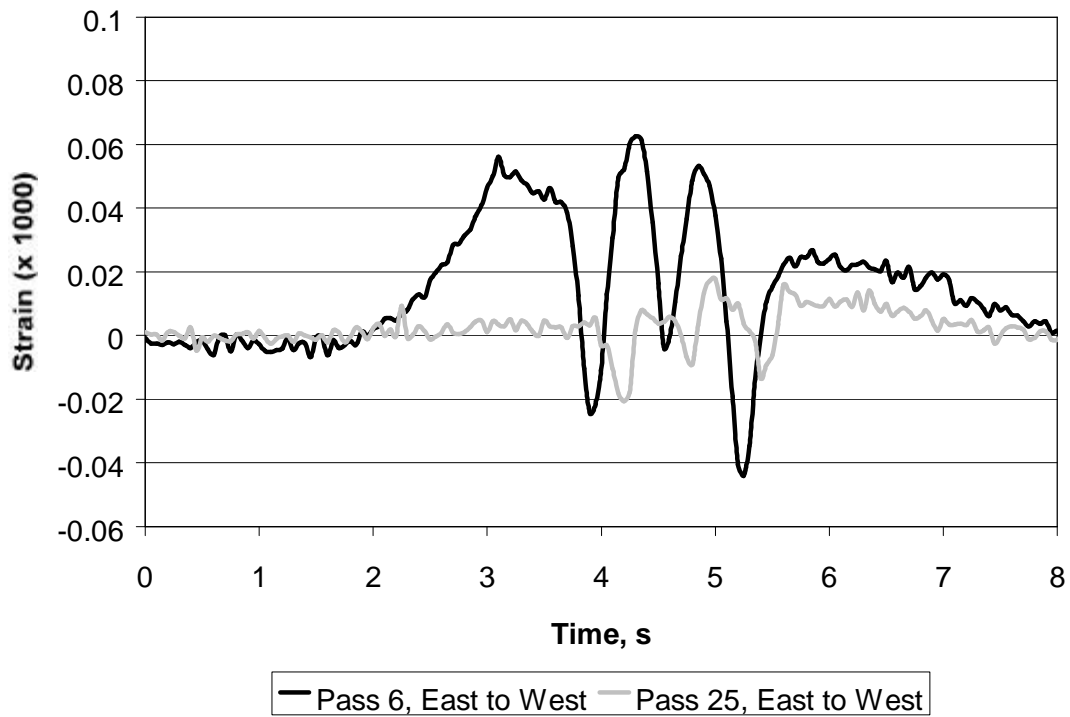
Figure 9. Strain Responses in Test Item HRS, Lane 1 (Six-tire Load)

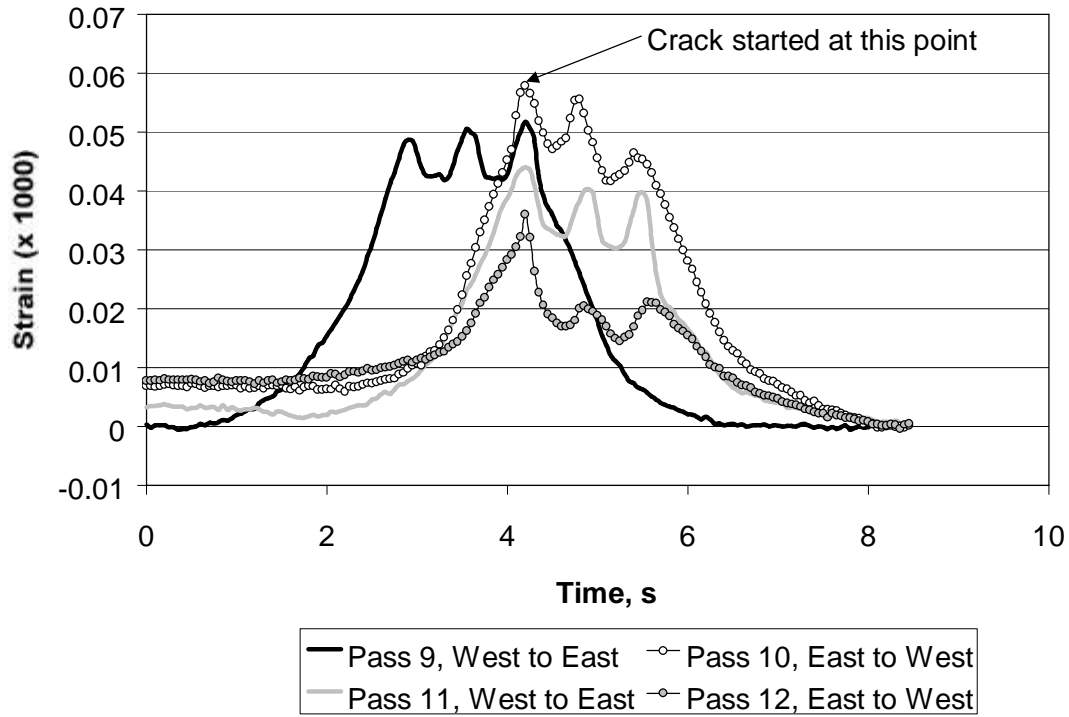
Figure 10. Strain Responses in Test Item HRS, Lane 1 (Six-tire Load). Strain gage at top of slab (CSG-12)

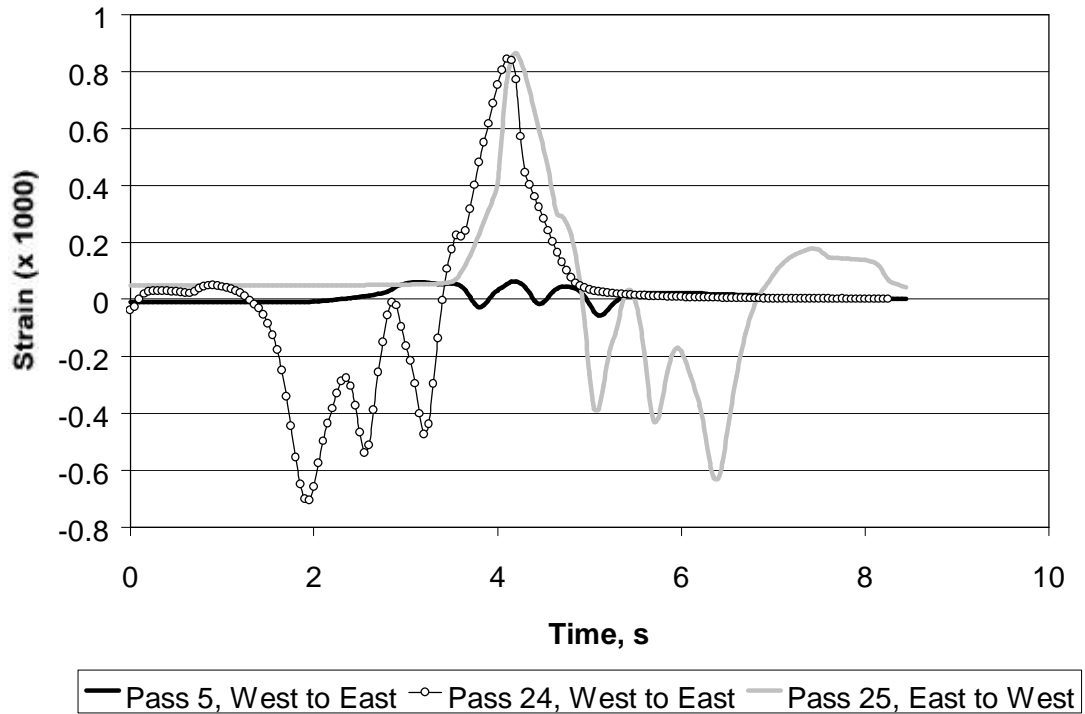
Figure 11. Strain Responses in Test Item MRS, Lane 1 (Six-tire Load). Strain gage at top of slab (CSG-156)
