# ANNUAL LANDFILL CAP OPERATION AND MAINTENANCE REPORT FOR 2010-2011

Parcel E-2, Industrial Landfill

Hunters Point Naval Shipyard, San Francisco, California

August 17, 2011

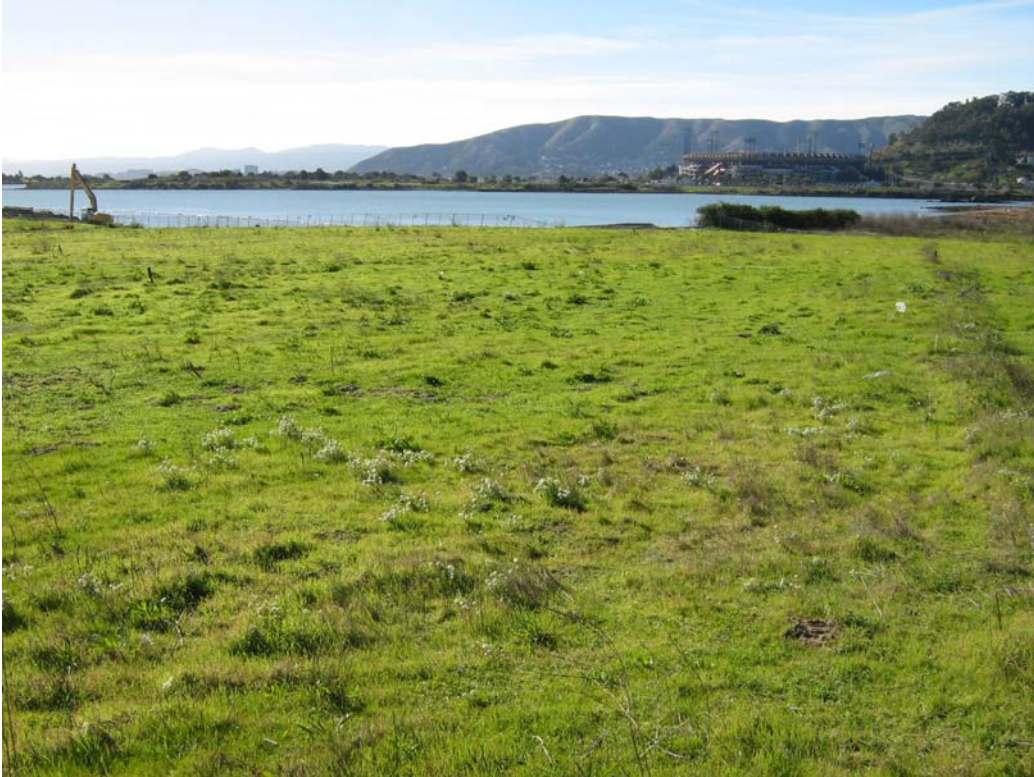
Facing west from landfill cap,  
December 30, 2010 quarterly inspection.

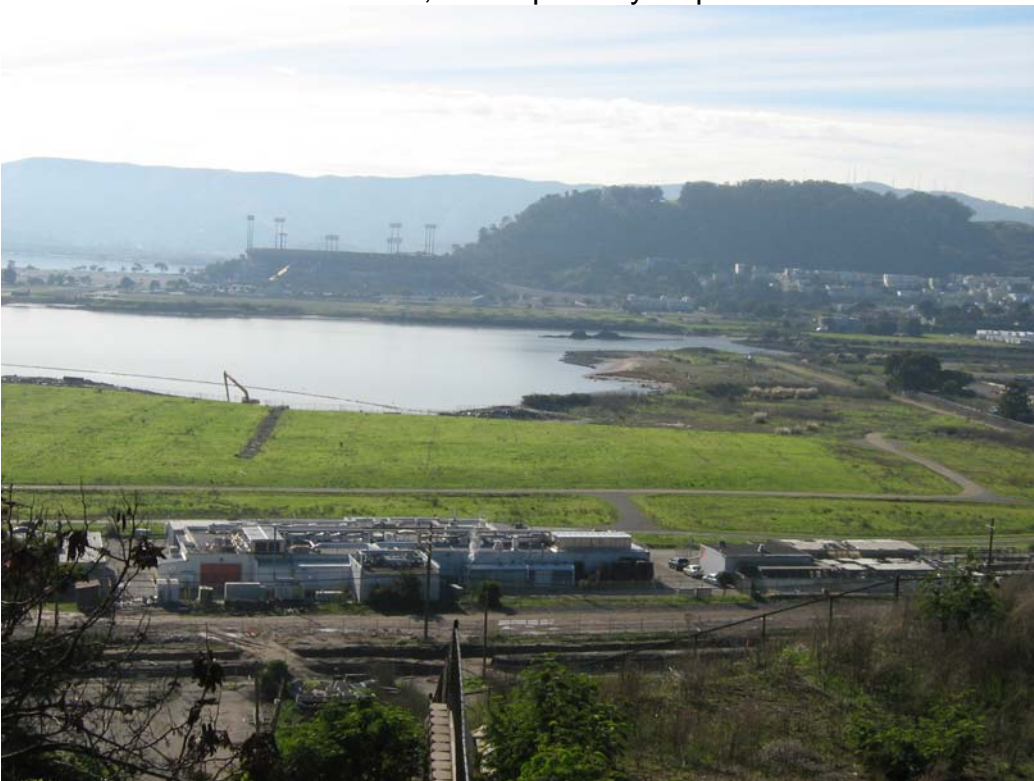
Facing west from hill overlooking Parcel E-2,  
December 30, 2010 quarterly inspection.

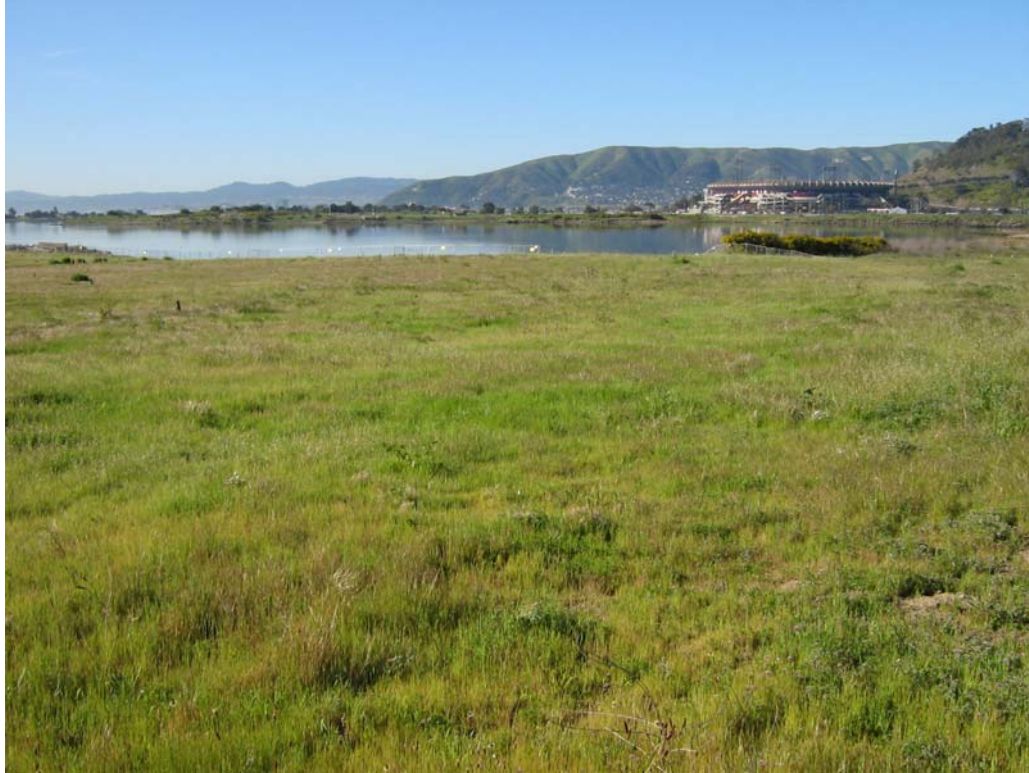
Facing west from landfill cap,  
March 31, 2011 quarterly inspection.

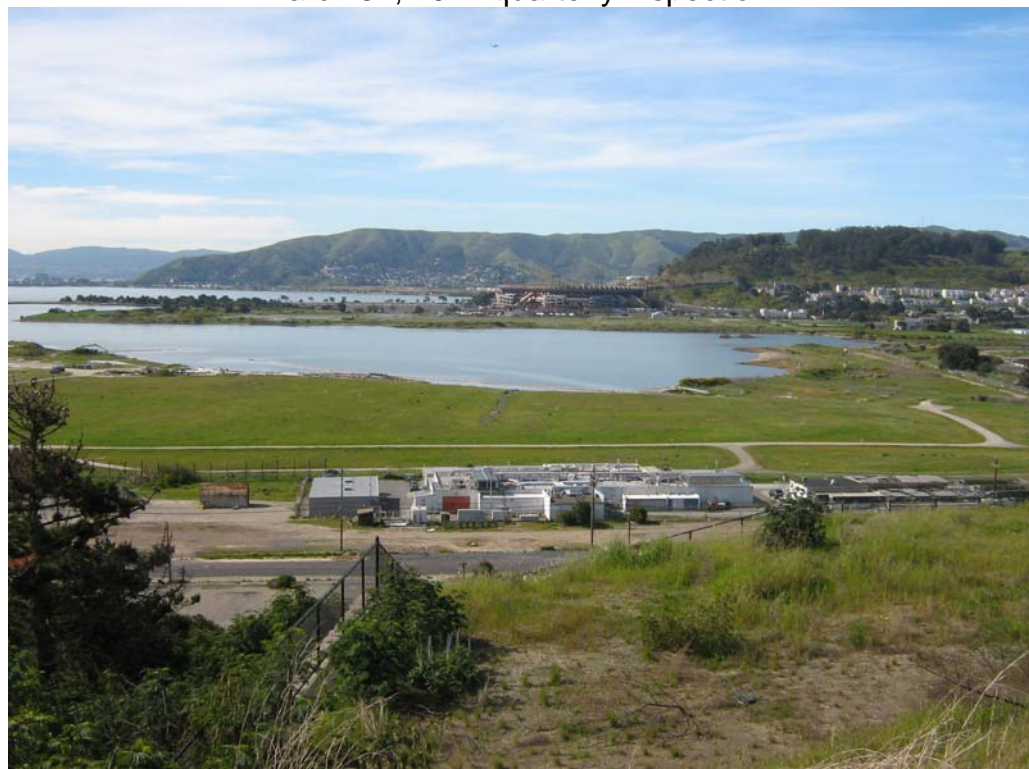
Facing west from hill overlooking landfill cap,  
March 31, 2011 quarterly inspection.

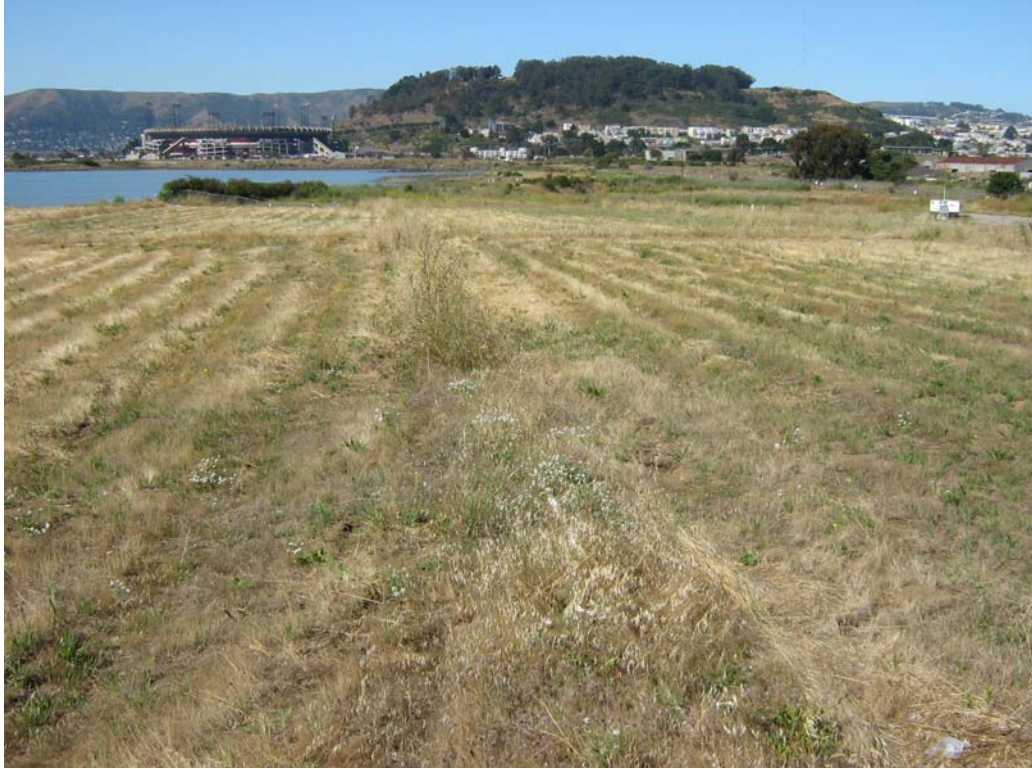
Facing west from landfill cap,  
June 30, 2011 quarterly inspection.

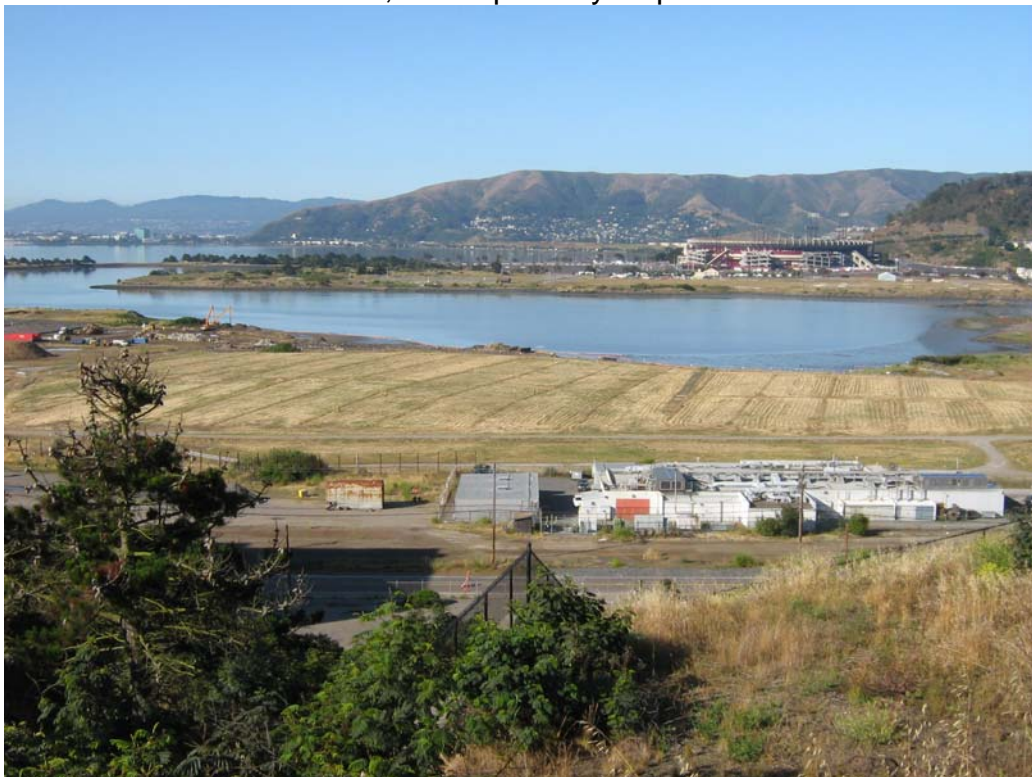
Facing west from hill overlooking landfill cap,  
June 30, 2011 quarterly inspection.

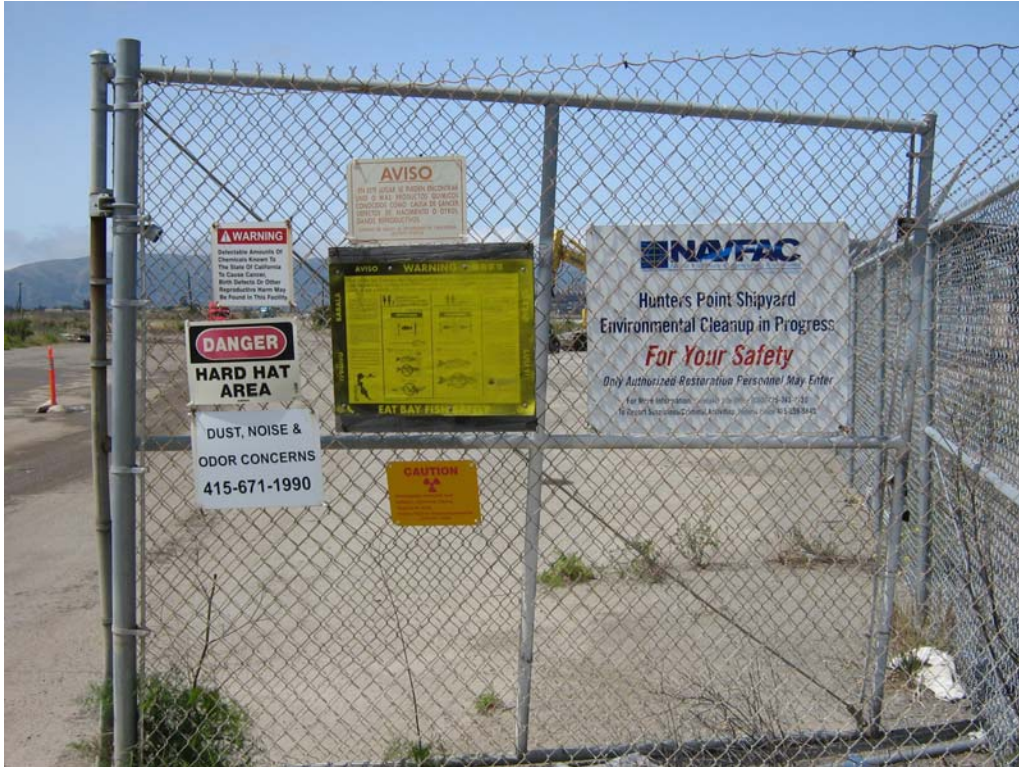
Signs at main entrance to Parcel E-2

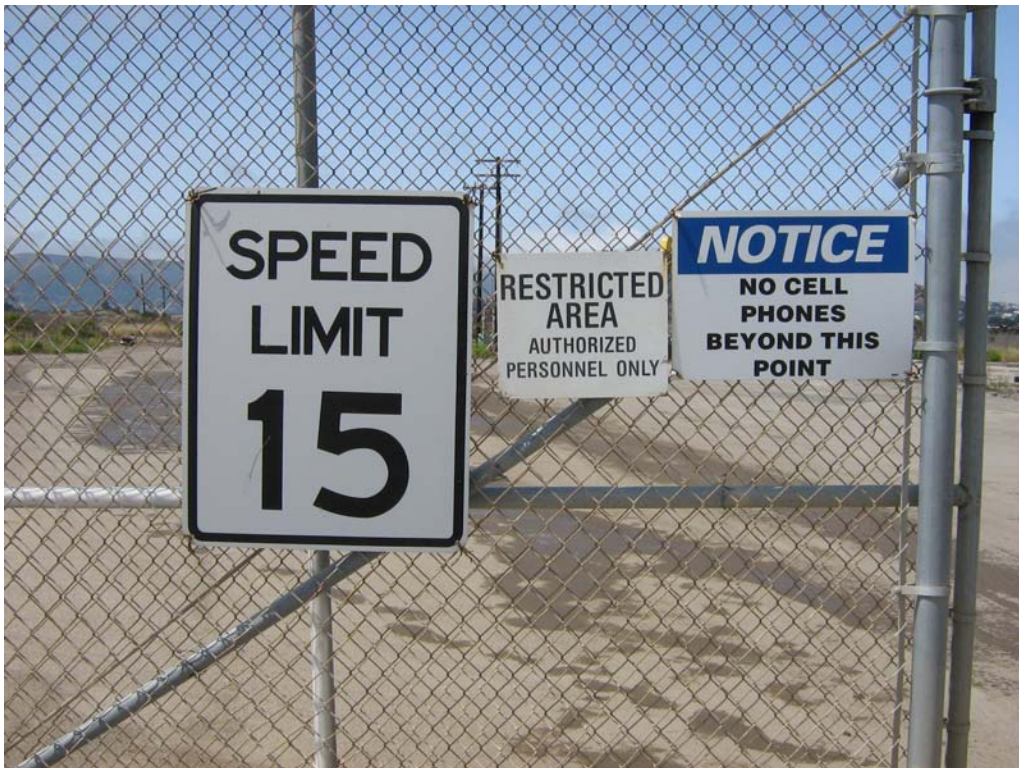
Signs at main entrance to Parcel E-2

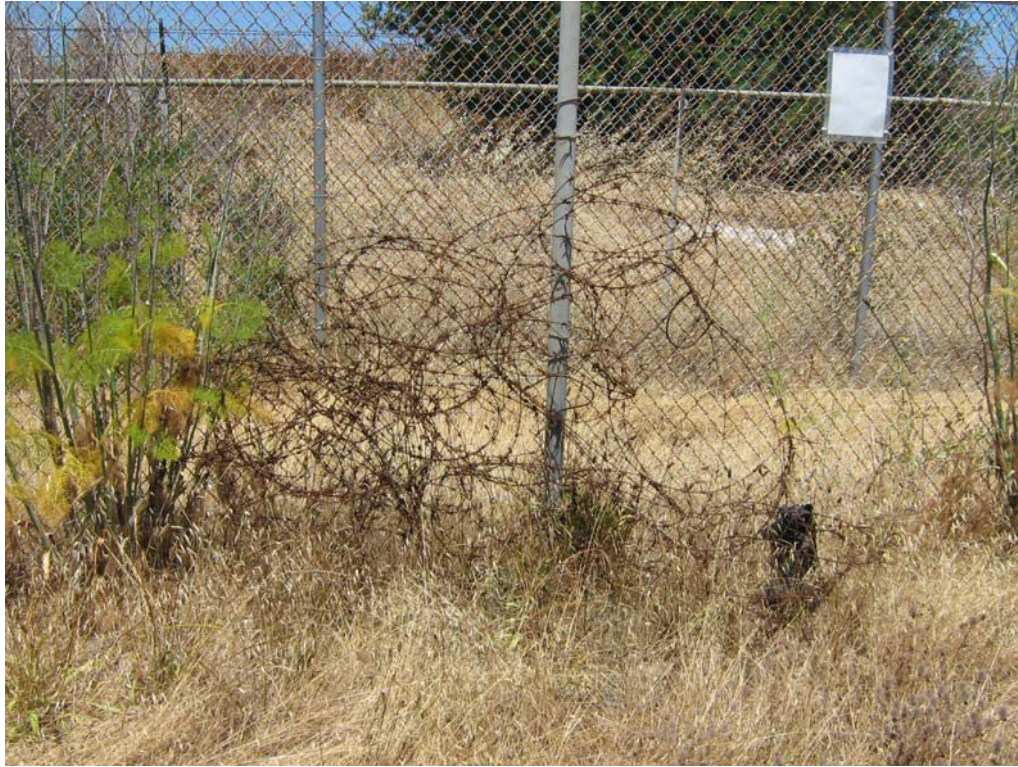
Repaired section of northwest perimeter fence for Parcel E-2.

As the security fencing around the landfill is a safety issue according to the OMP, the fences were checked during general site inspections, and informally throughout the year for any damage that might allow public access to the site (Appendix A). Whenever breaches were encountered, the HPNS CSO was notified of the situation and the fence was repaired. Photos of some of these repairs are included in Appendix C.

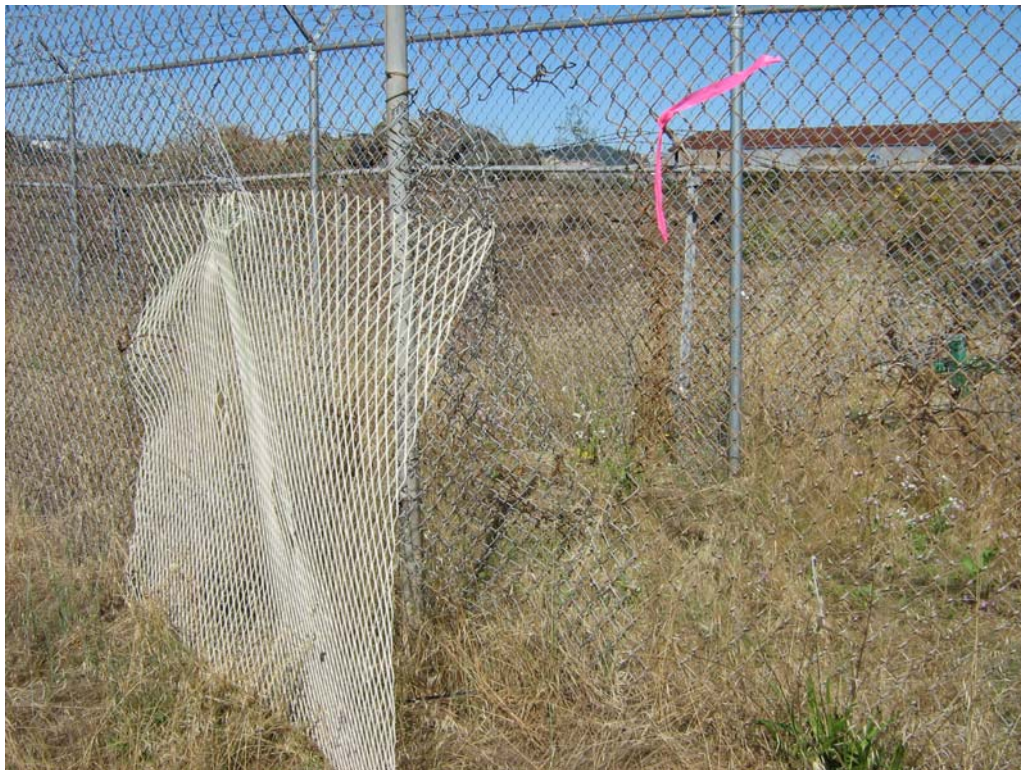
The Parcel E property fence restricts public access to the landfill site. During general site inspections, the fences were checked for any damage that might allow public access to the site (Appendix A). One breach in the fenceline was noted during the June 30, 2011, inspection; the CSO was notified that day of the breach. Photos of that damage, as well as some of the previous fence line repairs, are included in Appendix C (Inspection Photos).

Breached section of northwest perimeter fence for Parcel E-2,  
June 30, 2011 quarterly inspection.
