## Visual Streambank Assessment

### TOOKANY CREEK WATERSHED MANAGEMENT PLAN

Township of Cheltenham  
 Rock Creek Watershed

Assessed by the Tookany Creek Watershed Steering Committee Members

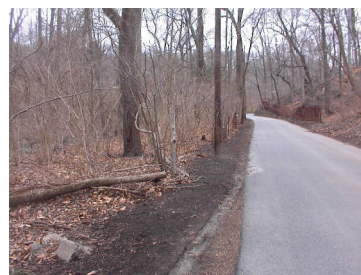
7. From Lorimer Drive to Washington Lane, for 1/3 mile the creek forms the southern border of Curtis Arboretum. The flowing stream regenerates itself. A spring feeds two ornamental ponds in the Curtis Arboretum before emptying into the creek.  
**Action/BMP** : Stop mowing around the spring areas to allow for native vegetation to persist in the riparian buffer to filter the runoff from the surrounding areas.

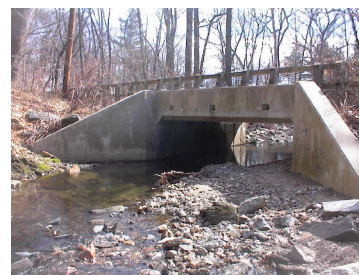
8. For the next half mile from Washington Lane to the Rock Lane bridge, the stream flows through a wooded valley with the lightly traveled Rock Lane close on its southern bank.  
**Action/BMP** : No action necessary; continue to maintain the land uses surrounding this area.
